ATK 32050

The following defects were noted on the sleeper car that was positioned as the third car behind the two locomotive train consist remaining upright.

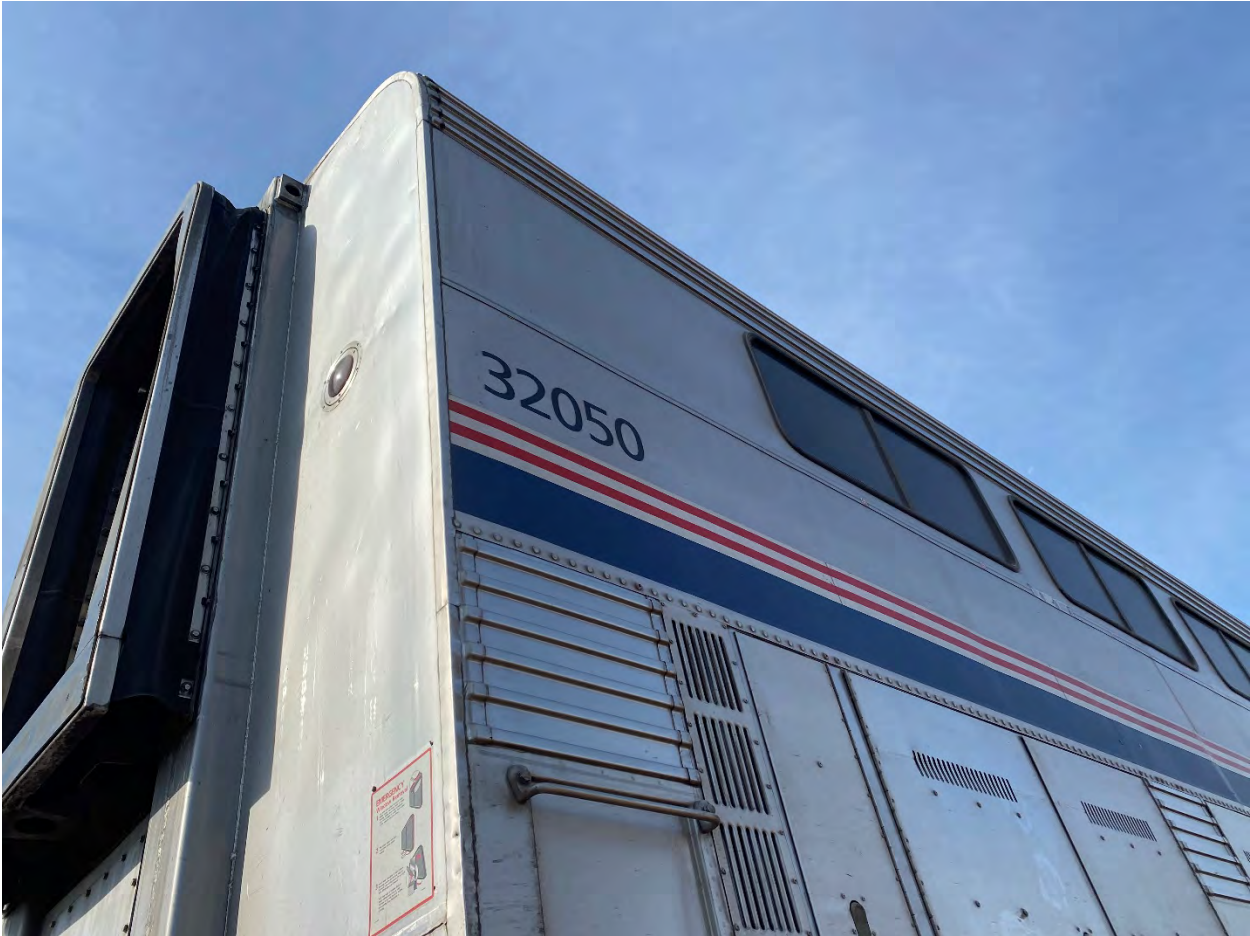
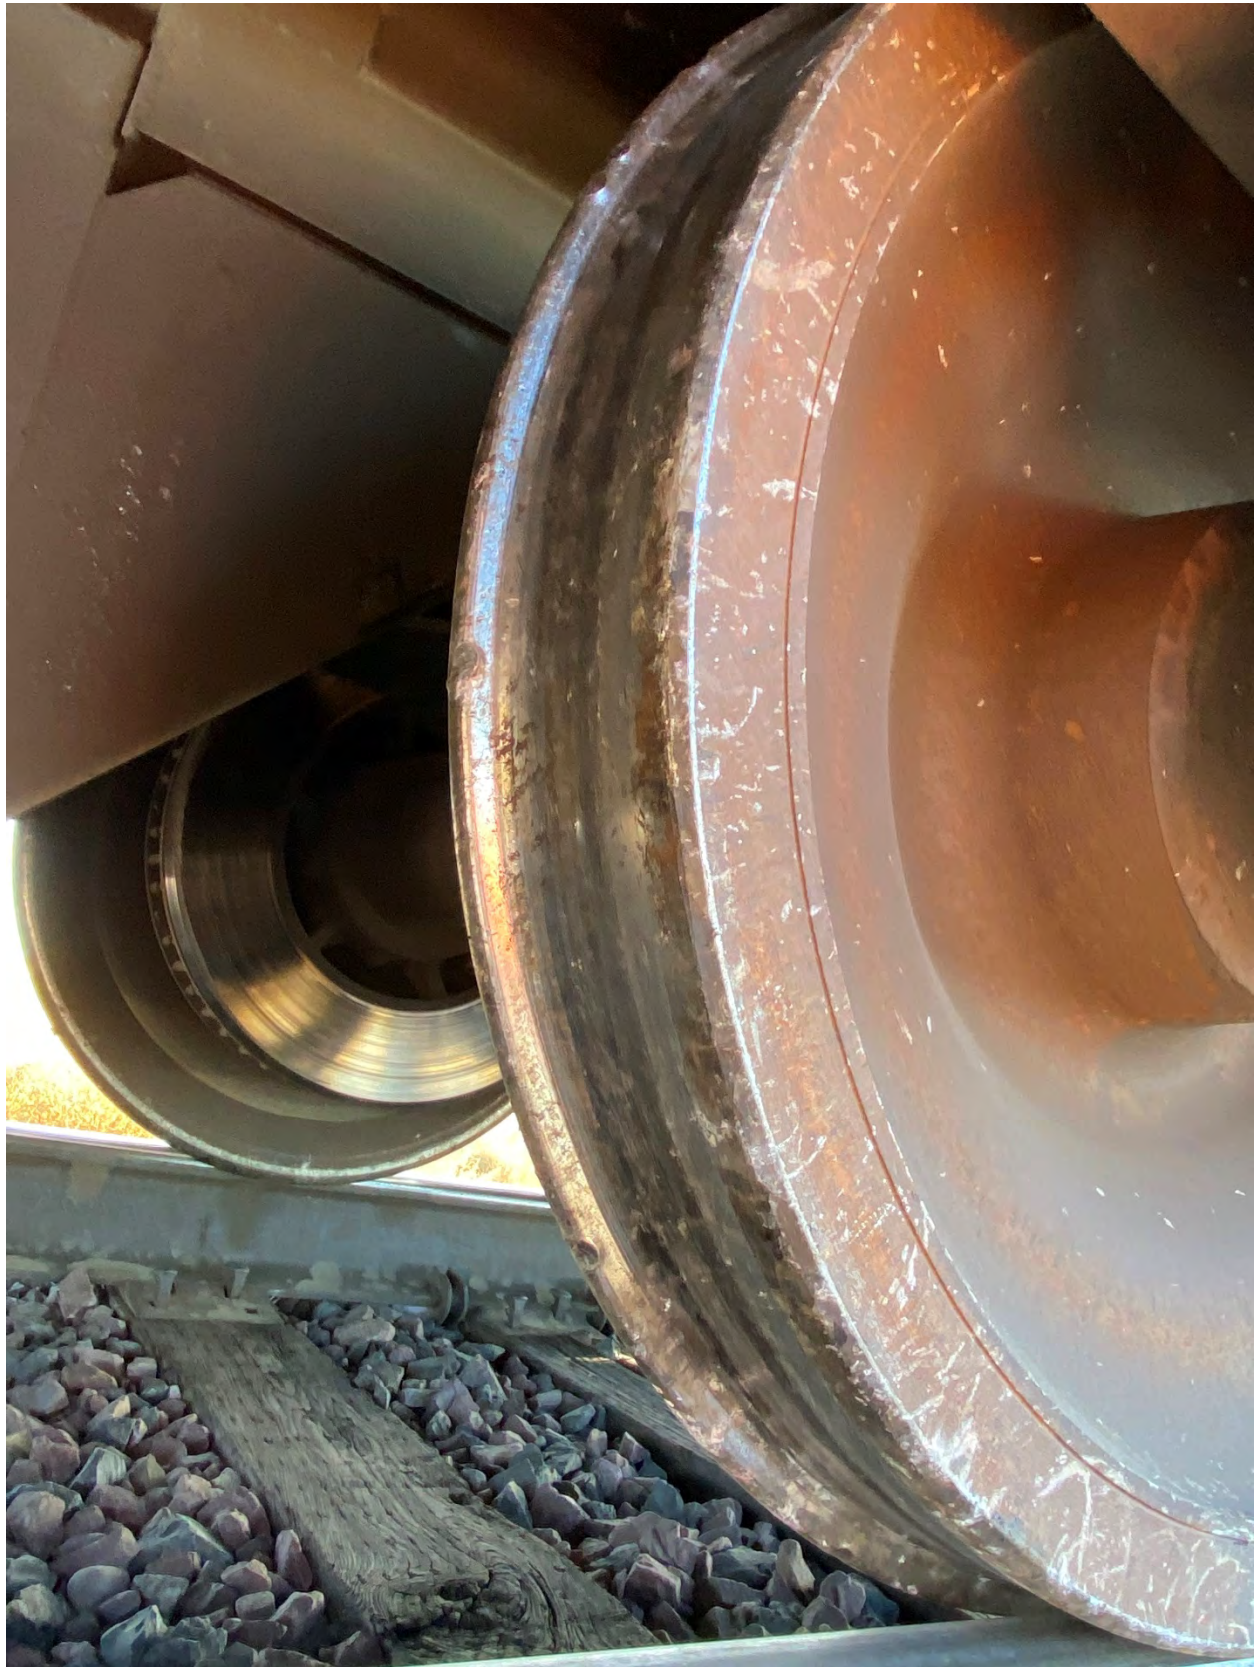
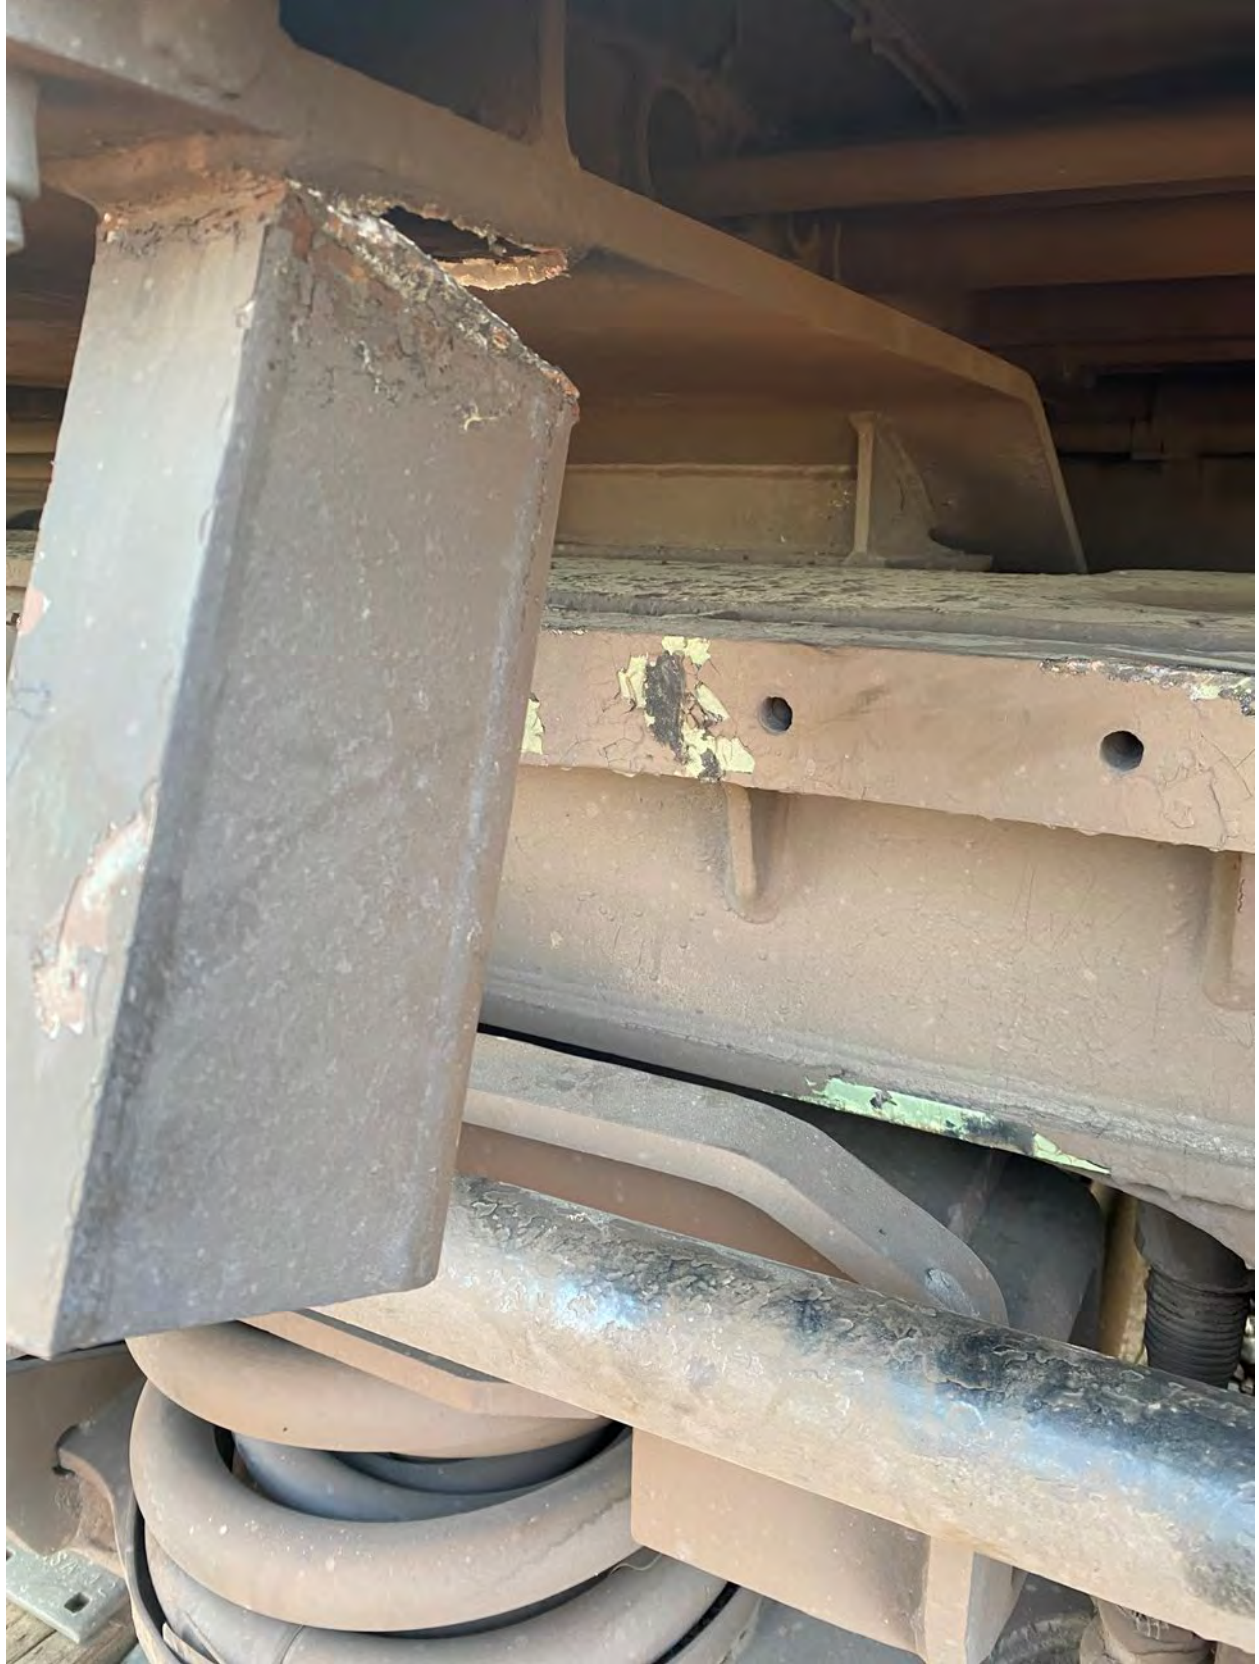
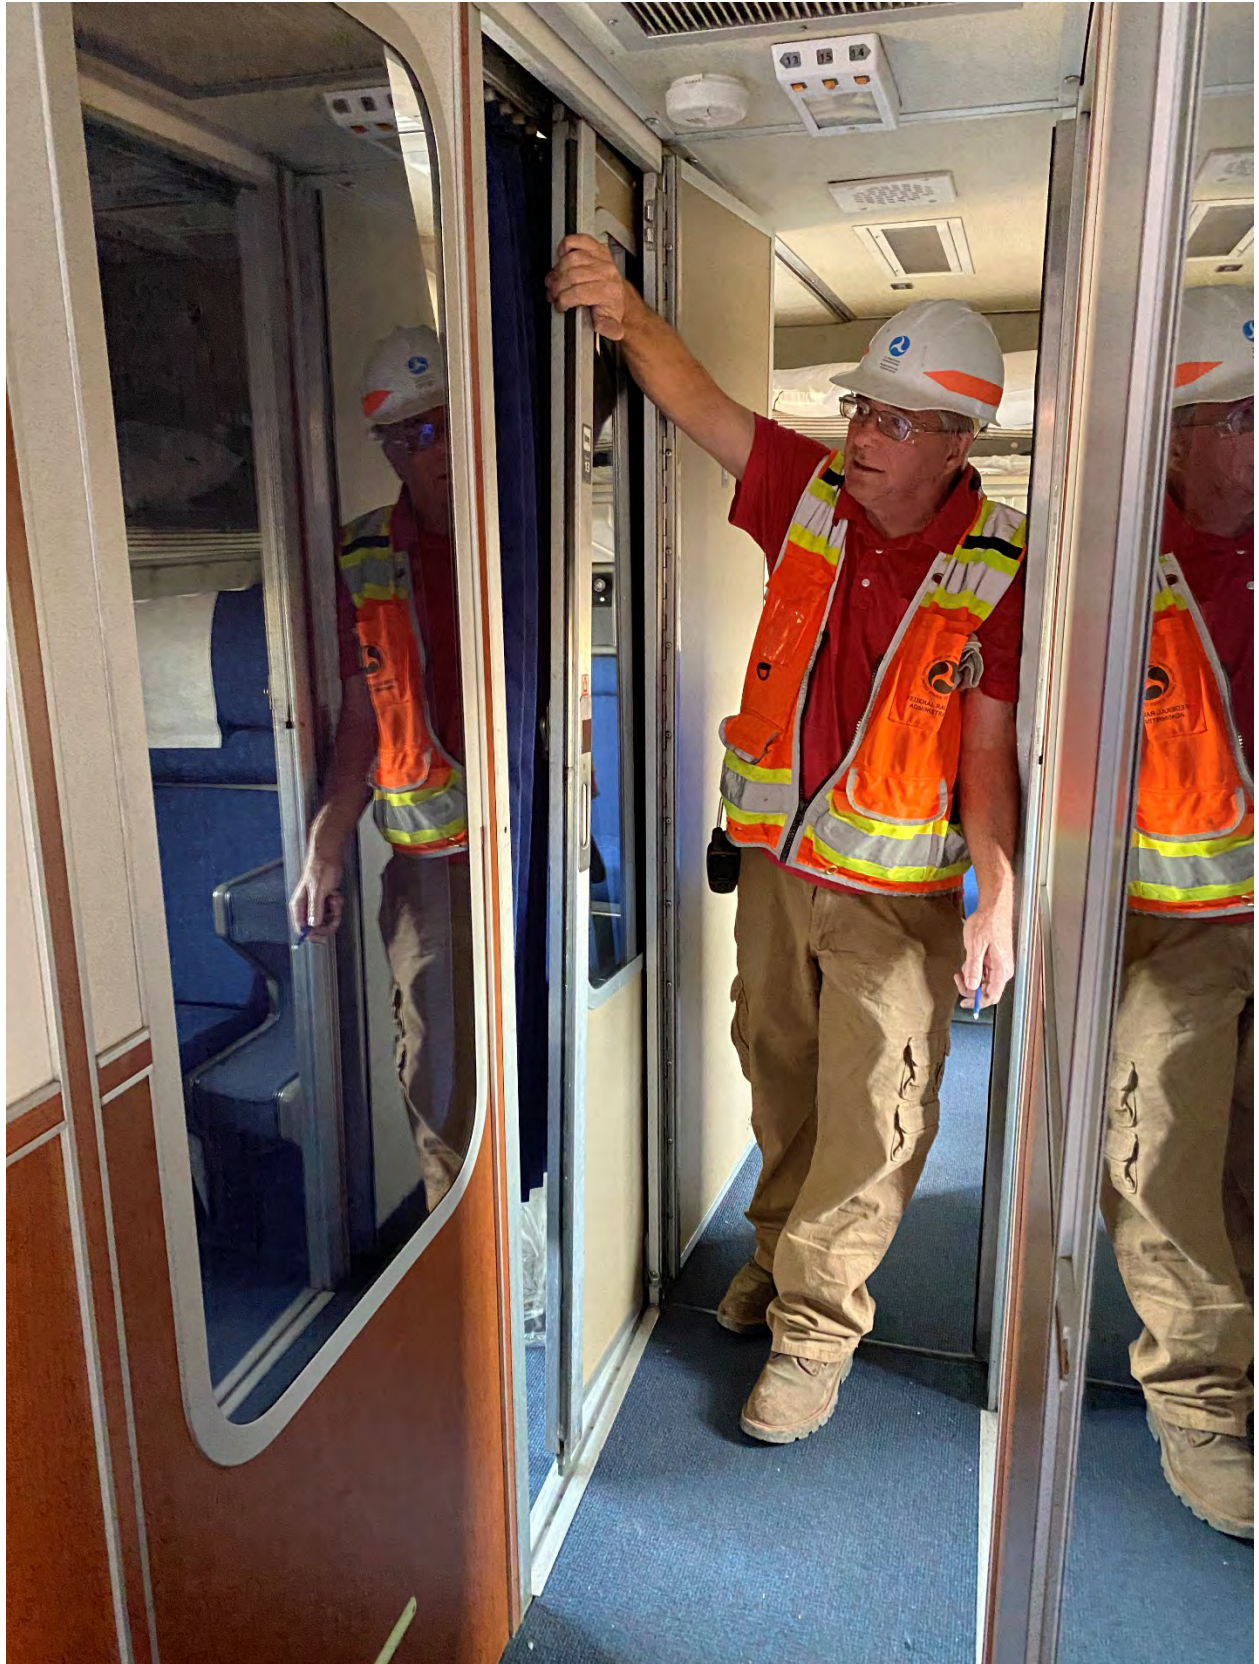
32050

The B-end of the passenger car rear trailing axle showed signs of all four wheels were off the rail. The left number two wheel had evidence of heavy impact marks on the wheel flange as noted in the photos. The left number one brake rotor showed evidence of dragging. The B-end stabilizer bars were bent and damaged. The B-end coupler right side bump stop was broken and impact marks on the top of the coupler shank from the buffer casting. The B-end right side truck frame had signs of dragging. The B-end right side spring saddle had signs of dragging.

The stateroom 13 door was off its track. The stateroom 11 window was missing. The interior A, B, and D room access doors were binding.

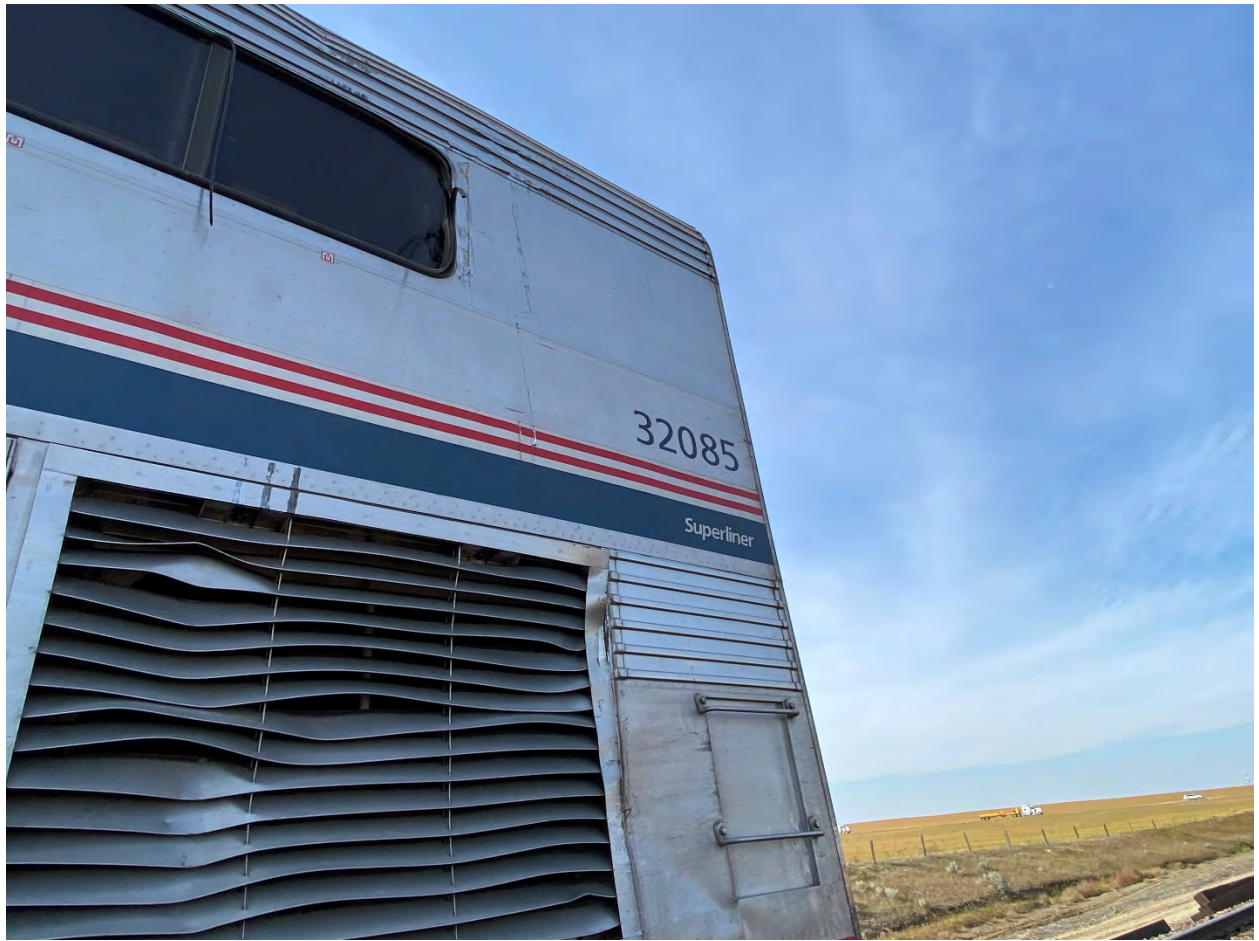
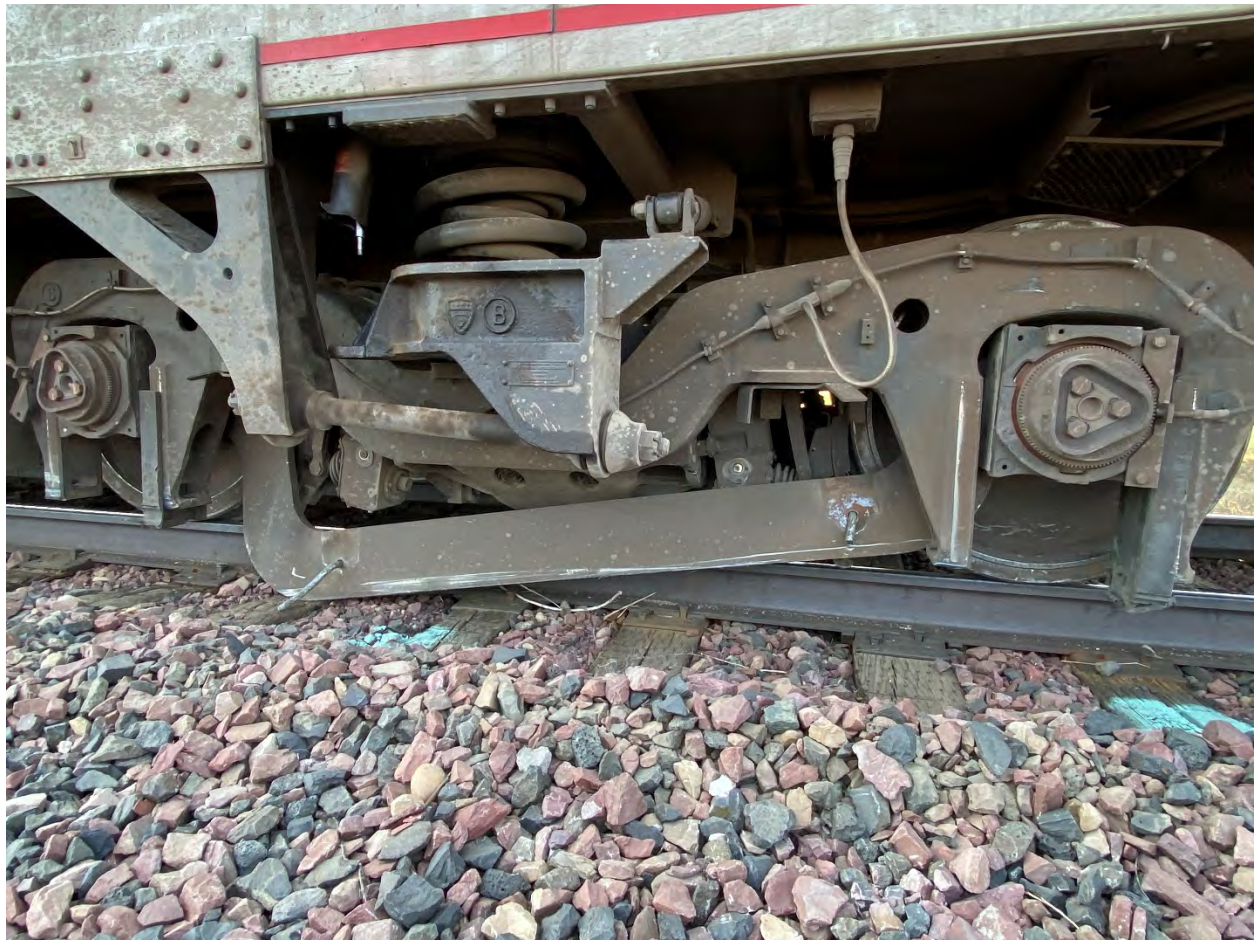
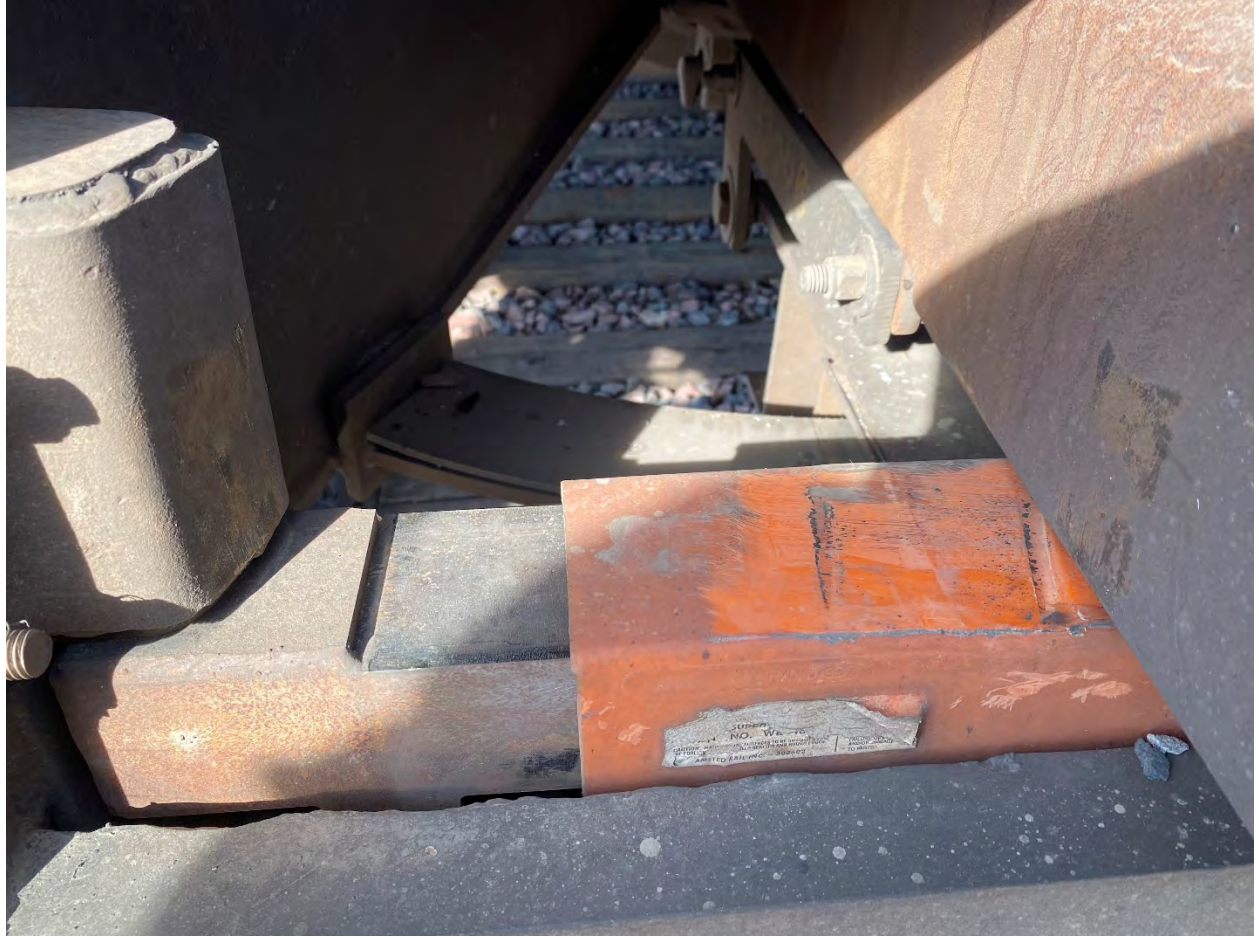
32085

All eight wheels were derailed. The L1 wheel was damaged extensively in a saw tooth pattern. . The R1, R3, R4, L1, and L2 wheel adapters missing. The R2 wheel adapter was out of place. The R3 and R4 truck springs missing. The L1 and L2 equalizer beams were missing. The R3 and R4 equalizer beams were out of position. The BL shock absorber was missing. The B end air brake top rod bent. The L3 tread brake unit broken. The AR side coupler bumper block missing.

The A end vestibule door dislodged from track. The B end vestibule door inoperable. The stateroom 7 bunk dislodged from safety latch.

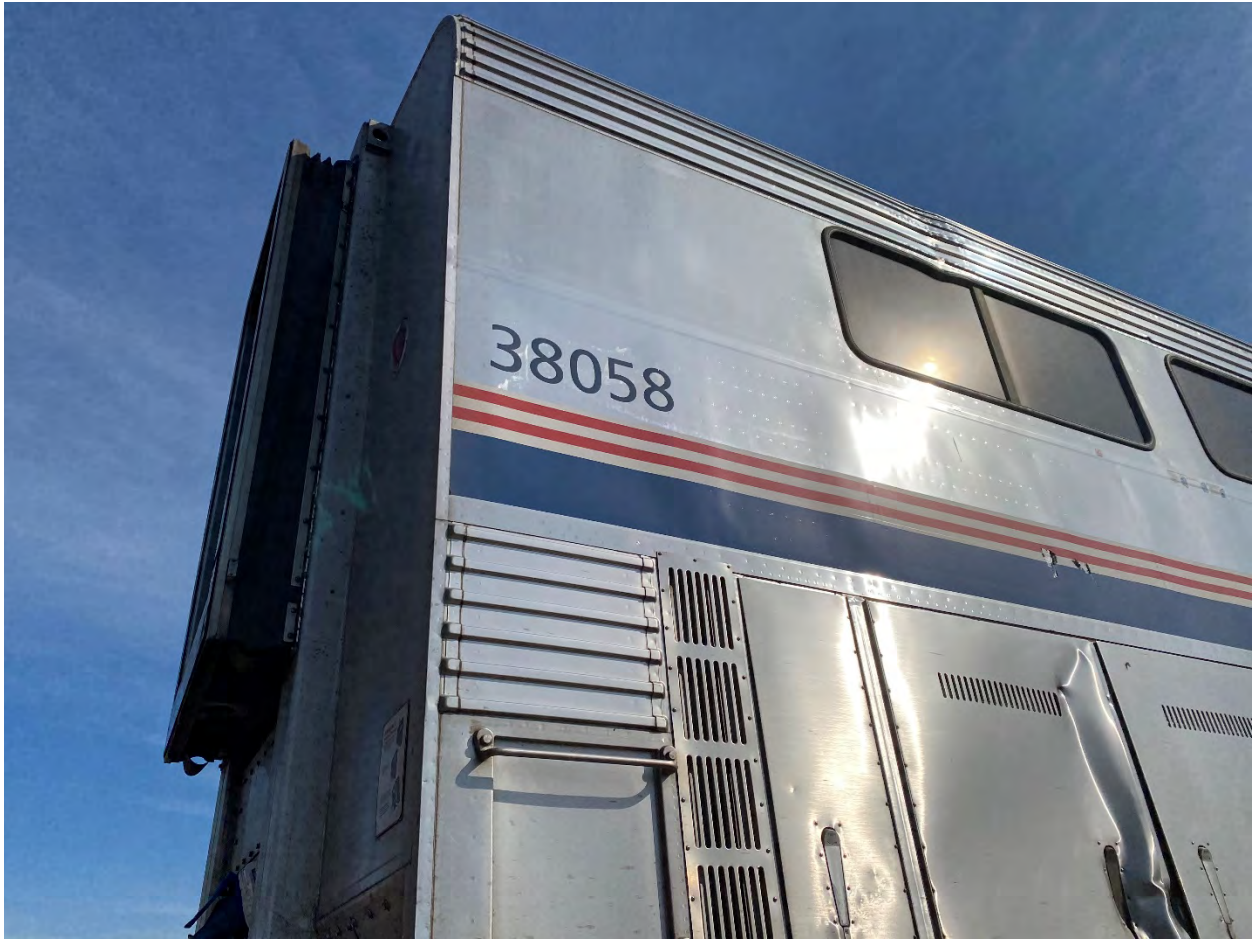
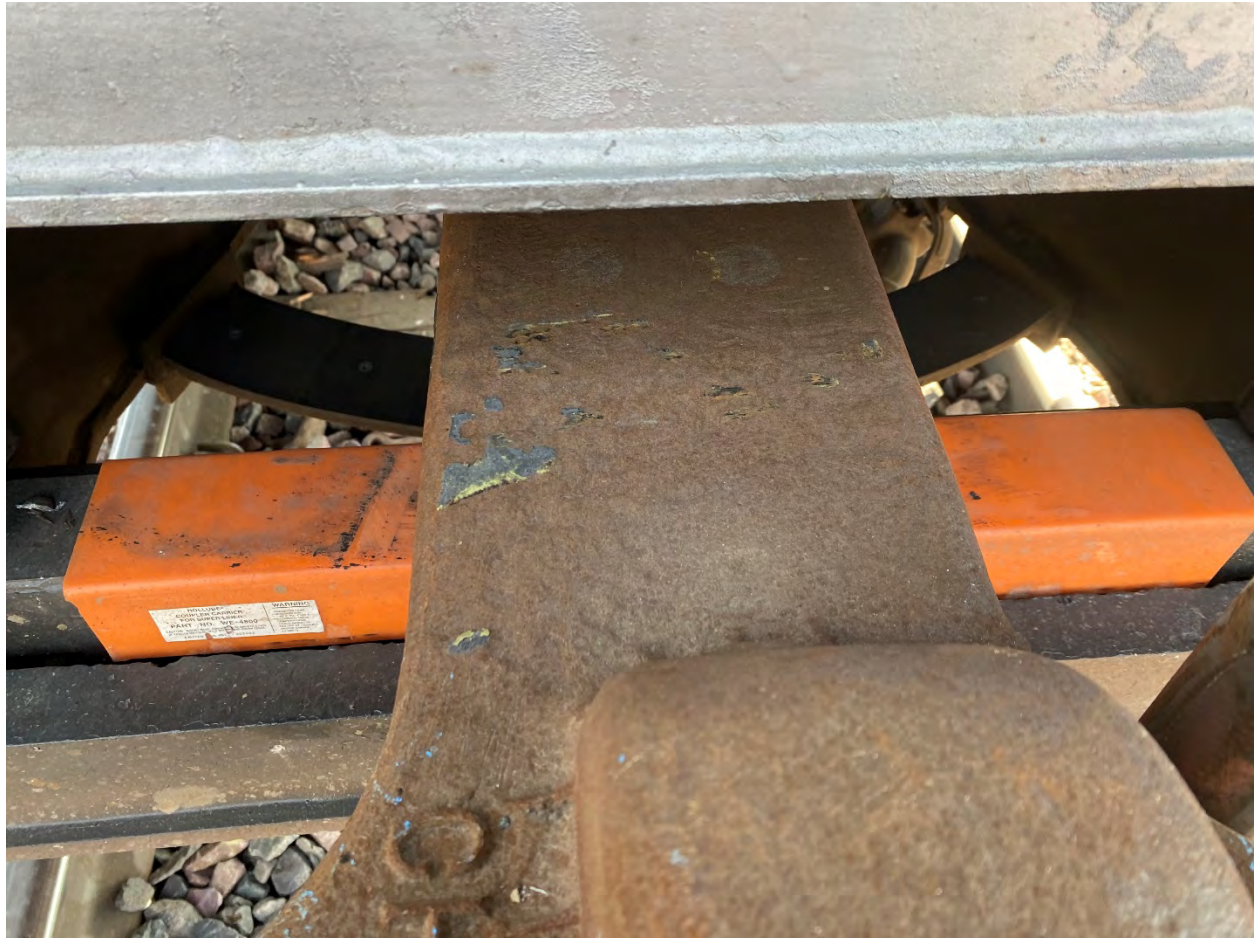
38058

All eight wheels were derailed with the car body remaining upright. The L1 and L2 wheels were damaged extensively with impact marks and rail burn. The L3, L4, and R4 wheel adapters out of position. The L1, L2 and L4 truck springs missing. The L3 truck spring was not in position. The L1 and L2 equalizer beams were not in position. The R3 and R4 outer equalizer beams were missing. The R3 and R4 shock absorbers damaged. The L1 and L2 truck tie bar plates missing. The A end brake pipe and cut out cock damaged. The B end coupler bumper stops missing. The A end bumper stops damaged.

The A end vestibule door diaphragm dislodged.

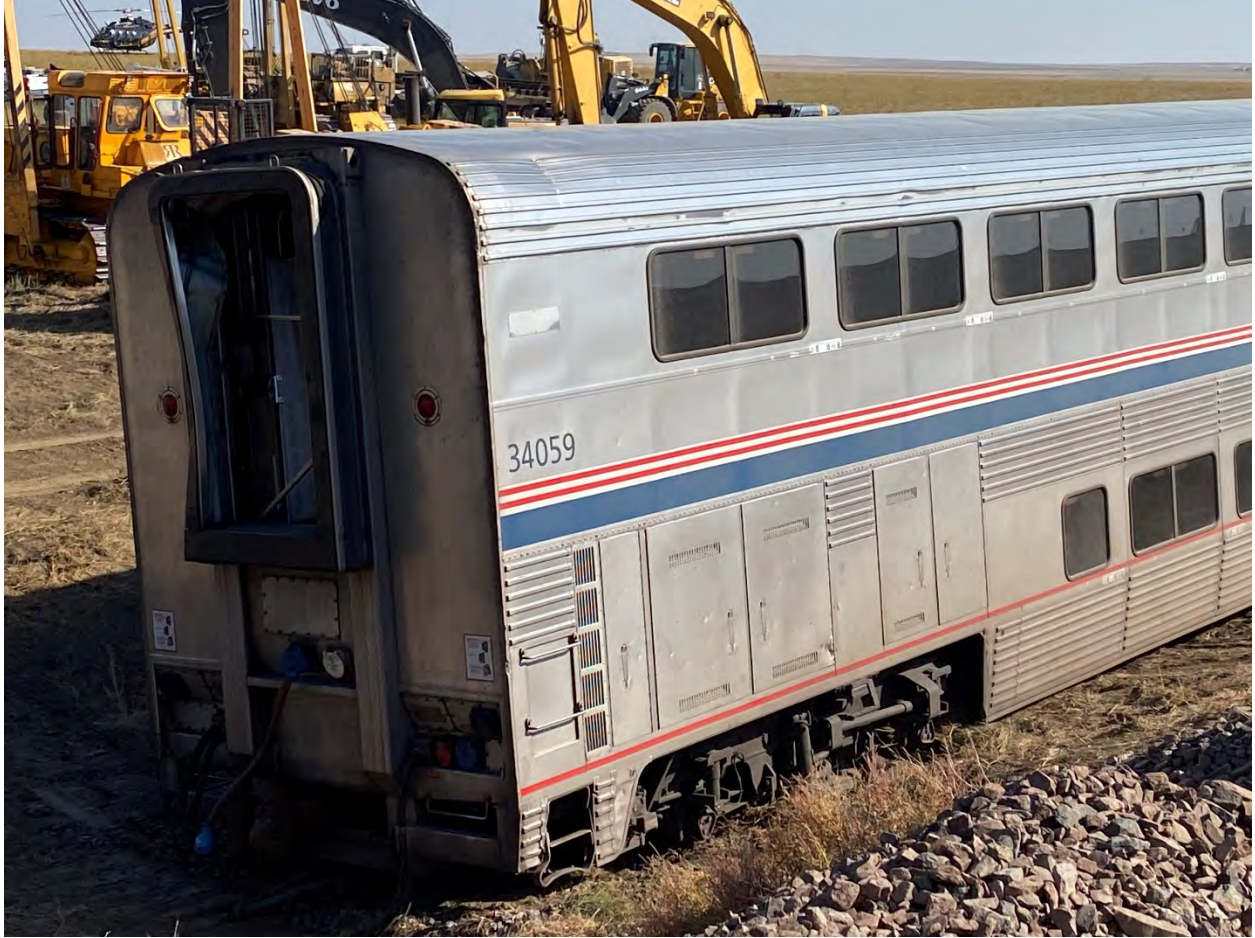
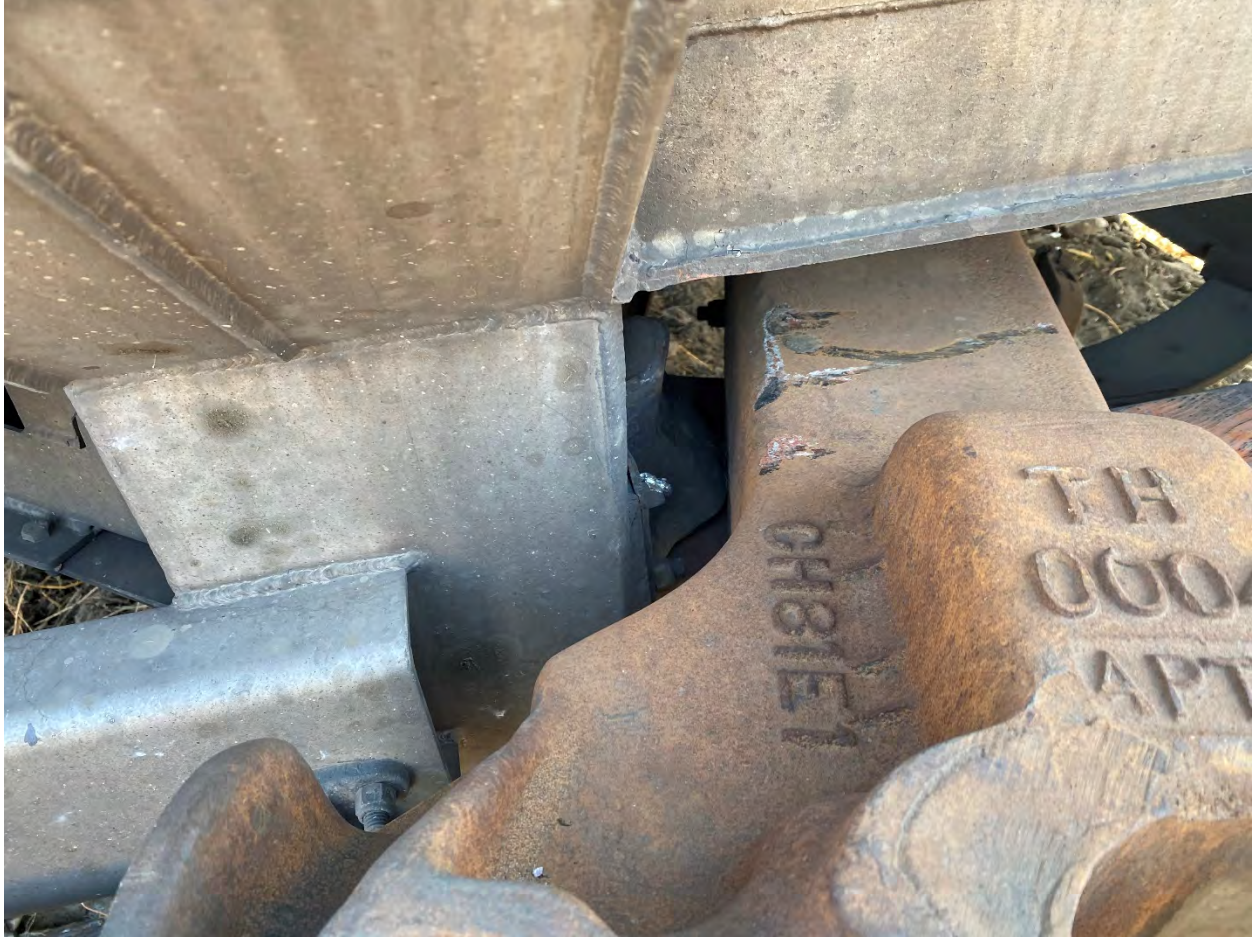
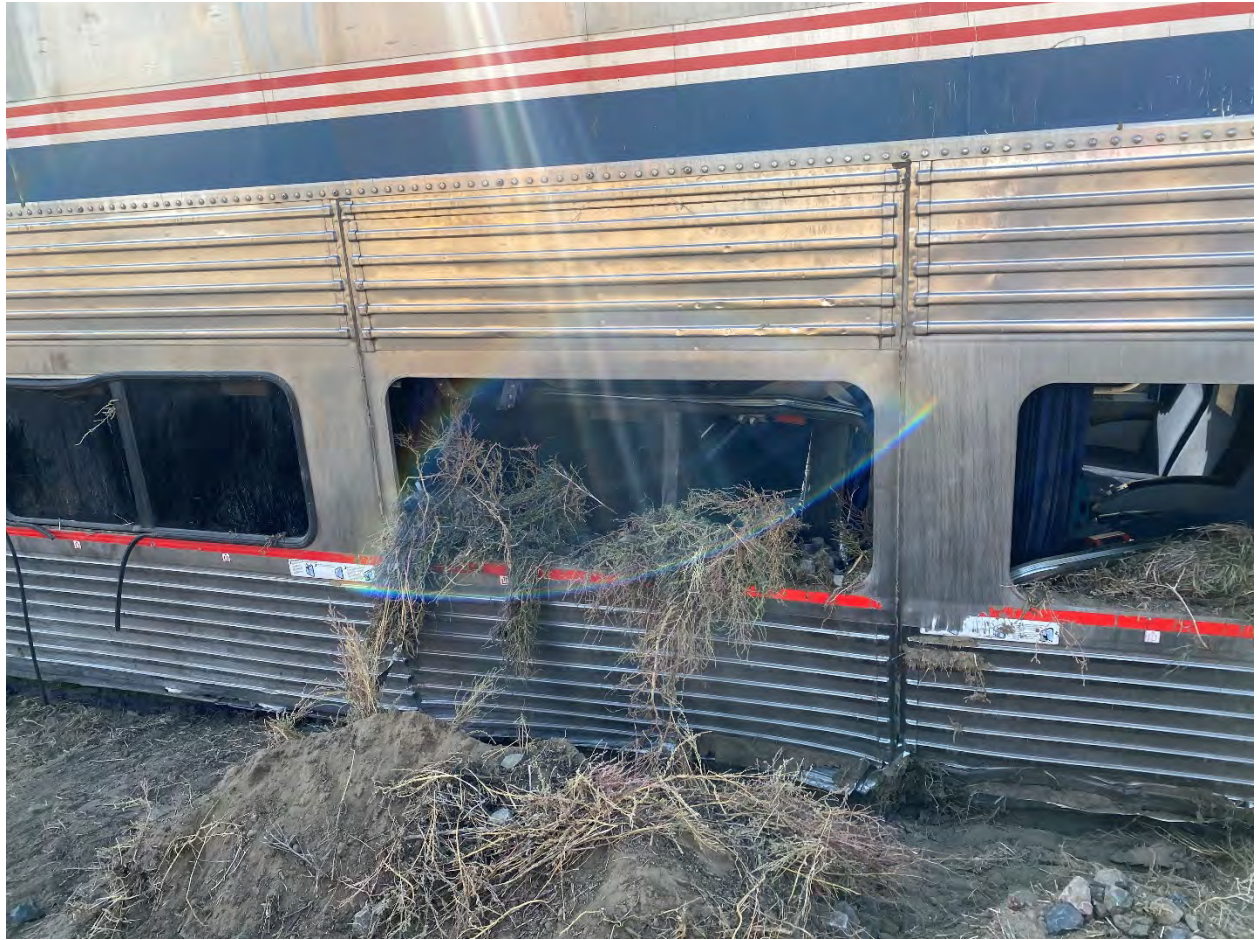
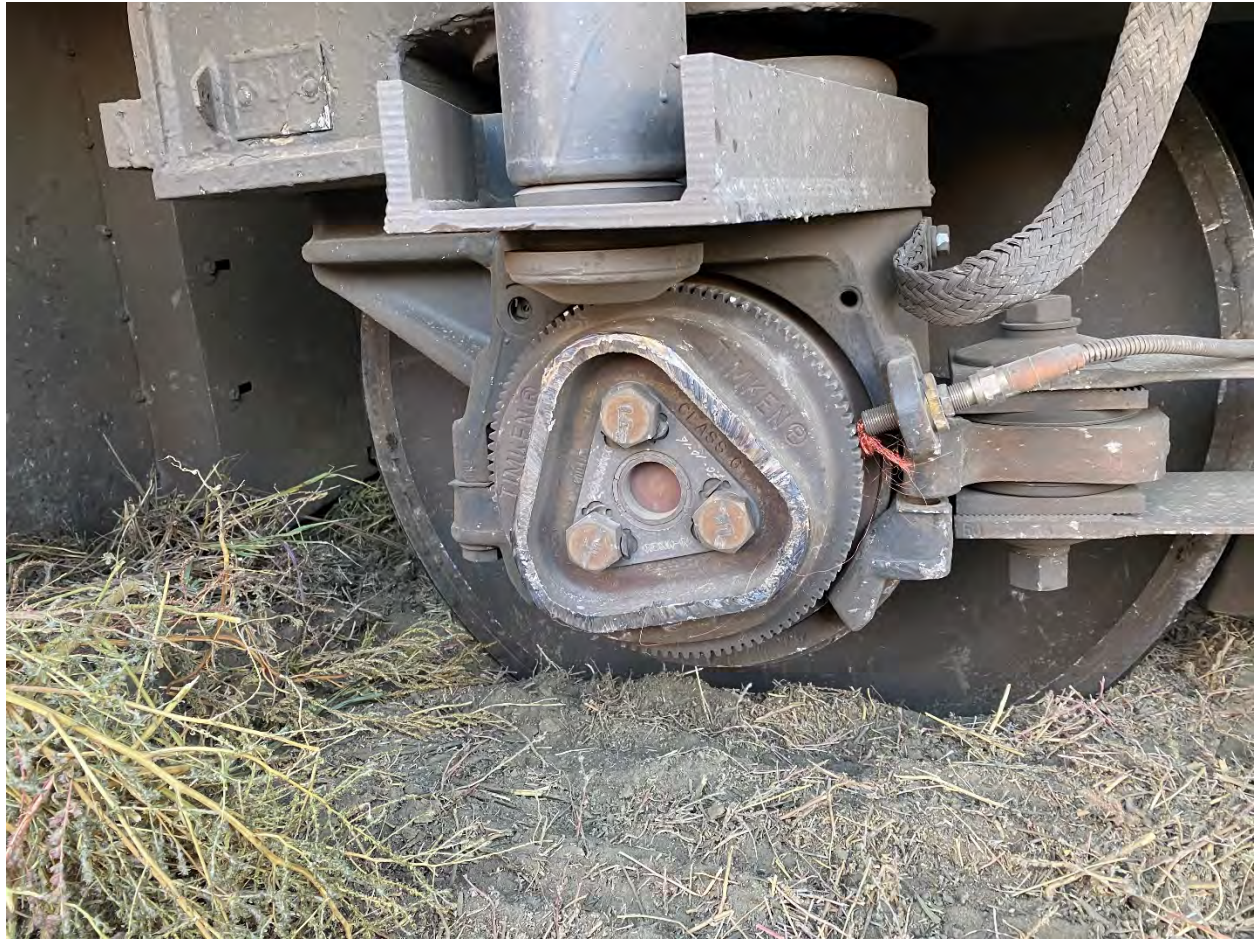
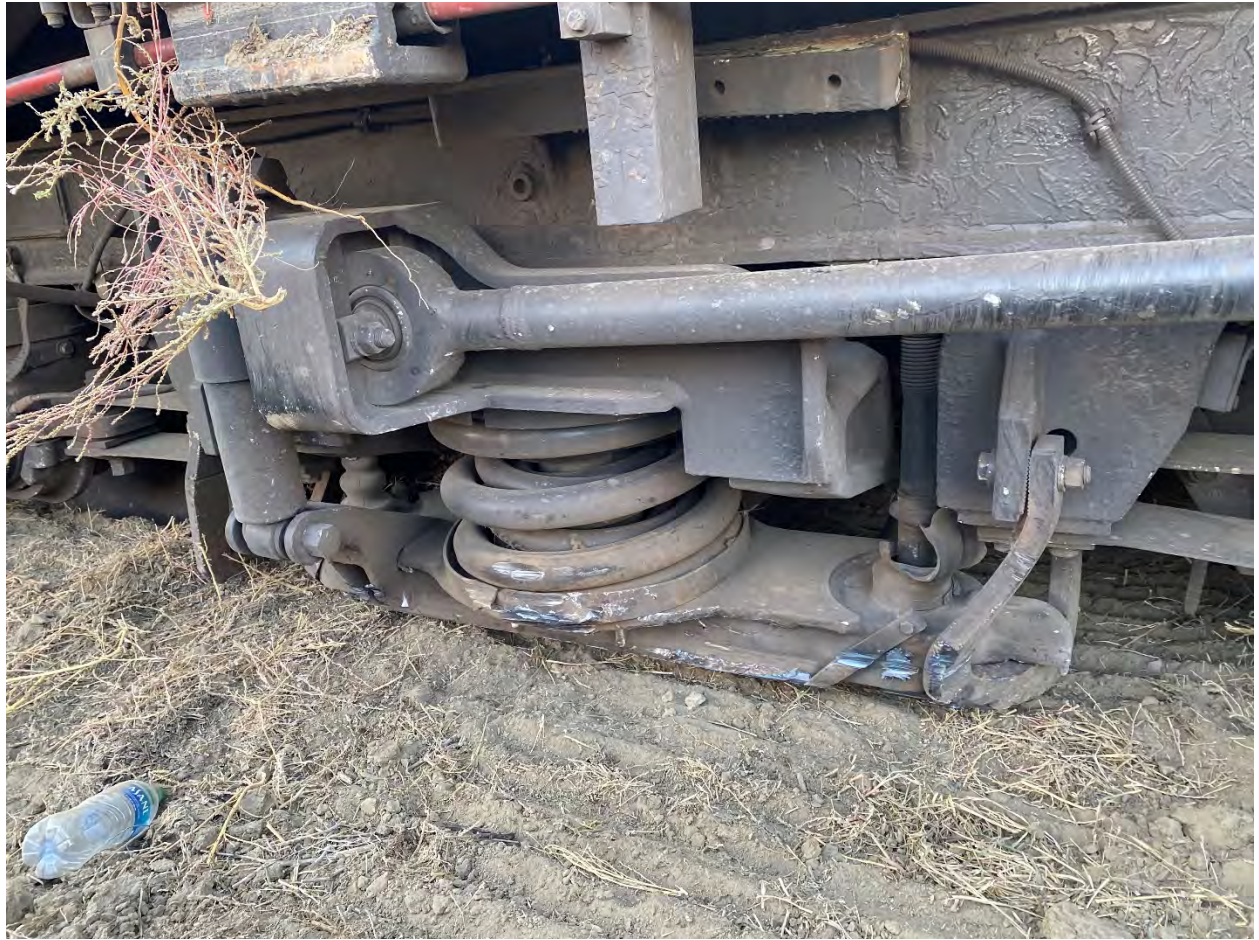
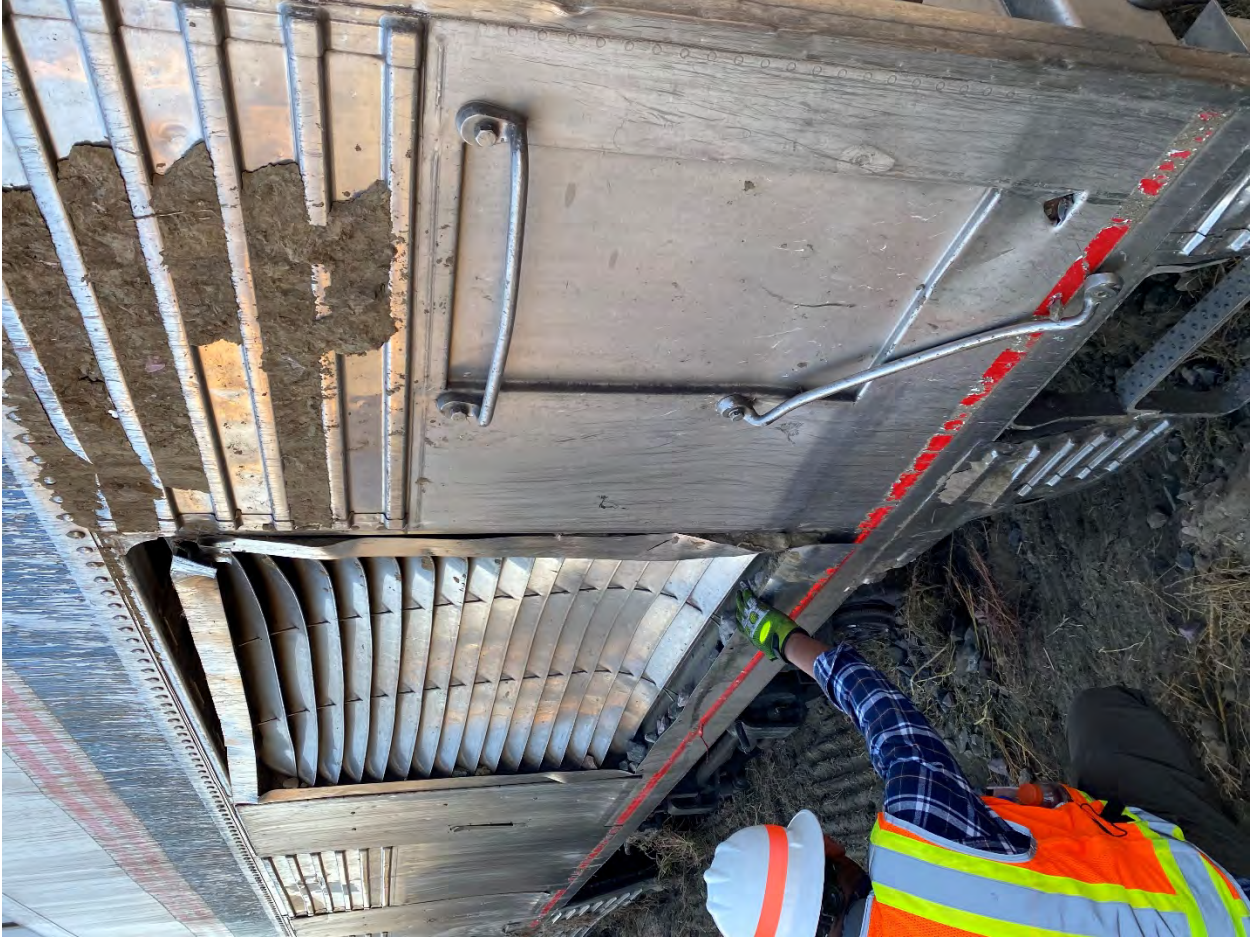
ATK 34059

The passenger car showed signs of all eight wheels were off the rail. The L1 wheel bearing cap bolt sheared off. The A and B end coupler bumper stops were damaged. The A end brake pipe and cut out cock damaged. The A end coupler buffer casting damaged. The BL side handhold broken.

The left and right-side entry doors were damaged. The end vestibule door diaphragm damaged. Top left side number one and two windows damaged. Seat 77, 78, 73, and 74 side windows dislodged. The seats 1, 2, 5, 6, 17, 18, 25, 26, 29, 30, 33, 34, 79 and 80 were dislodged.
