ATK 32050

The following defects were noted on the sleeper car that was positioned as the third car behind the two locomotive train consist remaining upright.

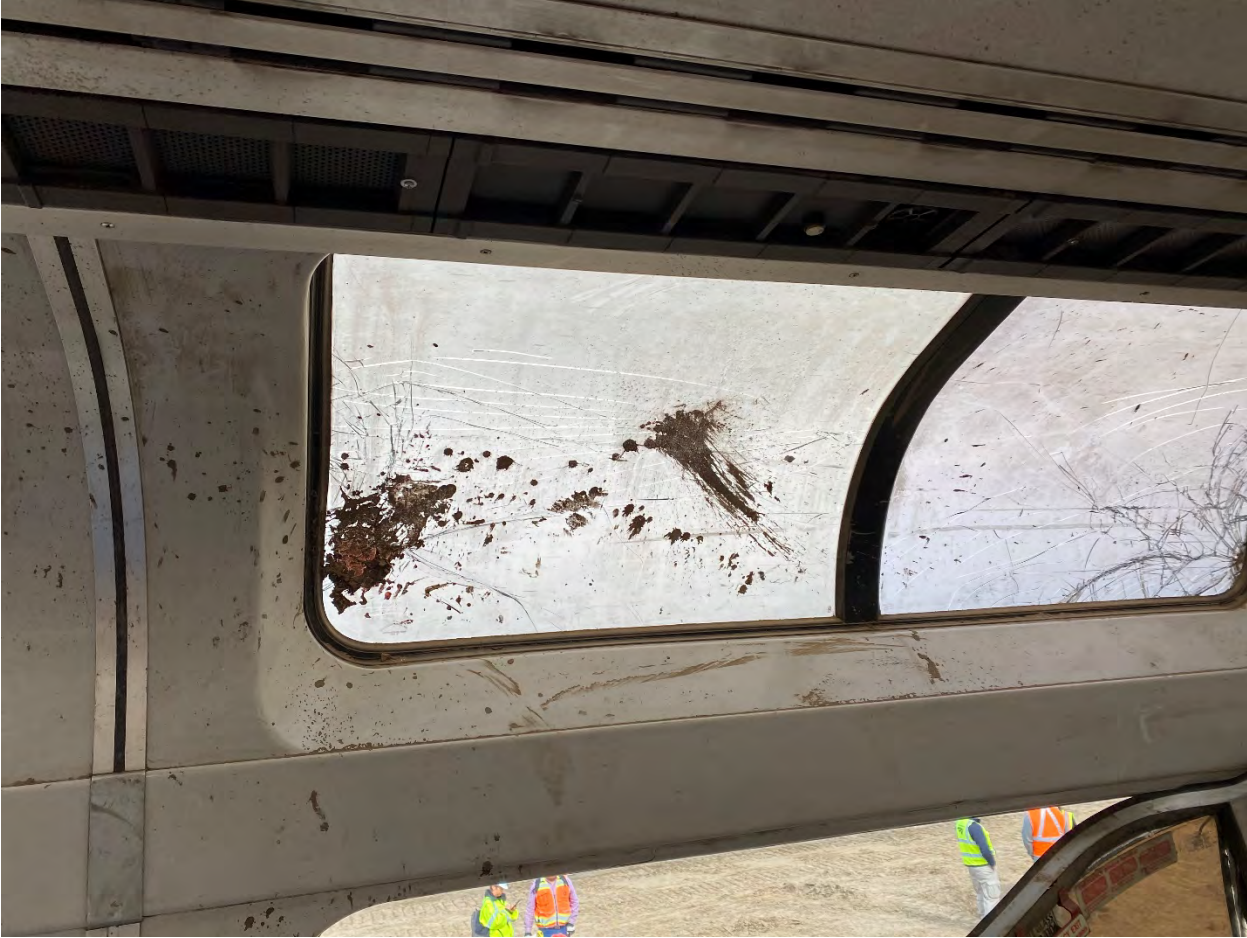
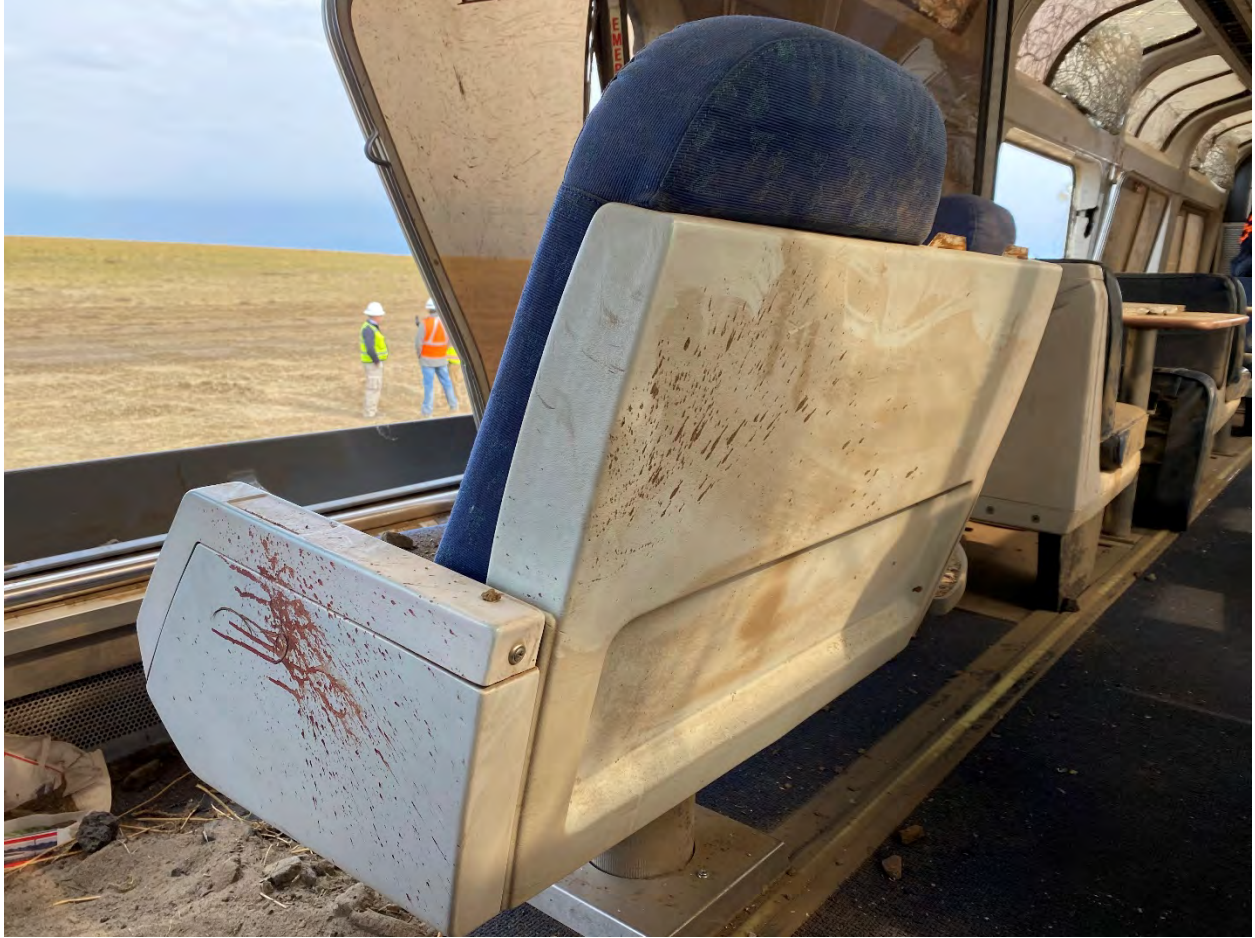
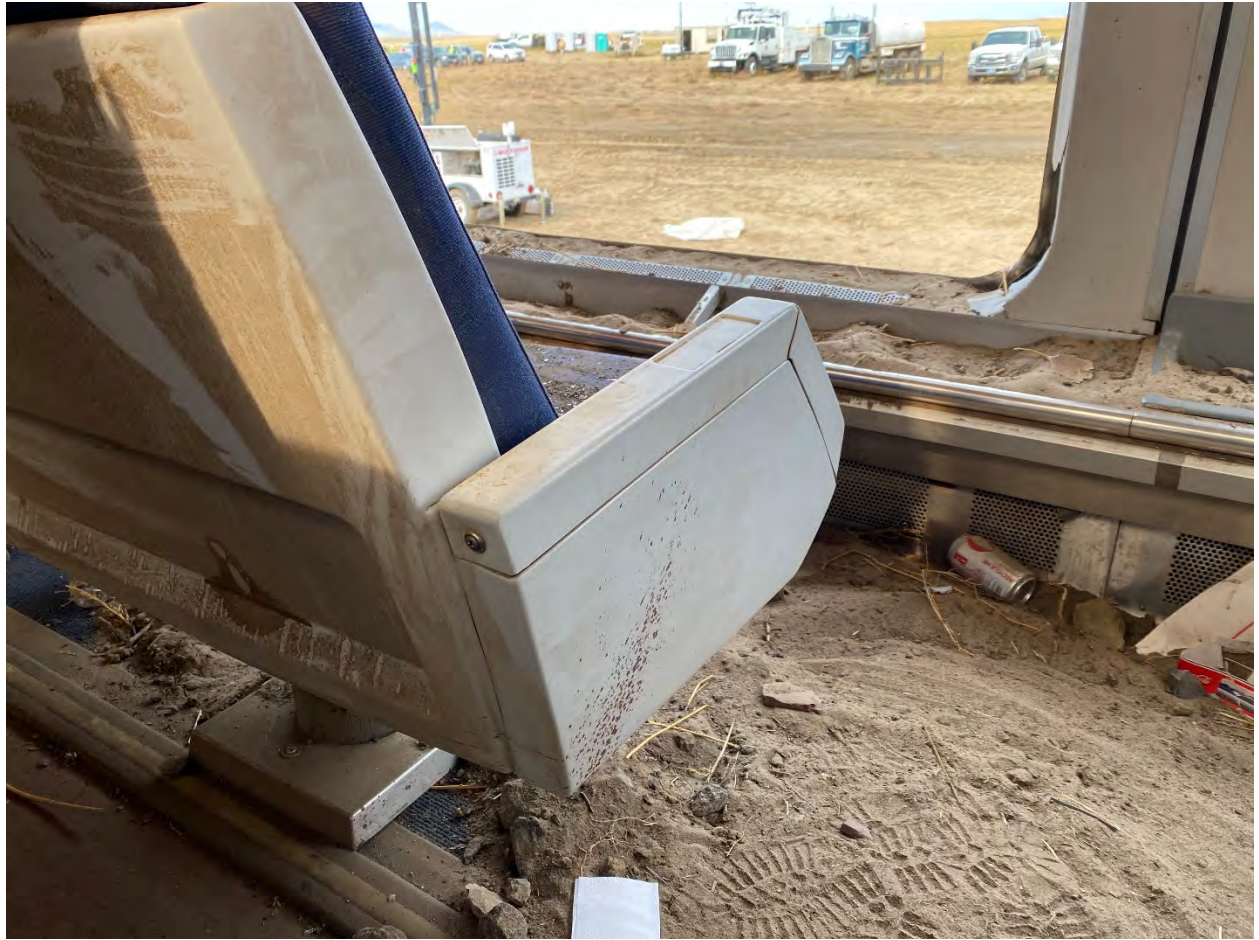
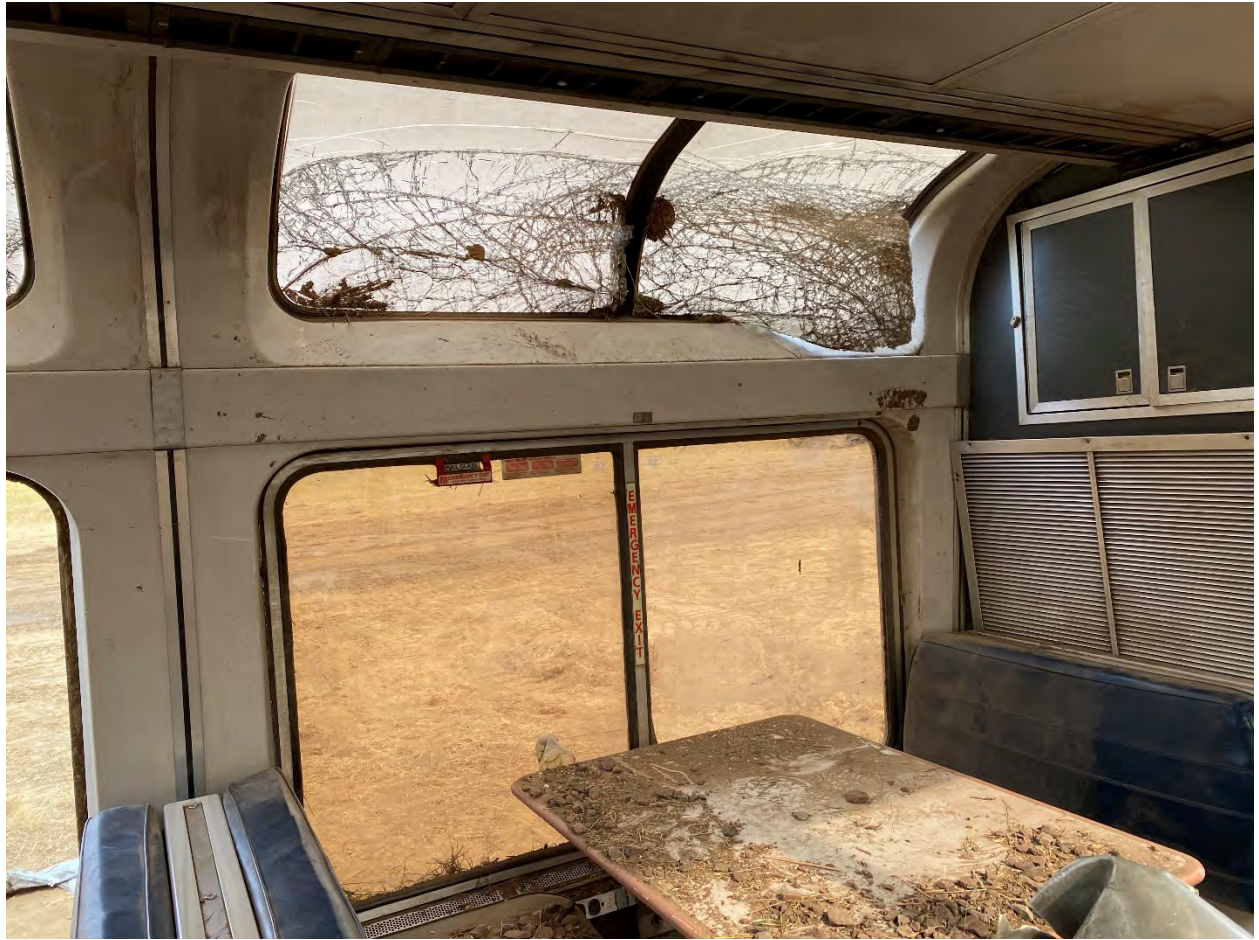
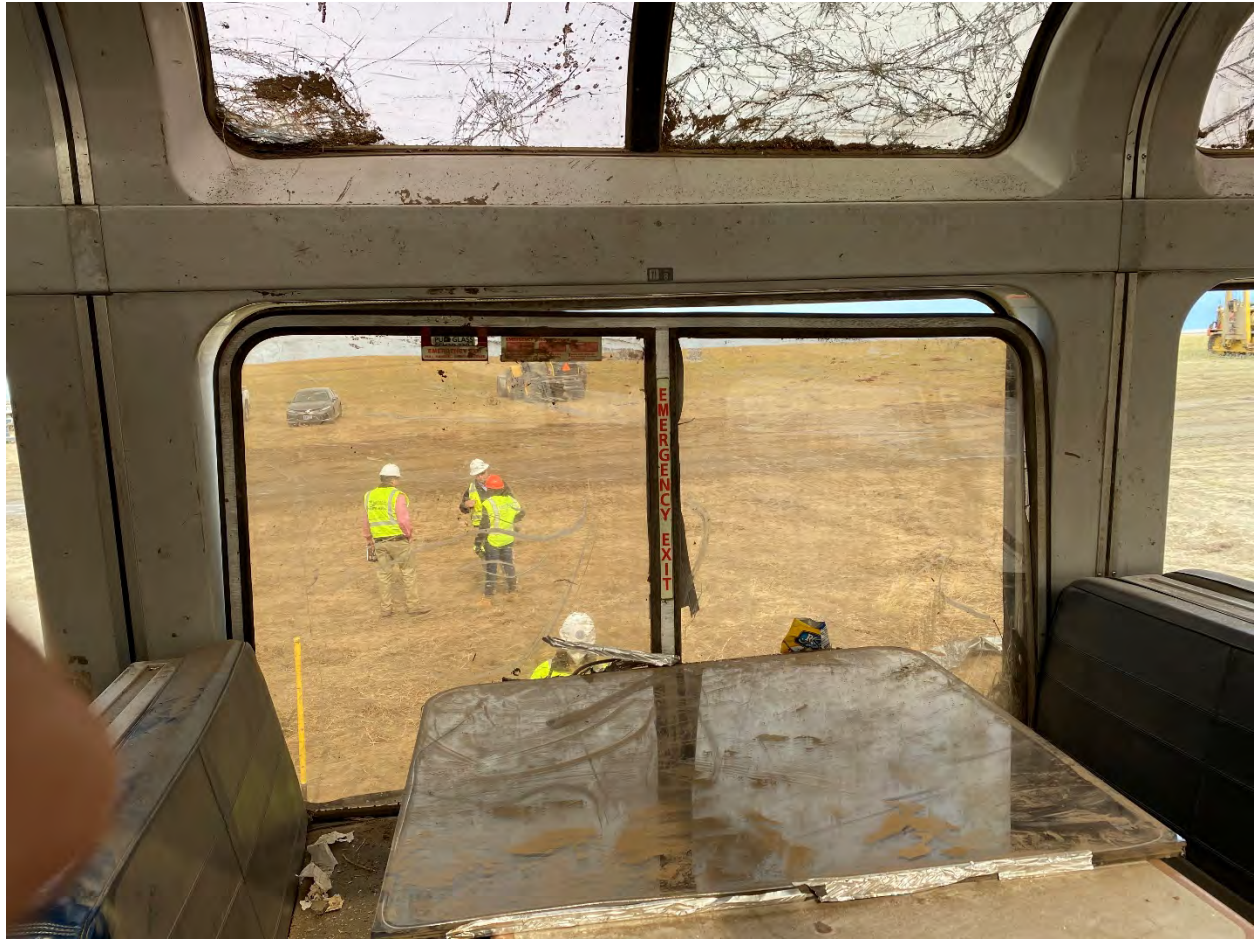
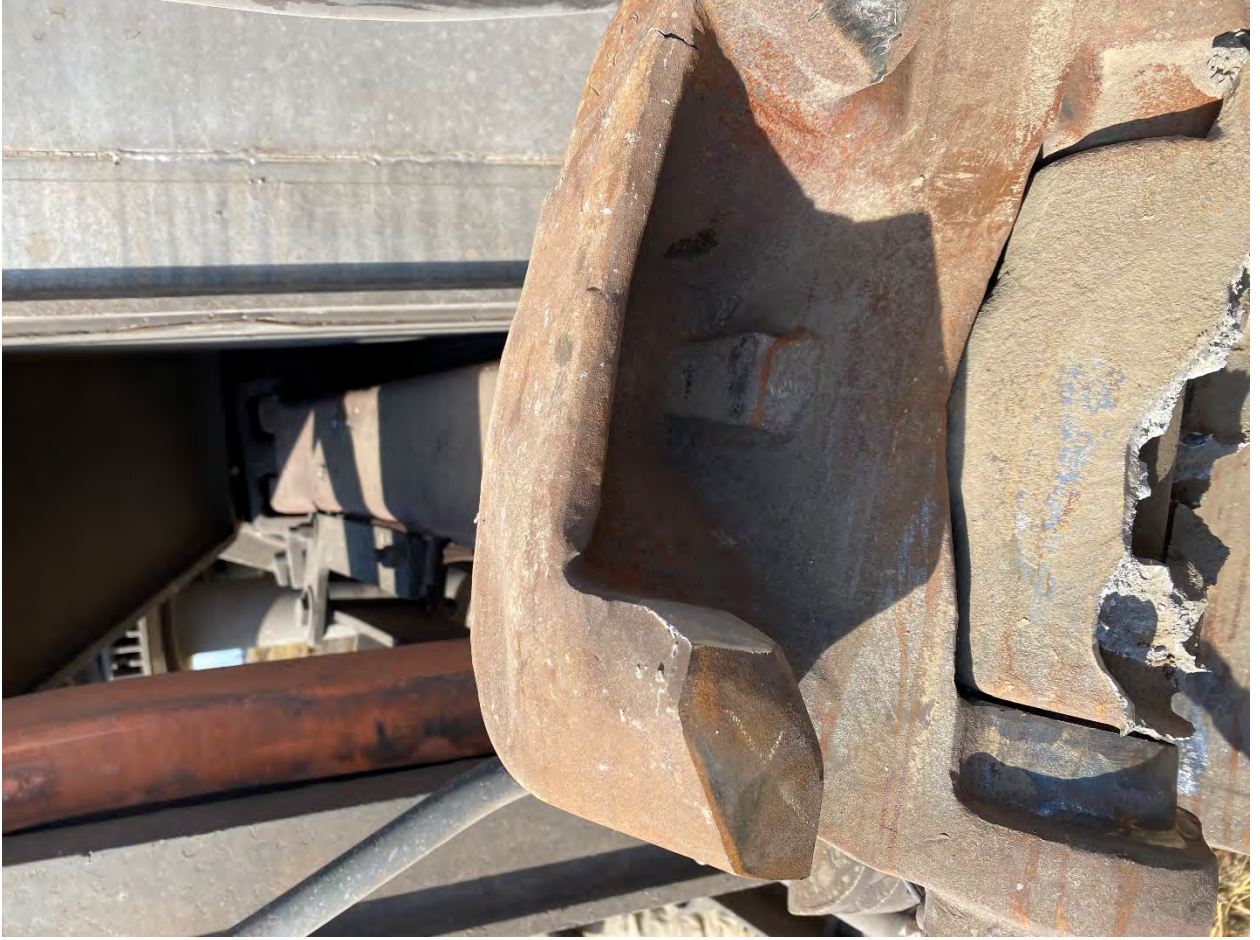
ATK 33049

The passenger car showed signs of all eight wheels were off the rail. The B end coupler knuckle broken. B end coupler shank twisted.

The B end vestibule door diaphragm damaged. The cab windows on upper lower decks on the right side were missing except for one. The fire extinguisher was missing.

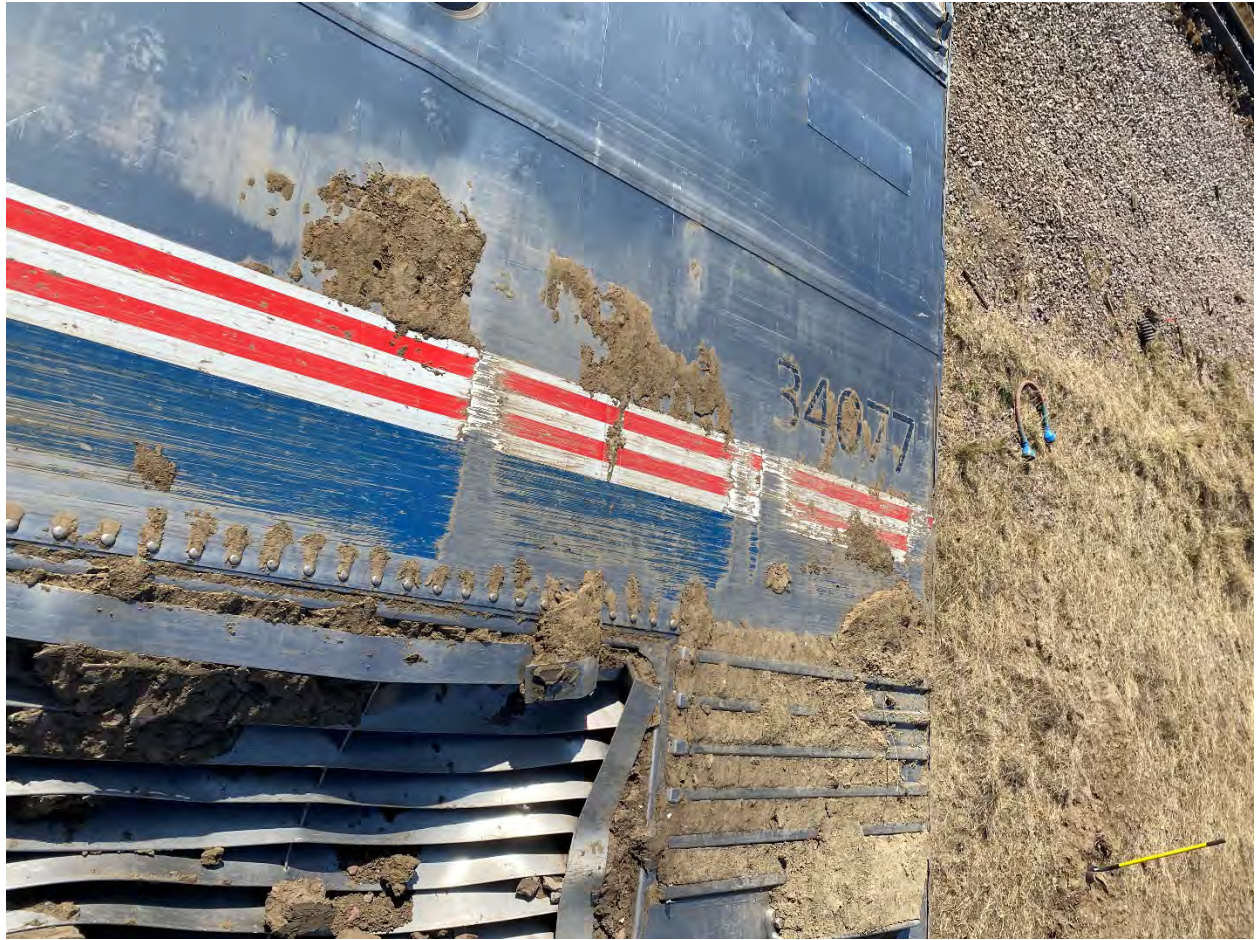
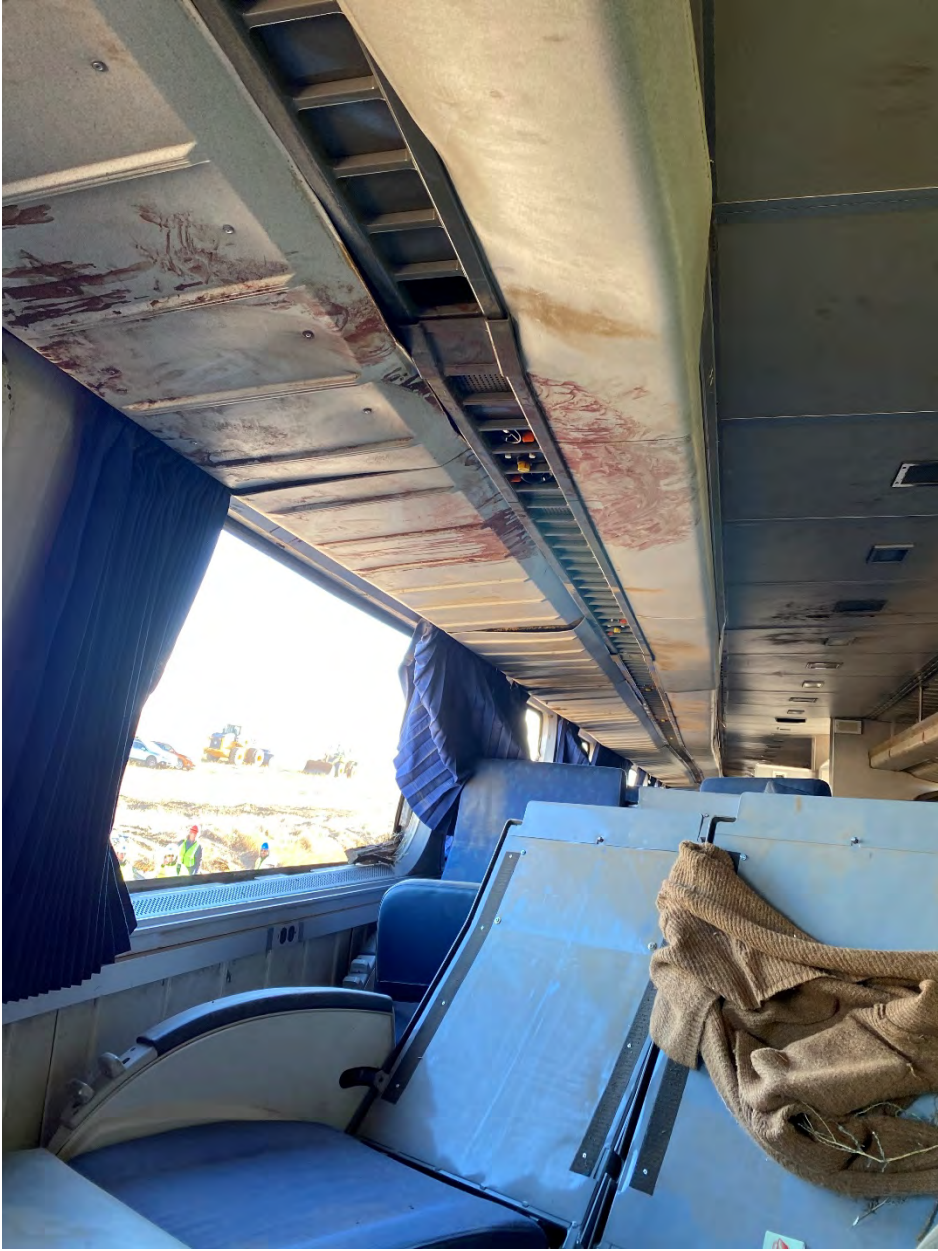
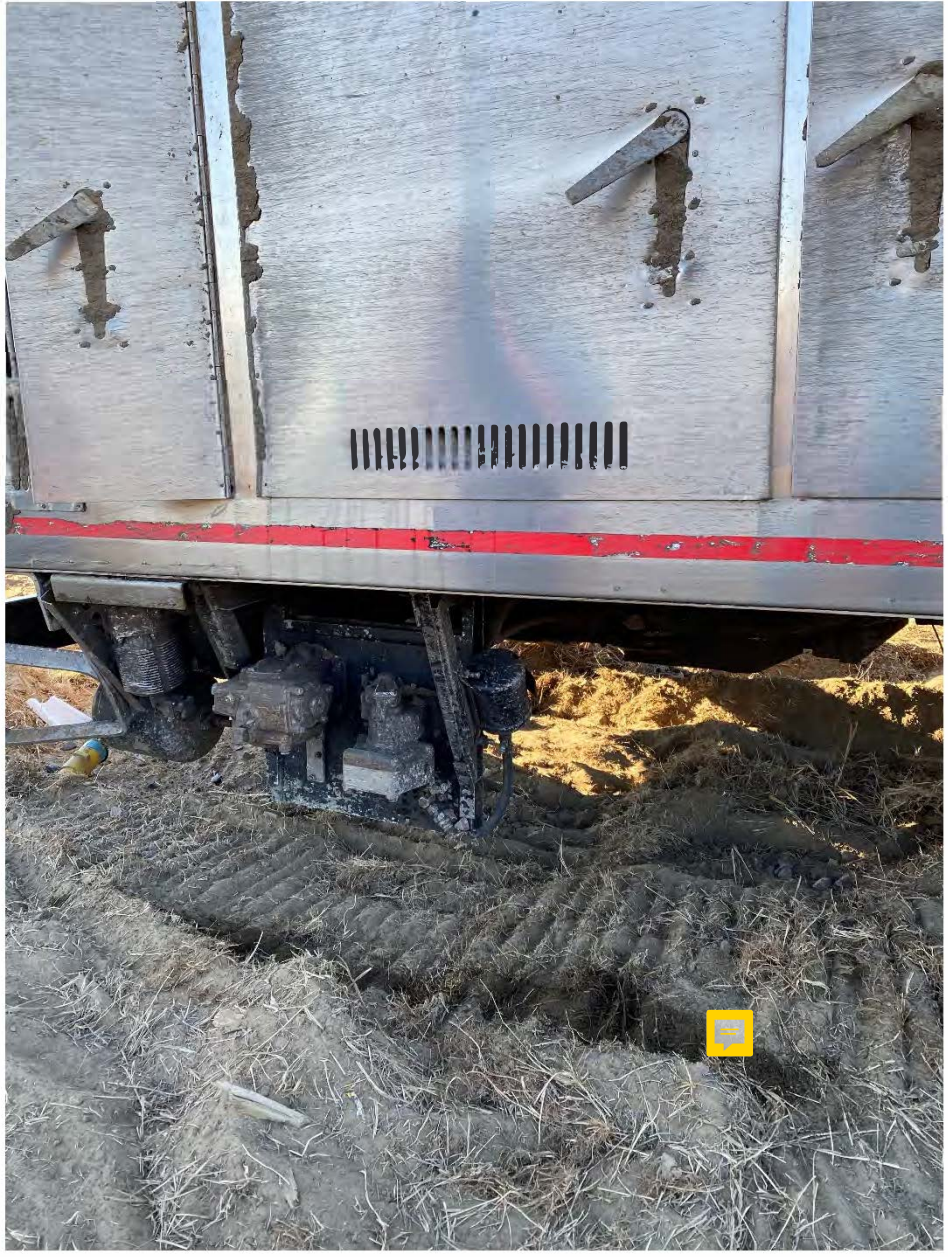
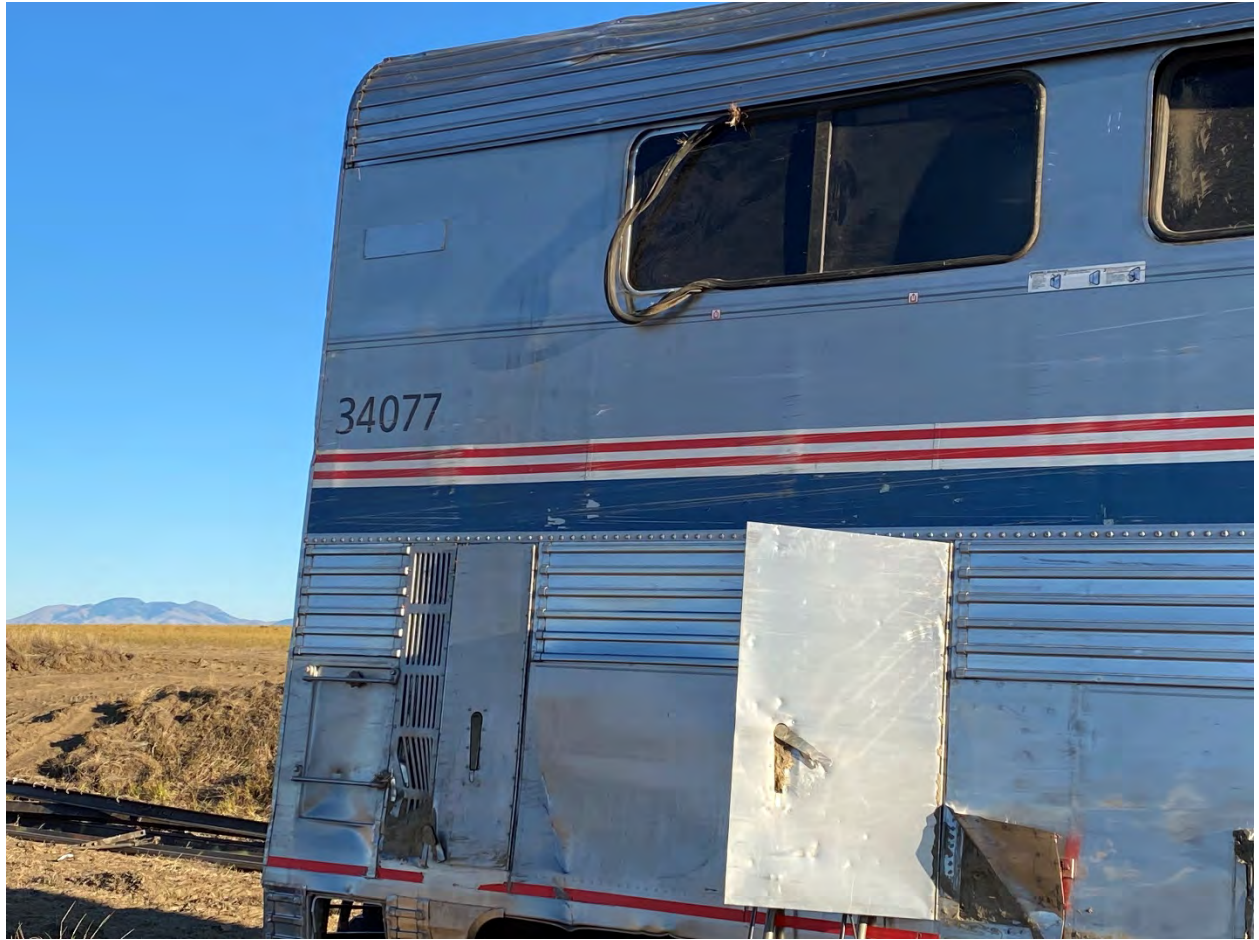
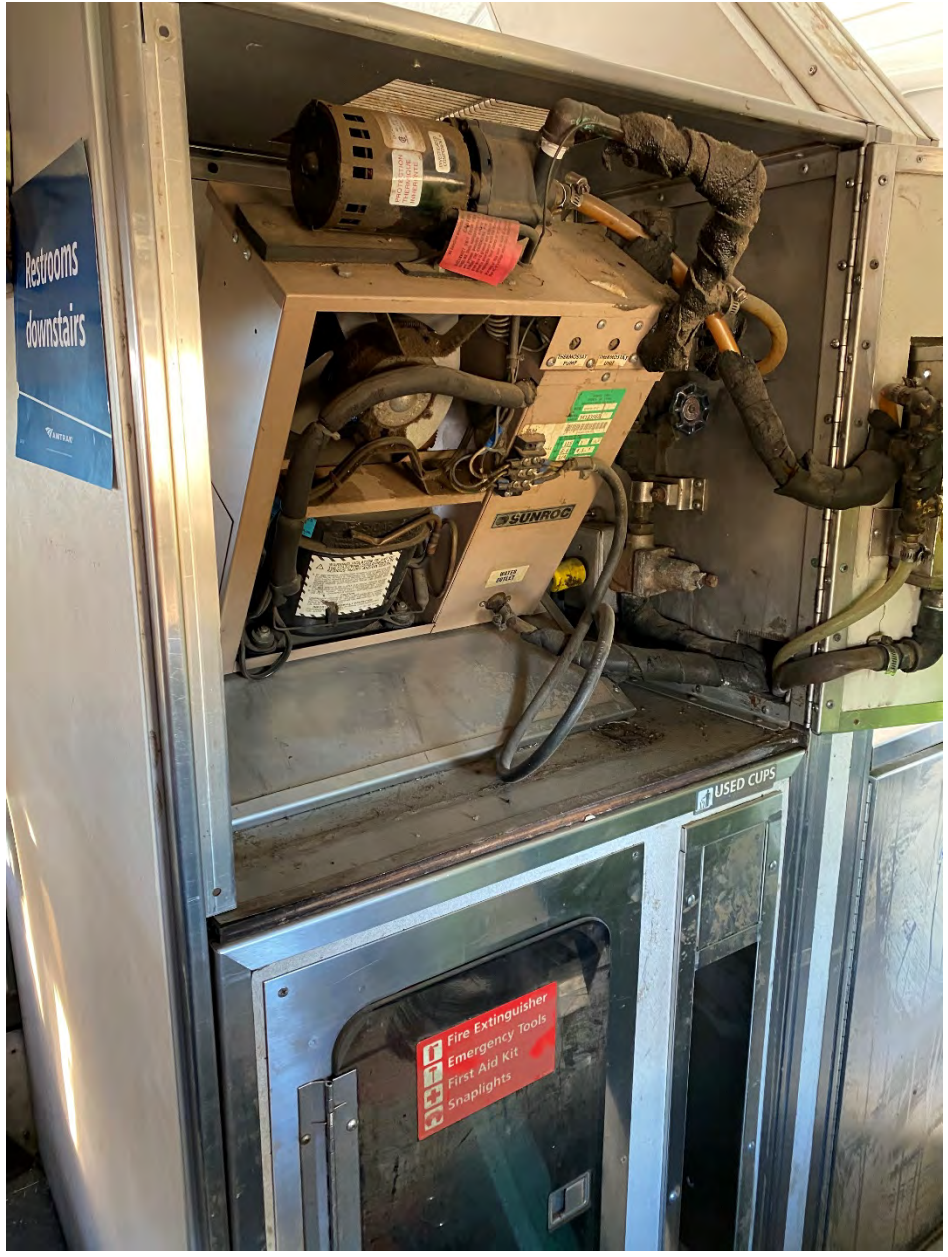
ATK 34077

The B end coupler horn broken, but still attached. The AR coupler bumper block missing. The B end coupler bumper blocks missing. The A1 air brake reduction replay missing.

The right-side batteries leaking acid. The seat positions 1, 2, 5, and 6 dislodged. Top lever water cooler fell out of the cabinet.

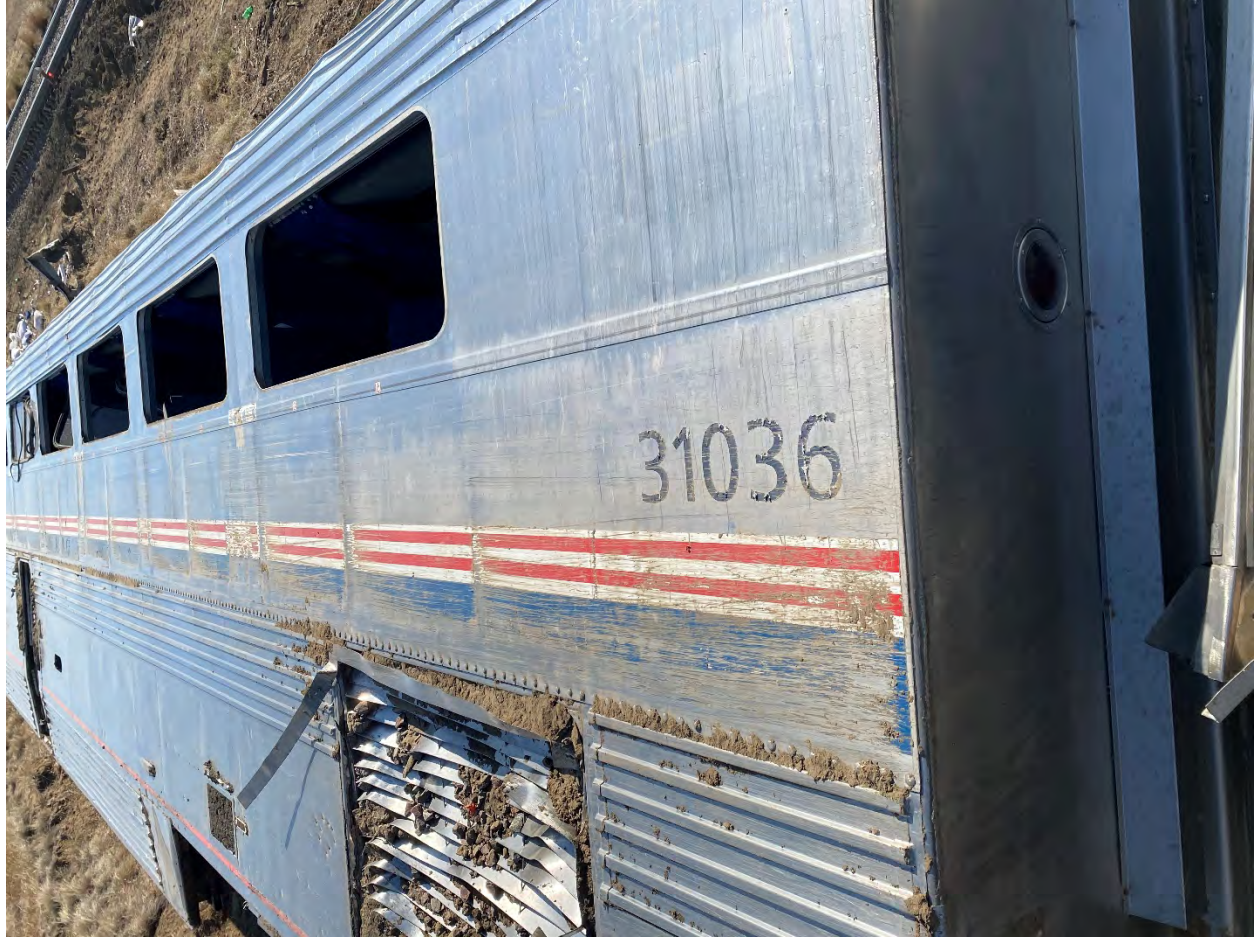
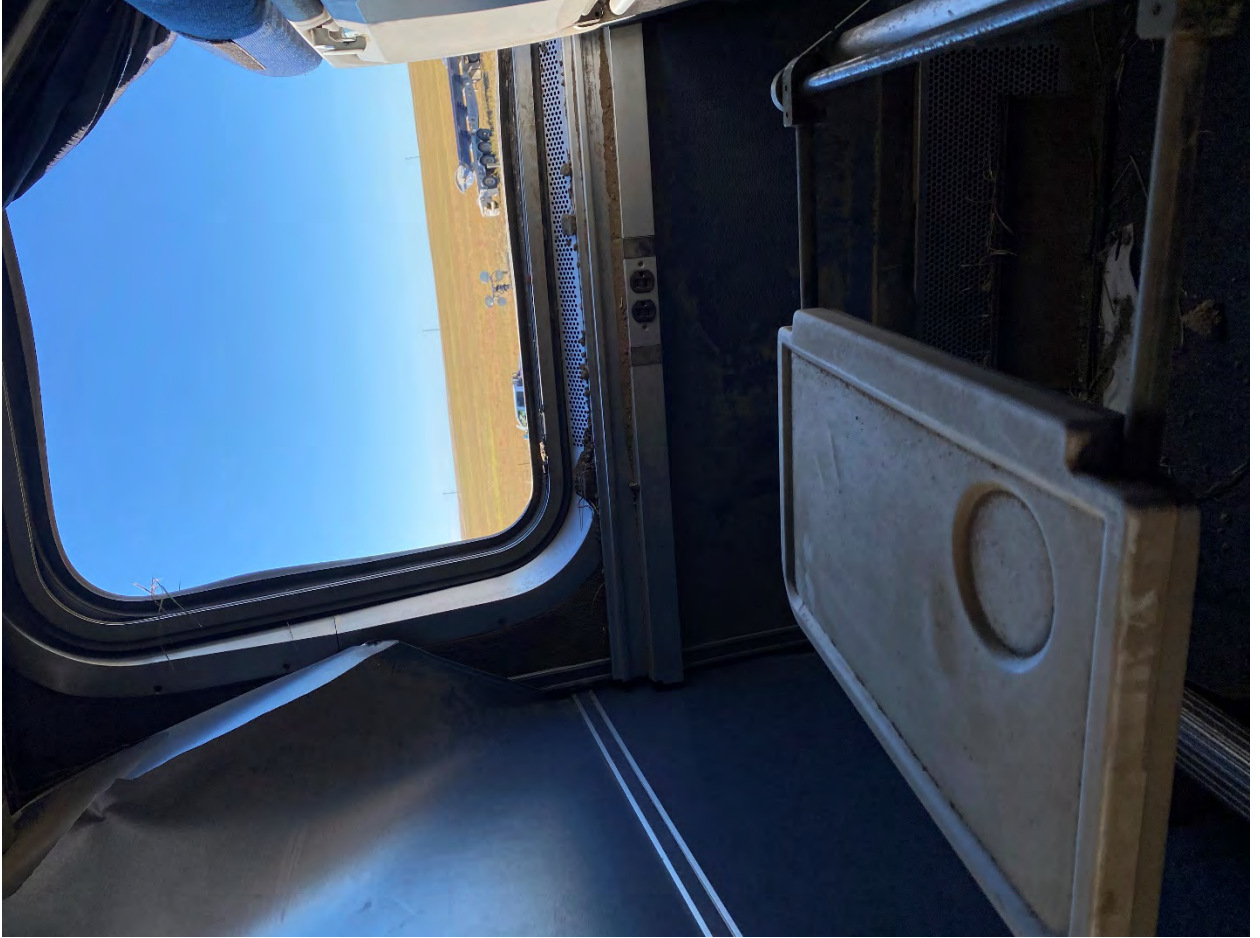
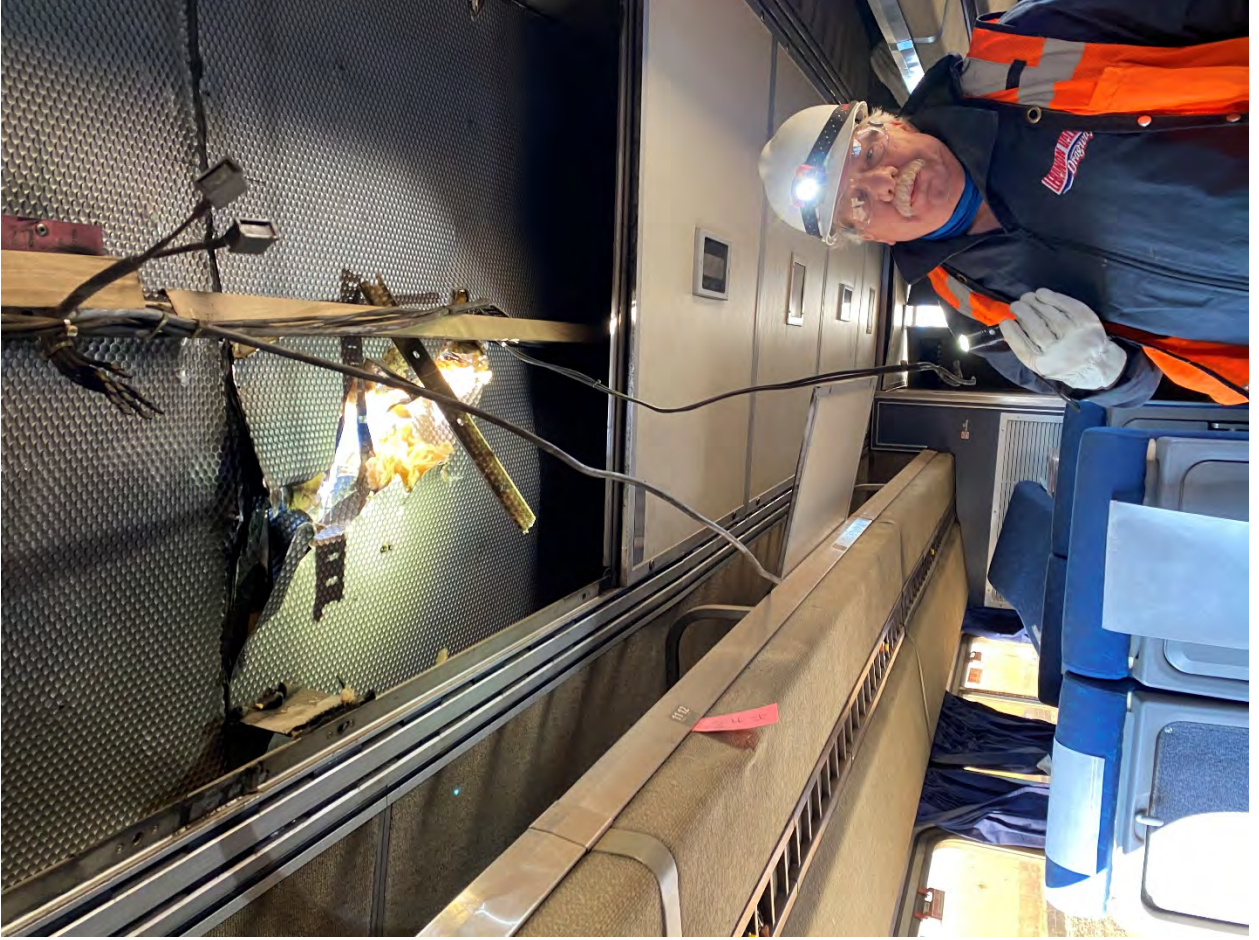
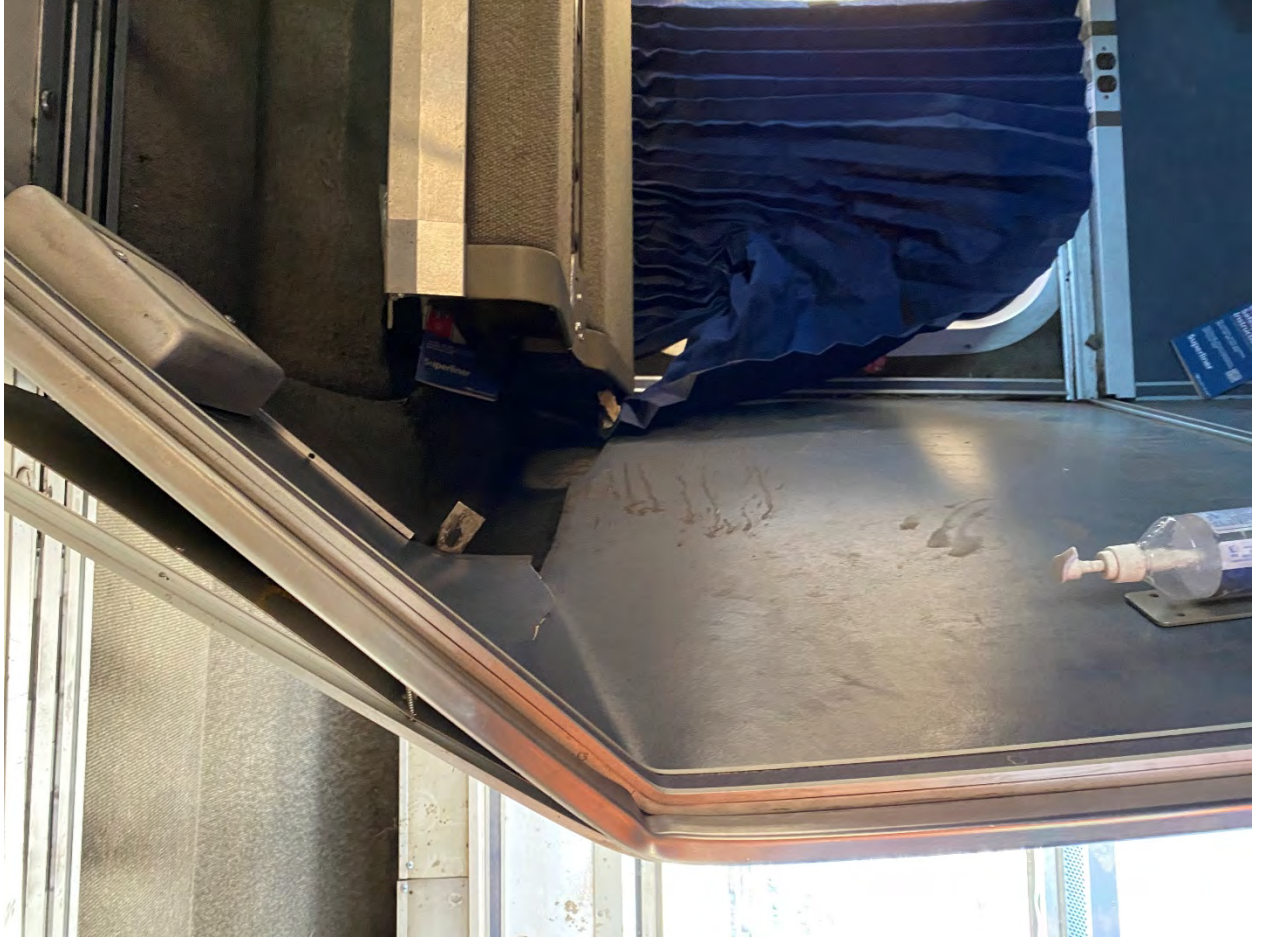
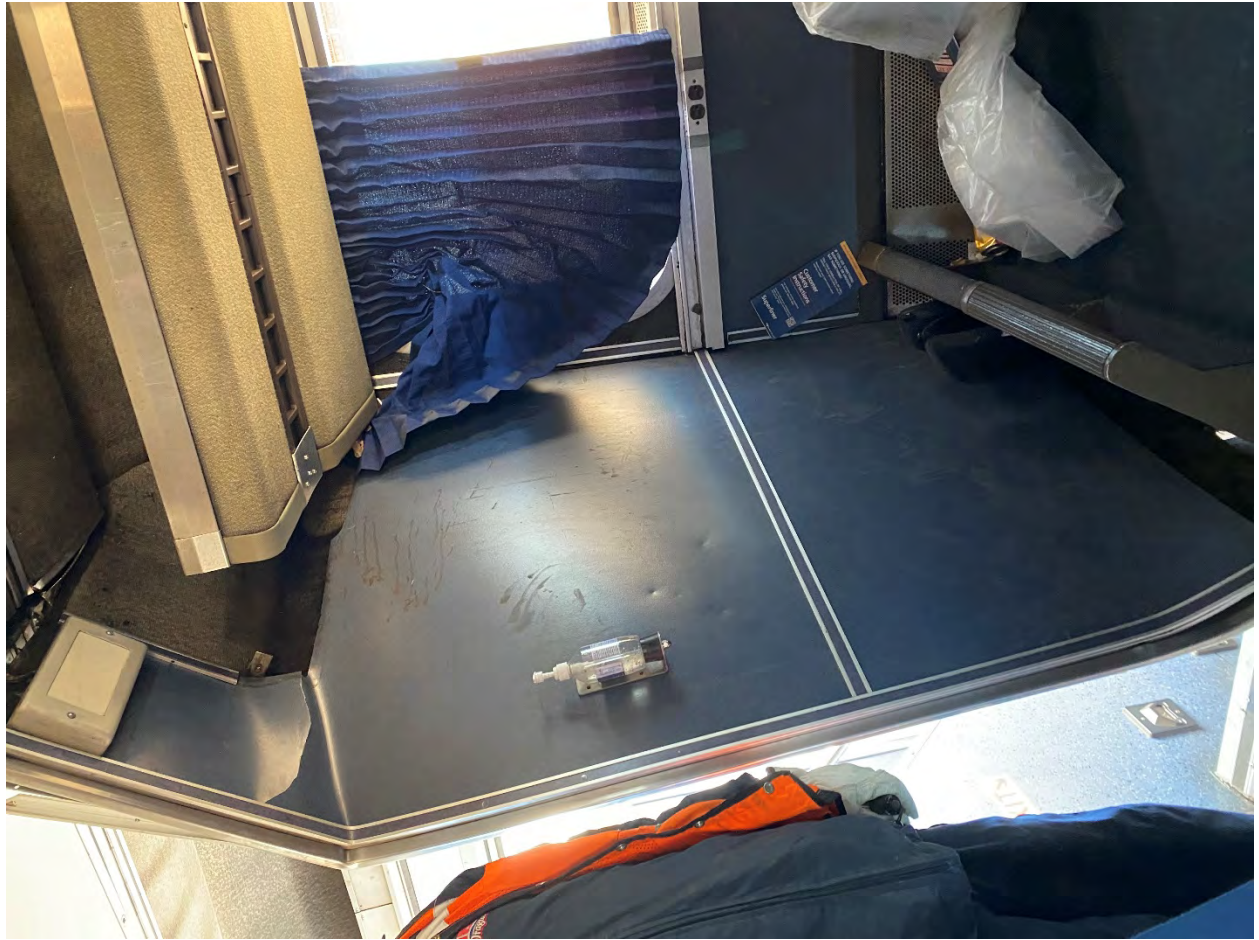
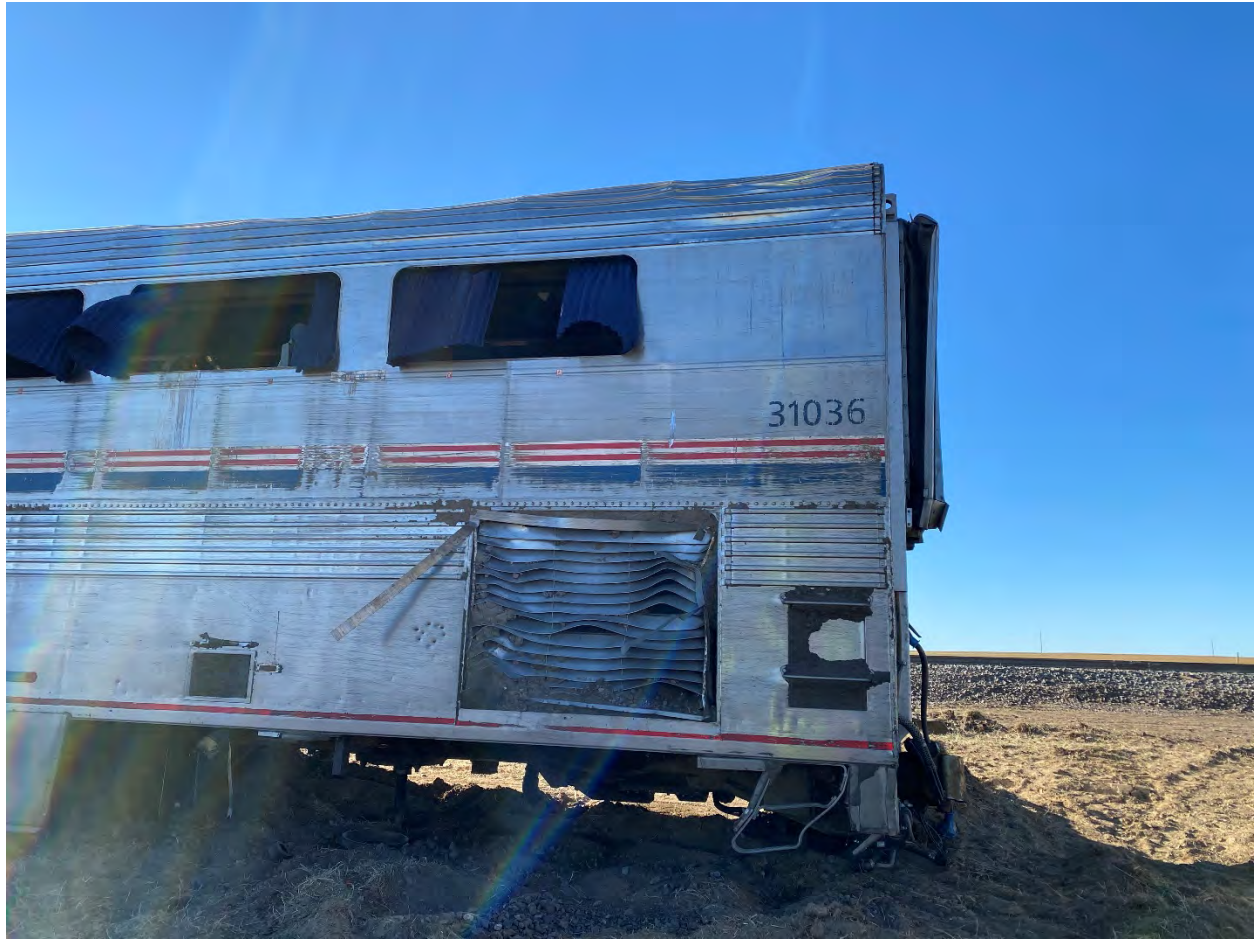
ATK 31036

The A end coupler blocks missing. The B end bumper blocks damaged. The L4 brake rotor bent.

The A end vestibule door diaphragm damaged. The bottom floor entry fire extinguisher dislodged from bracket. Between the seats 9, 10, 11, and 12 the cab roof was breached. The windows on seats 67 and 68 were gone. The B end right side batteries dislodged.
