ATK 32050

The following defects were noted on the sleeper car that was positioned as the third car behind the two locomotive train consist remaining upright.

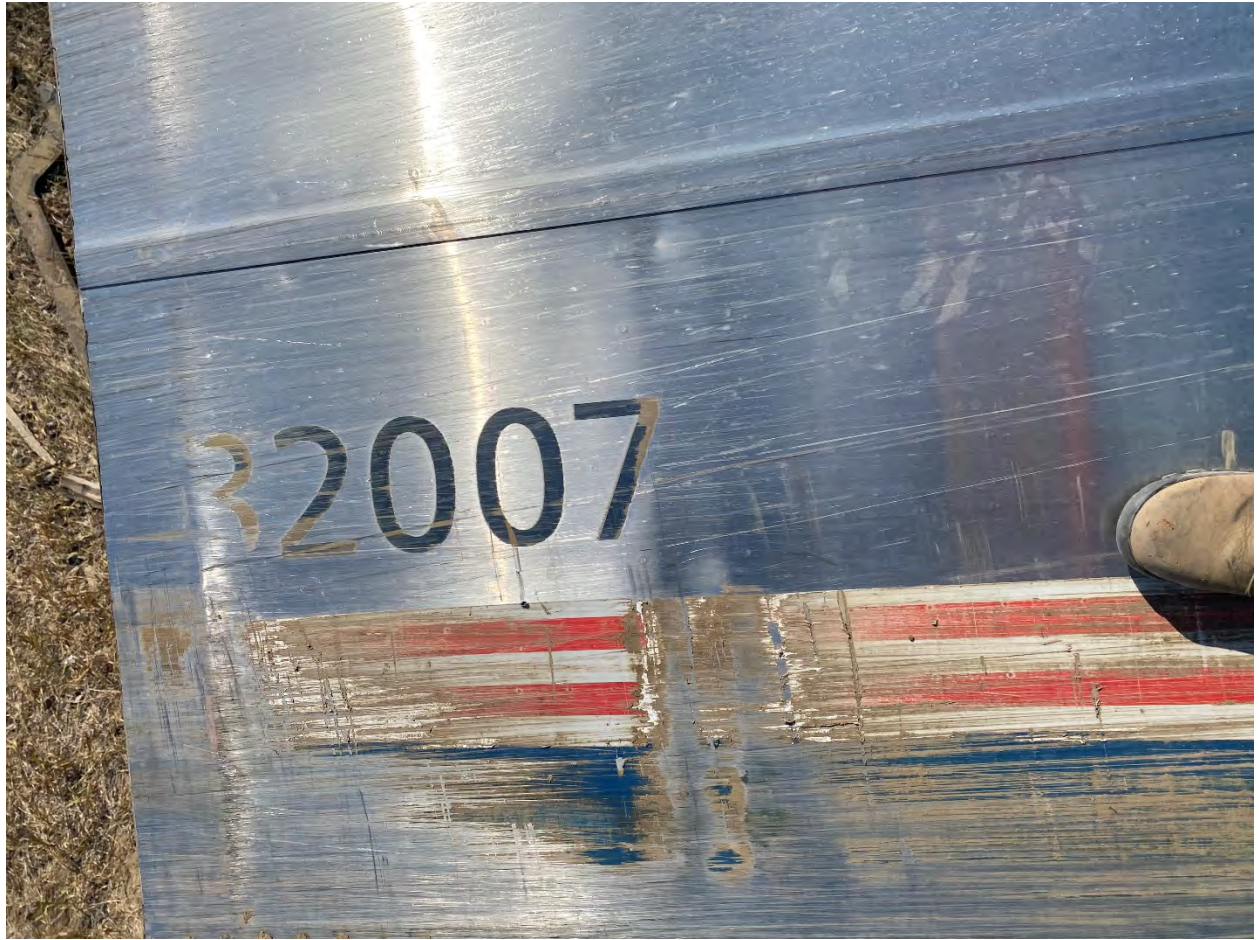
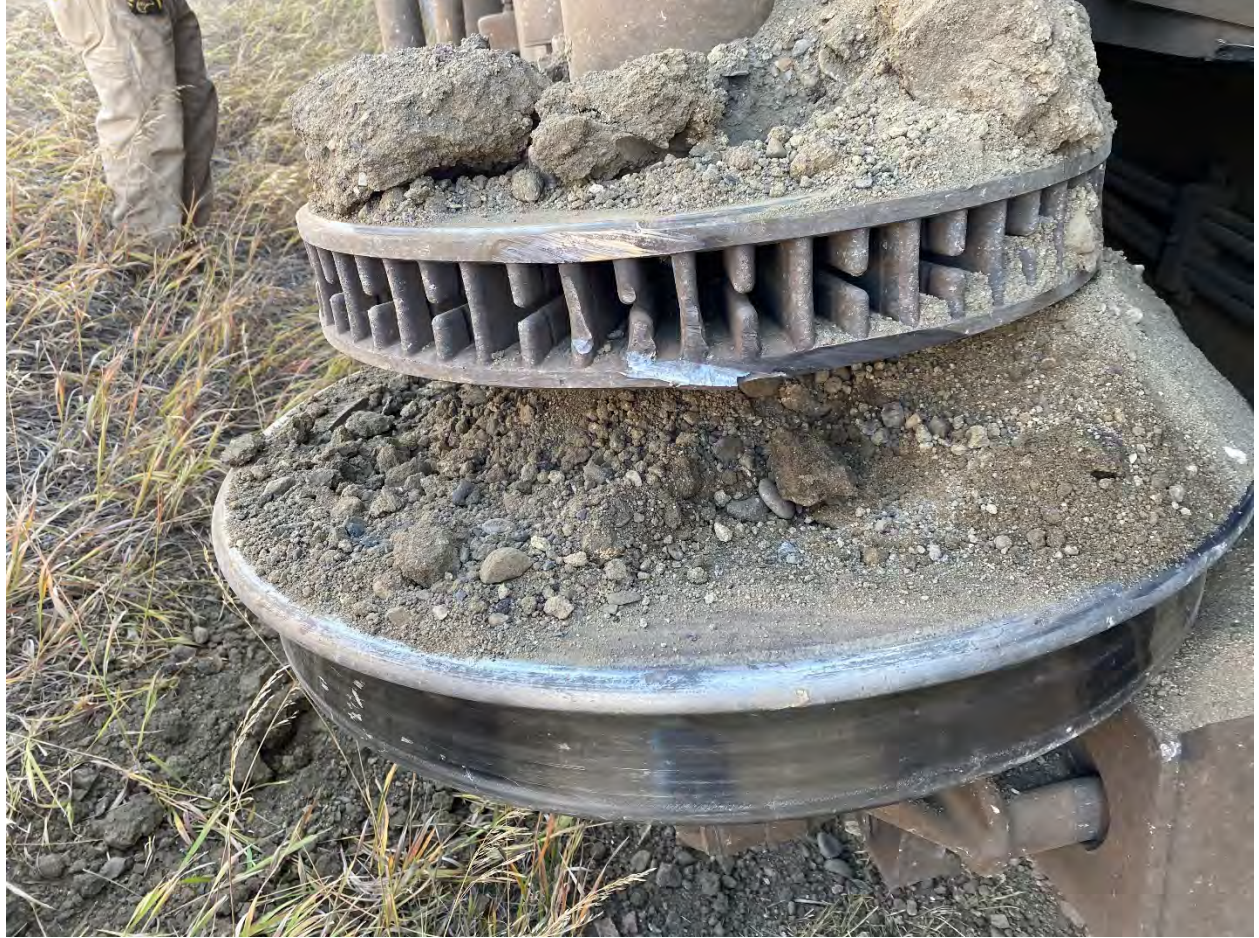
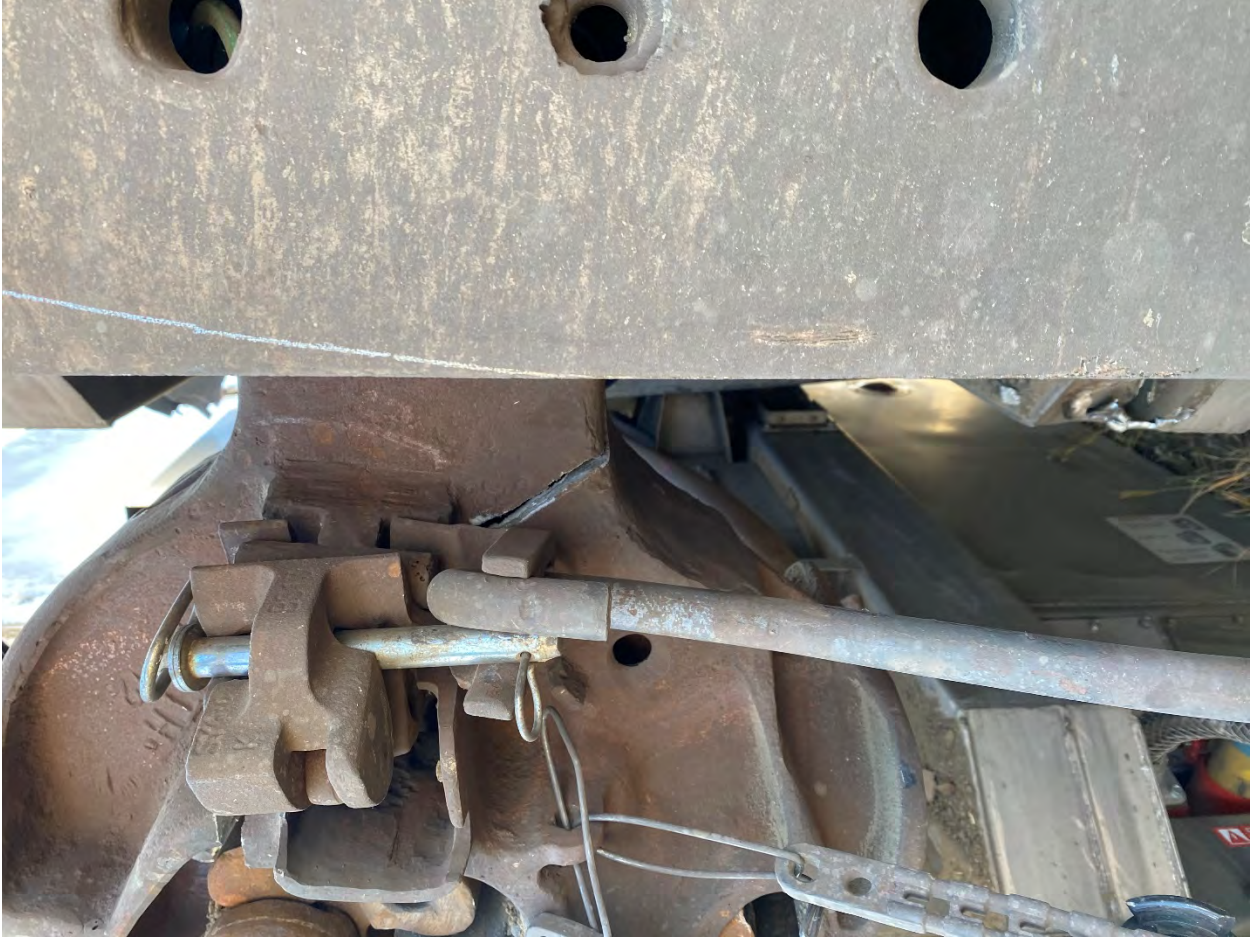
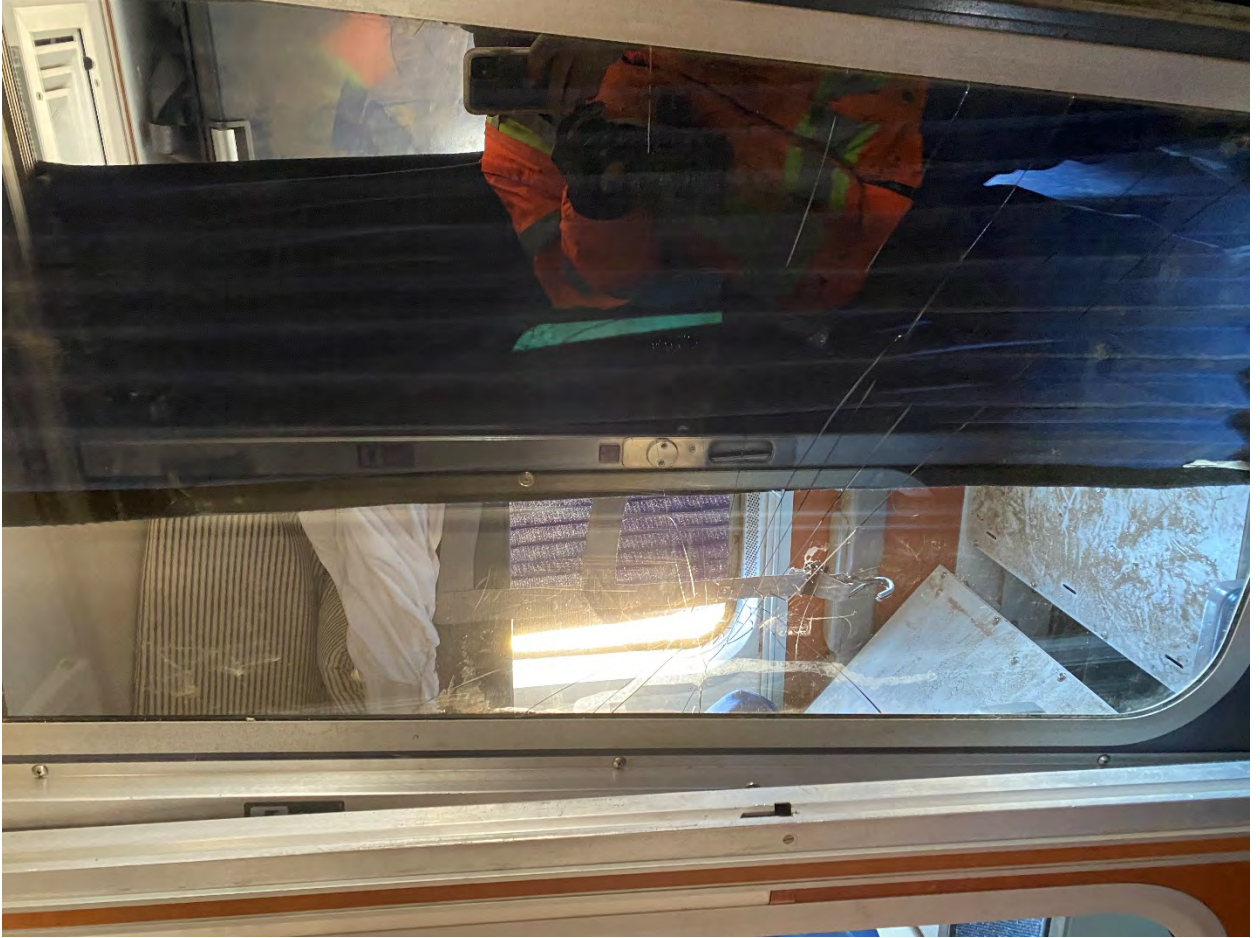
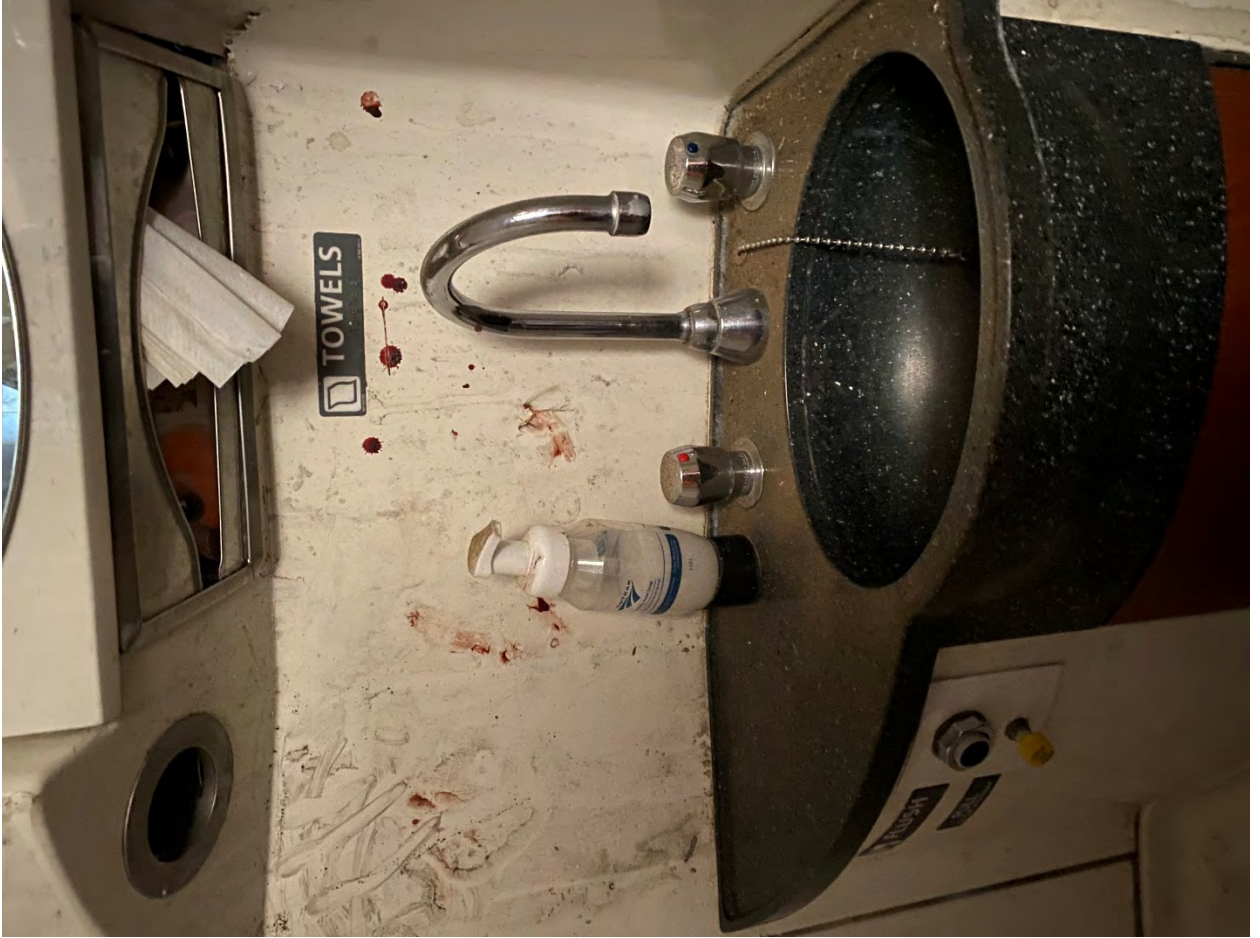
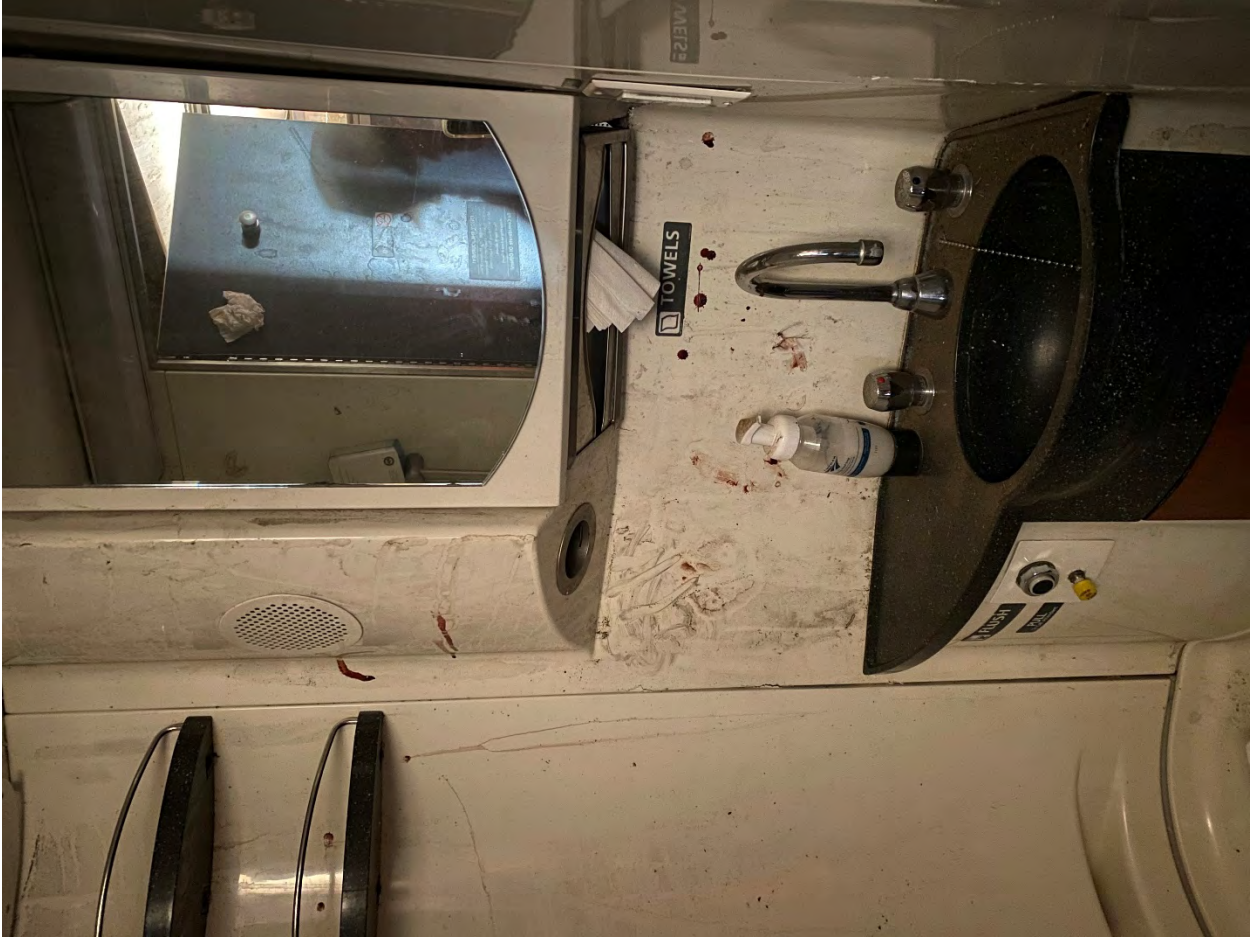
ATK 32007

The AL coupler bumper stop damaged. The R4 brake rotor damaged.

The right-side batteries dislodge. On the AR corner of the car body an equalizer bar breached the car body.

Room 3 wall glass and sliding door glass broken, laying inside and out of room.

Room 7 sliding door glass missing, pushed out.

Room 9 wall glass and sliding door glass removed to the inside.

Room 10 door glass missing, laying inside and outside of room.

Room 13 door glass missing, inside of room.
