National Transportation Safety Board

RRD23FR013

MECHANICAL

Group Chair's Factual Report

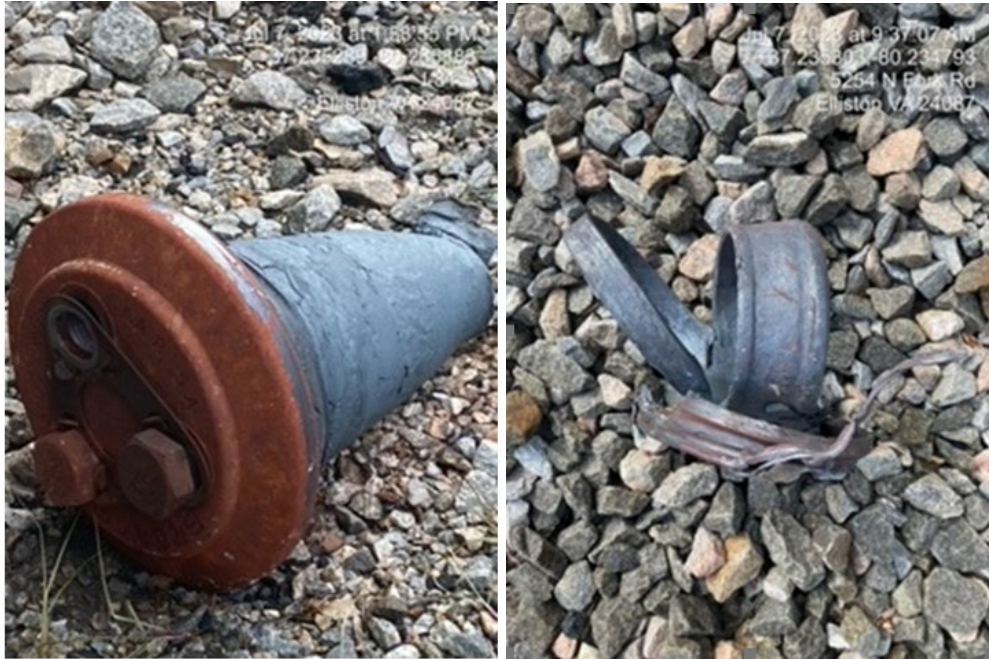
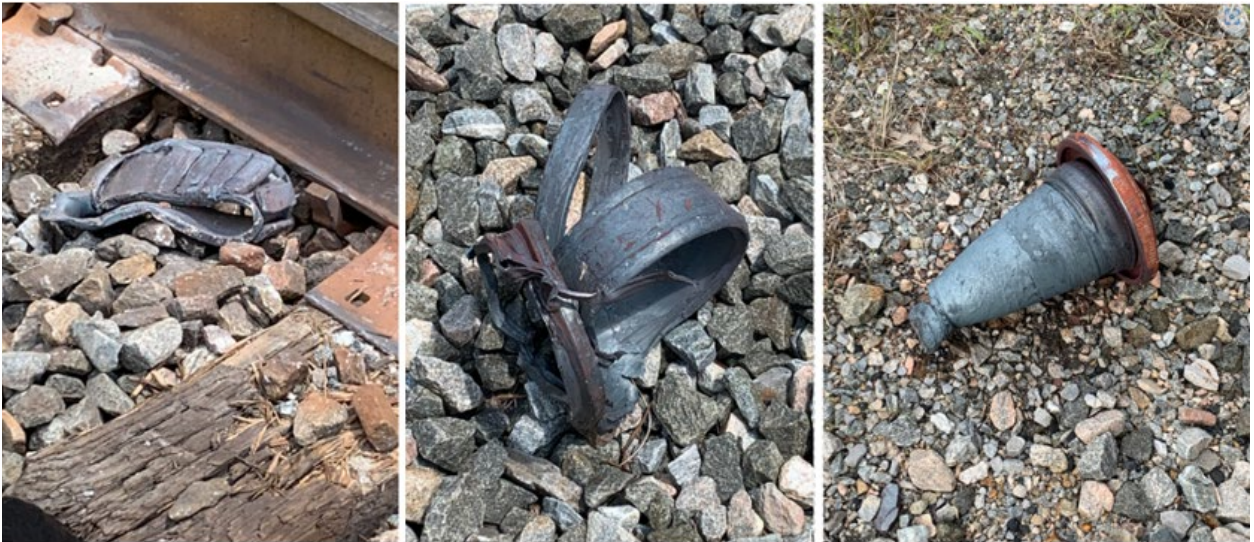
Figure 1: Photographs of Car CR 507499 - failed (burned off) journal bearing components

16 The R1 bearing had extensive thermal damage, and no traces of the polymer seals
17 remained. The steel components within the reconditioned bearing had evidence of
18 melting, portions of components galled and melted together, and extensive rub
19 damage and plastic deformation. The cages for both the inner and outer roller
20 assemblies were comprised of steel. Spalling damage (imperfections on the surface
21 due to cyclical loading resulting in component fatigue damage) that occurred prior
22 to the accident was observed on the inboard race of the bearing cup.
