National Transportation Safety Board

RRD24FR001

MECHANICAL

Group Chair's Factual Report

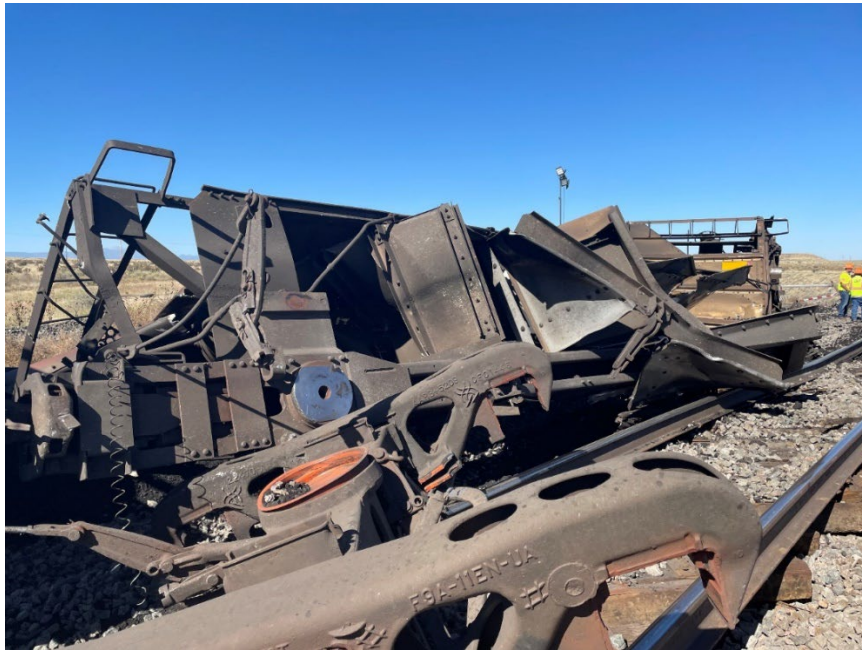
Figure 1 - Photo BNSF 651350 first car to derail on Train C-ATMCRD 0-31D Near MP 109.6

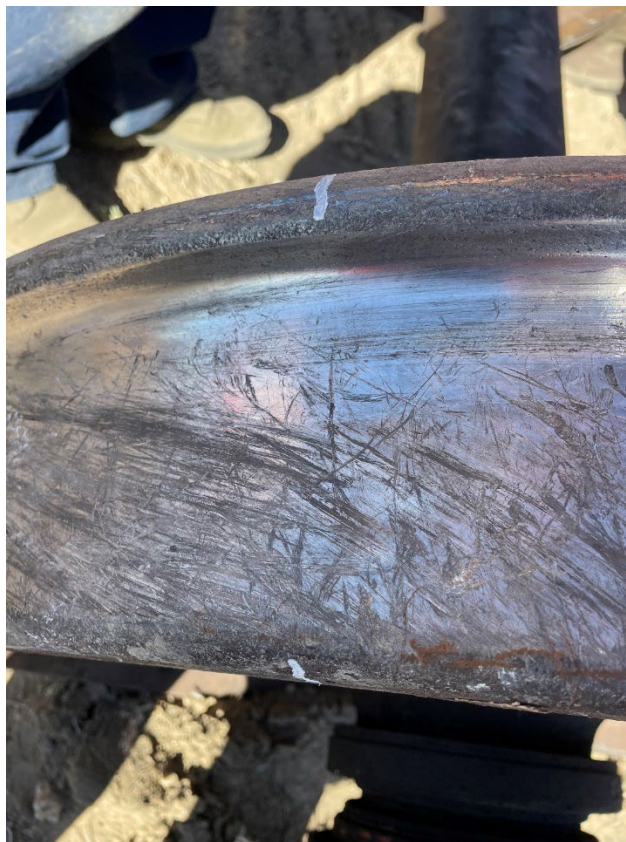
Figure 2 - Wheel from one of the railcars that passed over the broken rail with rail impact indentation.

Post accident locomotive consist air brake test passed and functioned as intended. Inspected wheel sets from first car derailed BNSF 651350 and all wheel sets passed the point of derailment. Observed indentations from the broken rail on several wheel sets. Inspected railcars, defects were noted but did not contribute to the derailment.
