National Transportation Safety Board

RRD22MR007

MECHANICAL WORKING GROUP

Group Chair's Factual Report

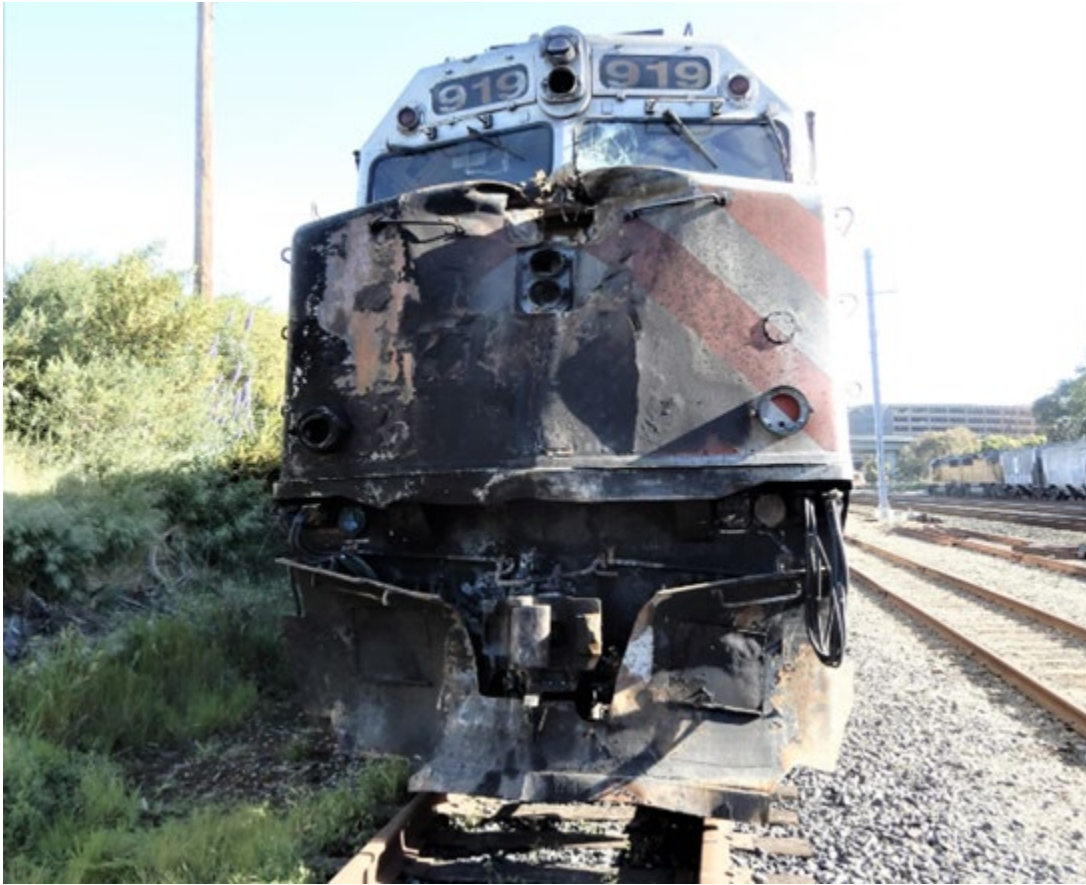
Figure 1. Caltrain Locomotive No. 919 from Train No. 506 at the laydown yard during mechanical inspection
