National Transportation Safety Board
Office of Railroad, Pipeline and Hazardous Materials Investigations
Washington, D.C. 20594

Union Pacific – Rear End Collision
Granite Canyon, Wyoming
October 4, 2018
Mechanical Group Factual Report

NTSB Accident Number: RRD19FR001
Date of Accident: October 4, 2018
Time of Accident: 7:38 p.m. (MDT)
Type of Trains: Freight
Railroad Owner: Union Pacific
Train Operator: Union Pacific
Fatalities: 2
Location of Accident: Granite Canyon, WY

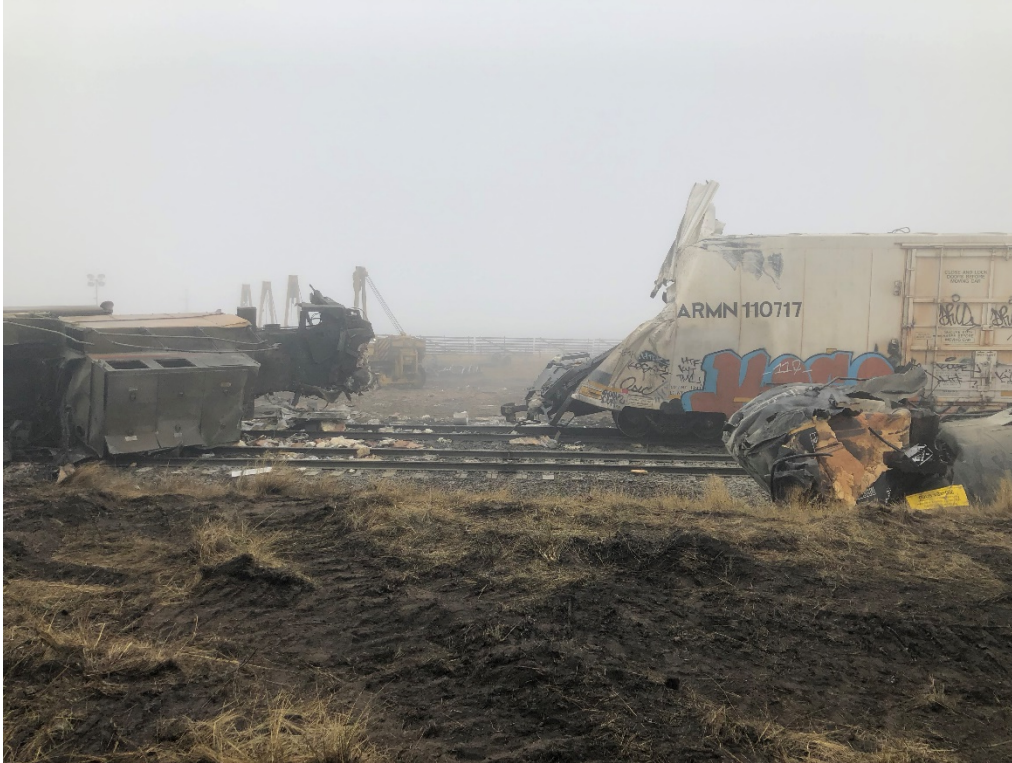
Figure 1 Depicting the front of the striking train (left) and the rear of the struck train (right)

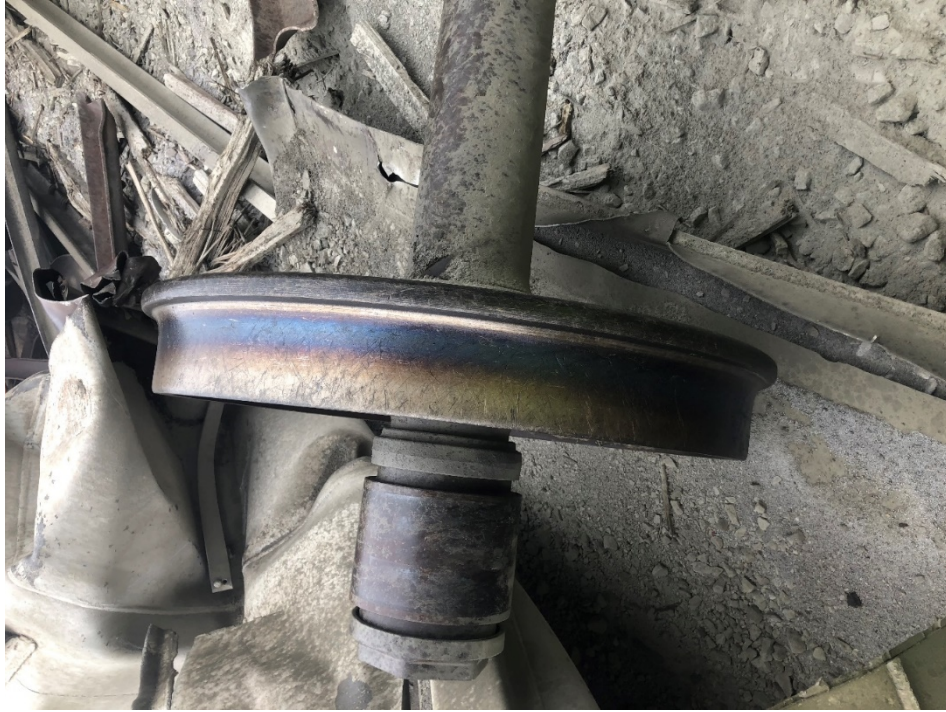
- Multiple wheel sets show signs of overheating and sliding in the general pile-up area towards the front of the consist. (figure 2)
- Multiple freight car brake beams show signs of excessive braking as evidenced by brake shoes worn to the backing plate and worn through to the brake head. (figure 3)

Figure 2 A wheel found toward the front end of the consist with bluing.

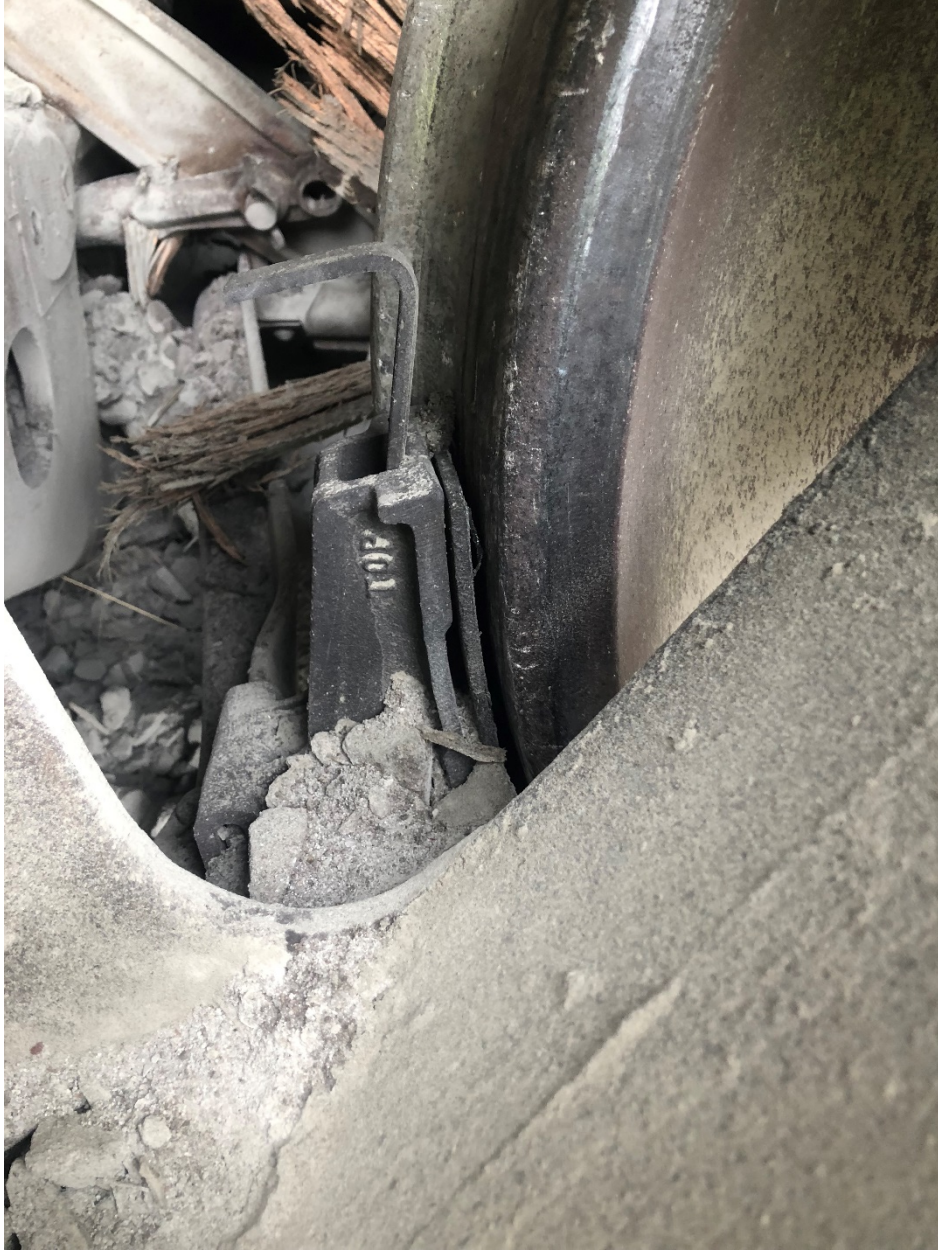
Figure 3 A worn brake shoe found towards the front of the consist.

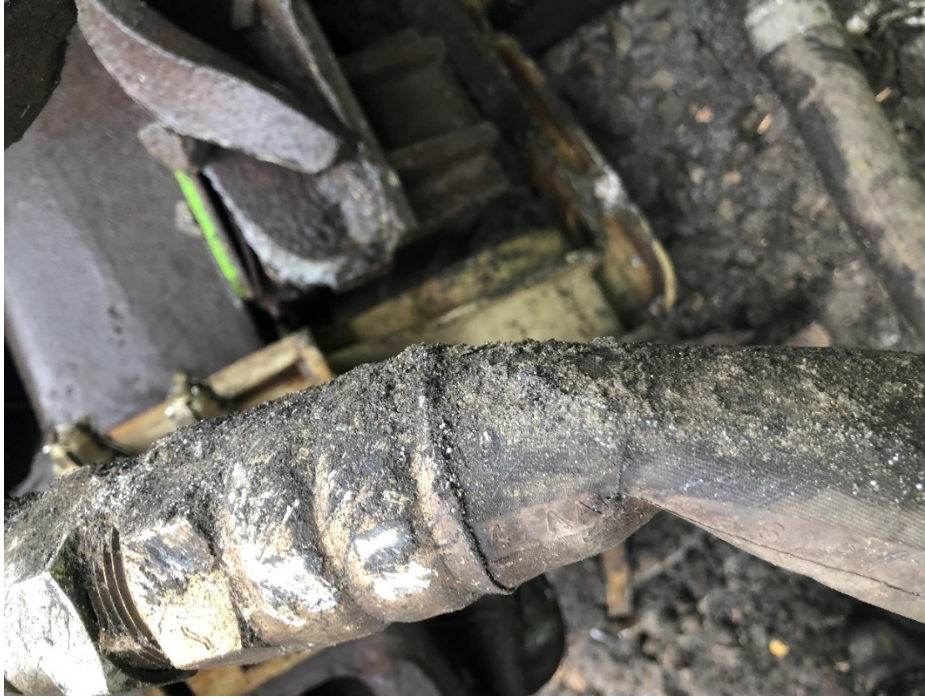
- The “A” end intermediate air hose of the 20th car from the head end (SSW87597 – bulkhead flat) show signs of kinking. (figure 4)
- An airbrake test was conducted on the remaining non-derailed cars of the striking train and resulted in no defects that would have affected the train performance, nor contributed to a “0 CFM” air flow reading through the brake pipe.

Figure 4 The "A" end intermediate air hose from car position 20.

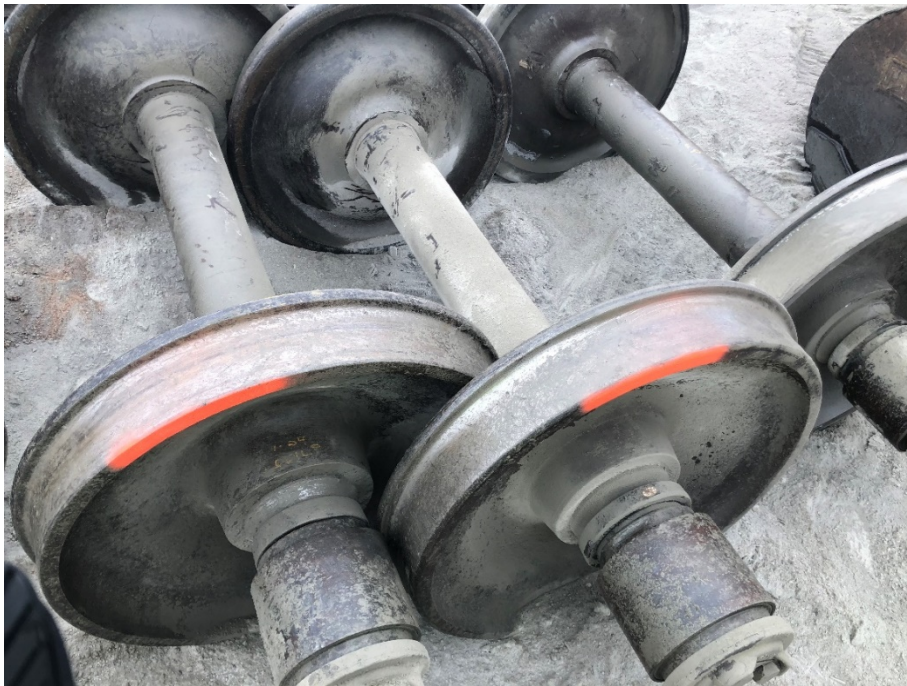
- The mechanical group met on the morning of October 7, 2018, at the accident site. The following observations were made:
 - About 45-50 car wheel sets were marked that showed signs of overheating and sliding. (figure 5)

- A review of the wheel detector report for the subject train indicated that axles 18-54 exhibited higher temperature readings than the remaining axles in the train.

Figure 5 Marked wheels that show signs of overheating or sliding.

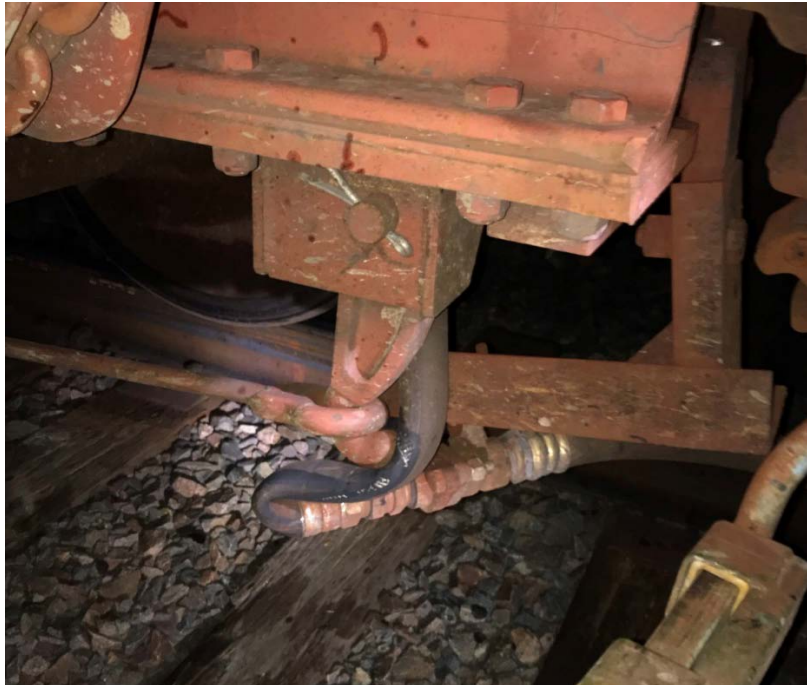
apply the air brake on the train, the crew realized that the reduction was not communicated to the rear of the train. The crew then attempted to apply emergency brakes by toggling the emergency brake function on the HOT device and the train went into emergency braking on the third attempt. Upon inspection, employees discovered a kinked trainline hose as seen in figure 6.

Figure 6 Kinked air hose on car west of Cheyenne, WY.

In December of 2018, Union Pacific created training material that covered proper repair and inspection of freight car end hose arrangements. This training contains a multiple point inspection criterion concerning proper air hose supports, pinched air hoses, fittings, valves, brake rigging interference, wear marks, and dimensions. All car department mechanical forces received this training by the end of December.

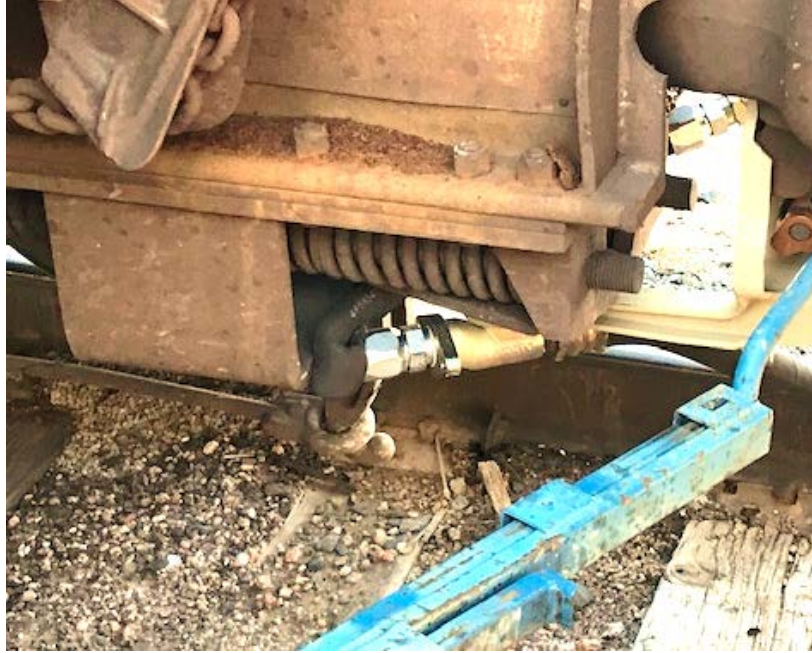
On December 20, 2018, a car that had recently received end hose arrangement repairs from a car repair shop was discovered on an outbound train by inspectors that had a similar kink. The end hose arrangement application was incorrect causing this defect in figure 7.

Figure 7 Kinked intermediate air hose after misapplication.

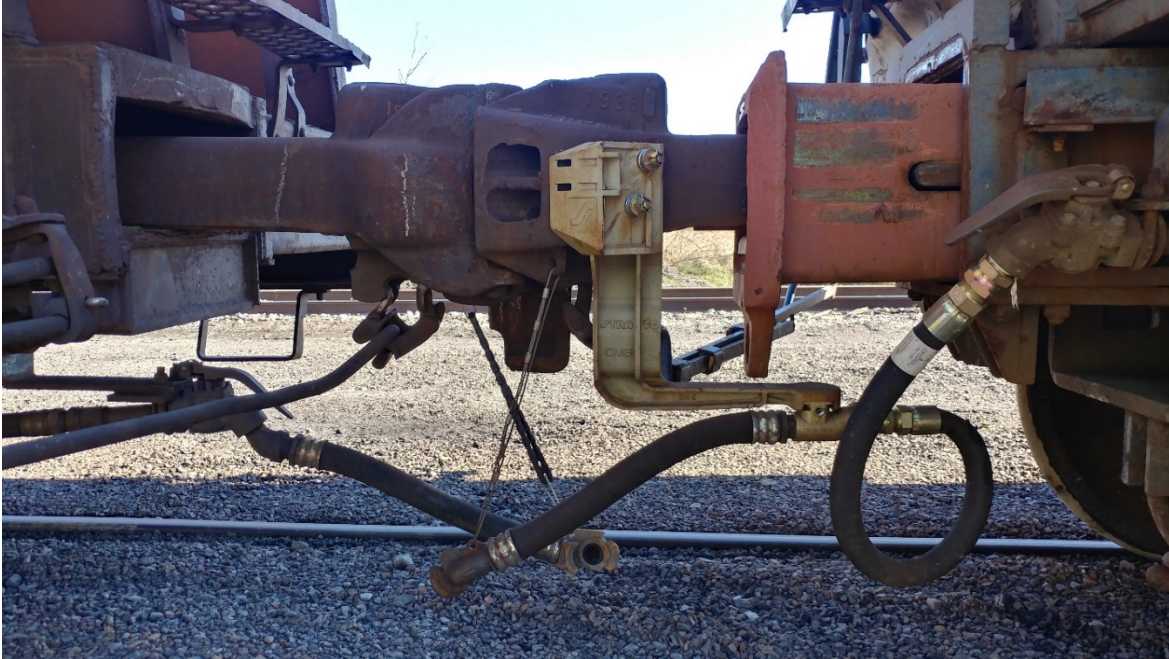
It was noted that exemplar Car SSW 87591 (bulkhead flat) had a few notable differences from the accident car. First, both ends of the exemplar car had end hose arrangements that did not utilize the S-4021 bracket, whereas the accident car did have a S-4021 bracket on both ends. This means that the exemplar car did not utilize a secondary hose and the angle cock was located under the coupler as opposed to on the end sill. The Strato representative explained that historically, brackets were welded to the cushioning device to support trainline angle cocks. However, because dissimilar metals were used, and because welding practices varied, cracks often developed in these areas leading to undesired emergencies and equipment not secured properly. Therefore, AAR changed the standards (Field Manual Rule 6) and required a coupler mounted bracket or other mechanical securement to be used in lieu of welding. When a CMB was used, the location of the angle cock had to be changed. The change in standards over time has led to variations between cars, and often between ends of the same car.

Car No. SP 338286 had a few differences as well. The B-end of the car had a S-4021 bracket, whereas the accident car did not. The A-end of the exemplar car had a bracket which is similar to the accident car. Secondly, it was noted that the B-end intermediate hose had an observable kink in a vertical direction. There was wear on the hose where it had contacted the center sill and/or cushioning unit. While this is different than the sister gondola car, it is similar to what the bulkhead flat car SSW 87597 was found with post-accident. Also, the B-end arrangement appeared to be installed improperly, with missing components replaced with a cotter key and a large water trap (low spot in the hose) formed in the intermediate hose.

Figure 10 SSW 87591 A-End (left) and SP 338286 B-end (right).

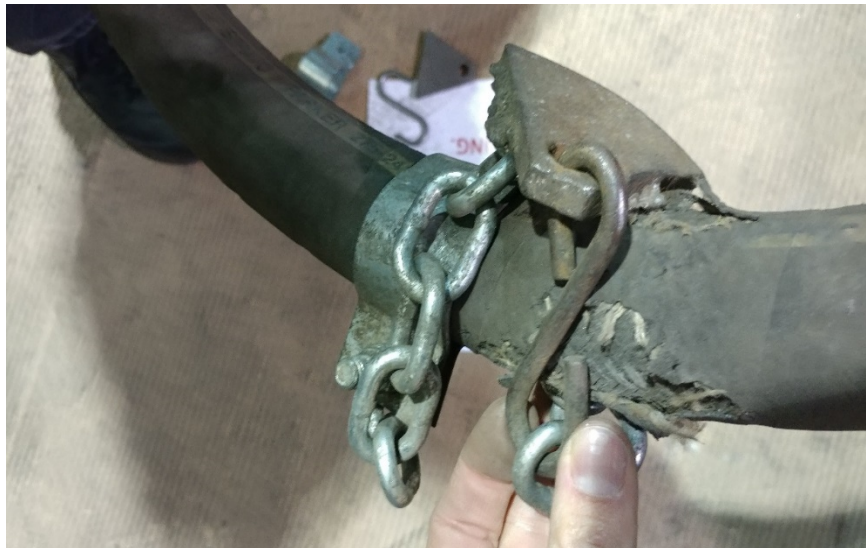
Preliminary examination of the subject intermediate hose support chain interface is consistent with the support chain not moving along the length of the intermediate hose before or during the accident. Preliminary evidence is also consistent with the chain support having been disconnected from the car body and wrapped around the hose causing premature wear prior to the accident.

Figure 11Wear marks on the intermediate hose

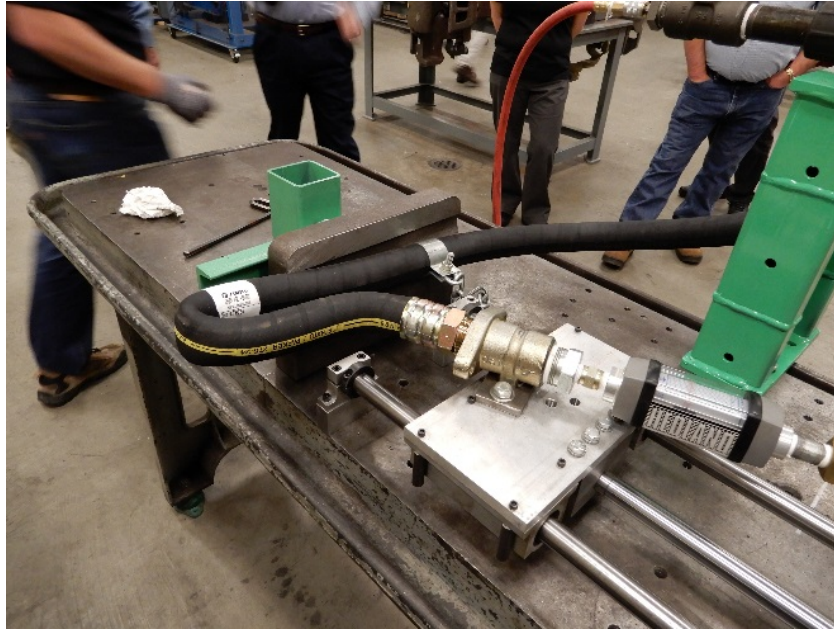
Based on the measurements of the sister cars in Council Bluffs, the car did not have any components that would have caused hose interference or obstruction, however the group recreated obstructed flow scenarios by putting the test rig in different buff and draft positions and placing the hose support in different locations in a manner to induce kinking. An air flow meter was connected to the rig to observe any air flow fluctuations while conducting these tests. The pressure in the hose was 90 psi and the flow was reduced to approximately 24 CFM. Initial event recorder data shows that previous to the incident, air flow readings were recorded between 20 to 27 CFM. Based on that data, investigators agreed to conduct testing at 24 CFM.

Figure 13 Pinched hose demonstration to study airflow. Not based on subject car geometry.

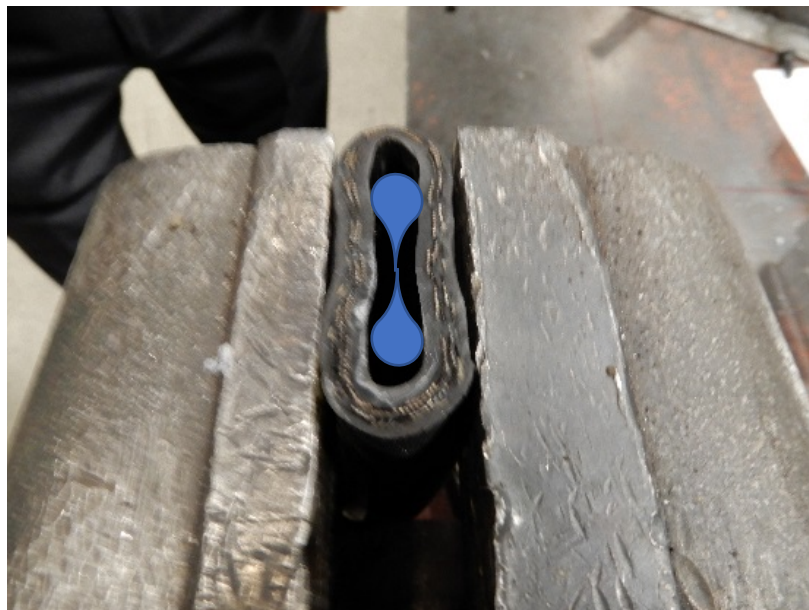
Investigators observed no changes in the air flow on the subject hoses from car SSW 87597 or on new hoses tested in multiple scenarios in an attempt to kink them. It was also observed that flow through the subject hoses was possible in nearly any configuration due to the material's tendency to form a figure eight (8) shape variance when kinked or compressed. (See figure 14) Investigators were unable to kink any hoses while pressurized to reduce the flow to 0 CFM.

Figure 14 Demonstrating figure eight (8) shape while compressing the hose using a vice.
