NATIONAL TRANSPORTATION SAFETY BOARD

MECHANICAL GROUP FACTUAL REPORT

CSXT Railroad, Derailment with Hazardous Materials Release and Fire

NTSB Accident Number: DCA17FR011
Date of Accident: August 02, 2017
Time of Accident: 4:54 a.m. (EDT)
Railroad Owner: CSXT
Train Operator: CSXT
Type of Train and No: Q38831 (Mixed Freight/Hazmat)
Crew Members: 1 Engineer, 1 Conductor
Location of Accident: Hyndman, PA

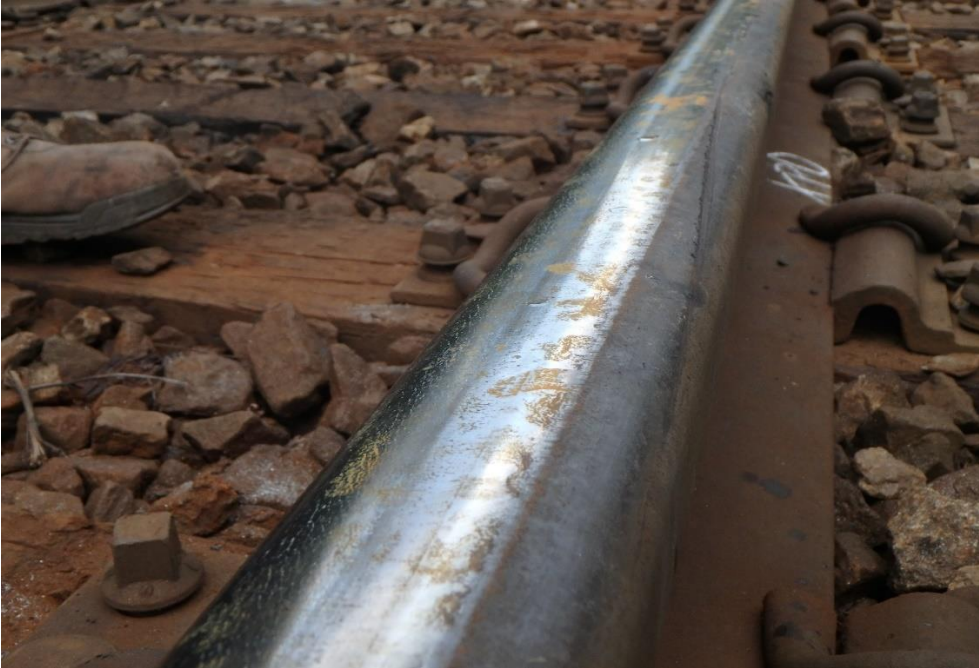
1 August 3, 2017. Evidence that a wheel climbed the high-side of the north rail on main track No.
2 2, while coming out of an 8.375-degree right-hand curve on a descending grade of 1.67 per cent,
3 traveling eastbound was observed. This was followed by an additional wheel climbing within 30
4 feet on the north rail as well. Investigators also photo documented flange and tread marks from
5 the derailed rail car wheels that were found on various track components to include flange marks
6 to the ties inside the gage. The POD was 1.7 miles west of a rail grade crossing (Hogback Road)
7 where additional rail cars departed the tracks.

2 **Figure 3. Photograph showing a section of rail with wheel flange departure mark across the rail in**
3 **curve at the Point of Derailment.**

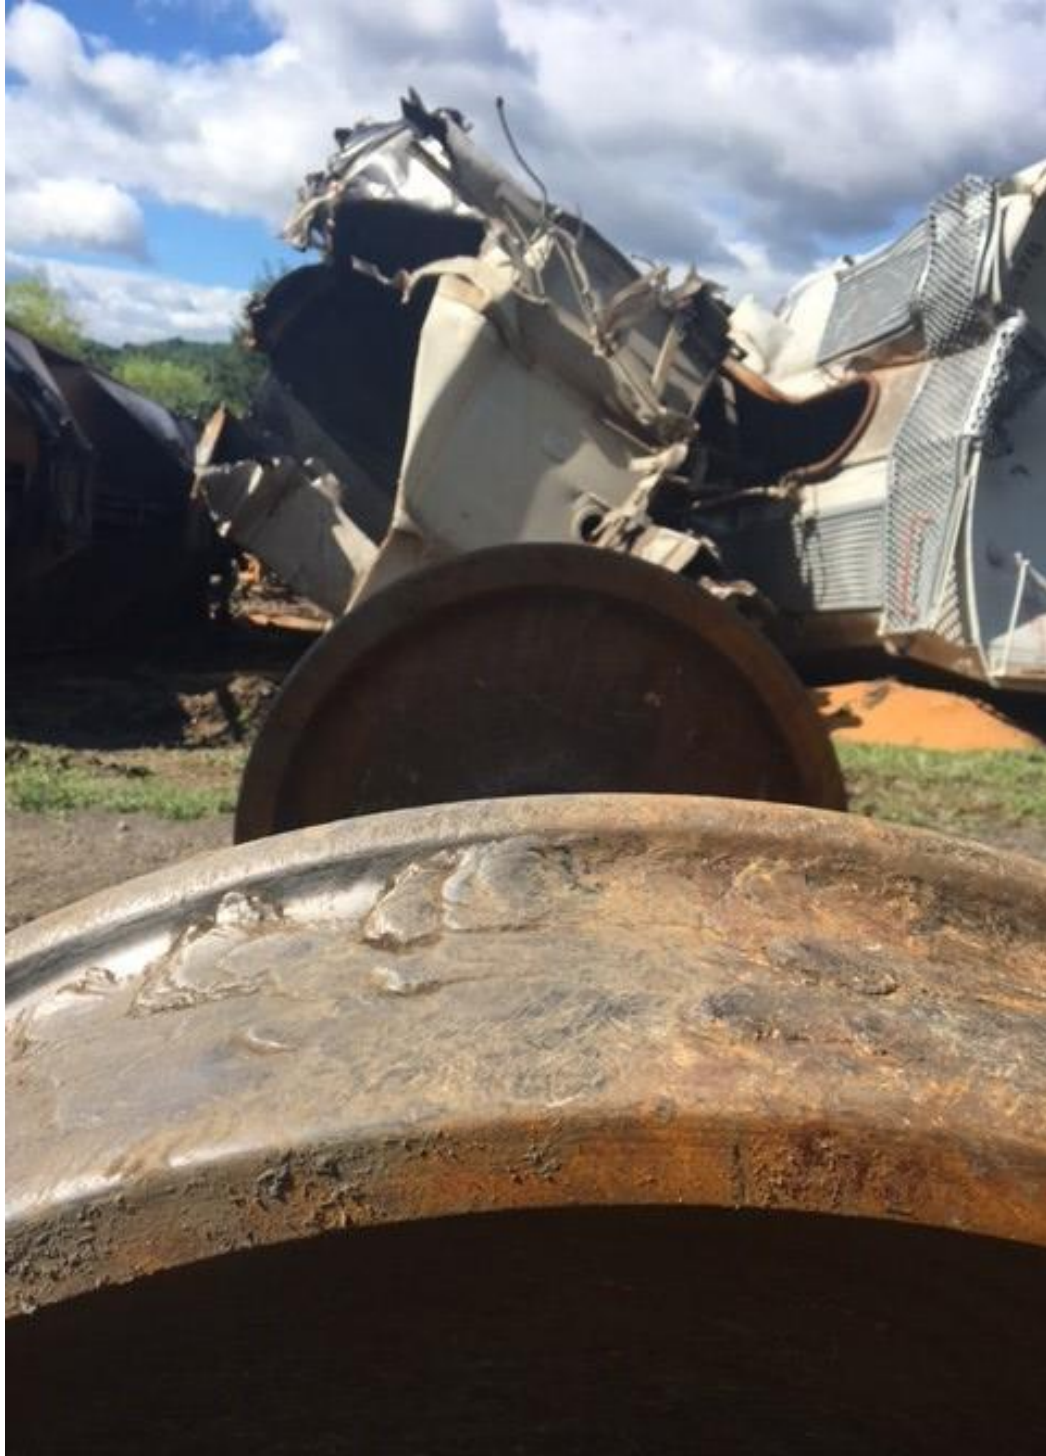
11
12 The 35th cars' #3-wheel set had heavy built up tread on the tread surface and the
13 throat of the flange. The tonnage from the first car in the consist to the 35th car was
14 1,631 tons. There was 16,621 tons trailing the 35th car. The 35th car was an empty high-
15 sided gondola and was in a block of 27 empties.

7 All the wheels of car FWTX 620111 had indications of overheating. The
8 overheating of the wheels of the #4 and the #2 axles (1st and 3rd axles in direction of
9 movement) were observed with a reddish-brown discoloration on both the front and
10 back of the rim; extending more than four inches into the plate. The wheels of the #4 and
11 the #2 axles were also observed to have extensive built-up tread.

Figure 3. A close-up view of a wheel tread surface (from a wheel of the 35th cars' #3-wheel set). Heavy metal build-up can be seen on the tread surface and in the throat of the wheel flange.

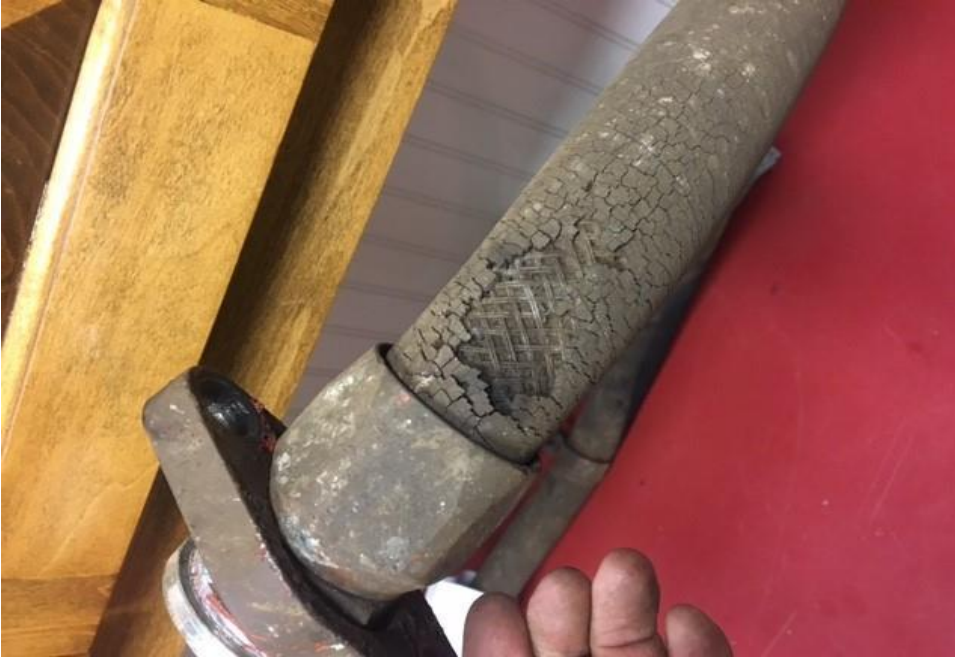
16 After securing the train the conductor made a walking inspection of train Q38831.
17 At car #159 (LW 62114), a bulkhead flat, the conductor found an air leak to the brake pipe
18 train line at the cars' b-end intermediate brake pipe hose. The conductor then returned to
19 the lead locomotive where he and the engineer remained, while waiting for a relief crew,
20 due to Hours of Service (HOS).

9 Mechanical investigators inspected the hose that was removed and found no
10 visible signs of kinking. The hose was fitted with a glad hand on one end and a pipe nipple
11 and cap on the other. The hose was then pressurized to identify the location of the leak.
12 The hose leaked at one end just behind the hose clamp and flange fitting. Arrangements
13 were then made with CSX in Cumberland Terminal to attach the hose to the rear of a 67-
14 car freight train prepared and inspected ready for departure. Leakage on the train before
15 attaching the hose at the rear was 2 psi. After attaching and cutting in the leaking hose,
16 the leakage showed an increase of between 1 and 1 ½ psi.

2 **Figure 4. A close-up view of the intermediate air brake hose removed from**
3 **car LW 62114 due to leakage. Some deterioration of the hose cover can be**
4 **seen next to the hose assembly fitting.**

22 CSX Mechanical Department employees replaced the hose, informed the train
23 crew (relieving crew) of the repair, and remained on-site to provide additional assistance
24 if needed.
