National Transportation Safety Board
Office of Railroad, Pipeline and Hazardous Materials Investigations
Washington, D.C. 20594

Passenger Fatality BART

September 13, 2021

Mechanical Group Factual Report

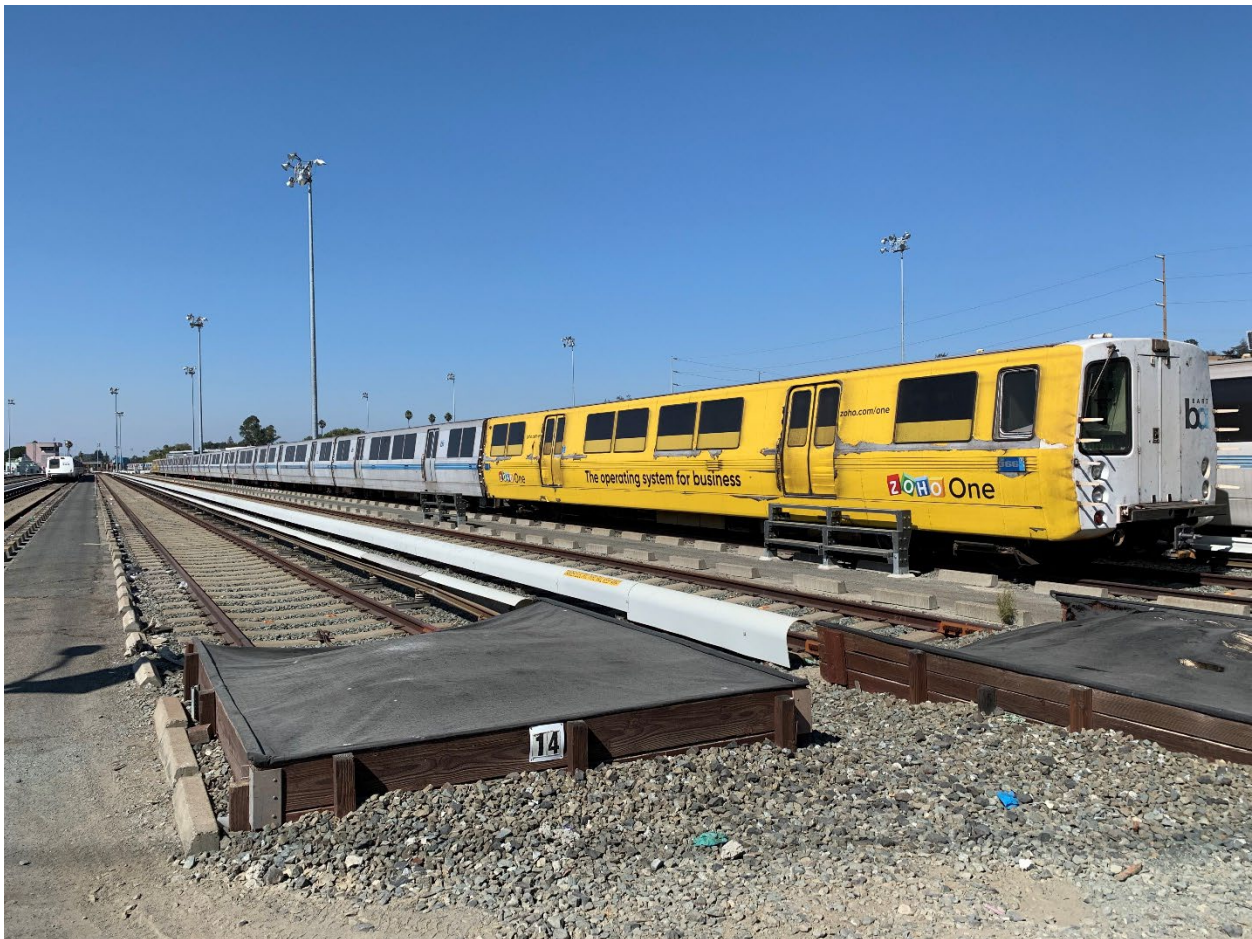
Figure 1 Accident train located at Concord Mechanical Facility.

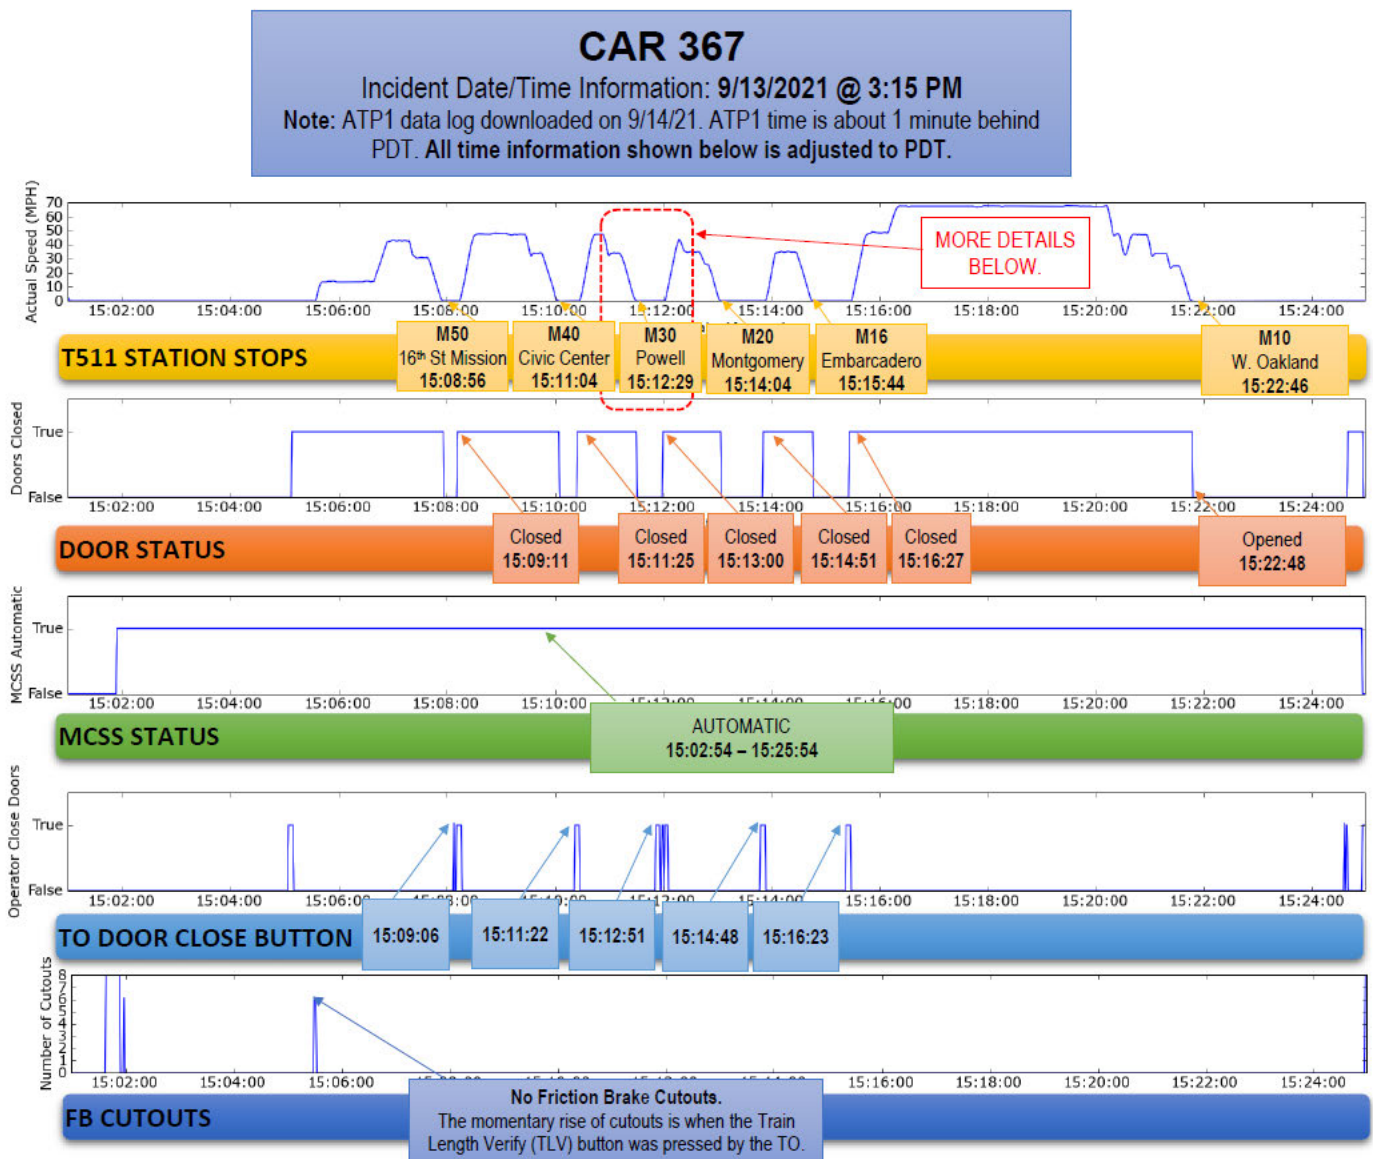
Figure 2 Data recorder showing station stops and door dwell times for the subject train.

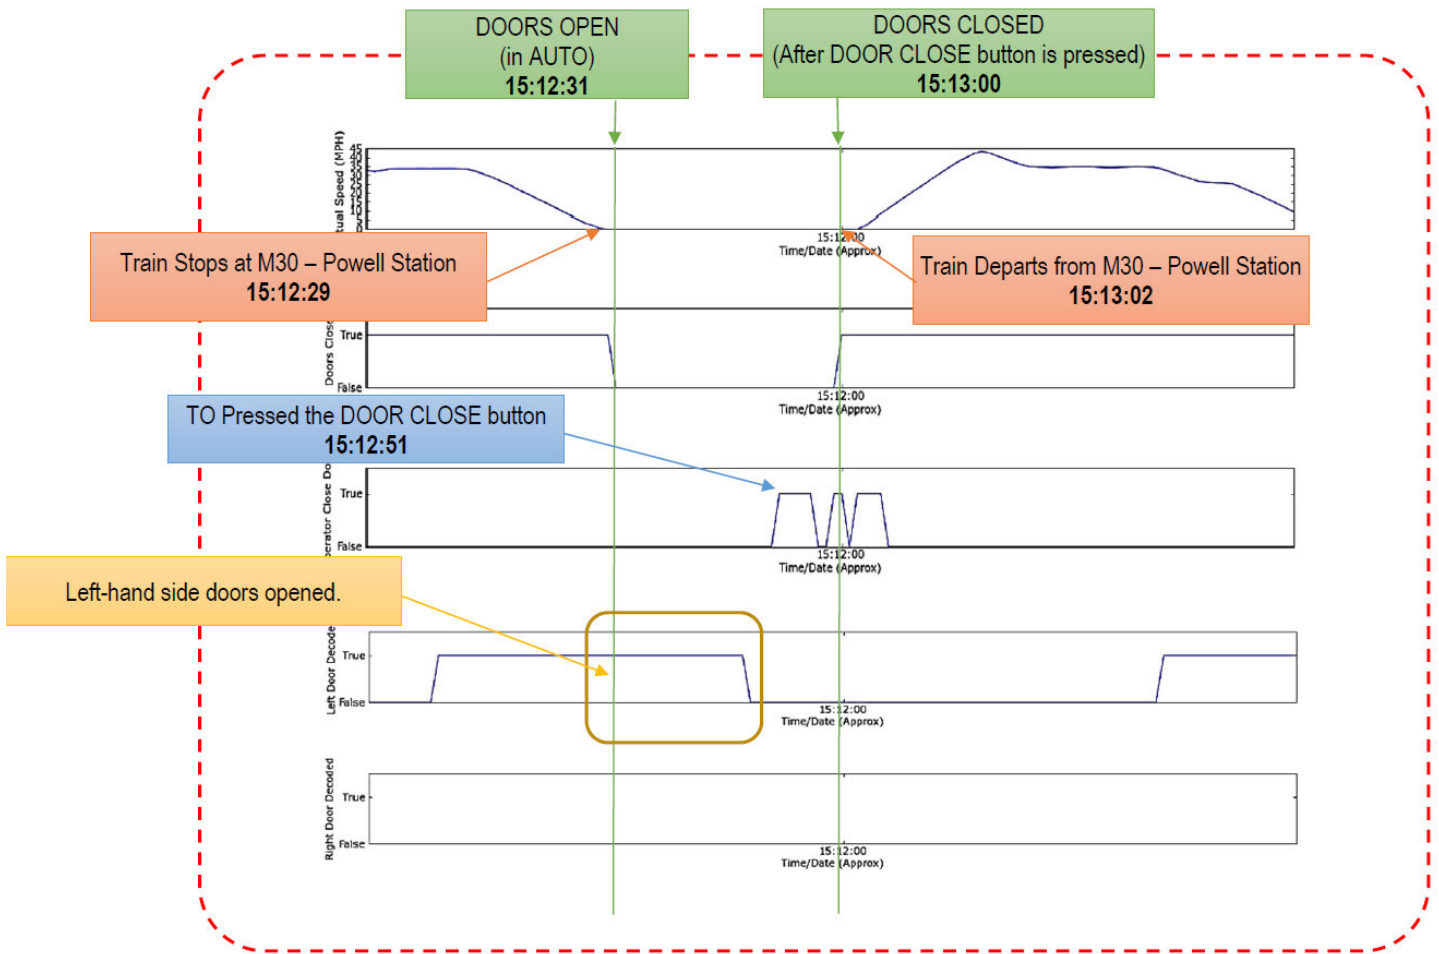
Figure 3 Enlarged view of the data recorder from the Powell Station stop.
