U.P. Derailment on Bridge with HAZMAT

Tempe, AZ

July 29, 2020

Mechanical Group Factual Report

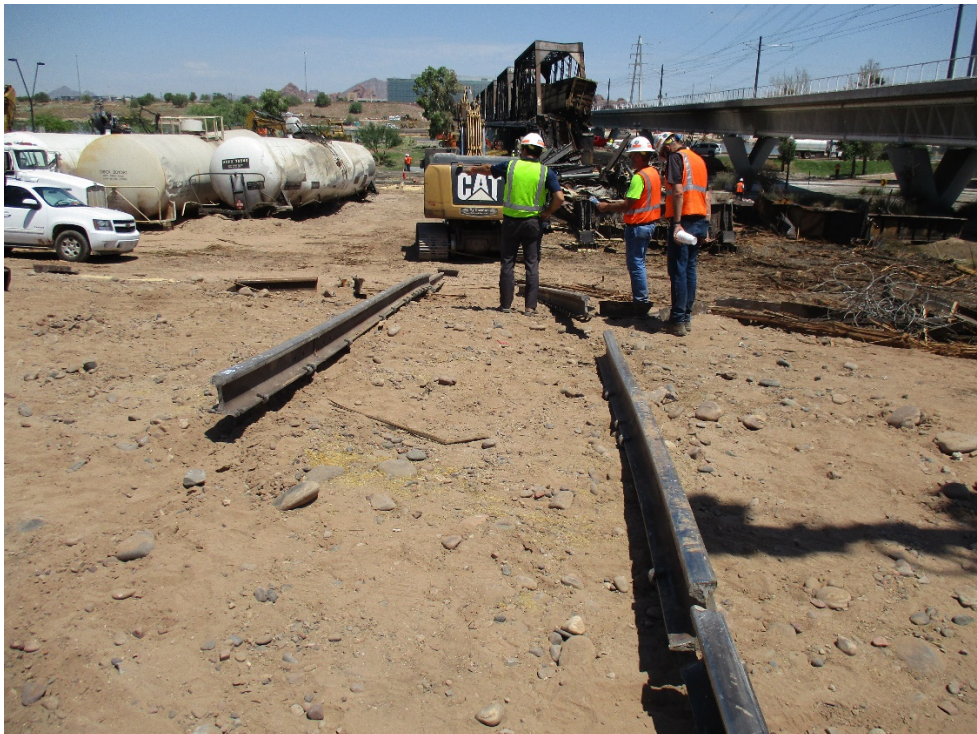
Figure 1 Photo of the accident scene at the south end of the bridge looking north. (Photo by FRA)

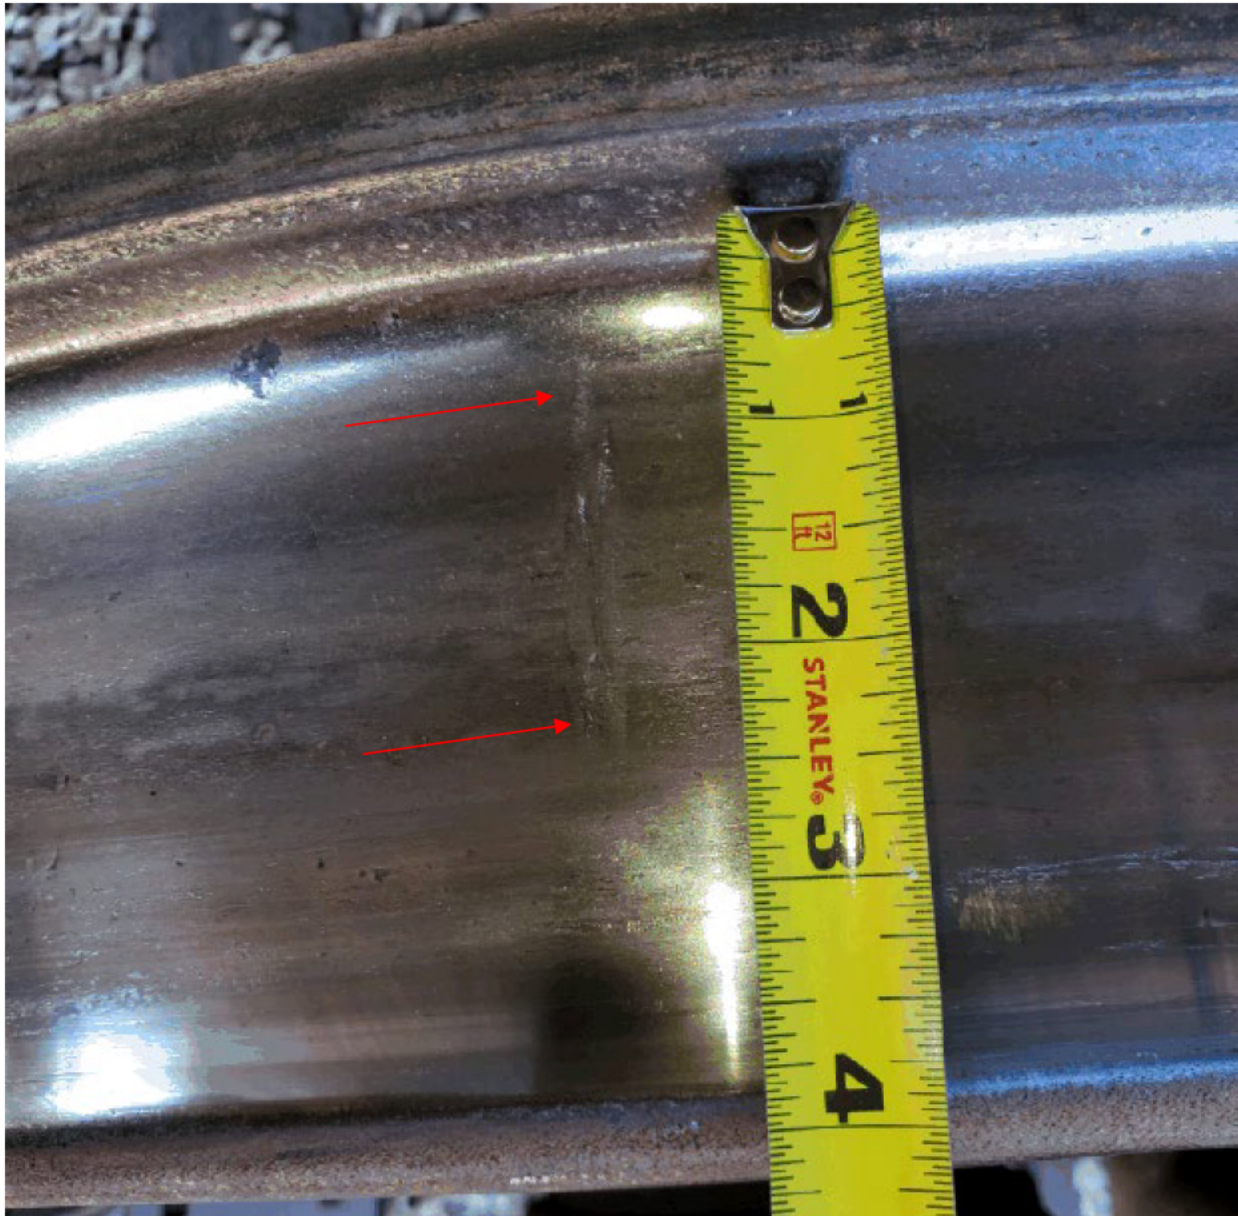
the brake components and running gear showed normal wear patterns. From the front of the train cars 49-60 derailed including cars 55-59 which were on the ground below where the bridge was (See Figure 4). Total mechanical damage was approximately \$485,000. Two cars were discovered with witness marks on the wheels indicating that they had traversed a broken or damaged rail head (See Figure 2).

Figure 2 Photo of the witness mark on the right 3 wheel of car NATX 160112 (Photo by FRA)

The 2 cars that had wheels with witness marks were loaded hopper car TILX 518747 and loaded tank car NATX 160112 which were cars 48 and 49 respectively from the front of the train. TILX 518747 had a

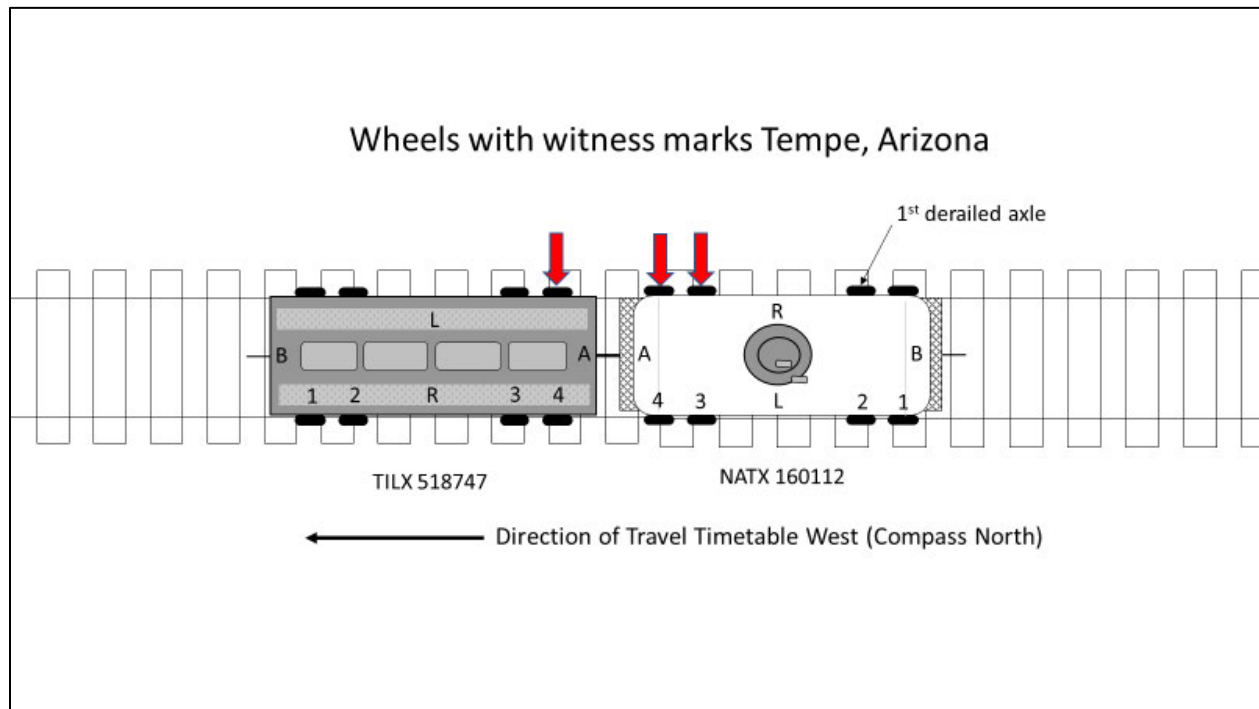
witness mark on the trailing axle and NATX 160112 had witness marks on the leading 2 axles. This indicates that without witness marks, the number 2 axle was the first derailed axle. (See Figure 3)

Figure 3 Diagram indicating the wheels where witness marks were located and the first derailed axle.

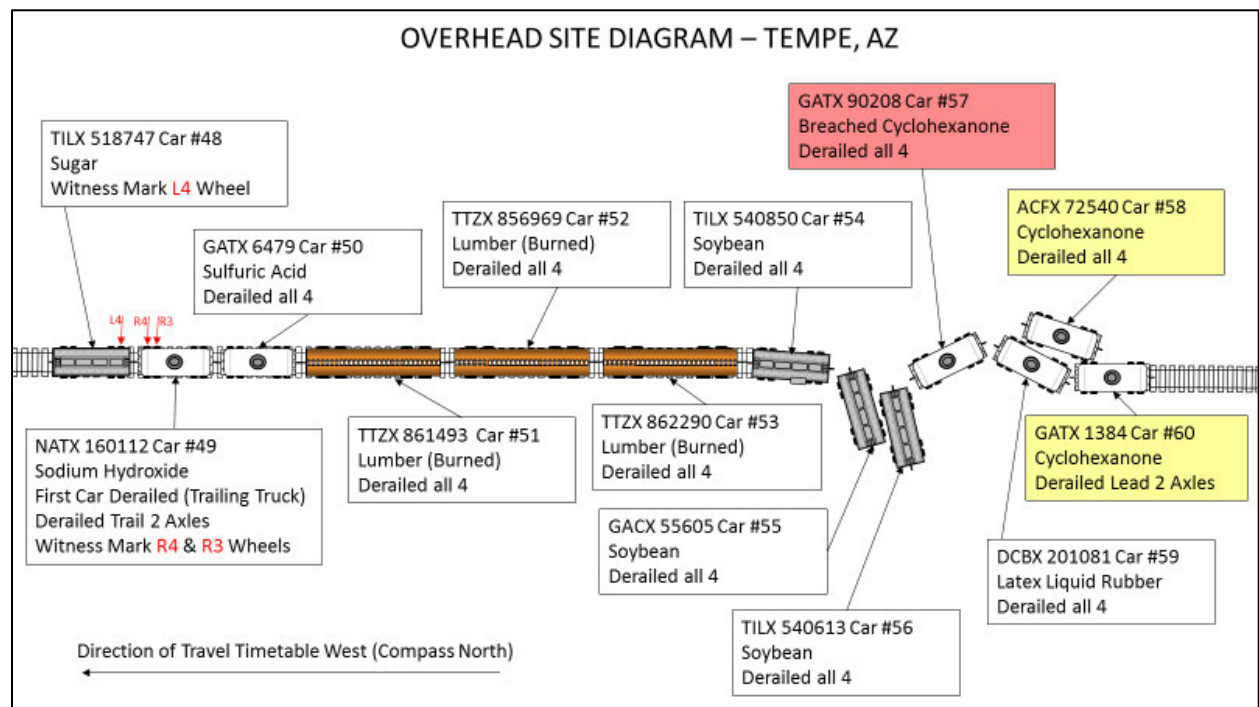
Figure 4 An overhead depiction of the derailed cars including the cars that had axles with witness marks.
