National Transportation Safety Board
Office of Railroad, Pipeline and Hazardous Materials Investigations
Washington, D.C. 20594

Collision of SEPTA Light Rail Vehicle 155
Upper Darby, Pa
August 22, 2017
Mechanical Group Factual Report

Accident #: DCA 17 FR 012
Accident Type: Light Rail Rapid Transit Vehicle Collision
Location: Norristown High Speed Line in Upper Darby, PA
Date of Accident: August 22, 2017
Railroad Owner: SEPTA
Train Operator: SEPTA
Fatalities: 0
Injuries: 42

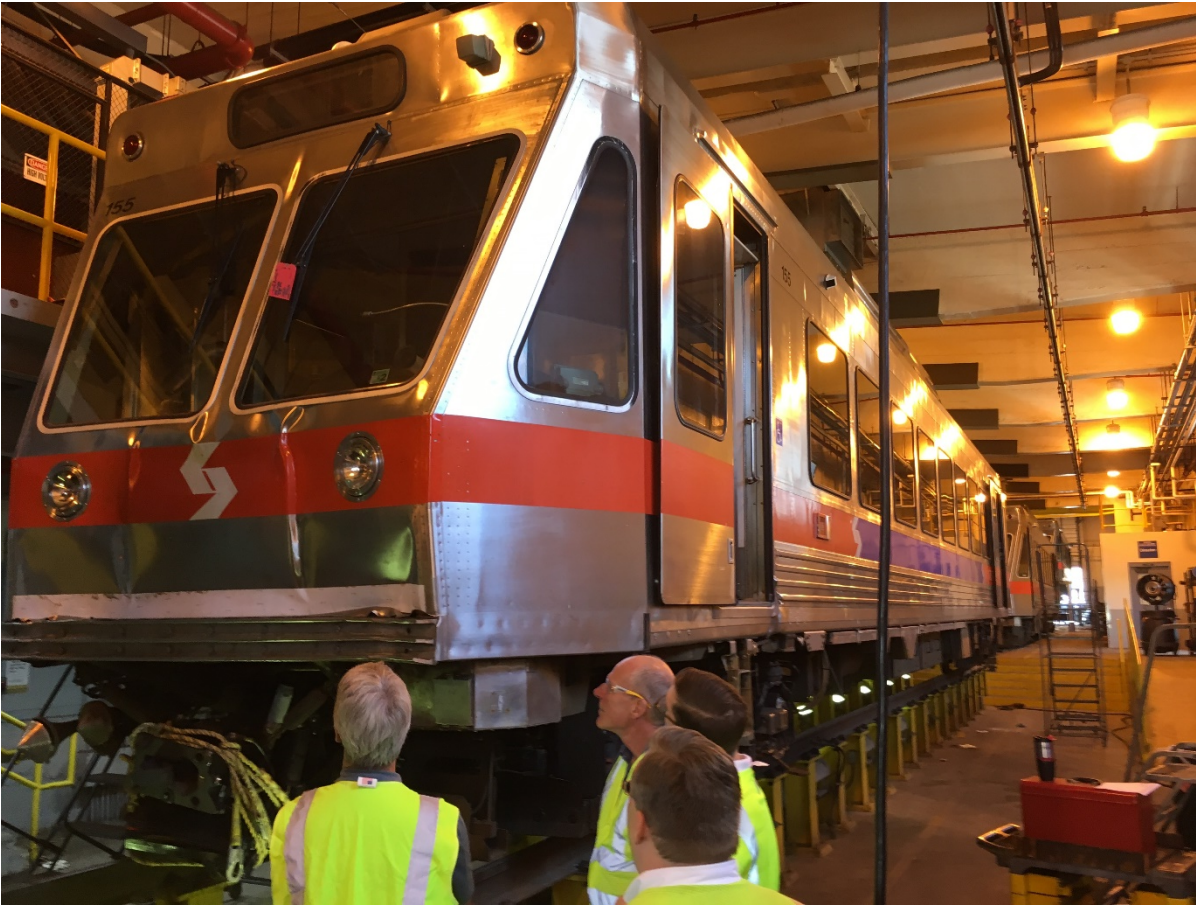
Figure 1 Photo of SEPTA car 155 in the Upper Darby repair facility while being examined.

Car #155 remained in the upright position with all eight wheels on the rail. It sustained front end damage on the “A” end carbody. The coupler assembly sustained heavy damage. Pneumatic systems to the coupler and horn, and the “A” end wiring harness were also damaged as a result of the impact. The struck vehicle (car #148) had similar damage.
