NTSB MEMORANDUM FOR RECORD

Date: 4/30/2020
Persons Contacted: See Below
NTSB Accident Number: ERA20LA160

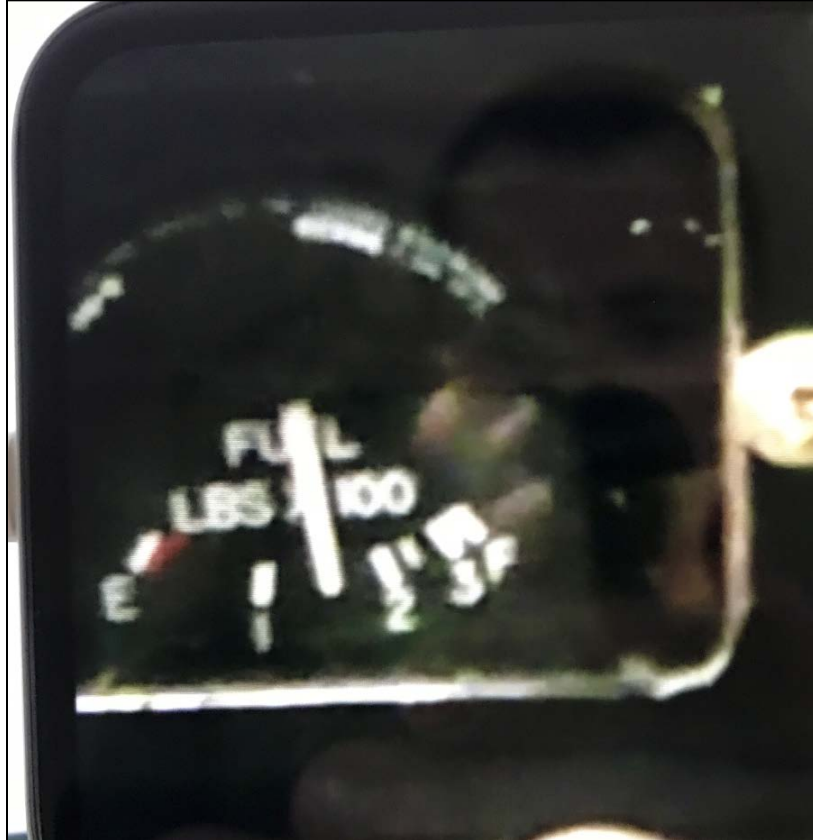
The battery master was turned on. The fuel gauge, as indicated, displayed about 150 lbs of fuel onboard.

Photo 1: View of the fuel gauge showing about 150 lbs

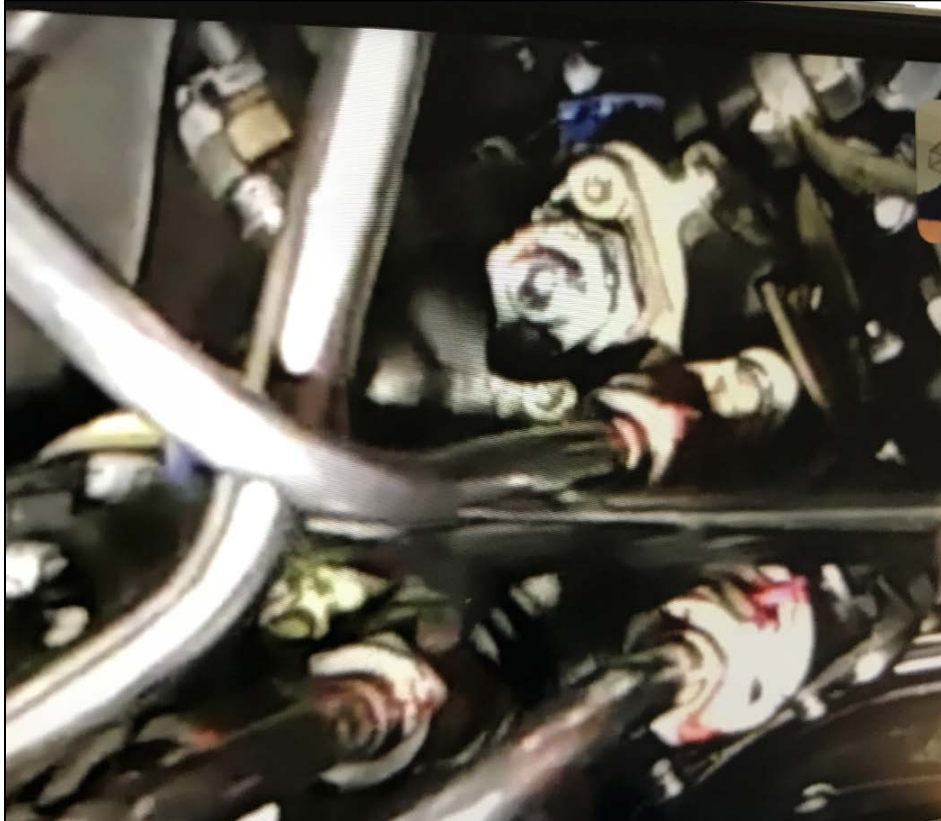
Prior to removing any fuel lines or air lines leading to the engine, each were viewed and checked for damage and security. There were no anomalies observed with the fuel and air lines. All lines from the compressor, fuel control, fuel pump, and fuel nozzle were undamaged, and their respective nuts were found secured and tight.

Photo 2: View of the fuel and air lines

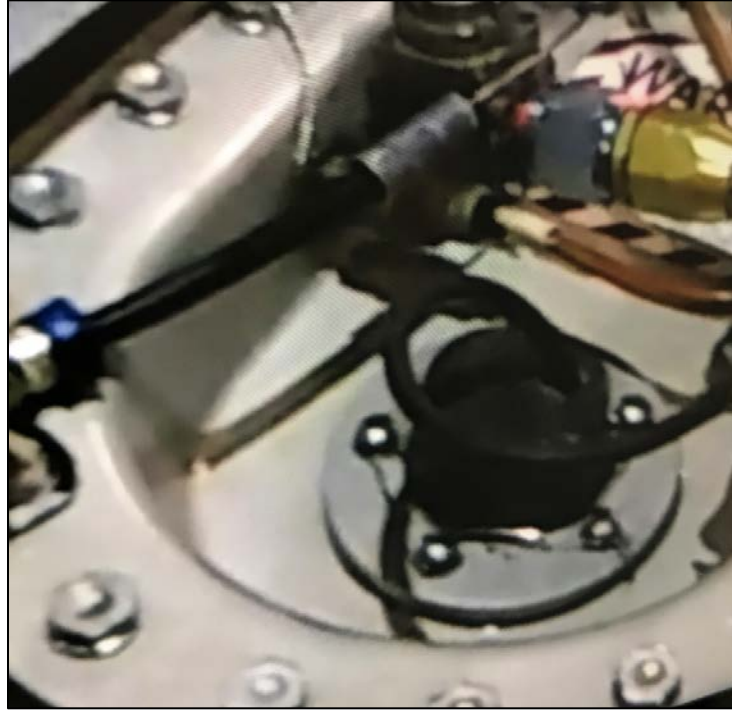
With the battery master turned on, the electrical fuel pump switch was moved to the on position, and the pump did not turn on. When the access panels to fuel pump were removed, a voltage indicator when applied to the fuel pump wires found that the normal 28V was being received. All fuel lines on the fuel pump were tight. Fuel was present in the electric fuel pump.

Photo 3: View of the electric fuel pump

The fuel line coming off the electric fuel pump was boroscoped. No obstructions were seen. The electrical fuel pump was replaced with a new fuel pump, and when the master was turned on, the new fuel pump activated. The fuel pump was used to pump out fuel from the fuel tank.

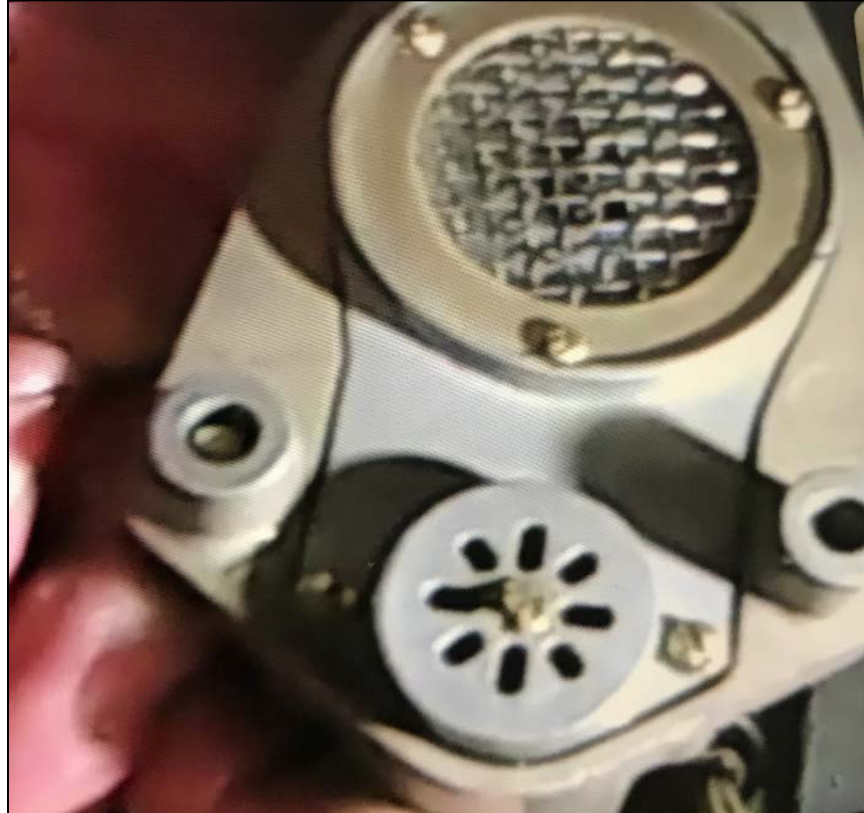
The fuel pump screens for the engine and electrically driven fuel pumps were clear of obstructions.

Photo 4: View of the fuel pump screens

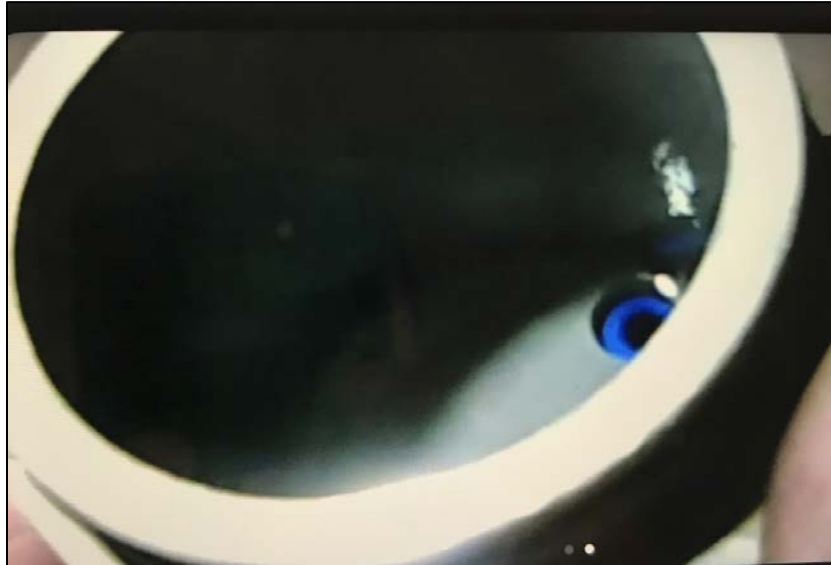
The engine driven fuel pump filter housing was found secured to the engine. It was then removed, and small remnants of fuel was inside of the filters housing. The housing and filter contained no debris.

Photo 5: View of the engine driven fuel pump filter housing with remnants of fuel

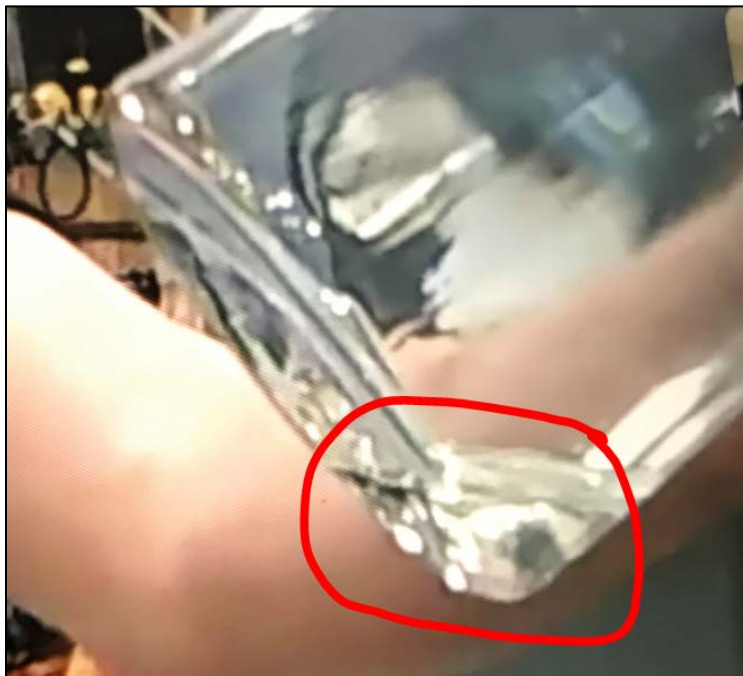
Photo 6: The red circle provides a view of the remnants of fuel found in the engine driven fuel filter housing

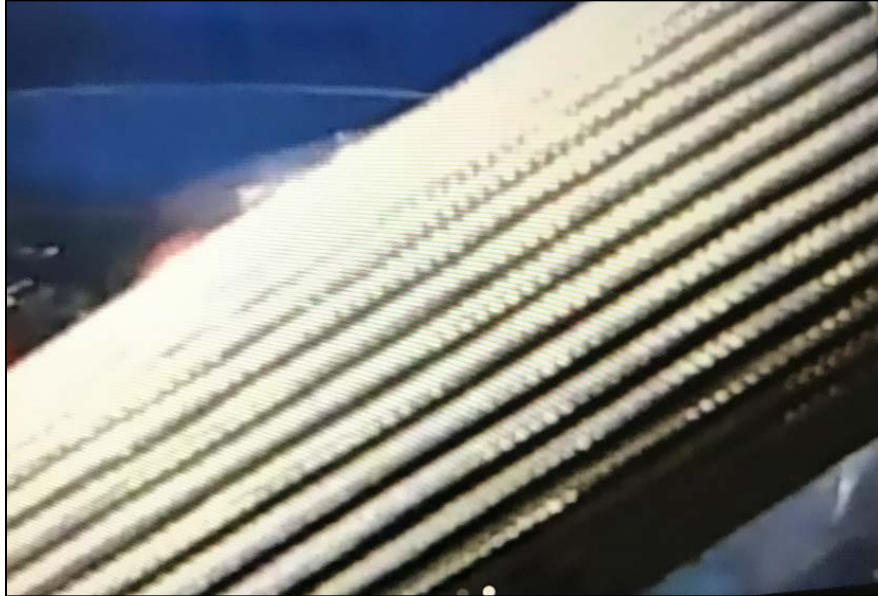
Photo 7: View of the engine driven fuel pump filter

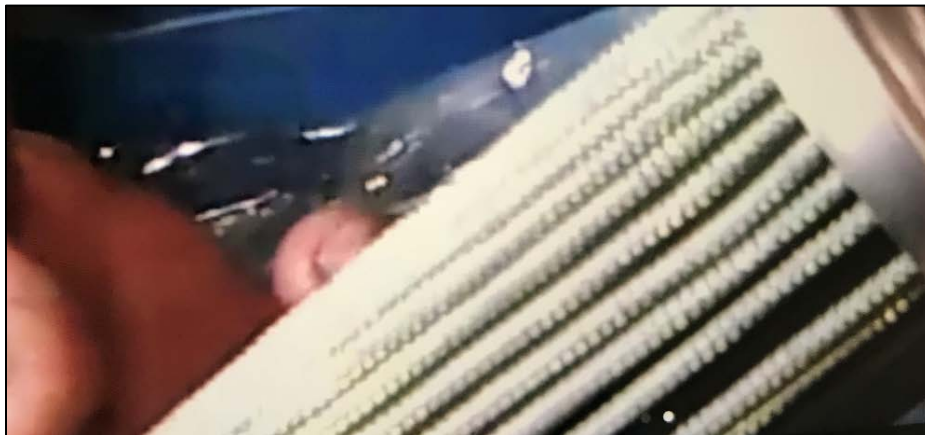
Photo 8: A second view of the engine driven fuel pump filter

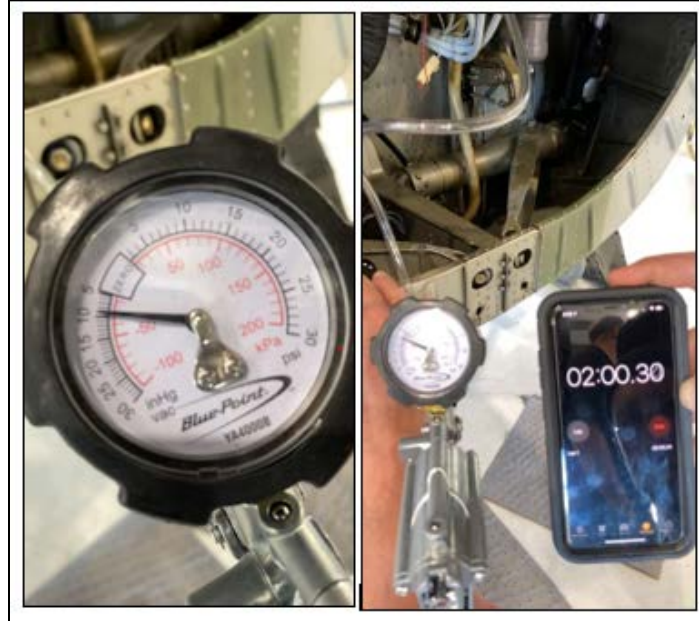
A PC line pressure check was performed. Via an air compressor, 50 lbs of air pressure was applied to the PC filter. There were no pneumatic leaks observed when fluid was applied to the lines.

Figure 1: Photographs taken during the PC line pressure check

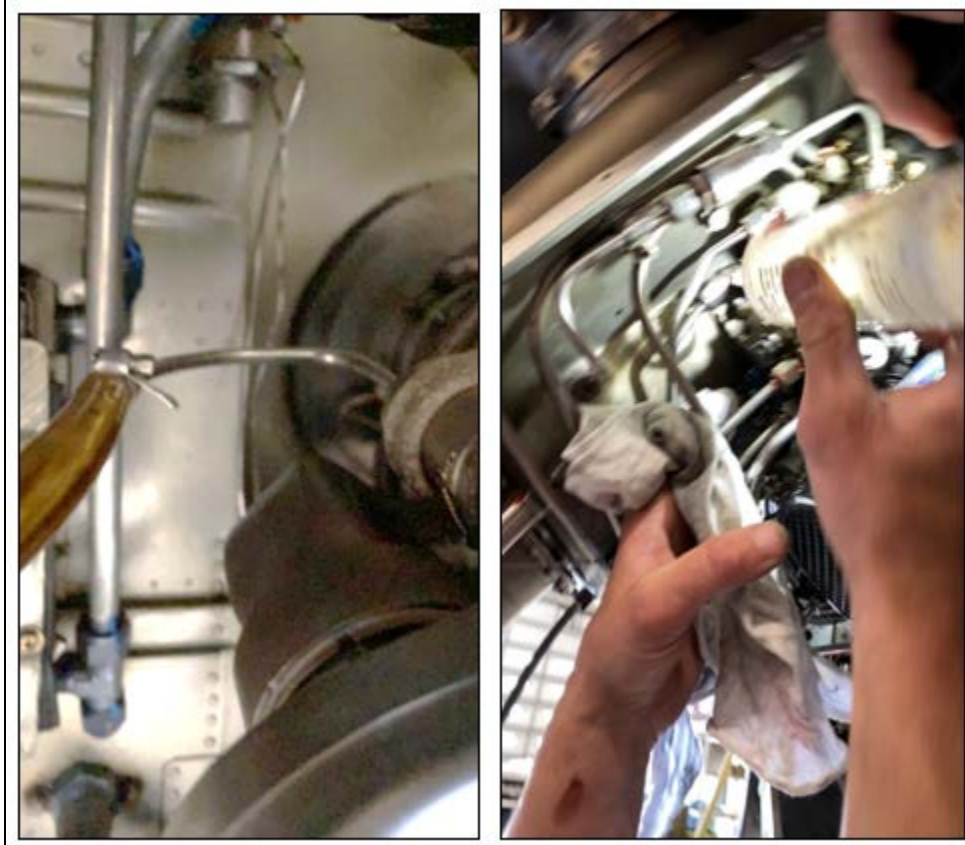
Figure 2: Photographs taken during the PC line pressure check, while fluid was applied to the lines

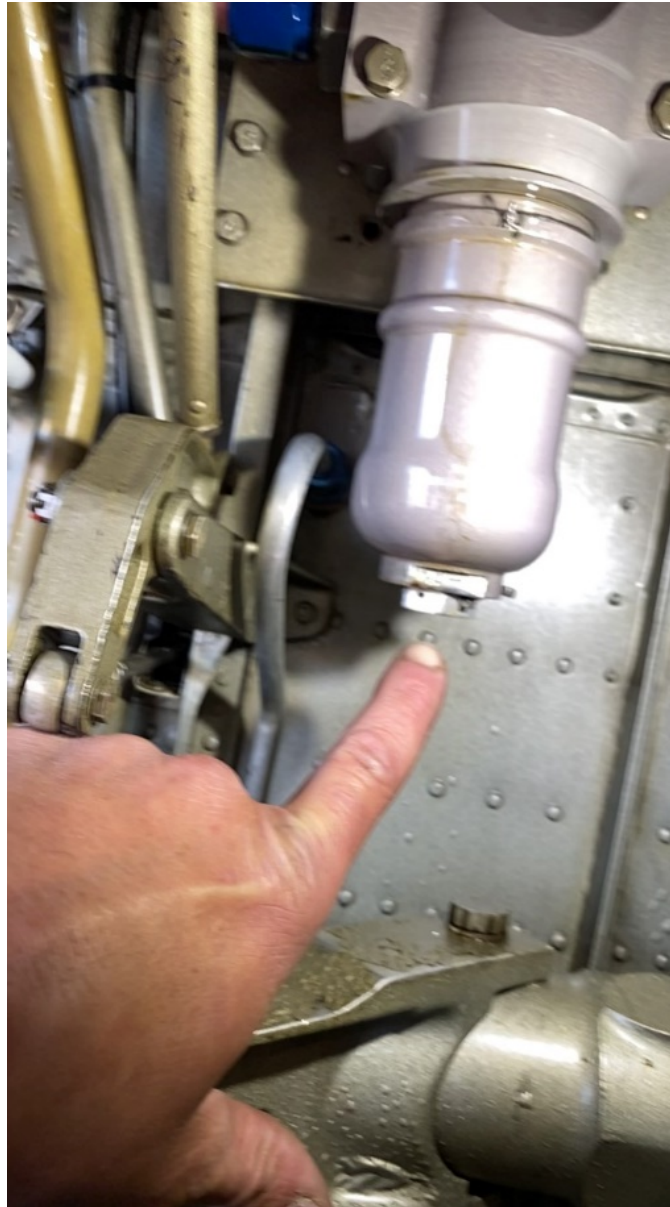
On the airframe oil scavenge filter, the red indicator was stowed and no anomalies were observed.

Figure 3: The airframe oil scavenge filter, with the red abnormal indicator stowed

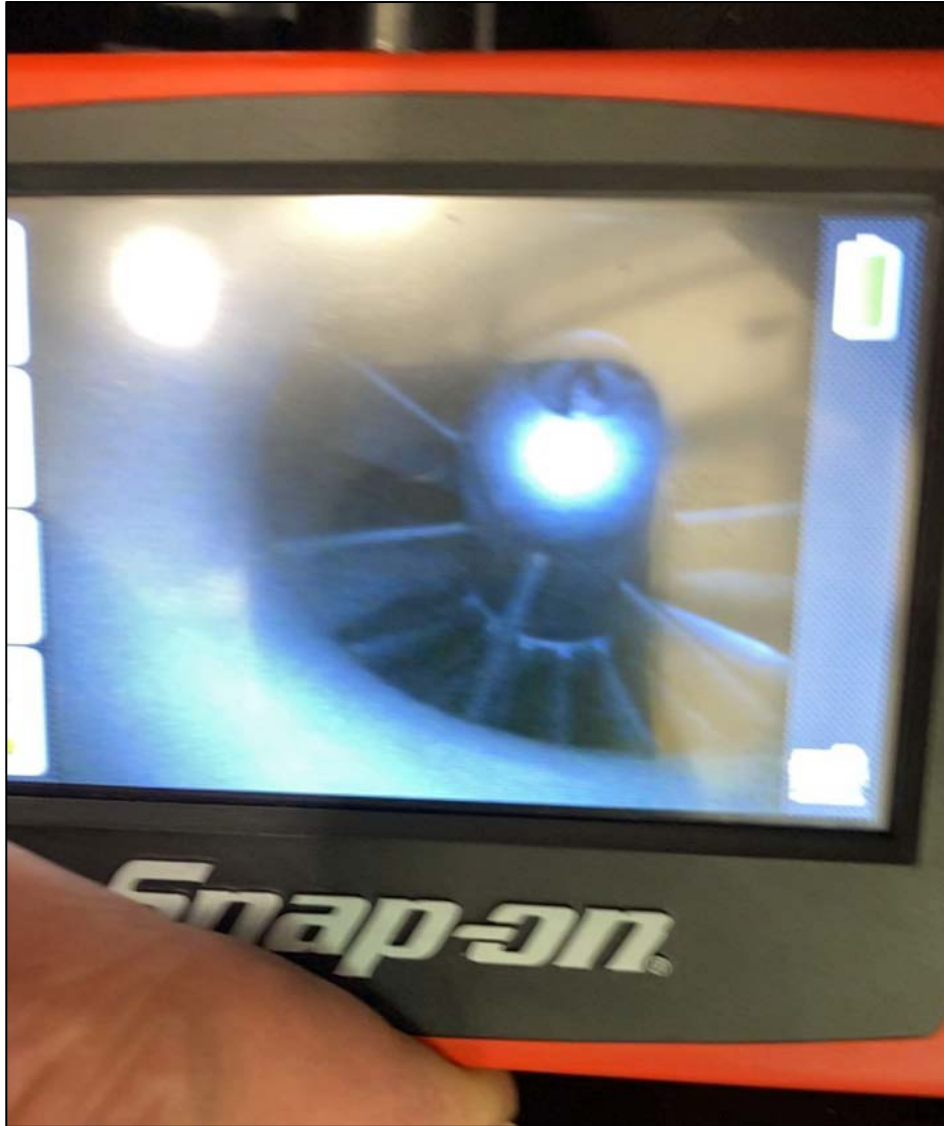
The only fuel sump is located under the main fuel tank under the fuselage. No airframe mounted fuel filter was installed. There were no obstructions noted in the engine air inlet.

Figure 4: Photograph of the unobstructed engine air inlet.

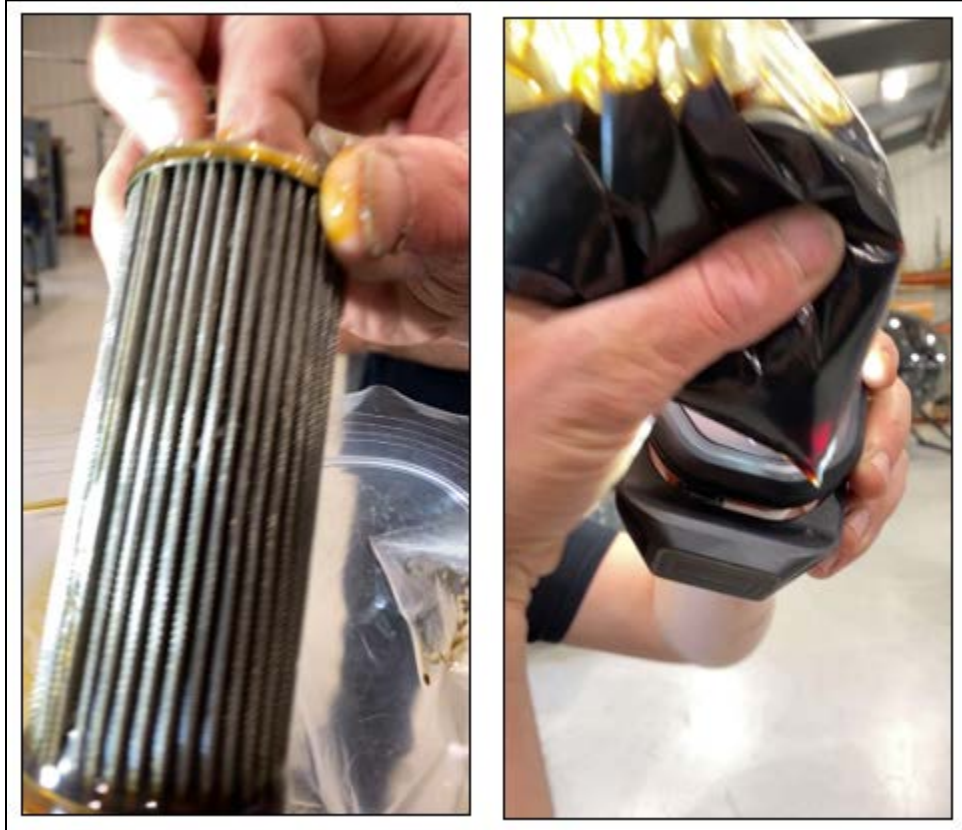
The oil filter safety pin was removed. The external oil filter and oil that leaked out from the casing (once it was removed for examination) was free of contaminants.

Figure 5: View of the oil filter and oil sample
