MEMORANDUM FOR RECORD

Date: November 23, 2021
Subject: Oil Sending Units and Wiring Harnesses
NTSB Case Number: CEN21FA130

On November 23, 2021, the oil sending units from the accident airplane (N13VT) along with their associated wiring harnesses were examined and tested at Velocity Inc., Sebastian, Florida.

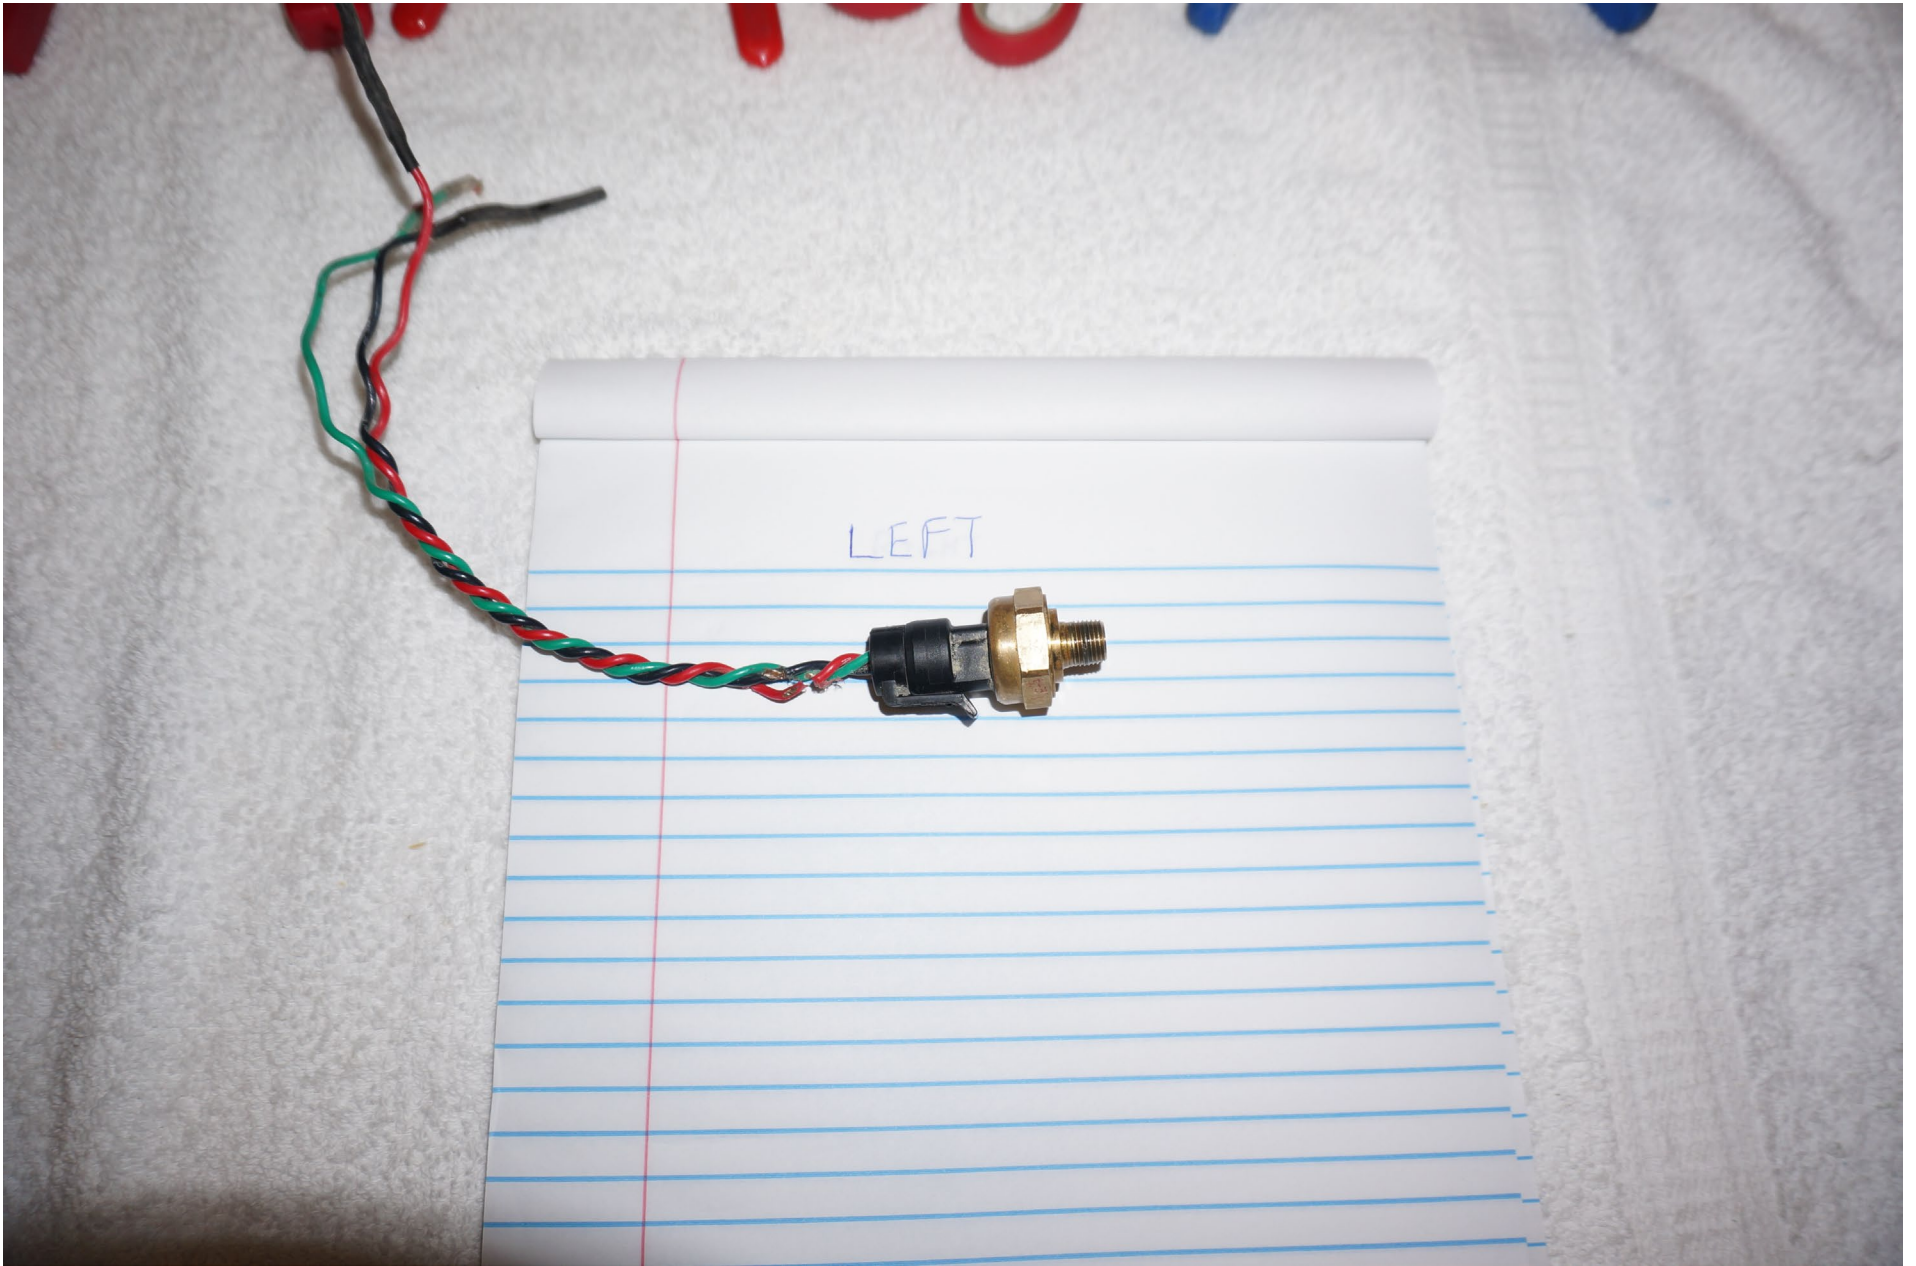
Examination of the left and right wiring harnesses indicated that they consisted of an attachment plug with three wires (Red, Green, Black). Further examination revealed that the wiring harness for the right oil pressure sensor was intact, but the wiring harness for the left oil pressure sensor displayed visible damage with the Red wire displaying a break (cut), which had separated the wire into two pieces, and visible cuts which had penetrated the insulation of the Green and Black wires.

Photo 1 - Left Wiring Harness and Oil Pressure Sensor

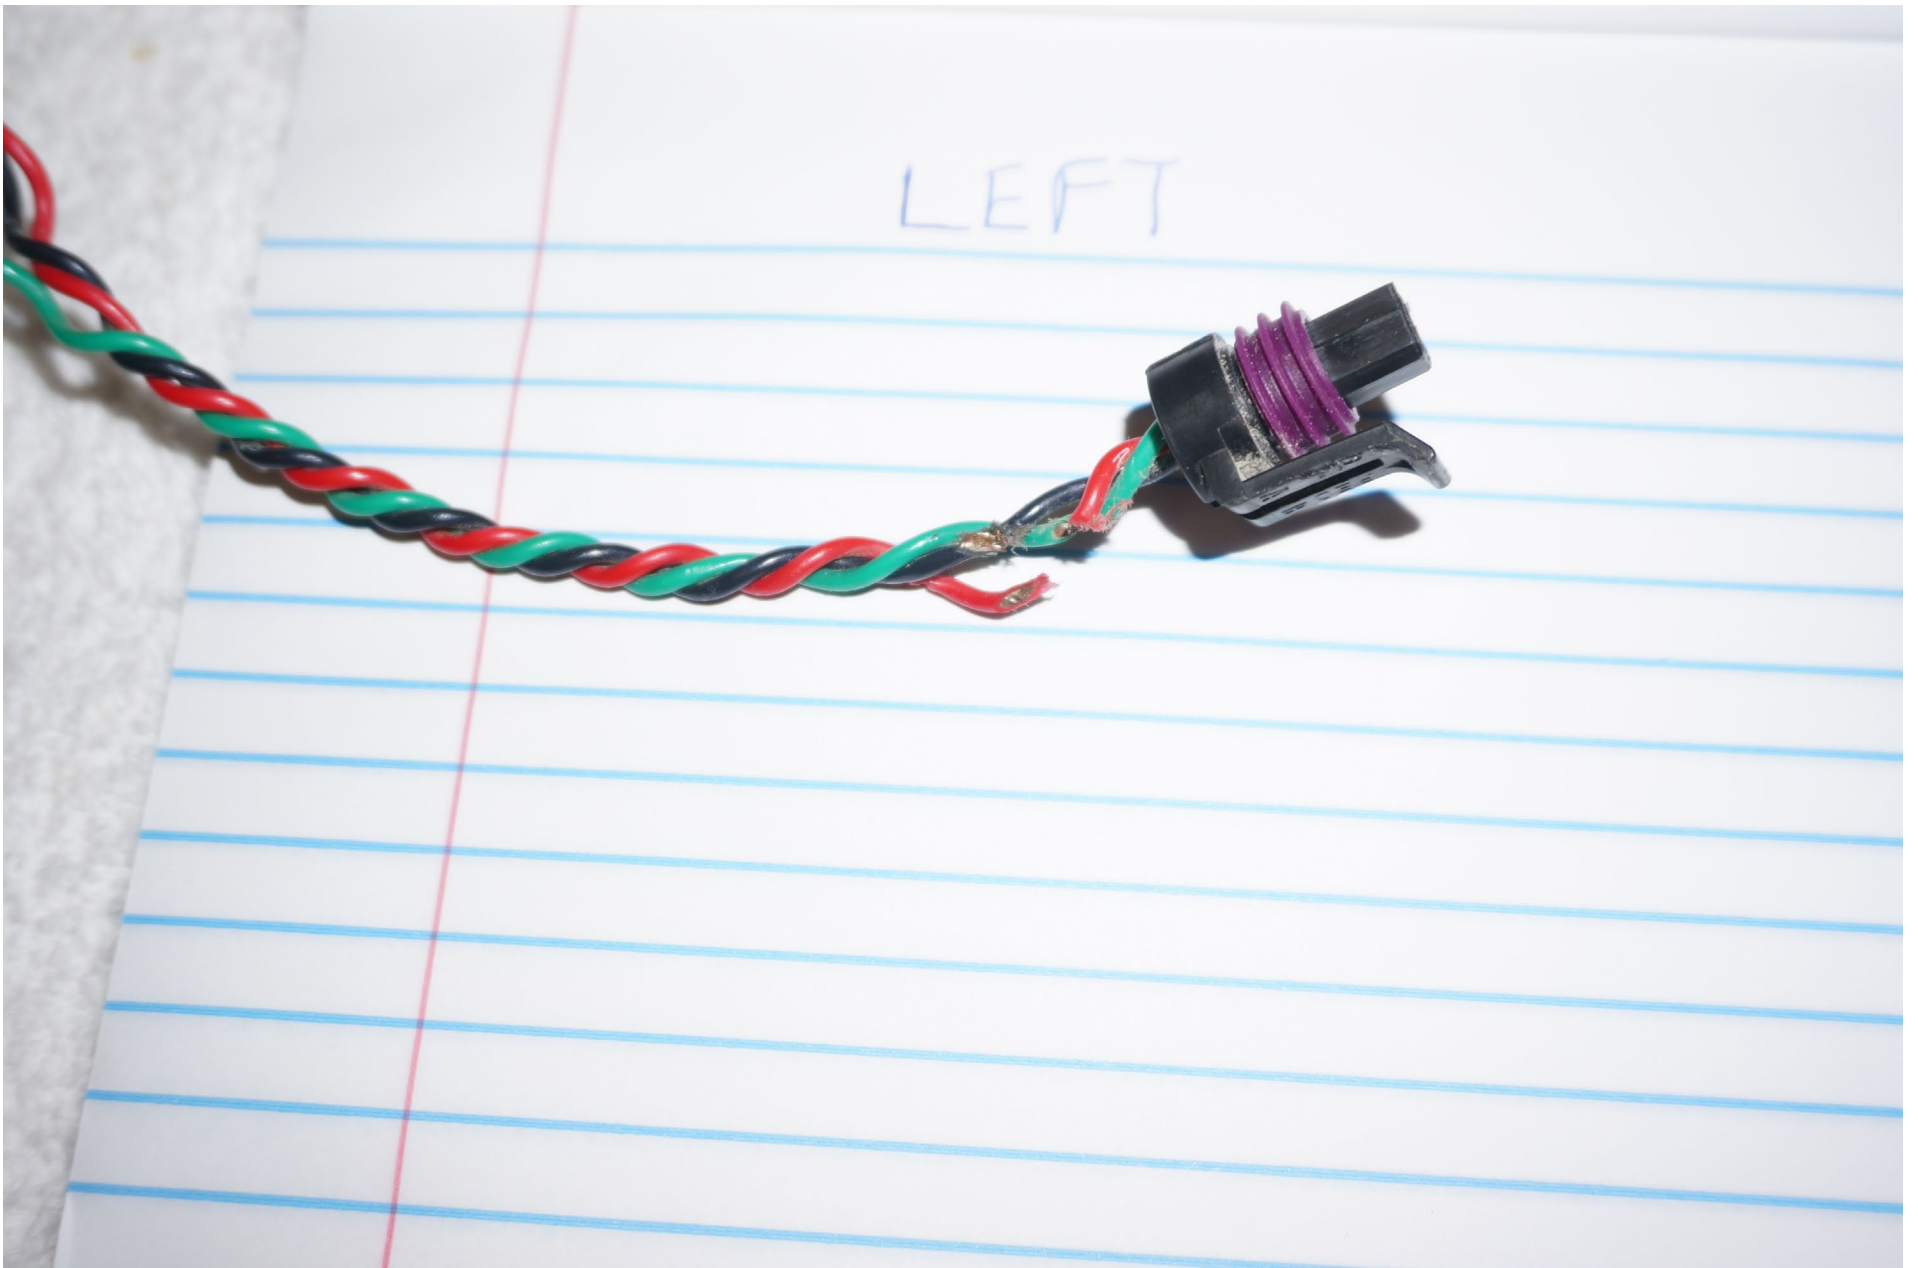
Photo 2 - Left Wiring Harness

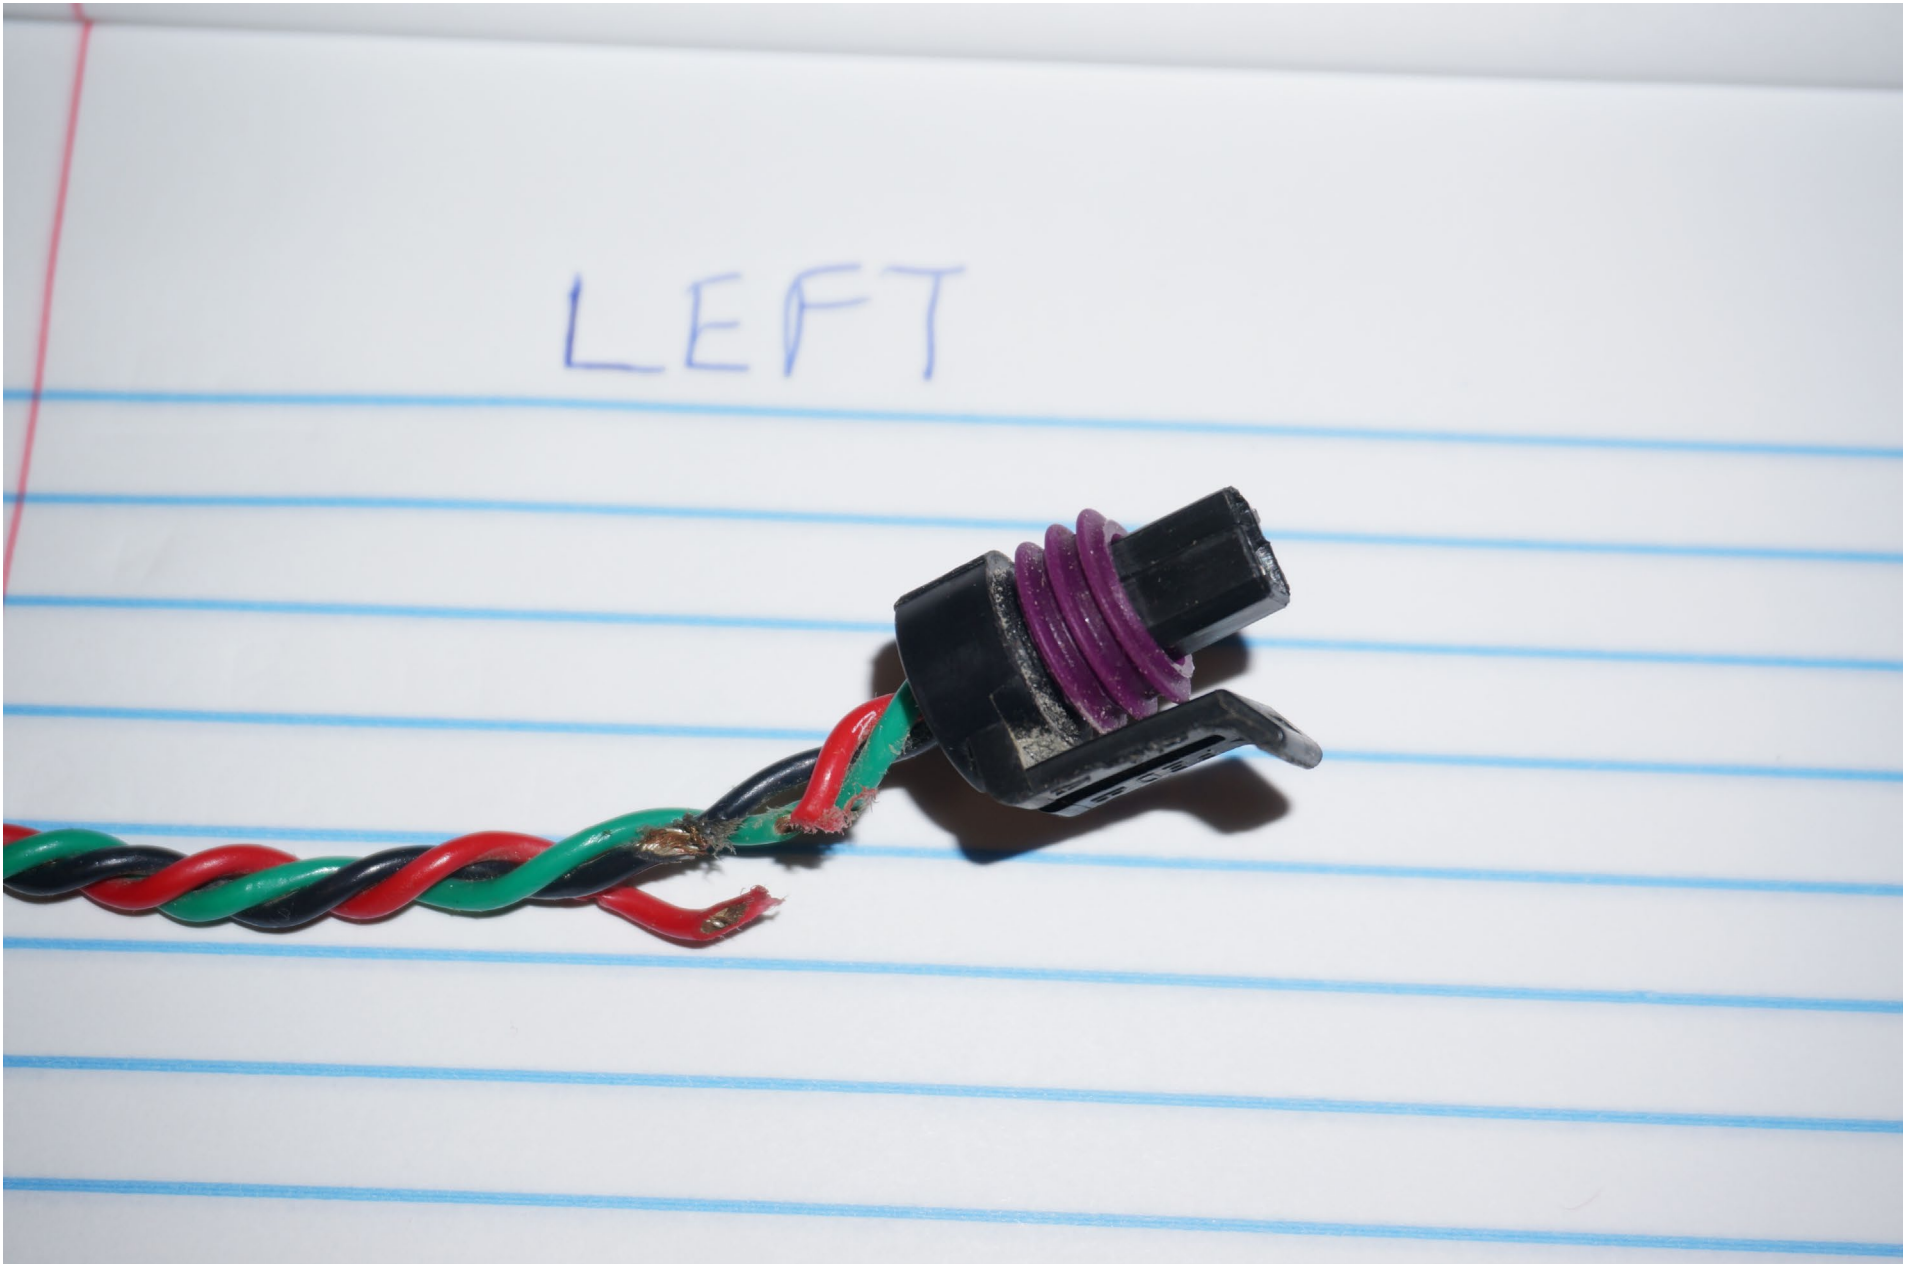
Photo 3 – Close Up of Left Wiring Harness

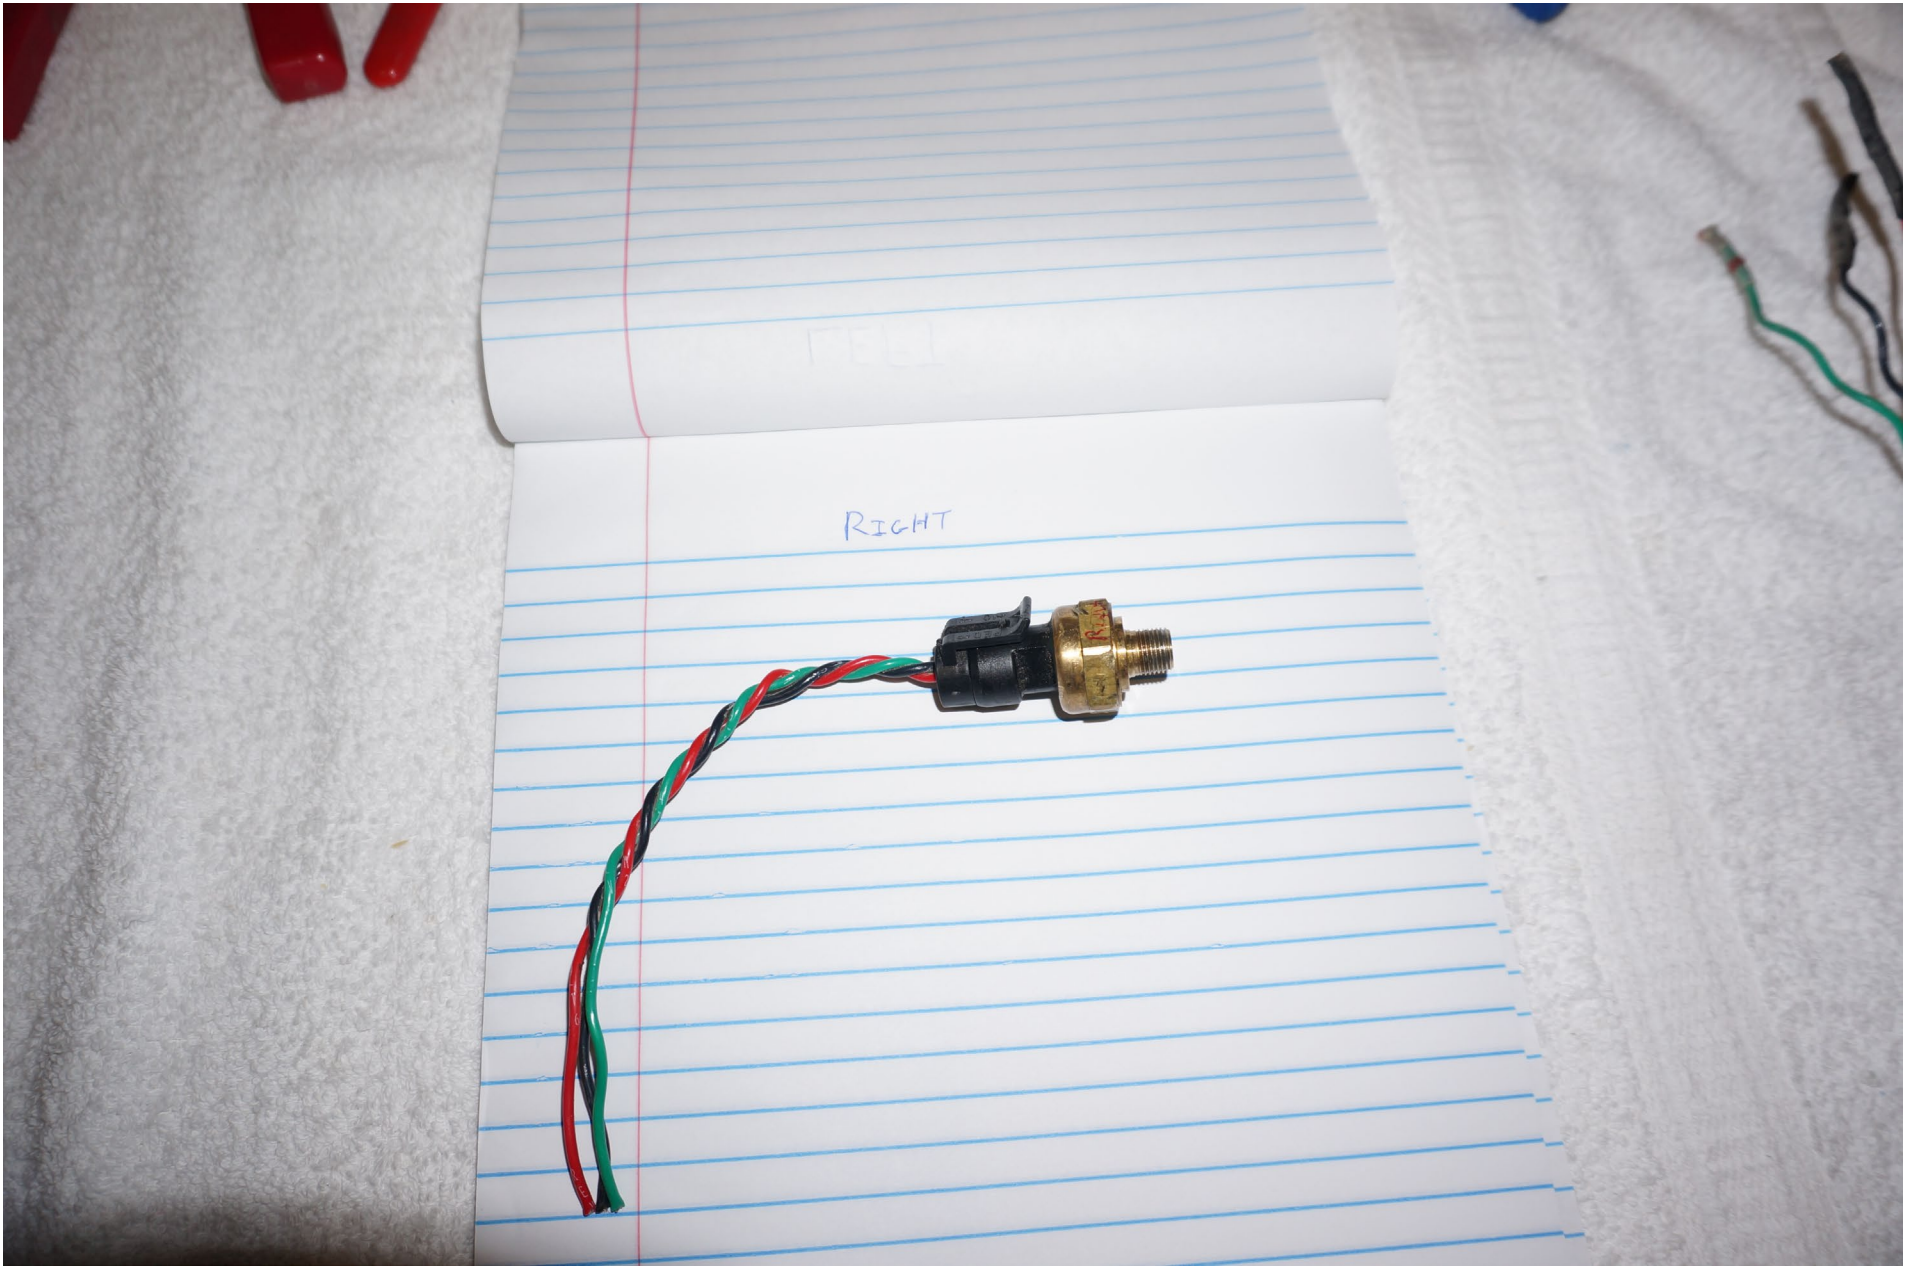
Photo 4 - Right Wiring Harness and Oil Pressure Sensor

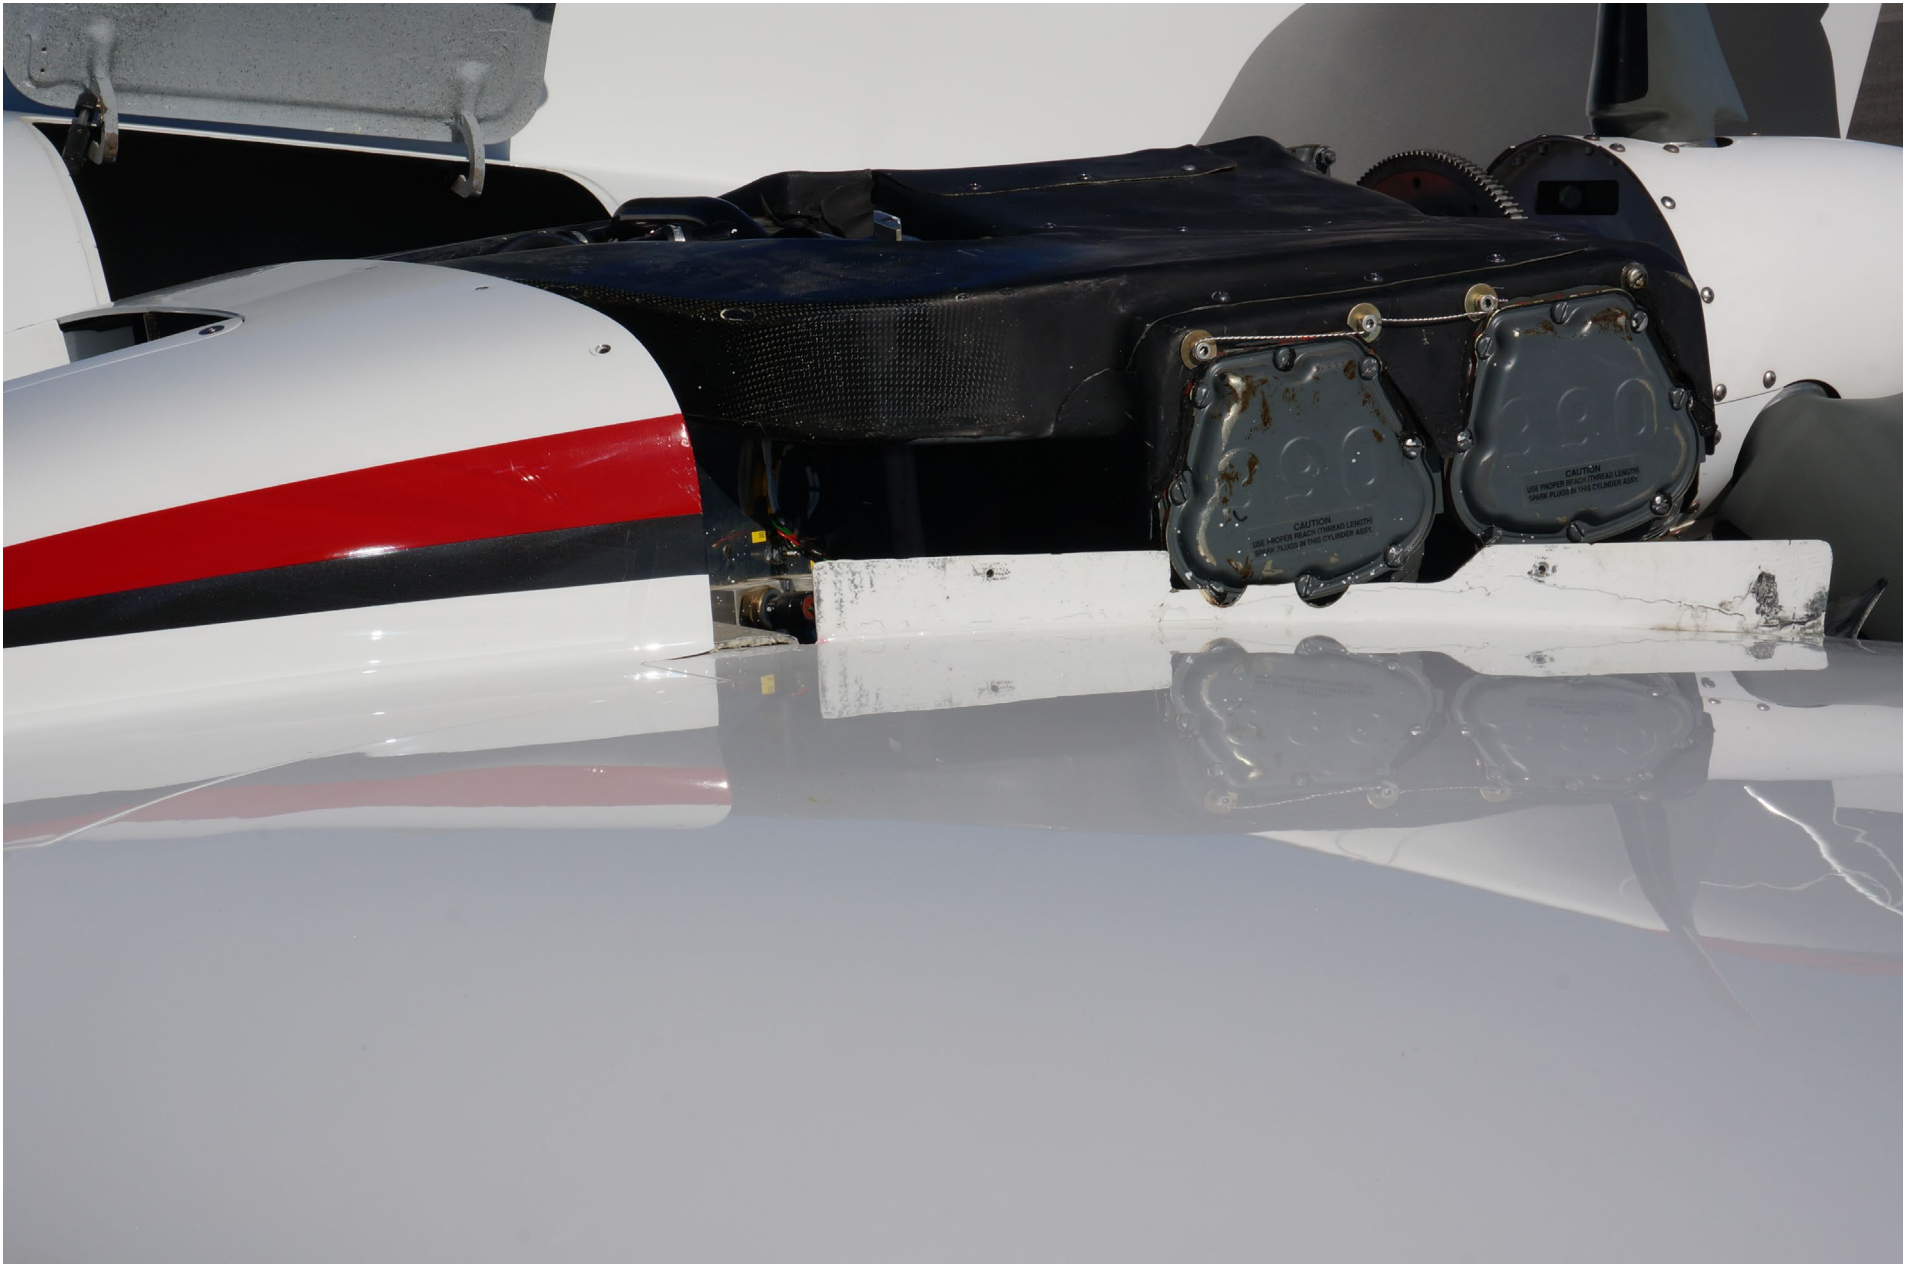
Photo 6 – Testing Location of Oil Pressure Sensors (Forward Left Engine Bay)

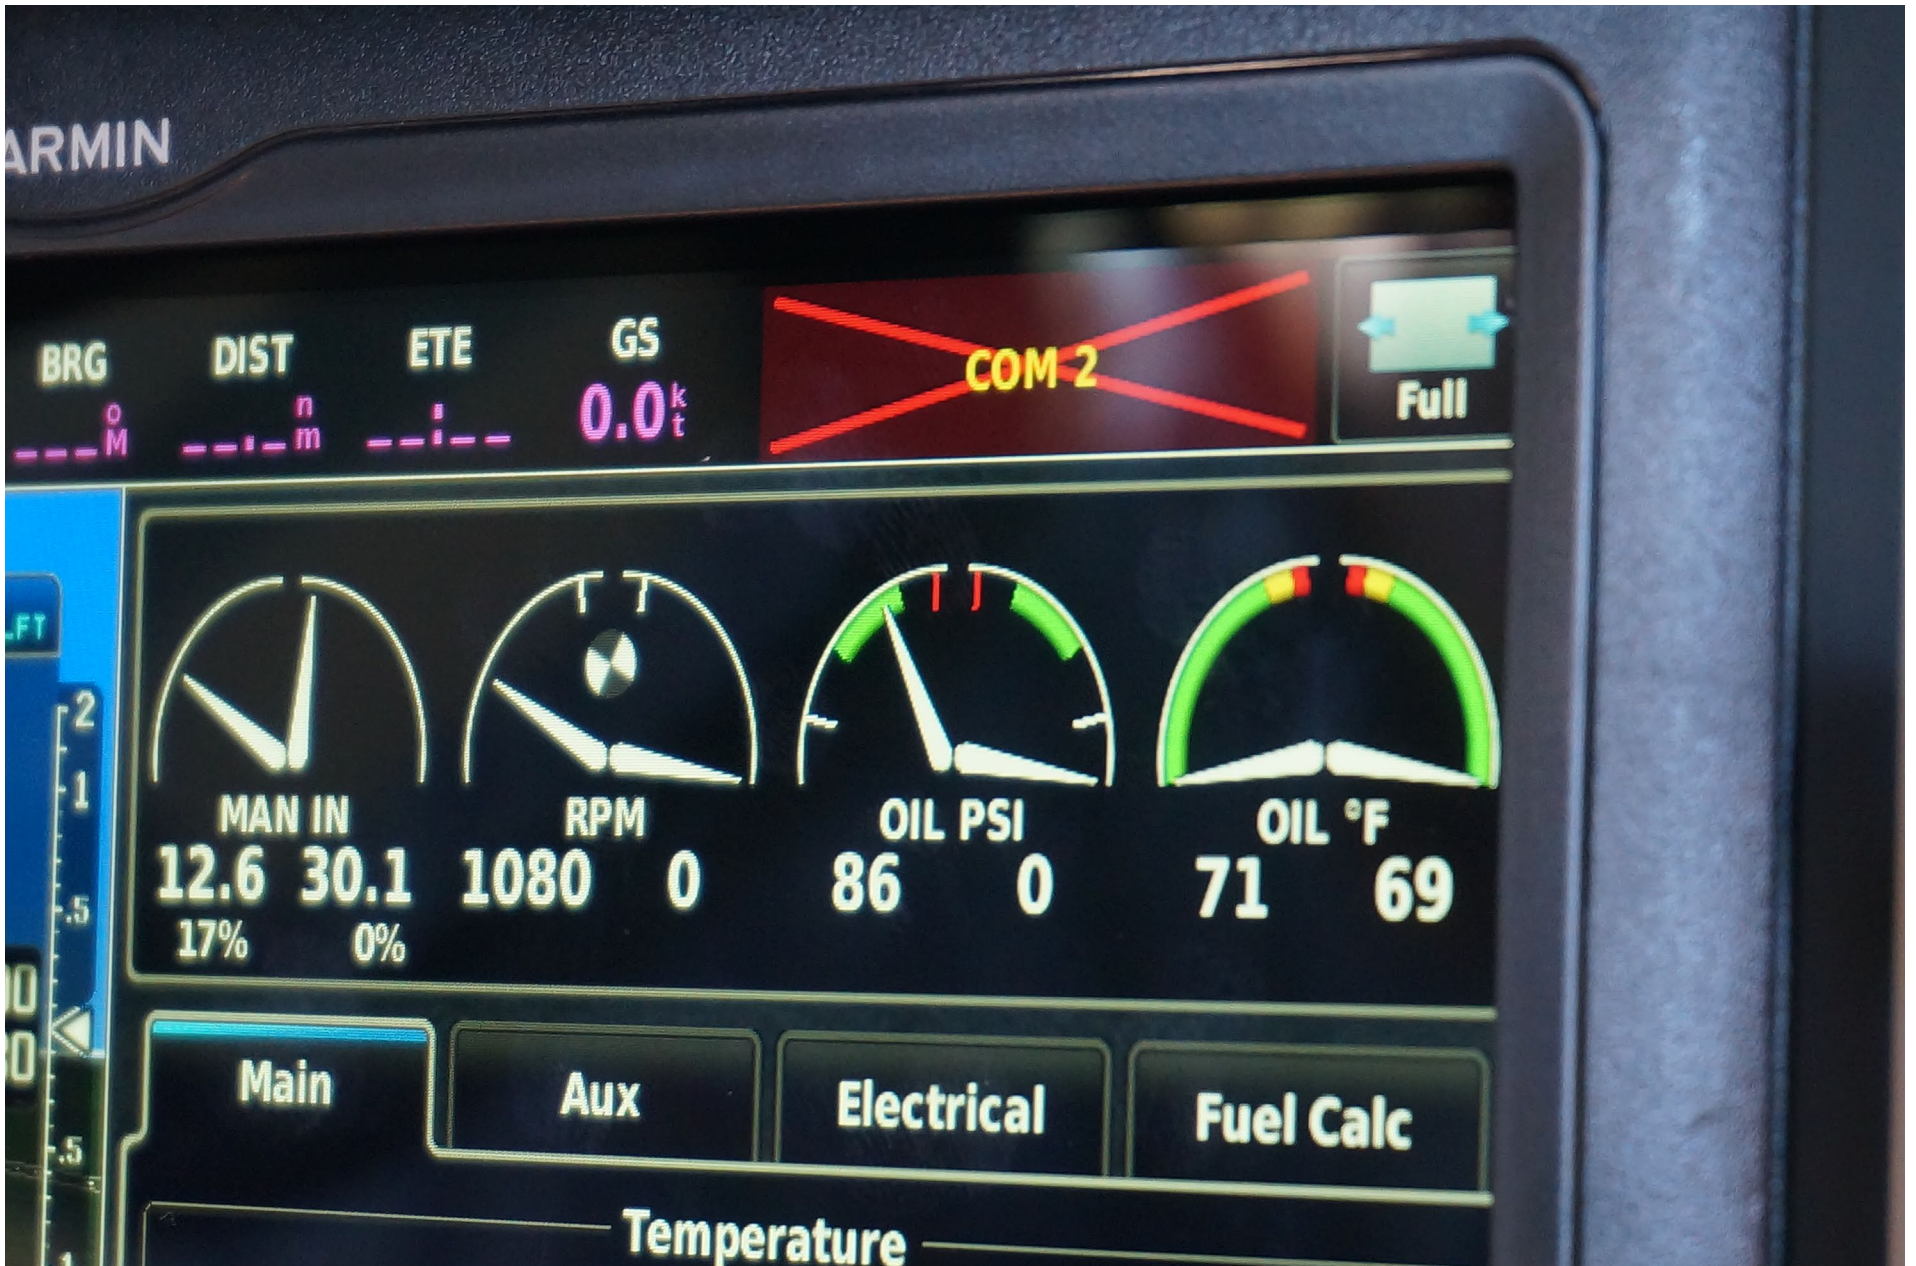
- The left oil pressure sensor was tested first, by attaching a surrogate wiring harness to it in place of the damaged one, and installing it in the mounting position on the left engine firewall. After starting the engine, the sensor was able to detect the left engine's oil pressure.
- The right oil pressure sensor was then tested using its original (as found) wiring harness from N13VT, and installing it in the mounting position on the left engine firewall. After starting the engine, the sensor was able to detect the left engine's oil pressure.

Photo 7 - Left Oil Pressure Sensor Test - Indicating Oil Pressure (Left "OIL PSI" Needle

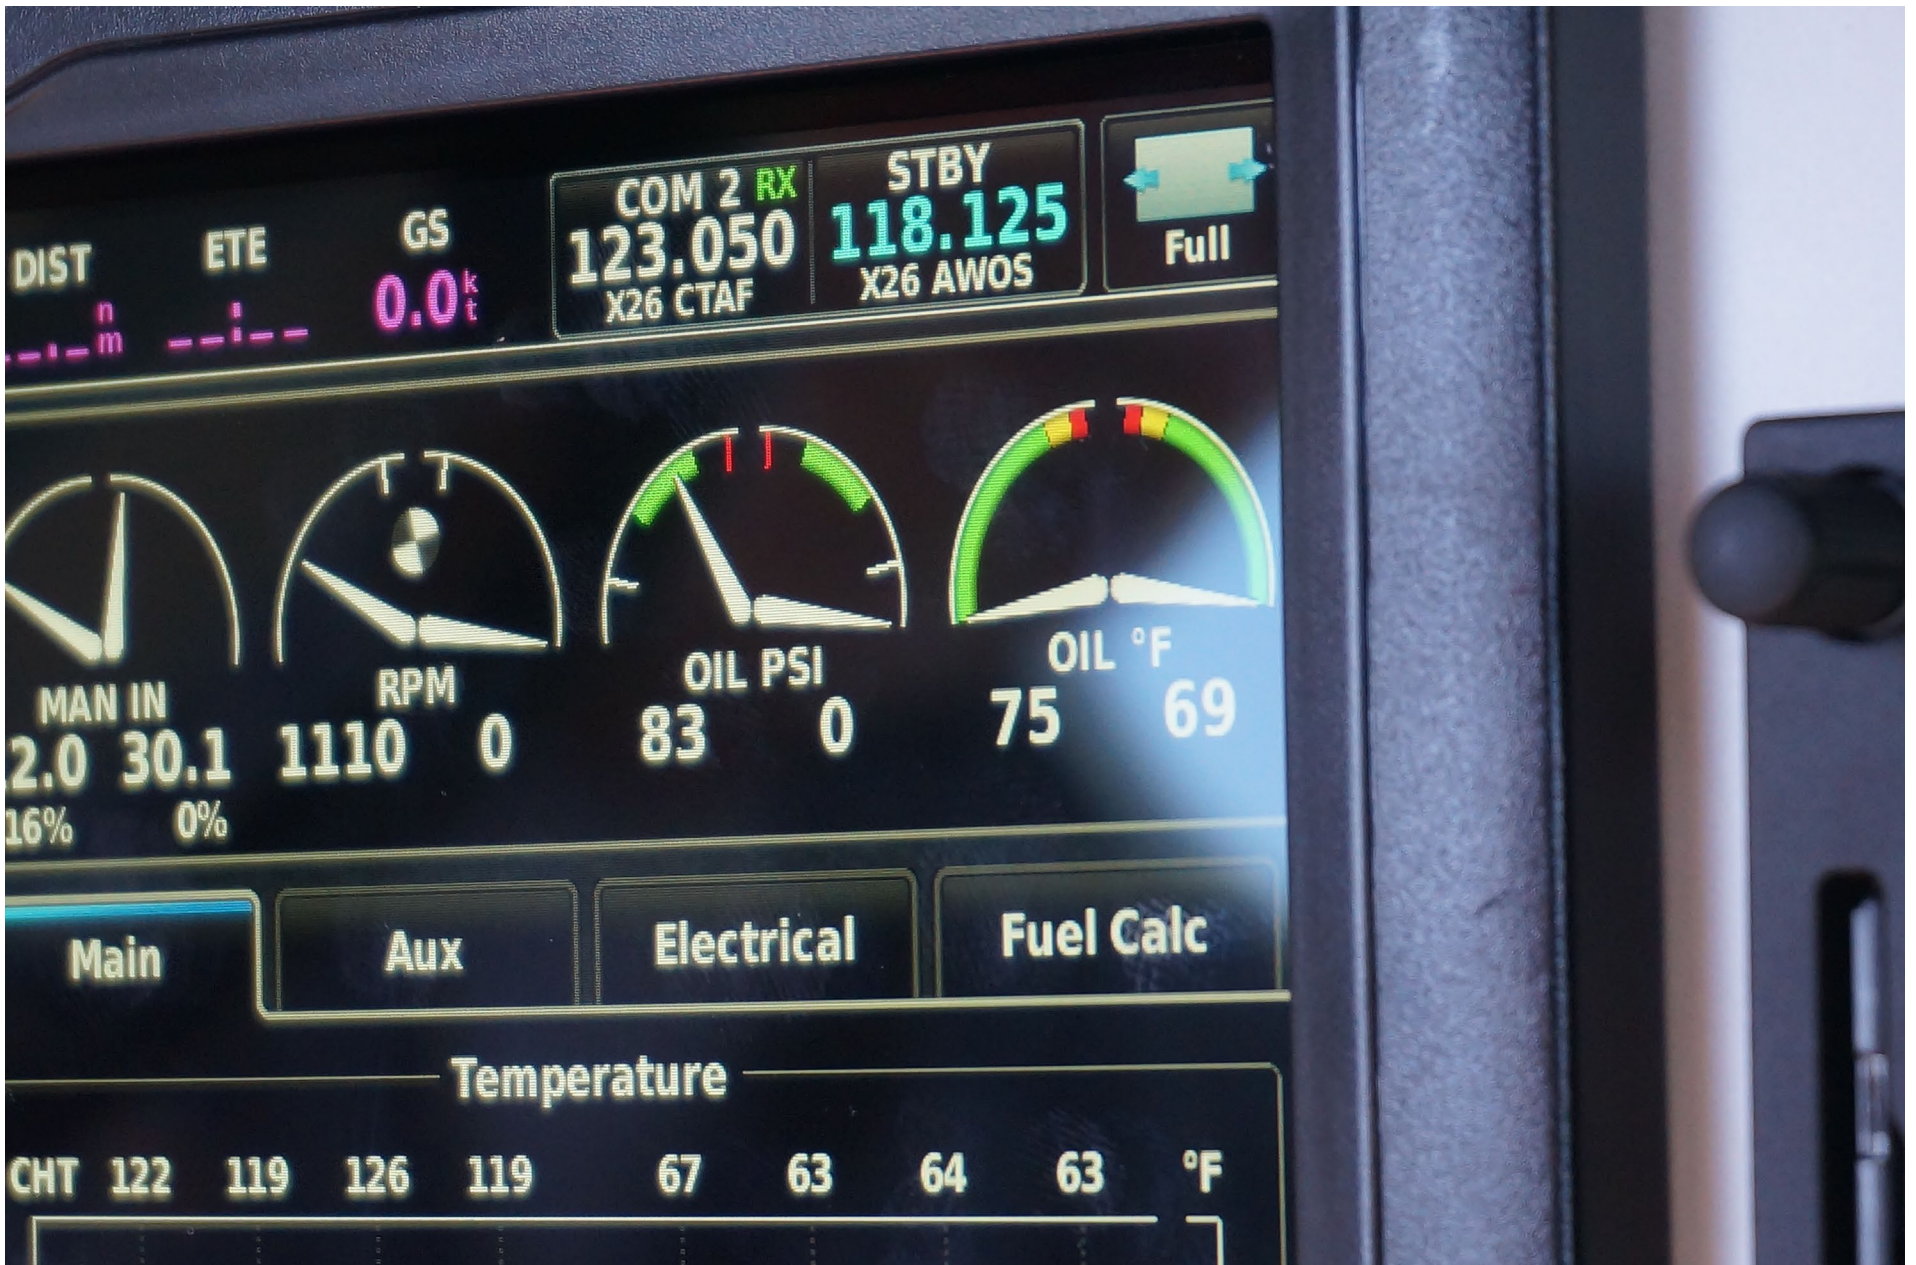
Photo 8 - Right Oil Pressure Sensor Test - Indicating Oil Pressure (Left "OIL PSI" Needle)
