The National Transportation Safety Board

Office of Aviation Safety Central Region Memorandum for the Record Engine and Propeller Examination Findings CEN19FA270 New Orleans, Louisiana

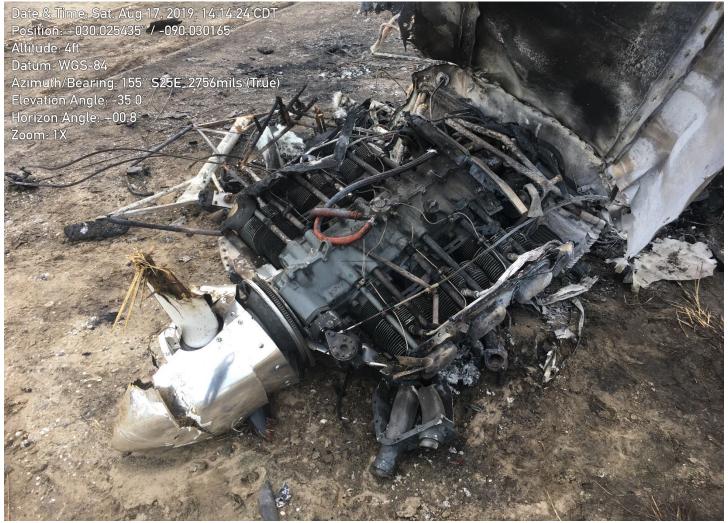
• As found at the accident site, the engine sustained severe thermal damage from a post-crash fire. Examination of the engine and propeller did not reveal any pre-impact mechanical anomalies. The wooden propeller blades were severely fractured and splintered, consistent with powered rotation at the time of impact.

Photo 1 Engine at Accident Site

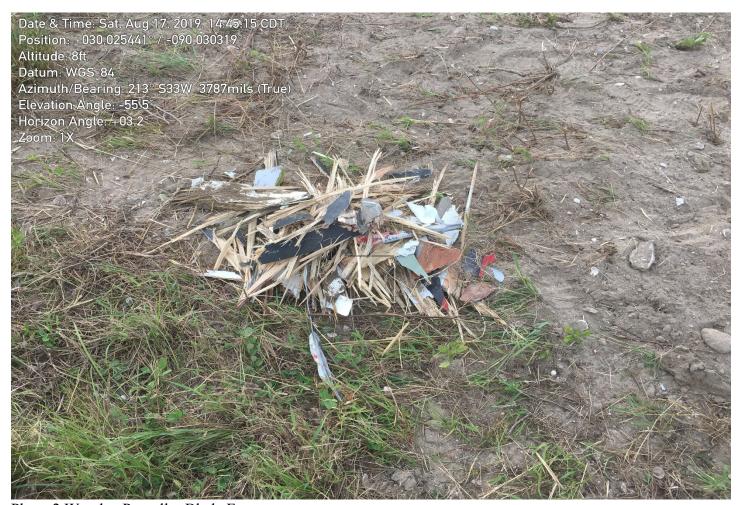
- Propeller governor screen found clear of debris.
- The wooden propeller blades were fractured and splintered, consisted with powered rotation at the time of impact. The fragments were dispersed around the accident area and collected for the photo.

Photo 2 Wooden Propeller Blade Fragments
