Alexander Lemishko  
Senior Air Safety Investigator  
NTSB, Central Region

**Date:** October 26, 2022

**Subject:** CEN23FA019 Wreckage Examination Findings

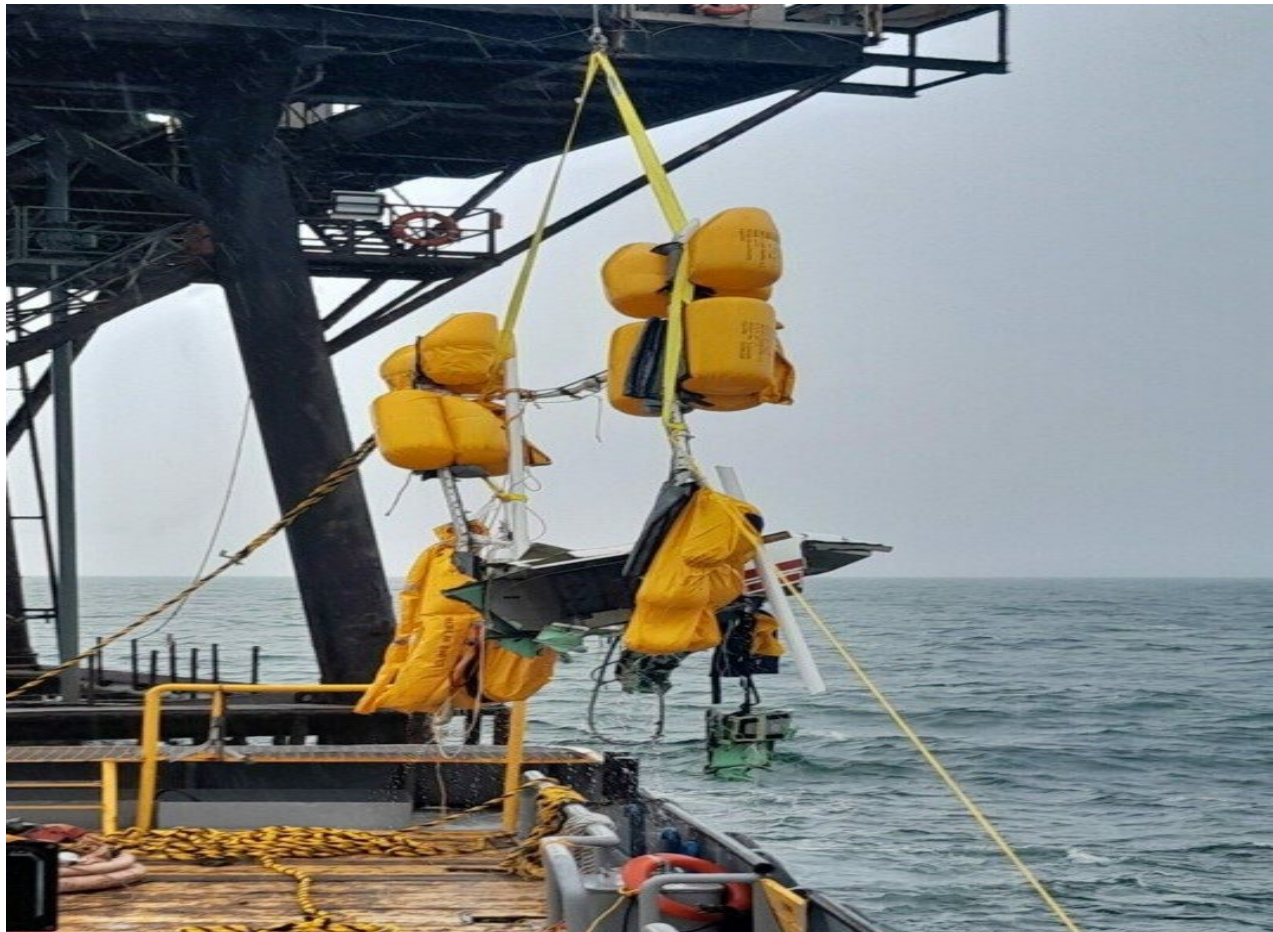
After the accident, the position of the helicopter wreckage was located, marked, and additional flotation was attached. During the wreckage retrieval, the engine, transmission, flight controls, most of the cabin structure, tail boom, and main rotors were lost at sea due to rough, unfavorable sea conditions. The only parts of the helicopter wreckage that were recovered were portions of the intermediate fuselage/baggage compartment, and most of the landing gear skids. The skid-mounted floats were attached to the skids and were deployed. See Photographs 1&2.

Photograph 1 Recovered Wreckage at Sea (Courtesy of: Westwind Helicopters)

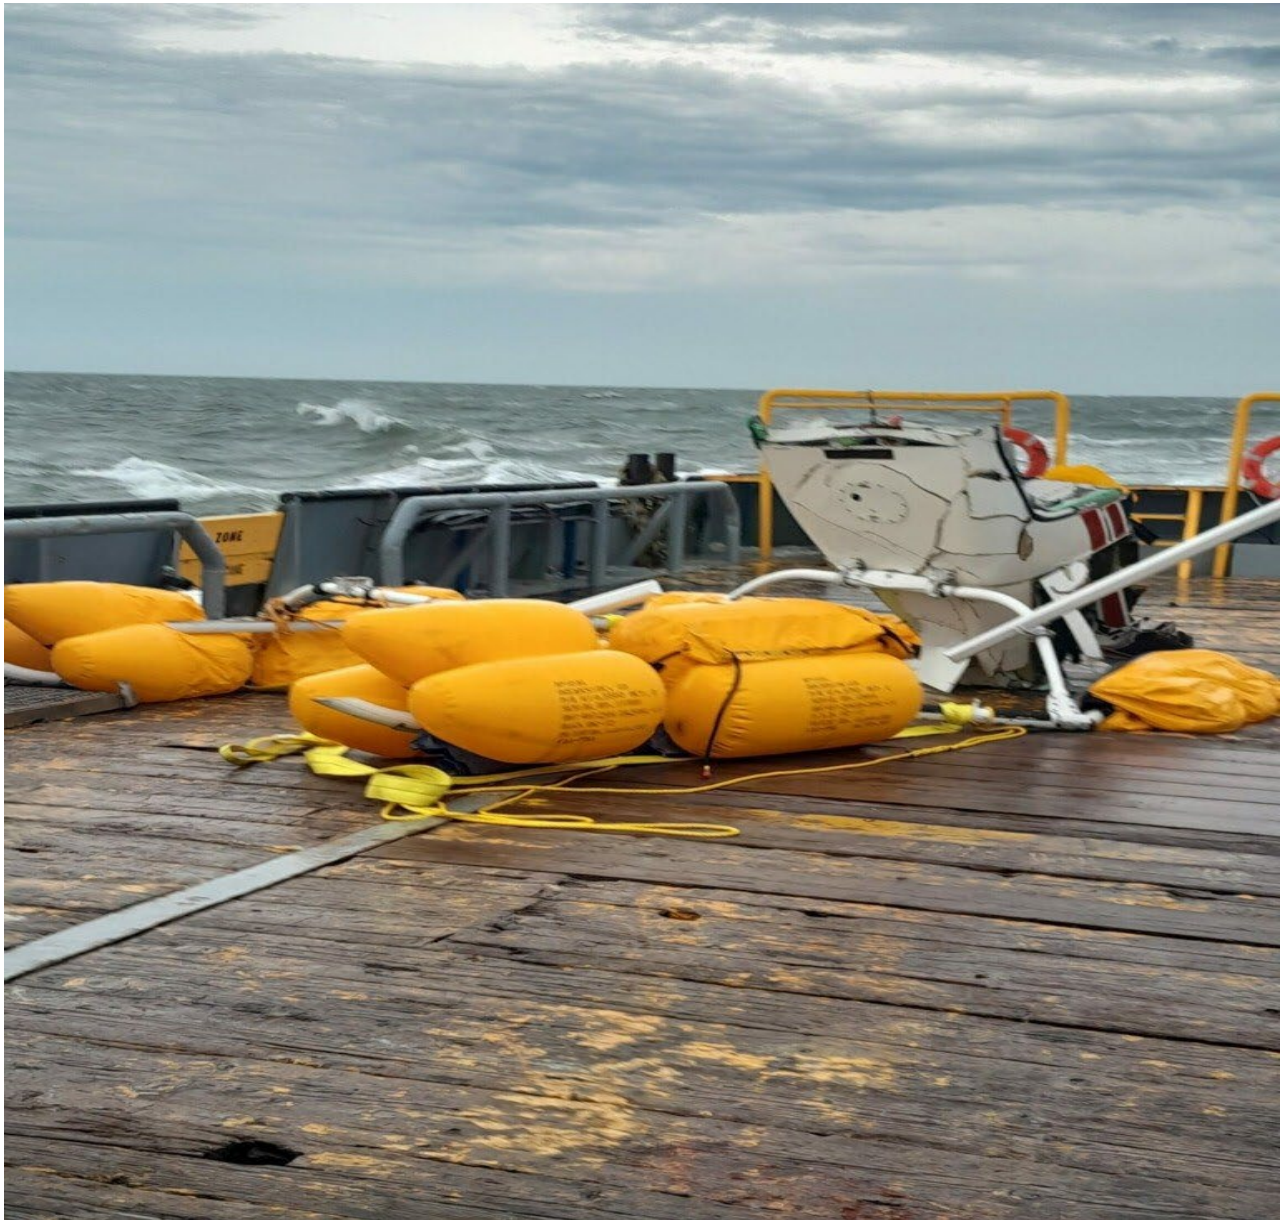
Photograph 2 Recovered Wreckage on Deck of Recovery Vessel Leslie Ann (Courtesy of Westwind Helicopters)

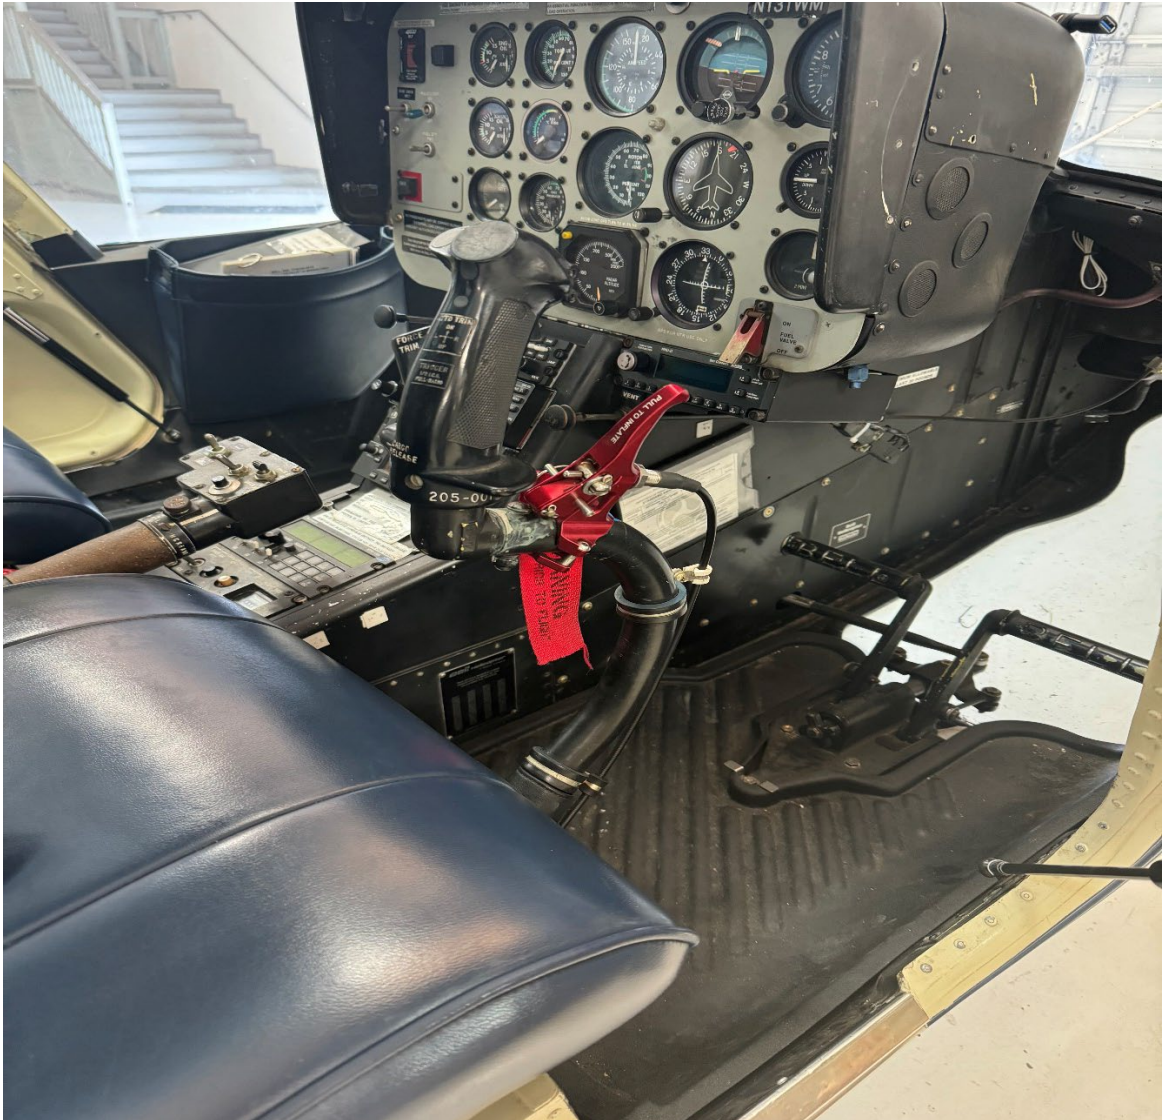
strap assemblies were fractured. The aft cross tube remained attached to the fuselage. The floats remained attached to the skid tubes and had been deployed. Note: The float system was activated from the cockpit prior to water entry. The helicopter was equipped with Apical emergency floats. Apical floats are mechanically activated from an activation handle that is located on the pilot's cyclic control stick in the cockpit. The float system is comprised of a series of cables that release compressed gas from the float cylinders into the skid-mounted float bladders when the cyclic activation handle is pulled. See Photograph 3.

Photograph 3 Exemplar Cockpit Float Activation Lever (Red) Mounted on Cyclic Control (Courtesy of Westwind Helicopters)
