NATIONAL TRANSPORTATION SAFETY BOARD
Office of Railroad, Pipeline, and Hazardous Materials Investigations
Washington, D.C. 20594

Group Chairman's Factual Report of the Investigation¹

– Railroad Equipment Crashworthiness² –

NTSB Number:	RRD22MR010
Location (Jurisdiction):	Mendon, MO (Chariton County)
Date / Approx. Time of Accident:	June 27, 2022 / 12:43 (p.m.) CDT ³
Brief Synopsis:	Amtrak intercity passenger train collision with a highway vehicle (dump truck) at highway / rail grade crossing, and subsequent derailment
Train Equipment Owner / Operator:	Amtrak / Amtrak
Railroad (Property Owner):	BNSF
Accident Site (Location):	BNSF, Main Line, Track #2, Marceline Subdivision, Chicago Division, at (approximately) MP 363.8

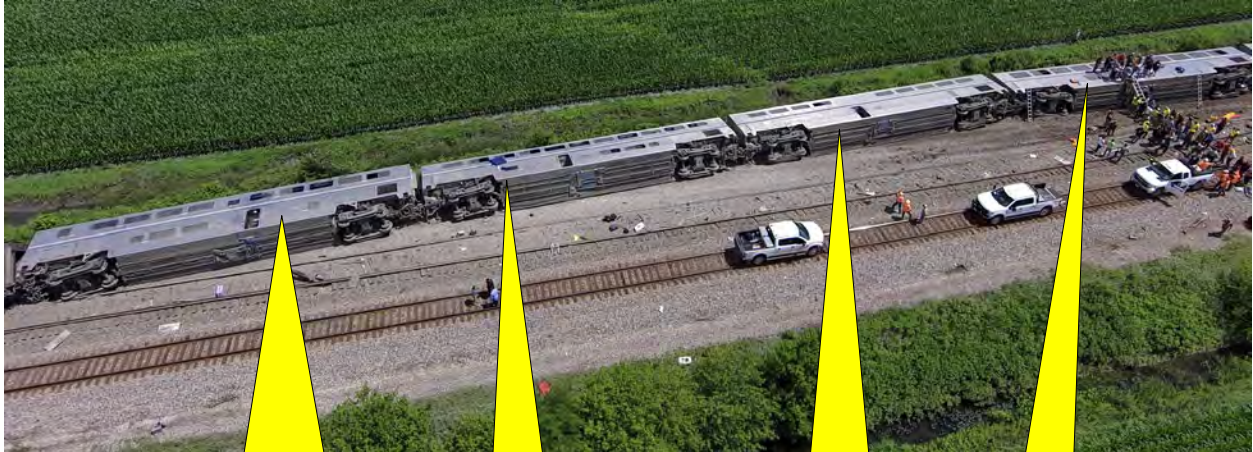
Transition Sleeper Car # 39045

Diner Car 38060

Sleeper Car # 32104

Lounge Car 33046

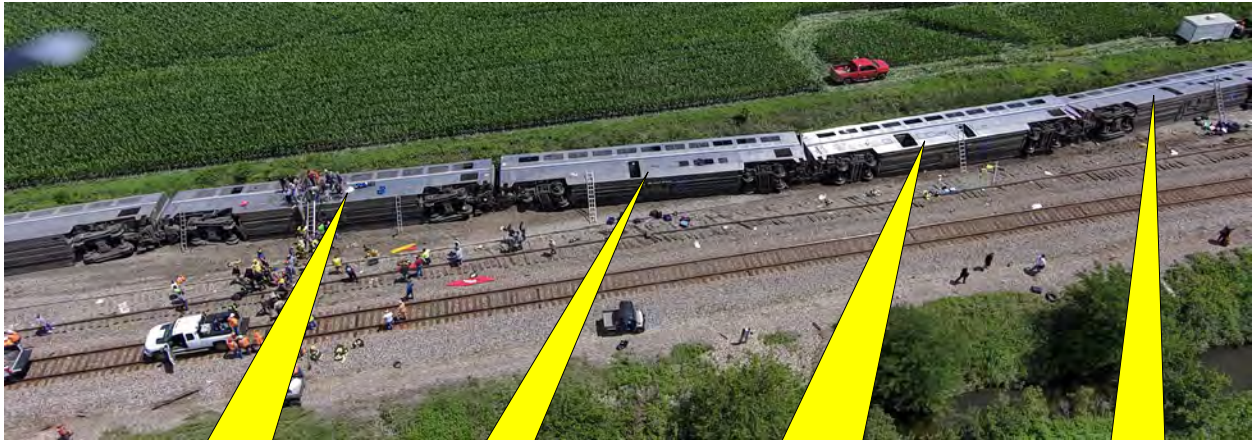
Lounge Car # 33046

Coach Car # 34026

Coach Baggage Car # 31029

Coach Car # 34102
