Preliminary Report: RRD22MR010

Railroad Investigation

Mendon, Missouri

June 27, 2022

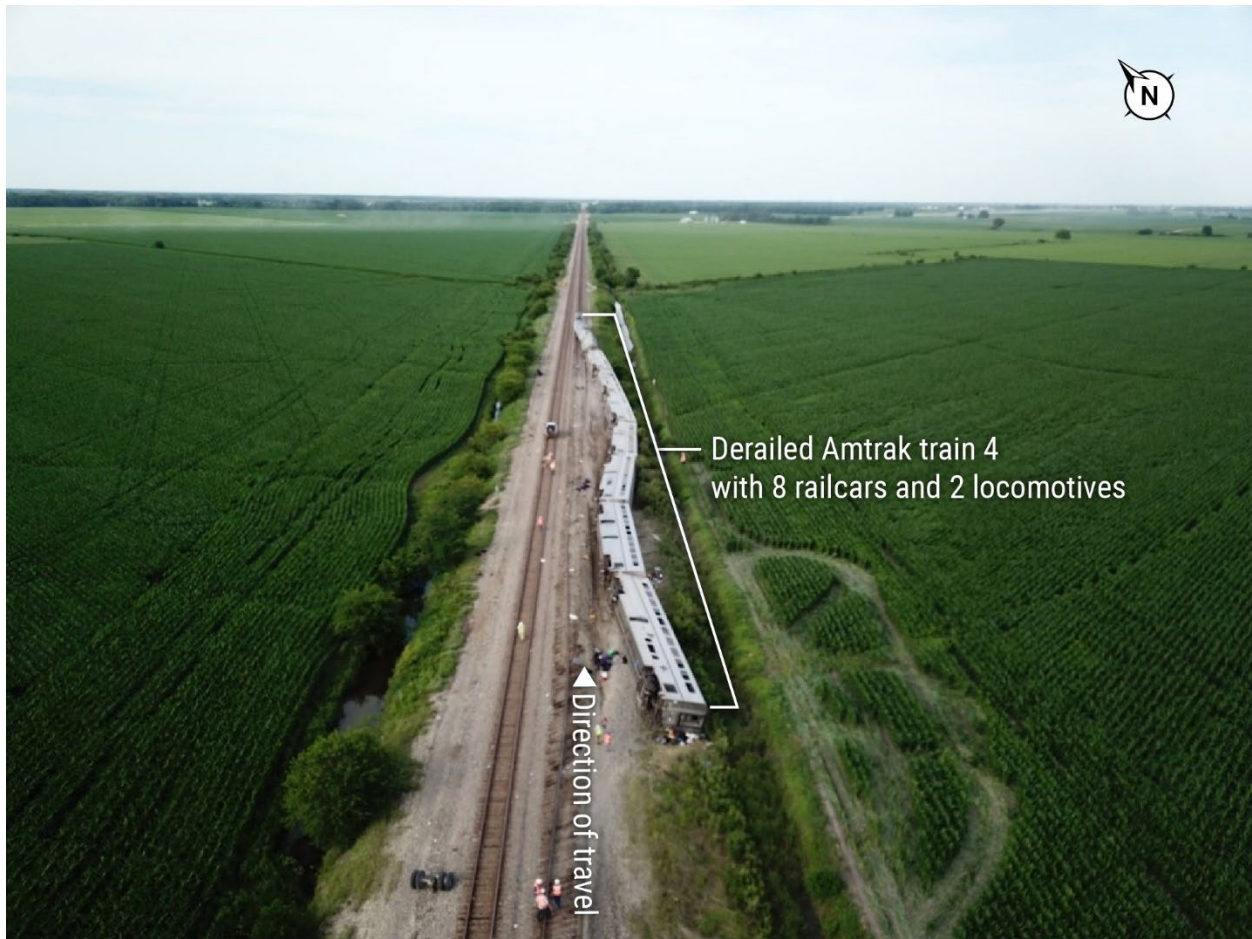
Figure. Amtrak train 4 derailed. (Source: BNSF).

Amtrak train 4, traveling from Los Angeles, California, to Chicago, Illinois, consisted of two locomotives and eight railcars. The collision with the fully loaded dump truck occurred at milepost 363.8 on the BNSF Marceline Subdivision near a rural passive highway railroad grade crossing on County Road 113, also known as Porsche Prairie Avenue.² The highway railroad grade crossing was equipped with crossbucks, and a stop sign on the right side of Porsche Prairie Avenue as the dump truck driver approached from the south. All locomotives and railcars derailed with seven of the railcars coming to a rest on their sides. The dump truck received heavy damage and came to rest in a ditch northeast of the rail crossing adjacent to the road.
