**NATIONAL TRANSPORTATION SAFETY BOARD Office of**  
Railroad, Pipeline, and Hazardous Materials Investigations  
Washington, D.C. 20594

**Pipeline Operations / Integrity Management**

**Group Chairman's Factual Report**

<b>Accident Number:</b>	DCA17FP006
<b>Location:</b>	Millersville, Pennsylvania
<b>Date:</b>	July 02, 2017
<b>Time (approximate):</b>	12:32 p.m. Eastern Daylight Time (EDT)
<b>Material Released:</b>	Natural Gas
<b>Type of System:</b>	Gas distribution pipeline
<b>Owner / Operator:</b>	UGI Utilities, Inc.
<b>Property site:</b>	206 Springdale Lane, Manor Township, PA.
<b>Fatalities / Injuries:</b>	1 Fatality / 3 Injuries
<b>Damage / Clean-up Cost:</b>	\$ [data not provided by the distribution pipeline operator]

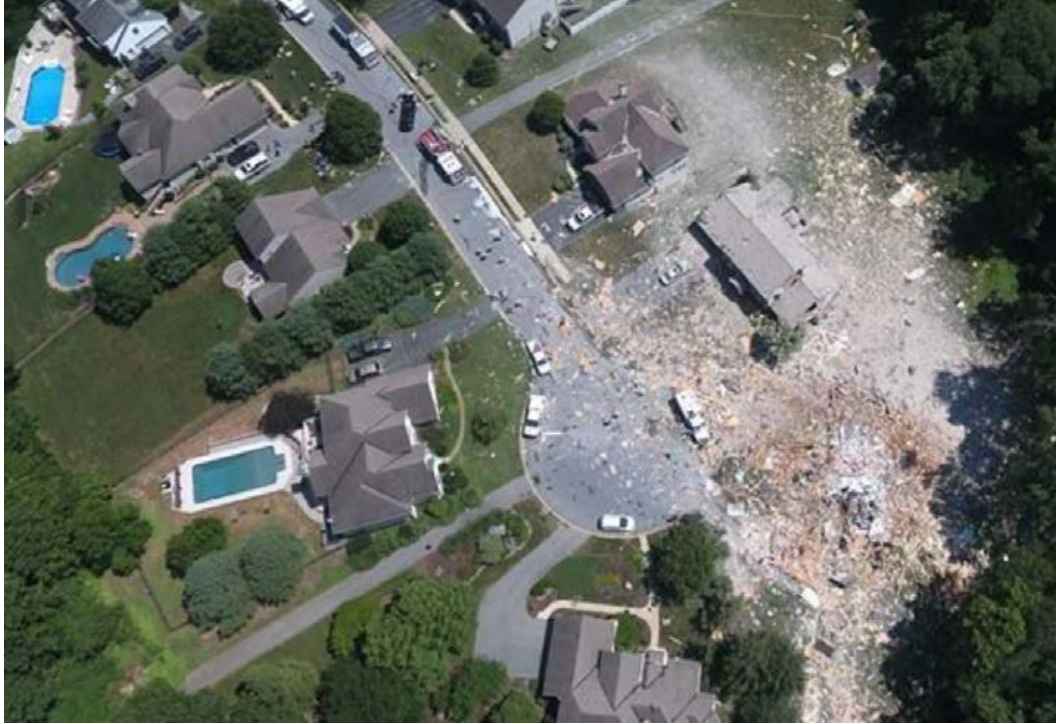
On Saturday, July 2, 2017, at approximately 12:32 p.m. EDT, a natural gas-fueled explosion occurred at the single-family residence located at 206 Springdale Lane, Millersville, Pennsylvania. The explosion completely leveled the residence and damaged six neighboring homes, one which was subsequently condemned.

Local authorities initially condemned the residences to the left and right of the demolished home following an assessment of the damages (see Figure 1). The home at 201 Springdale Lane was subsequently repaired, while the home at 202 Springdale Lane was torn down and completely rebuilt.

*Figure 1. Debris field at cul-de-sac area where the explosion the occurred*

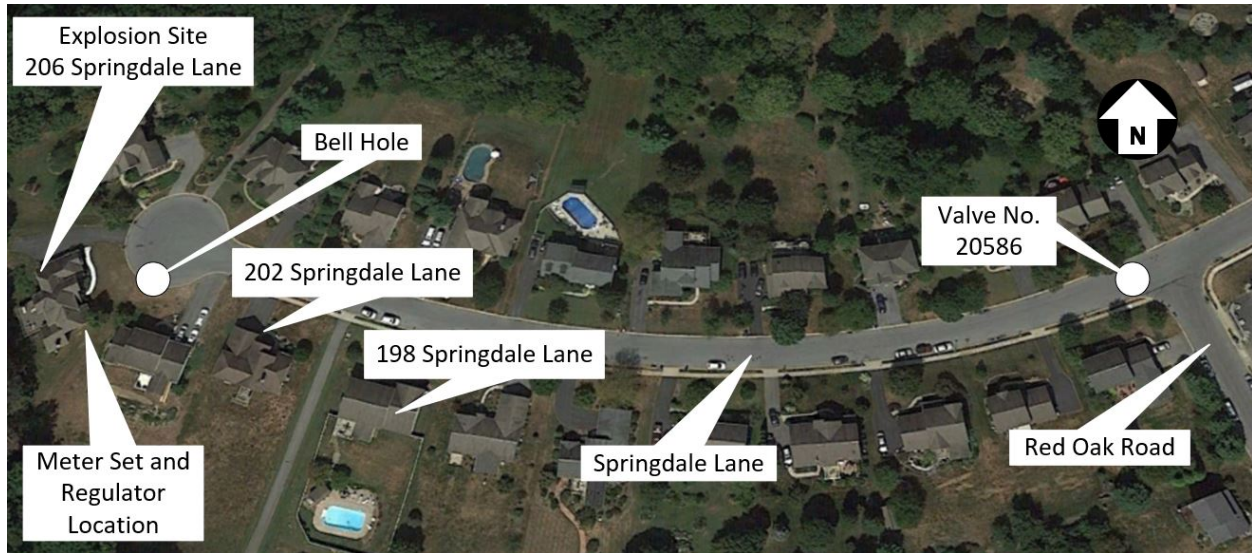
Prior discussions had taken place between the Supervisor and other UGI employees as to the possibility of closing the valve on the main (See Figure 2); however, the Senior Supervisor made a decision to squeeze-off the main line because of his belief that doing so was the most rapid way of stopping the flow of gas.<sup>15</sup> During his NTSB interview, the Senior Supervisor described the following factors that also influenced his decision to squeeze-off the main line: (i) prior to arriving on the scene, he reviewed the location of the nearest valve to 206 Springdale Lane<sup>16</sup>; (ii) he considered that given the circumstances surrounding the leak, even if the valve were turned off, gas would continue to flow to the leak until the system lost pressure; (iii) while he had the opportunity to stop the flow of gas using an excess flow valve fused to the outlet of the tee, the excess flow valve would not stop the gas from leaking out of the mechanical tee<sup>17</sup>; (iv) the line could be quickly and successfully excavated and squeezed, as compared to the time necessary to reach the valve; and (v) a vehicle may have been obstructing access to the valve.<sup>18</sup>

Figure 2 -- Location of gas shut-off in relation to accident site
