**NATIONAL TRANSPORTATION SAFETY BOARD**  
Office of Research and Engineering  
Washington, D.C. 20594

## **Video Study**

**NTSB Case Number:  
WPR19MA177**

Location: Dillingham Airfield, Mokuleia, Hawaii  
Date: June 21, 2019  
Time: 1822 Hawaii-Aleutian Standard Time (HST)  
Aircraft: Beech 65-A90

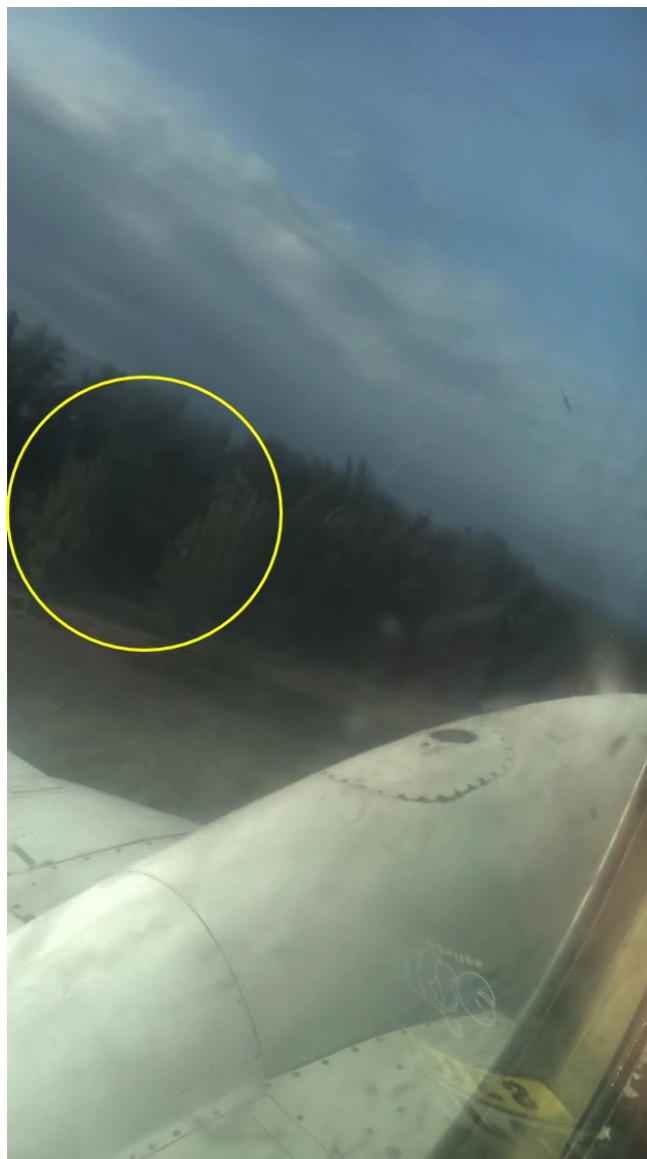
**Figure 1. Video Frame Showing Two Trees Visible through an Airplane Window**

There are many trees located along Farrington Highway that runs parallel to the runway, north of it. The details seen in video frames such as the one in Figure 1 were insufficient for determining which two trees were visible in the video. Therefore, YouTube videos were used to examine trees along Farrington Highway and identify the two trees visible in the video.

Comparison of the images of the two trees visible in Figure 1 with the two trees marked in Figures 2, 3 and 4 led to the conclusion that they were the same trees. The location of these two trees happens to be near the location where the accident airplane crashed. Figure 1 indicated that the airplane during its last flight before the accident flight started turning toward the ocean as it passed the two trees along the runway.

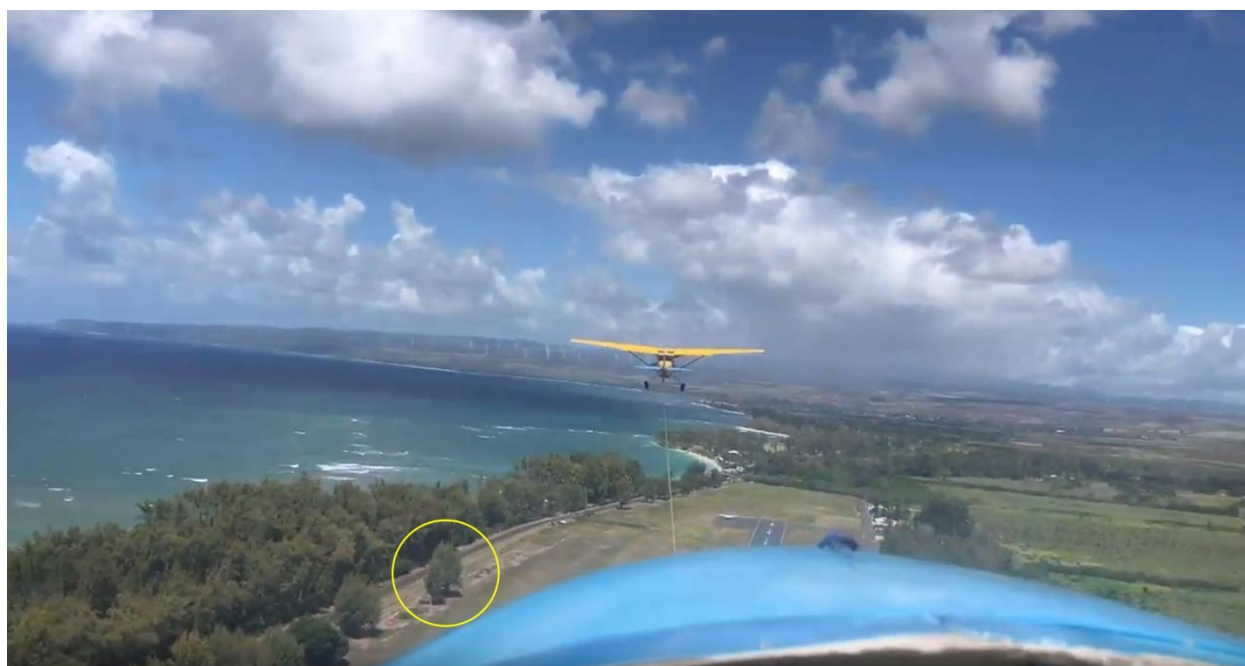
Figure 2 is a frame from a YouTube video recorded from inside a glider that was flying above Runway 8. The two trees are marked by the yellow circle. Figure 3 is a frame from a YouTube video recorded from inside an airplane that was flying above the runway. The two trees are marked by the yellow circle. Figure 4 is a frame from a YouTube video recorded from a car driving west on Farrington Highway. The two trees are marked by the yellow circle.

**Figure 2. Frame from a Video Recorded with a Camera Installed inside a Glider**

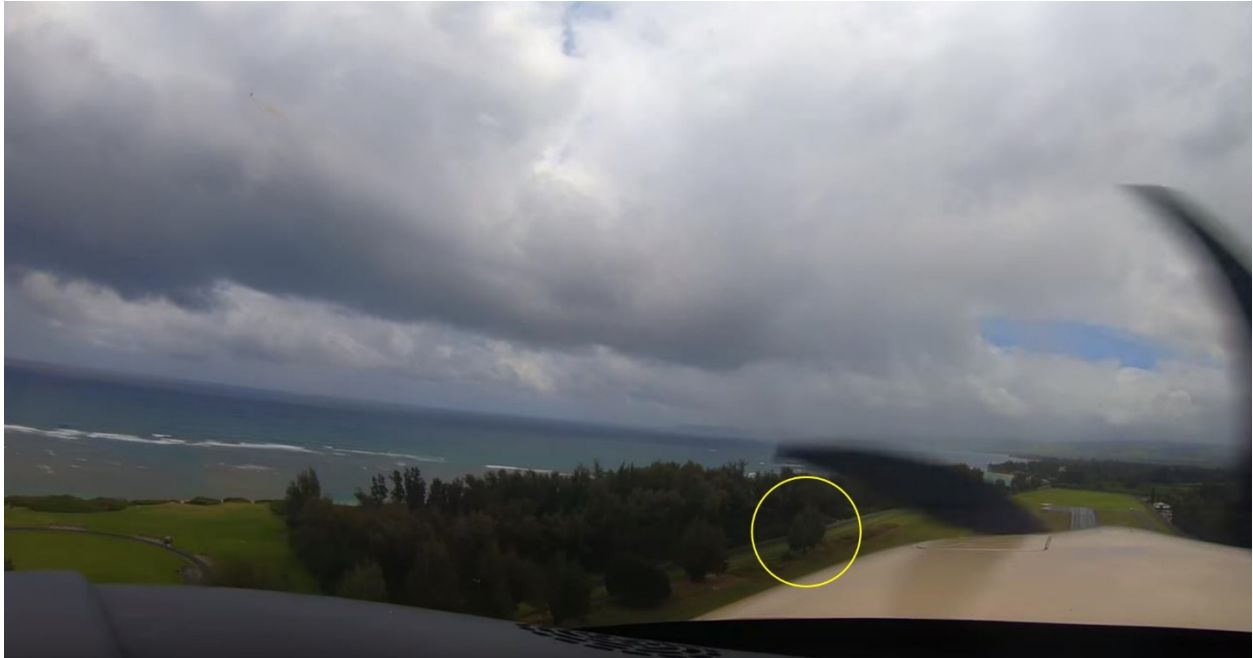
**Figure 3. Frame from a Video Recorded with a Camera inside an Airplane**

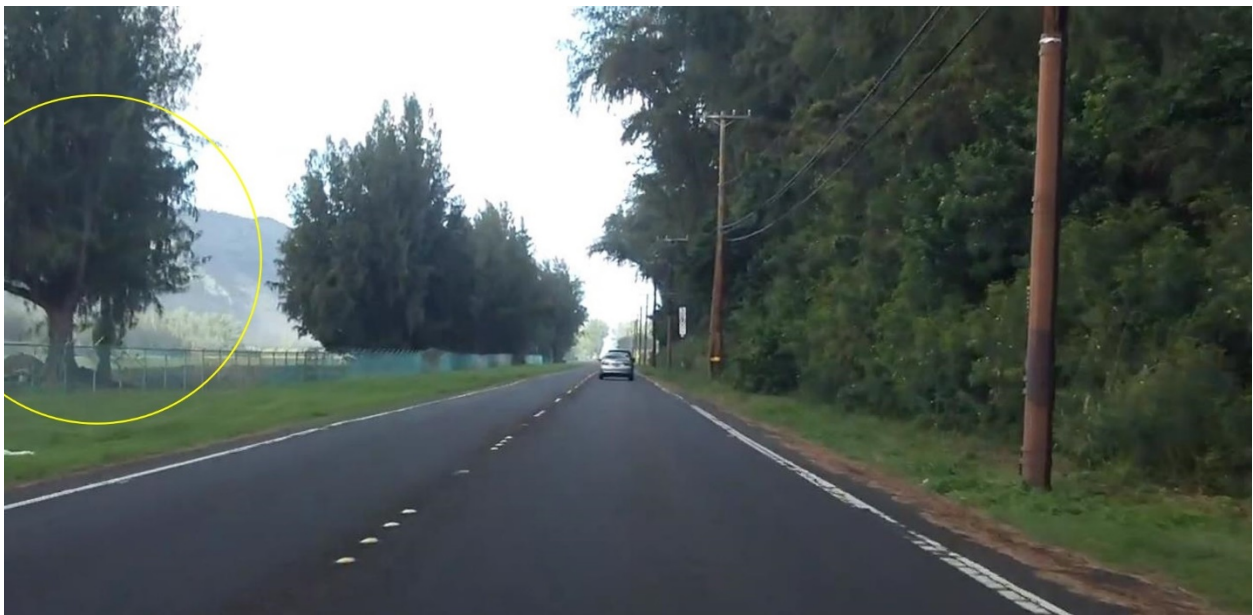
**Figure 4. Frame from a Video Recorded with a Camera Installed in a Car**

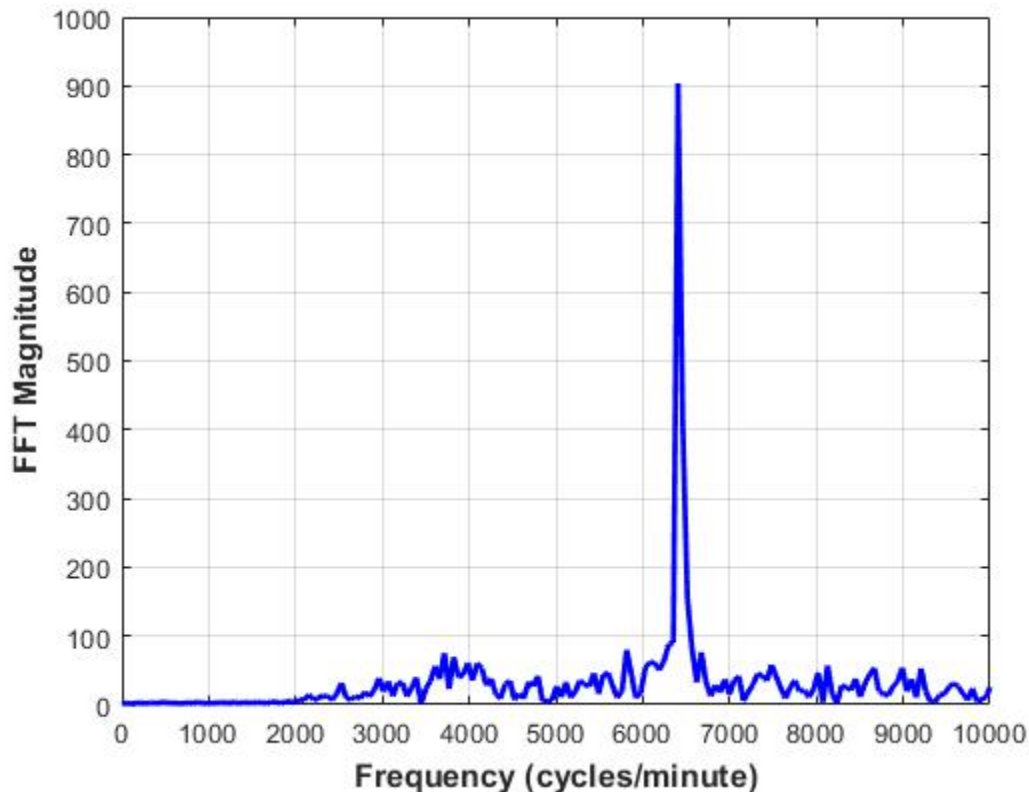
The video recorded sound at the rate of 44100 samples/second. Magnitude of the Fast Fourier Transform (FFT) spectrum of the sound signal is shown in Figure 5. The peak is at 6405 cycles/minute, indicating that the speed of the engines driving the 3-bladed propellers was  $6405/3=2135$  rpm. The FFT algorithm frequency bin was 54 rpm wide. The rotational speed of 2135 rpm is within the normal propeller shaft speed range

of the PT6A engines, 1800 rpm to 2200 rpm. The narrow spectral peak in Figure 5 indicates that the two engines were operating at the same constant speed.

**Figure 5. Spectrum of the Sound Channel in the Analyzed Video**

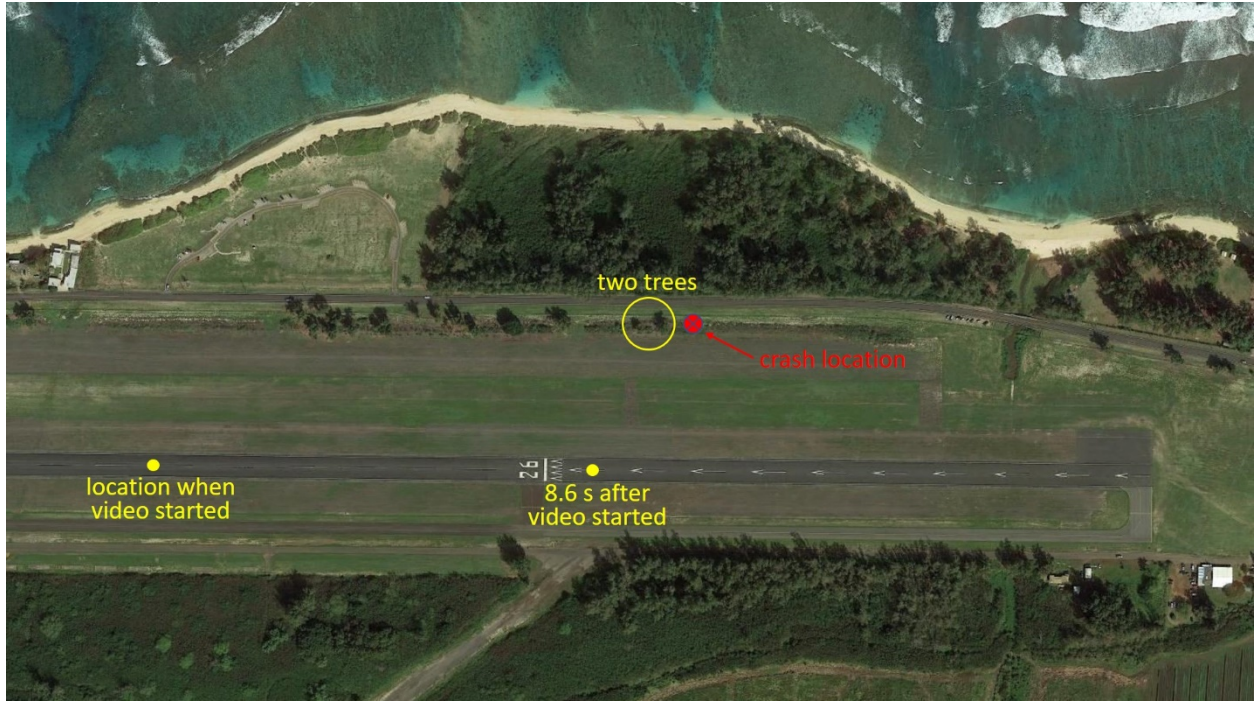
The Exif metadata in the video included the GPS location and information of the iPhone X camera when the video started. The latitude and longitude data are considered accurate because the specified location is near the centerline of the runway. Figure 6 shows that location. It is assumed that the camera owner did not manipulate the video and the GPS metadata indeed corresponds to the camera location when the analyzed video started.

The two trees mentioned above exited the field of view of the camera at video time 8.6 seconds as the airplane advanced along the runway. Assuming an airplane ground speed of 100 knots, after 8.6 seconds the airplane would have advanced 1452 feet. Its location on the runway at 8.6 seconds into the video would have been as marked on Figure 6. This location relative to the two trees marked in the figure agrees well with the location estimated above based on the visibility of the two trees in the video.

The crash location marked in Figure 6 is where the airplane crashed during an attempted takeoff after the flight that is analyzed in this report. Figure 7 is a photograph taken during the investigation of the crash. It shows the crash location and the two trees mentioned above.

**Figure 6. GPS-Based Airplane Locations on the Runway**

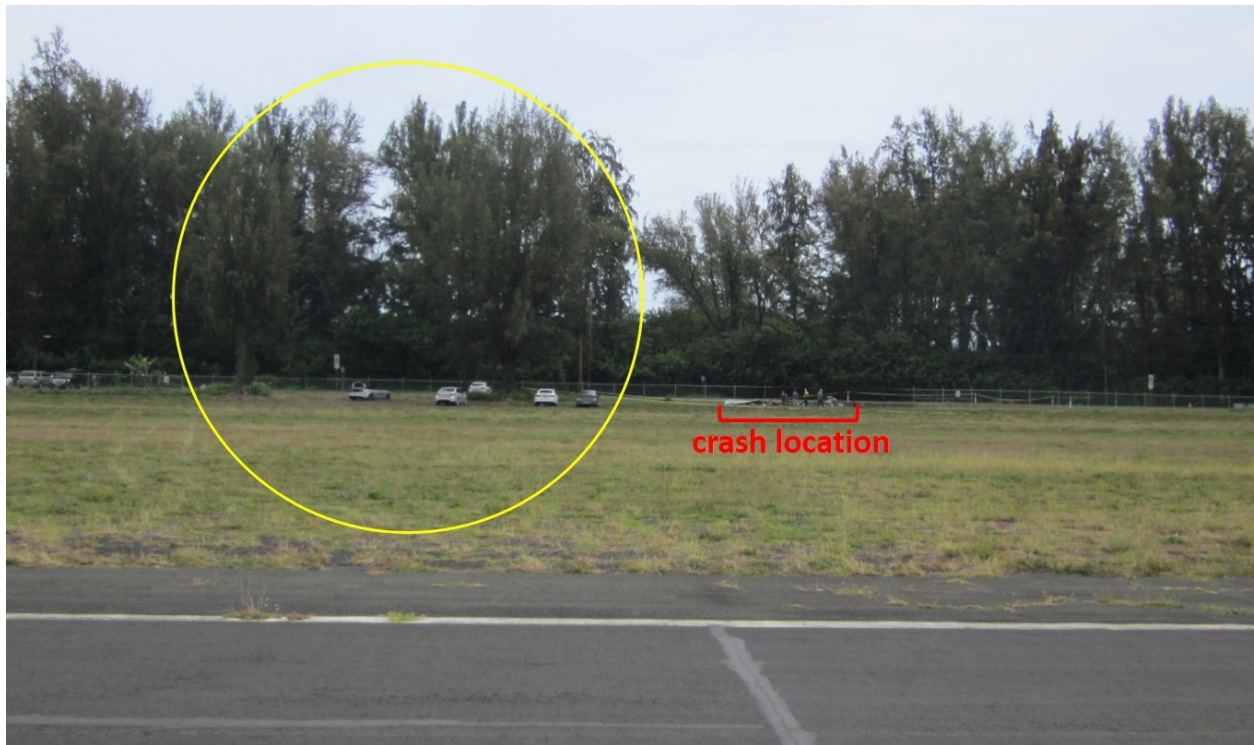
**Figure 7. Photograph Showing the Crash Location and the Two Trees**
