NATIONAL TRANSPORTATION SAFETY BOARD

SYSTEMS AND STRUCTURES GROUP CHAIRMAN'S FACTUAL REPORT

A. ACCIDENT: WPR19MA177
LOCATION: Dillingham Airfield, Mokuleia, Hawaii
DATE: June 21, 2019, at 1822 Hawaii-Aleutian standard time
AIRCRAFT: 1967 Beechcraft 65-A90 King Air, N256TA, (LJ-256)
Operated by Oahu Parachute Center

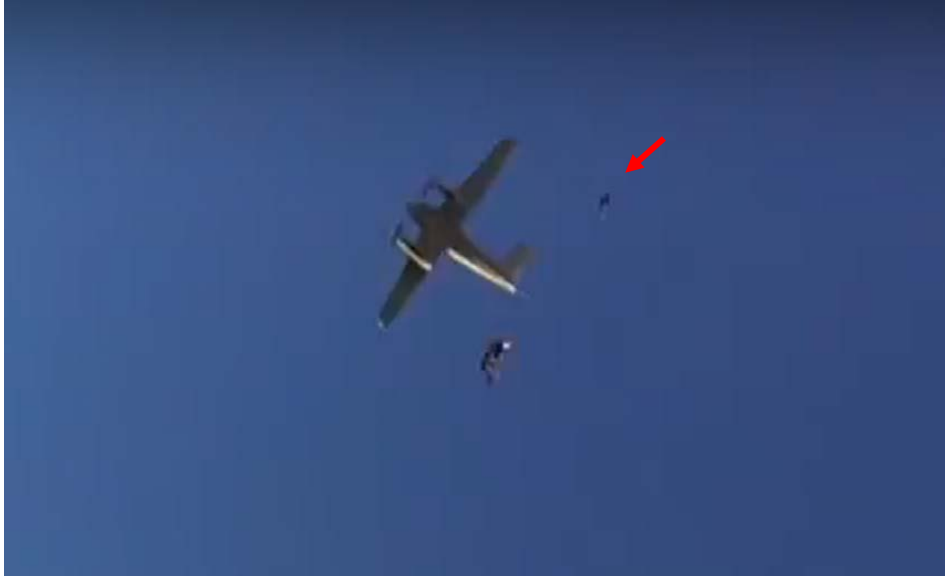
The right horizontal stabilizer and elevator separated during flight on July 23, 2016 and the event was partially recorded by one of the skydivers.¹ (See Figures 1- 3)

Figure 1. Still image from skydiver Achal Asawa 2016 video while he departed the airplane shows a lack of right horizontal stabilizer and elevator assembly.

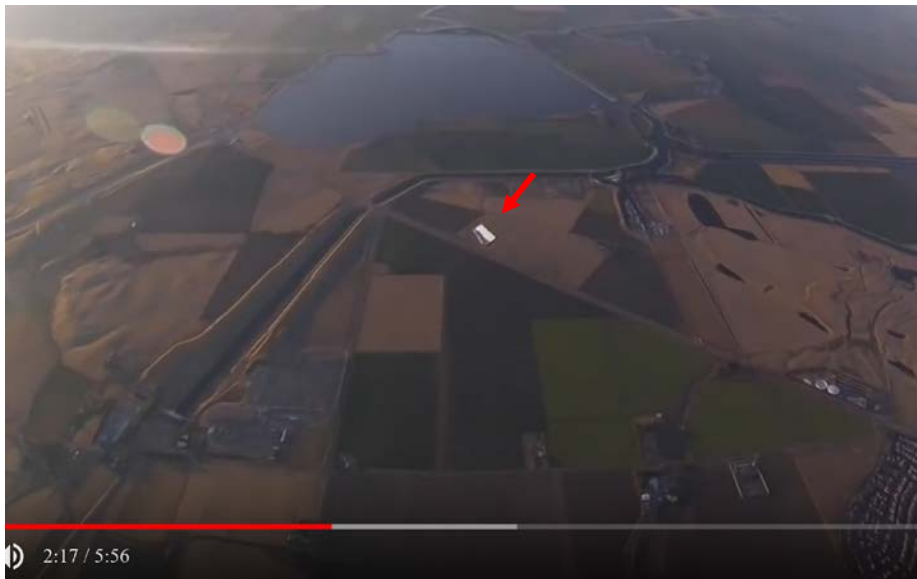
Figure 2. Still image from skydiver Achal Asawa video during freefall shows missing right horizontal stabilizer and elevator assembly (arrow) and another skydiver.

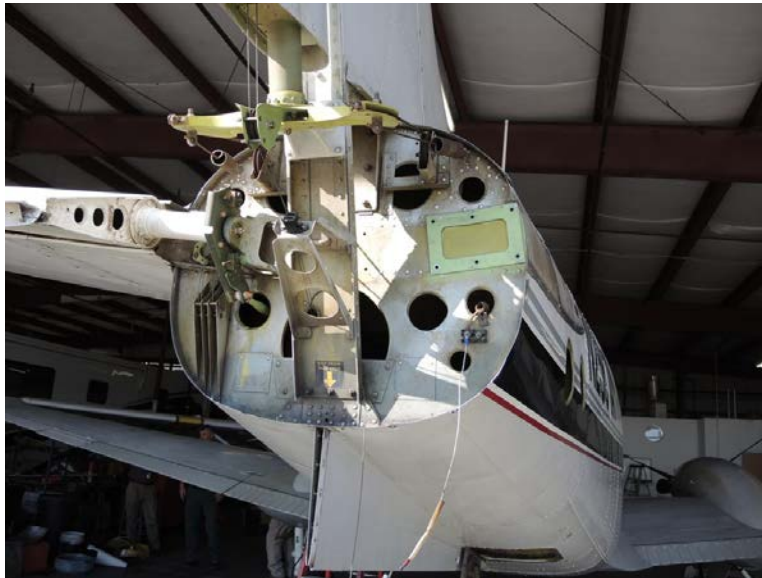
Photos were taken during the examination of the airplane after loss of the right horizontal stabilizer (HSTAB). The rear bulkhead on the right was found damaged where the horizontal stabilizer spar stub had attached. The fuselage skin and forward bulkhead also had damage. (See Figures 4 - 7)

Figure 4. The rear tail bulkhead with the tail cone fairing removed. (Photo from: Textron Report ASI-16-CF, taken August 11, 2016)

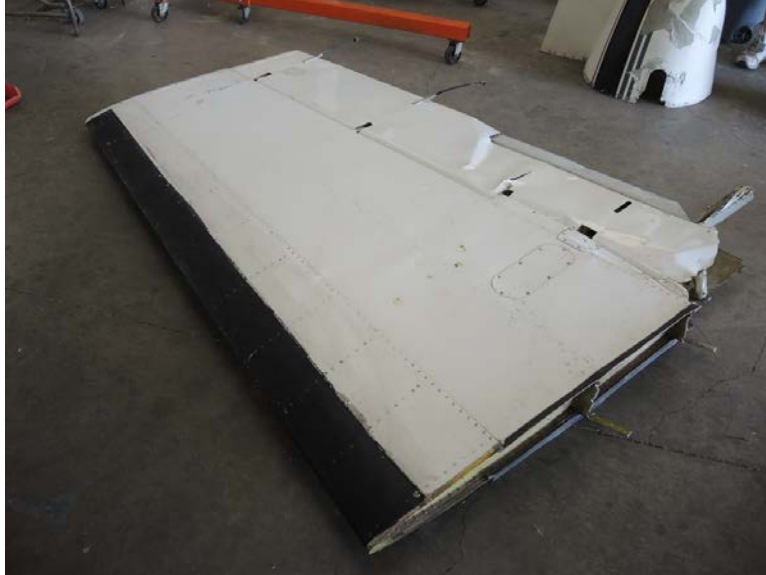
Figure 7. The damaged right HSTAB. (Photo from: Textron Report ASI-16-CF, taken August 11, 2016)

The horizontal stabilizer and elevator were replaced with parts from a 1965 KingAir Model 90,³ registered as N98B and built as serial LJ-87.⁴ The manufacturer's Illustrated Parts Catalog (IPC) does not show the Model 90 stabilizer as applicable to the Model A90 accident airplane (LJ-256). Figure 48, Item -11 of the IPC shows the effective right horizontal stabilizer part numbers for each airplane to be:

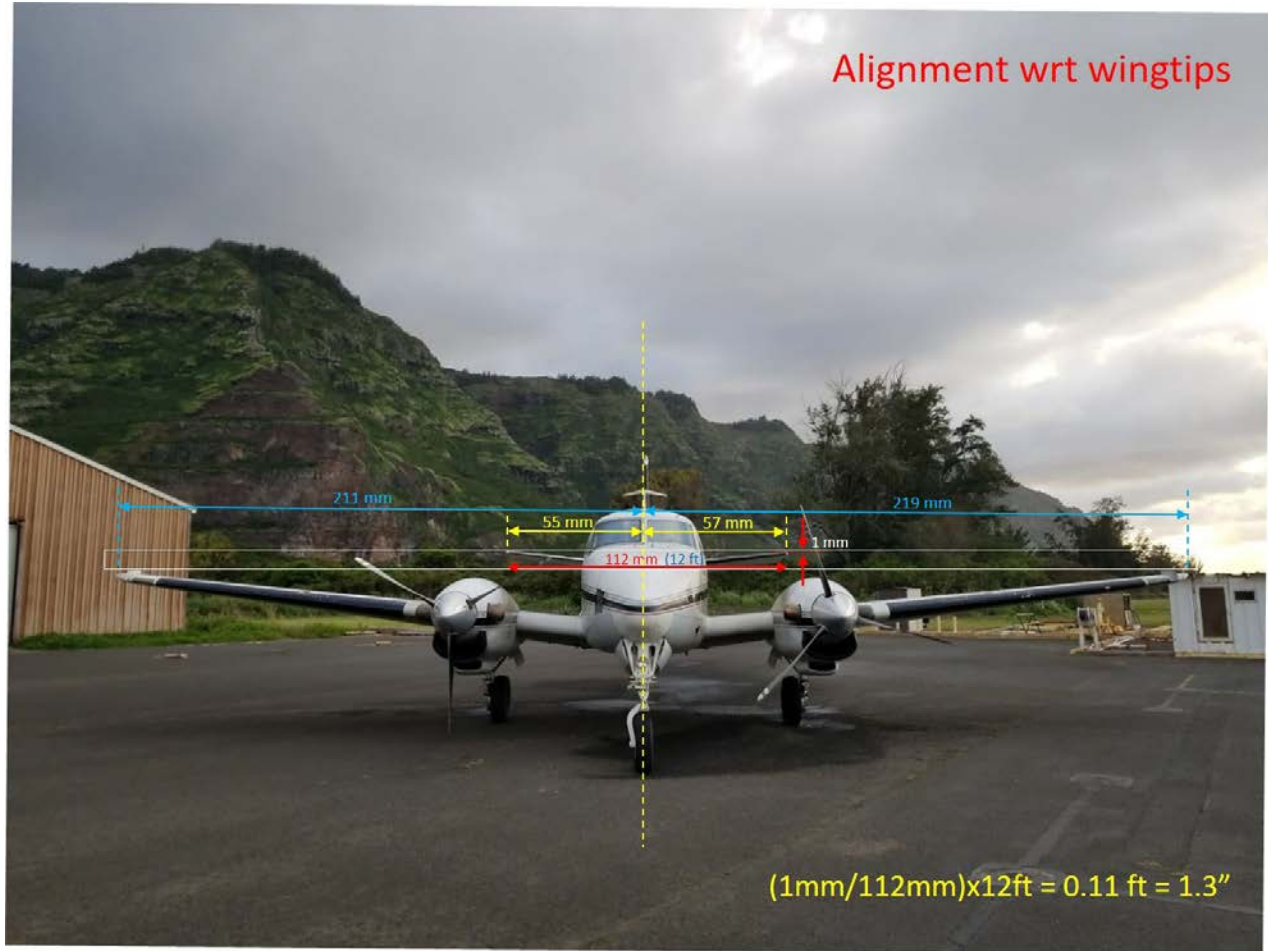
The group examined photo and video evidence about the airplane condition before the 2016 accident and the condition of the airplane after the accident. Two photos from the public showed the airplane as viewed almost directly at the nose. For each photo, NTSB image analysis experts reviewed the position of the aircraft left and right stabilizer tips. In each, the outboard tip of the left horizontal stabilizer was found lower (less dihedral) than the replacement right horizontal stabilizer. The details of their study were as follows:

Figure 8. Front view of airplane, showing alignment measurements. (Photo from: Skinner)

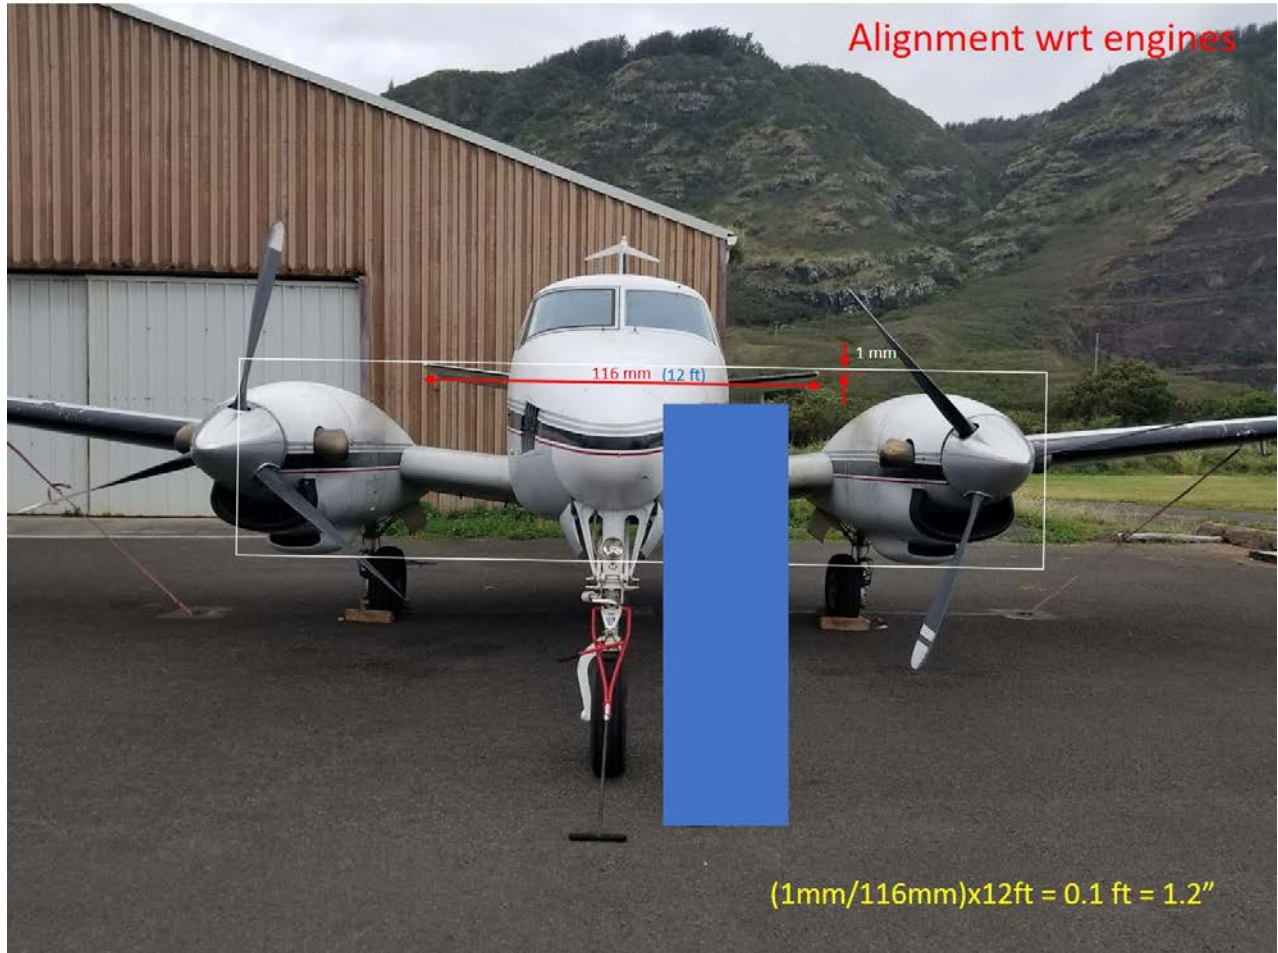
A similar analysis was performed on the other photograph, shown in figure 9. It does not show the wingtips and, therefore, the bottom of the engines was used as a height reference and the white rectangle was used for alignment. The estimated stabilizer tip height difference was 1.2 inches, in close agreement with the above 1.3 inches estimate.

Figure 9. Front view of airplane, showing alignment measurements. (Photo from: Skinner)

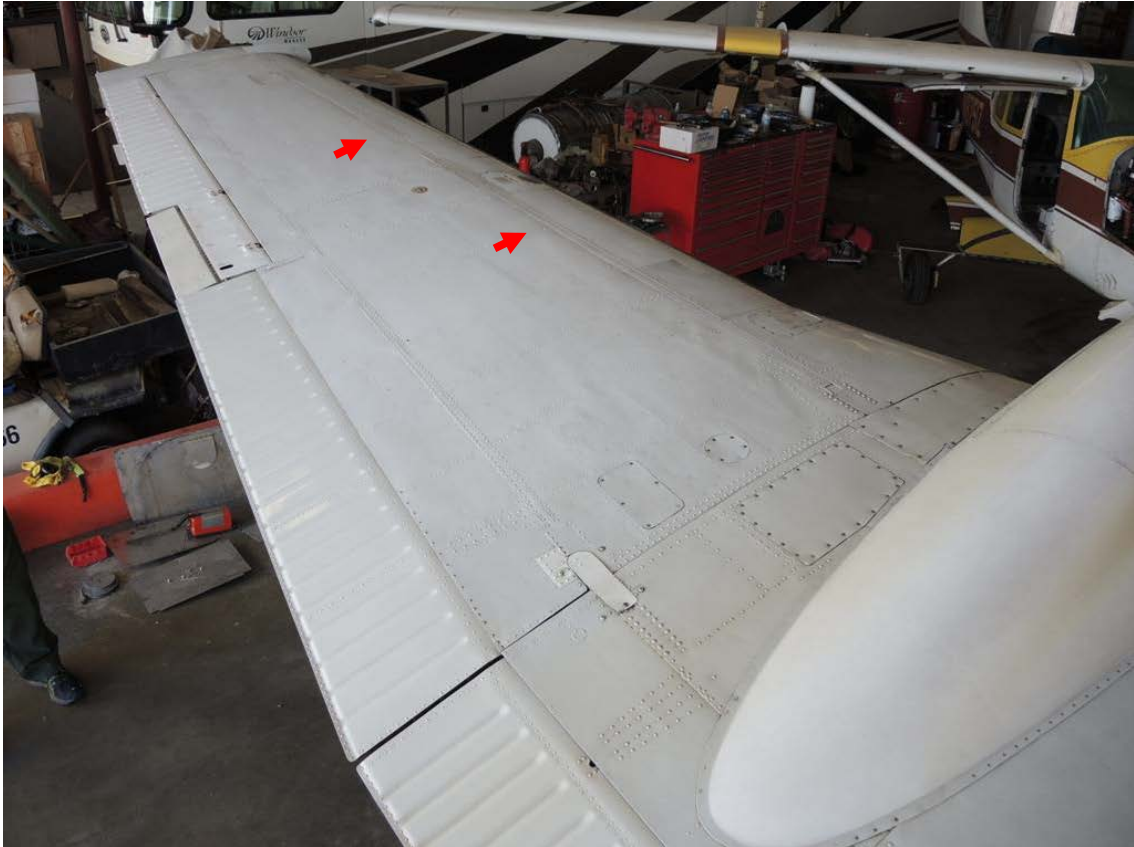
Wrinkles and other damage to the left wing were present in a series of photographs taken immediately after the 2016 tail separation and from subsequent flights through to the Dillingham accident.⁵ The direction of twist indicated by the wrinkles was leading edge up for the wing tip. The top of the

wing also had a raised ridge aft of the forward wing spar in the outboard wing panel in the photographs. A small fairing panel which covered the top rear spar attachment for the left wing was photographed in 2016 with an upward buckle in compression. (See Figures 12 - 14)

Figure 12. Wrinkles in the top skin of the left wing, immediately outboard of the engine and aft of the forward spar. The arrows indicate skin raised as a ridge aft of the outboard section of the forward wing spar. (Also visible in photos from the delivery flight to Hawaii in Figure 18) (Photo from: Textron Report ASI-16-CF, taken August 11, 2016)

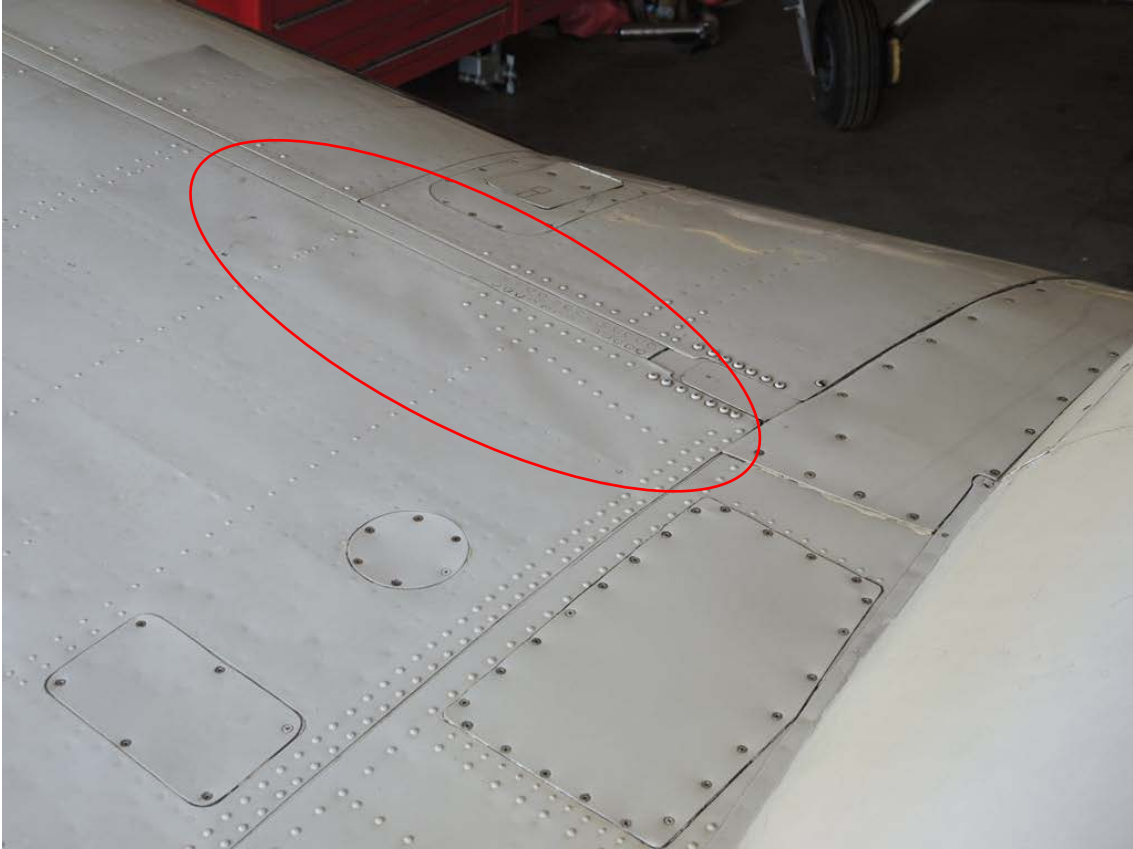
Figure 13. Close view of wrinkles in the top skin of the left wing, immediately outboard of the engine and aft of the forward spar, (Photo from: Textron Report ASI-16-CF, taken August 11, 2016)

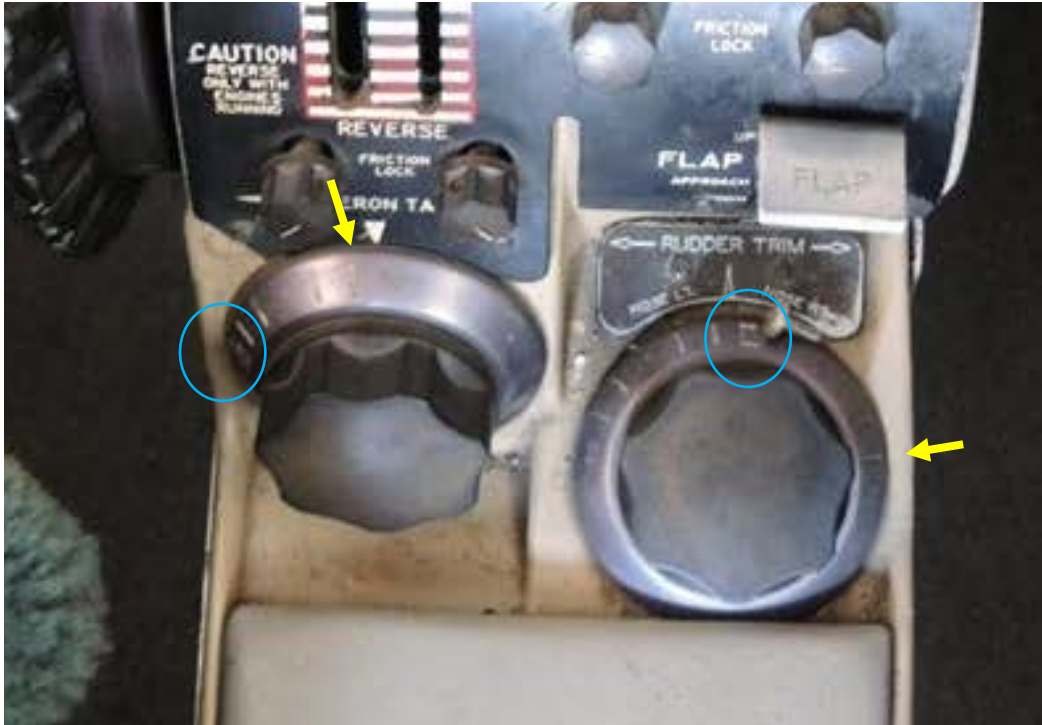
A post-accident 2016 inspection photo also shows the roll trim knob set to full left wing down. (See Figure 20)

Figure 20. As-found position of aileron trim (left knob) in full left wing down orientation after the 2016 accident and of the rudder trim knob (right). The center of graduated adjustment scales in each have rectangular markings which are circled, with five lines to either side. The last adjustment marking from the right can be seen at the top of the aileron knob. A corresponding arrow shows the equivalent mark on the rudder knob as an example. (Photo from: Textron Report ASI-16-CF, taken August 11, 2016)

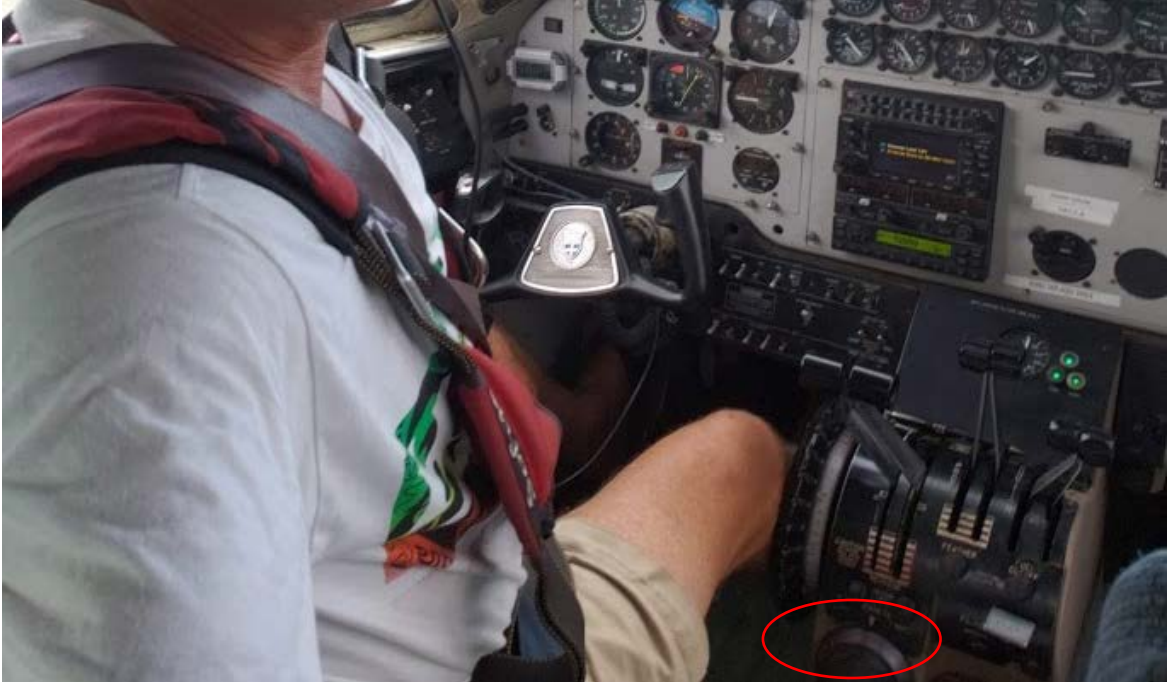
A 2018 photo of a pilot seated in the accident airplane showed the roll trim knob deflected fully to the left, and the knob was found in the same position in the wreckage. (See Figures 21A and 21B)

Figure 21A. This March 7, 2018 photo of a pilot recorded the aileron trim (left knob) in full left wing down orientation. (Photo from: Skinner)

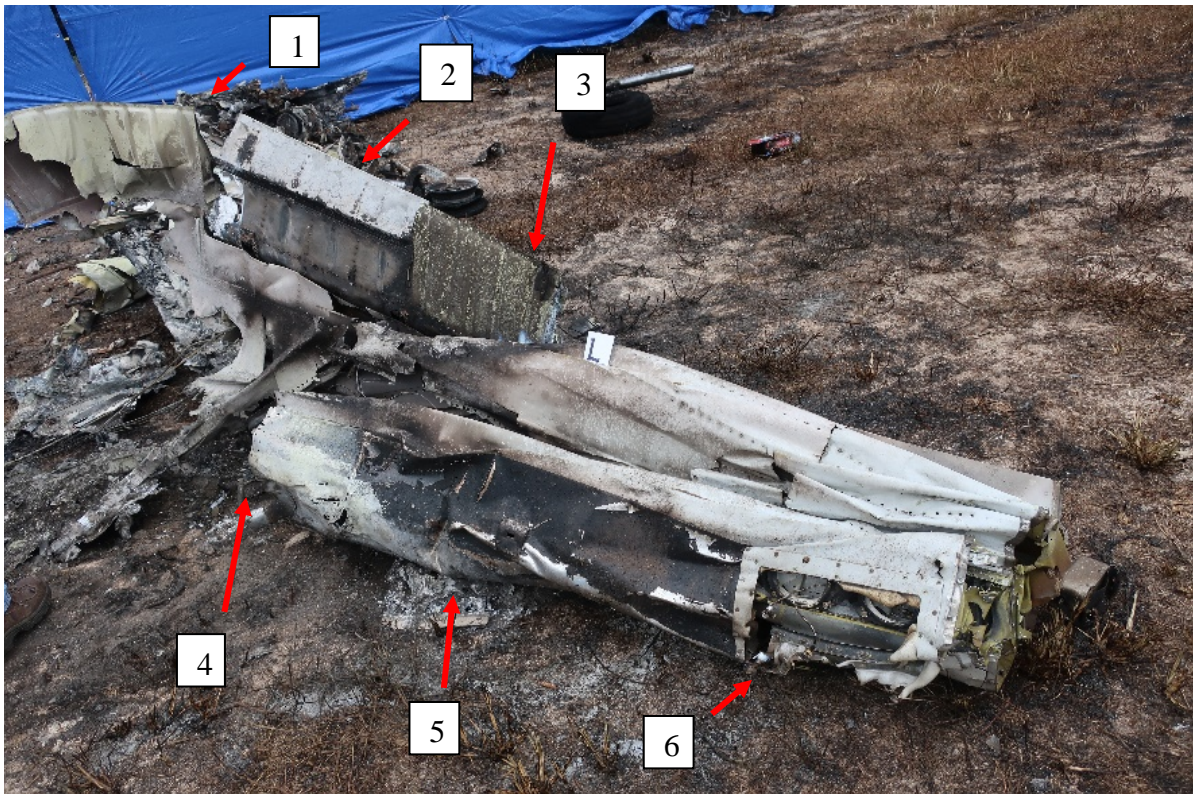
Figure 32. Outboard left wing in initial daylight photos, top surface. Item 1 denotes fire-damaged outboard tip of remaining wing flap. Item 2 points to the left aileron trim tab. Item 3 points to the outboard side of the remaining portion of left aileron. Item 4 points to the pitot tube. Item 5 points to the stall warning lift transducer. Item 6 points to the landing light. (Photo from: Textron)

On the accident aircraft, the area of the wing containing the lift transducer was damaged during the accident impact (see figure 32), and the stall warning light could not be located.

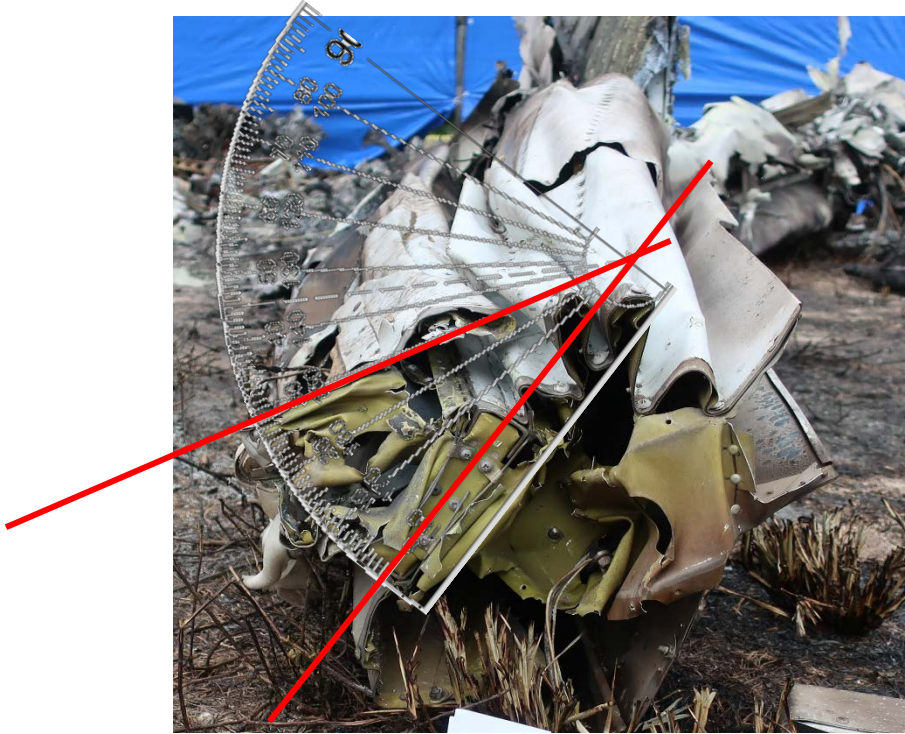
Figure 36. Crush line (upper red line) of the upper leading edge as measured to the vertical center of the wing spar (lower red line) at wing tip. (Photo from: Swaim)

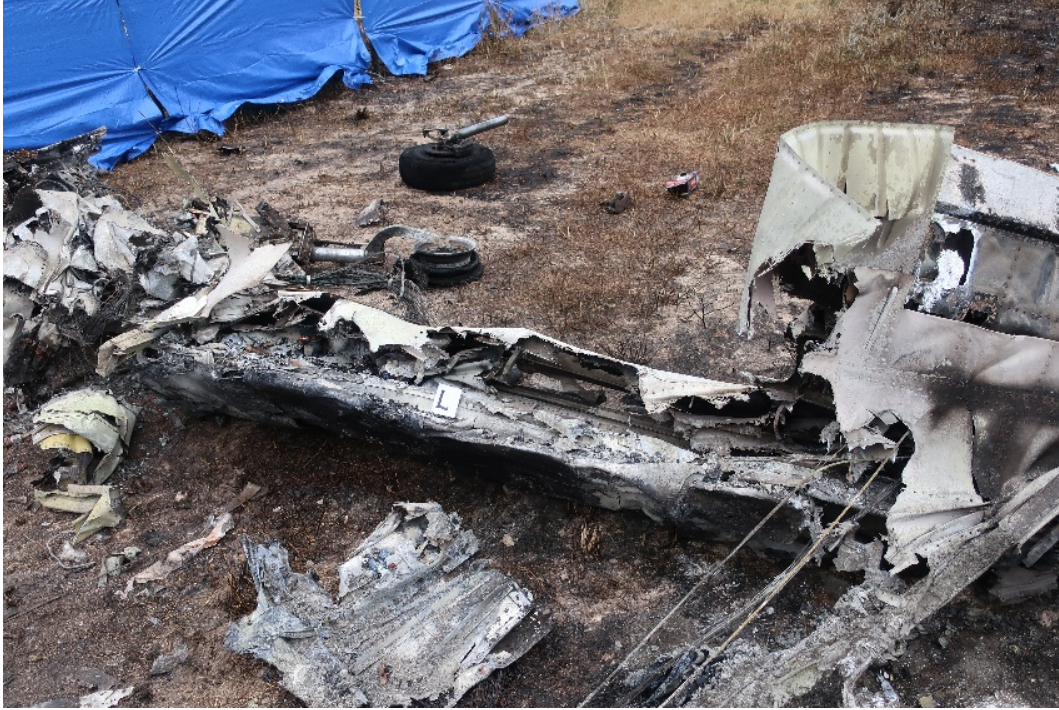
The structure between the left aileron and nacelle had been almost completely consumed by fire aft of the wing spar. Inboard of the engine pylon was more extensively fire damaged and little remained. The area of the engine pylon and outboard fuel tank had been consumed by fire, with remnants of the rear spar and surface stretched toward the location of the left engine. (See Figures 37 - 39)

Figure 37. The consumed wing, flap, and fuel tank area which had been outboard of the left nacelle. (Photo from: Swaim)

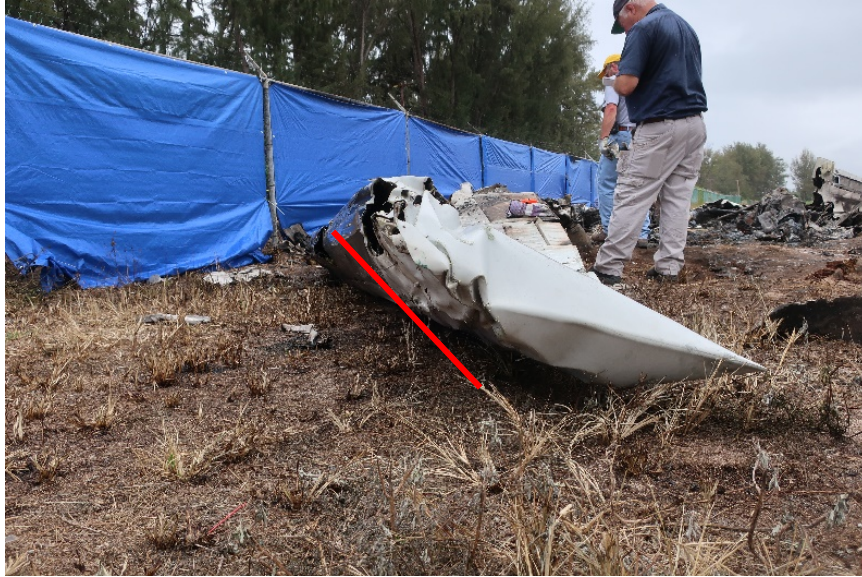
The right wing outboard of the pylon was found relatively intact on the top surface with the leading edge at the airport perimeter fence. A crush line of about 30 ° at the tip and leading edge was further along the top surface than the crush features observed on the left wing. (See Figures 40 - 42)

Figure 42. Right wing tip with added crush line. (Photo from: Swaim)

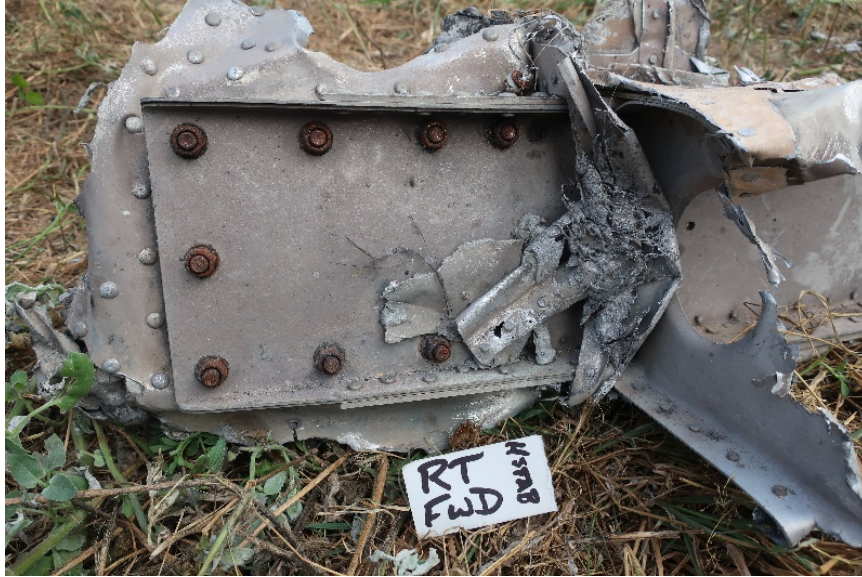
Figure 51. Right horizontal stabilizer forward spar stub bolted to a remnant of the aft fuselage bulkhead. (Photo from: Swaim)

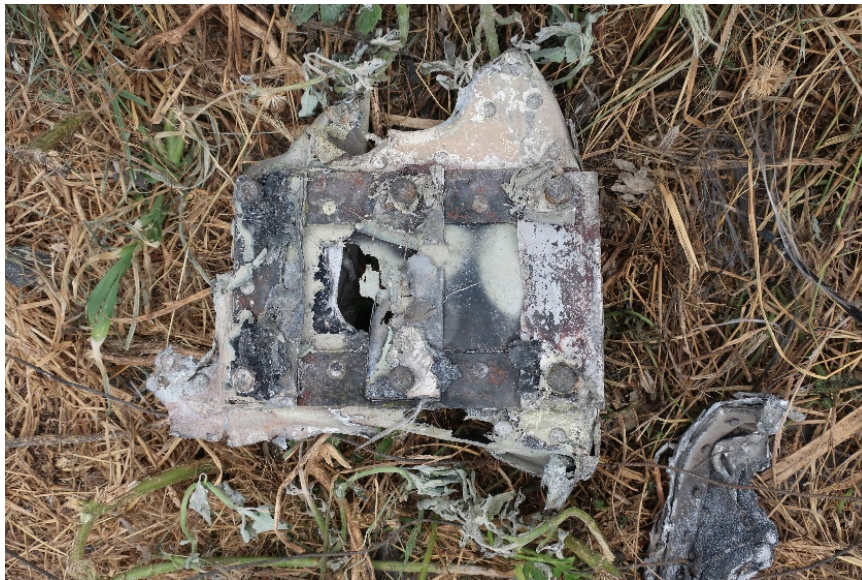
The right rear horizontal stabilizer stub had broken at the skin of the fuselage and the inboard portion remained bolted to the bulkhead. The horizontal stabilizer in general from the area had been consumed by fire. (See Figure 52)

Figure 52. Attachment of right horizontal stabilizer rear spar stub to airplane bulkhead. (Photo from: Swaim)

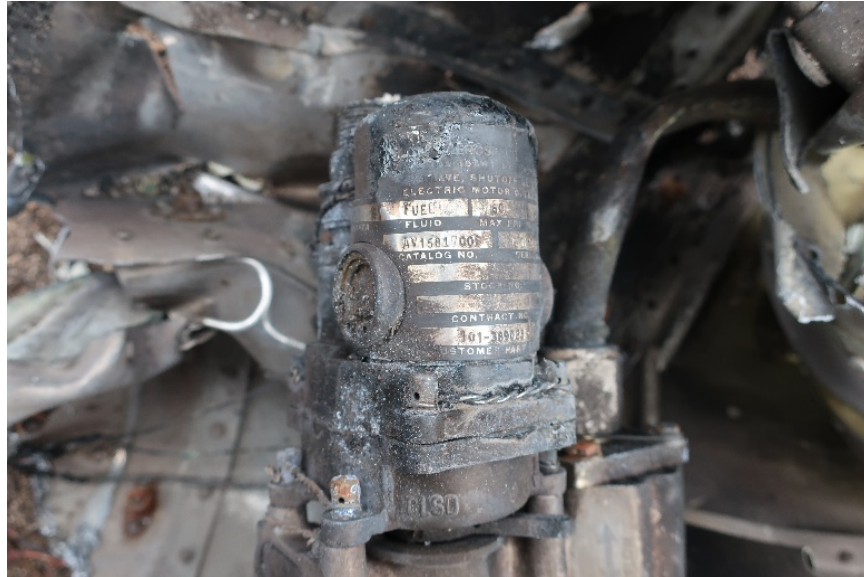
The fuel system components were in areas of extensive fire damage. A left wing fuel shutoff valve was found with the valve in the open position. (See Figure 59)

Figure 59. Fuel shutoff valve found in open position. (Photo from: Swaim)

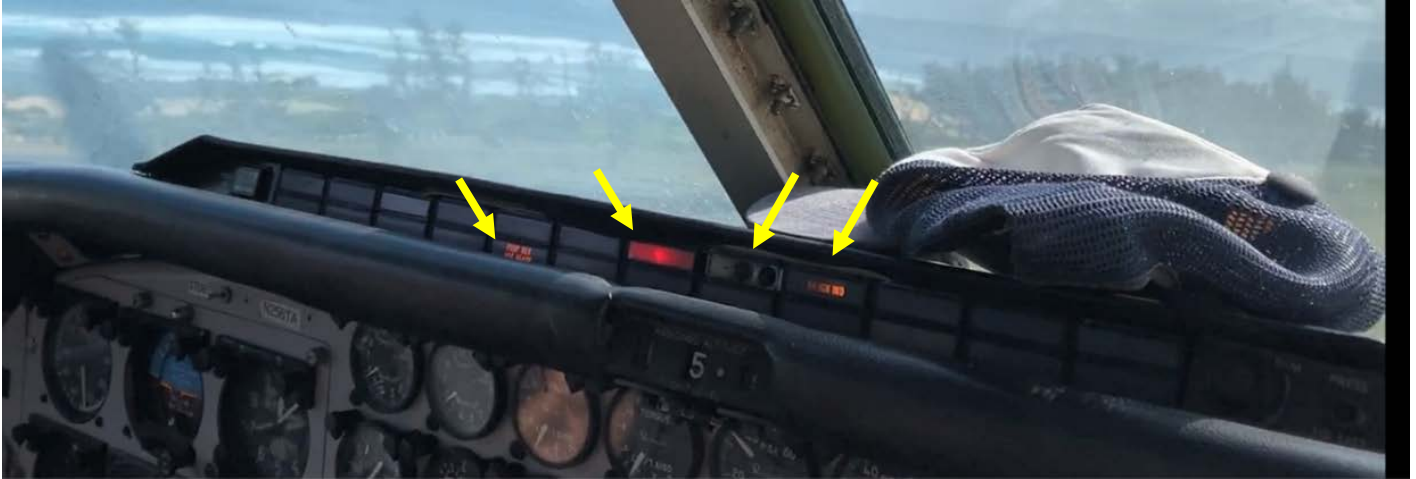
Figure 66. Annunciator panel during the landing approach on a previous flight obtained from public response to a request for photos and videos. (Photo of video from Kade)

- PROP REV NOT READY (Amber)
 - Propeller levers are not in the high rpm, low pitch position.
- CABIN DOOR (Red)
 - Cabin door open or not secure. (Open for parachute operation.)
- ALT WARN (Missing annunciator) (Amber)
 - Cabin altitude exceeds 10,000 ft. (Pressurization system components were removed per FAA form 337 – System inoperative for parachute operations.)
- RH IGN IND (Amber)
 - Right ignition and start switch are in the ignition and start mode or the right auto-ignition is activated.

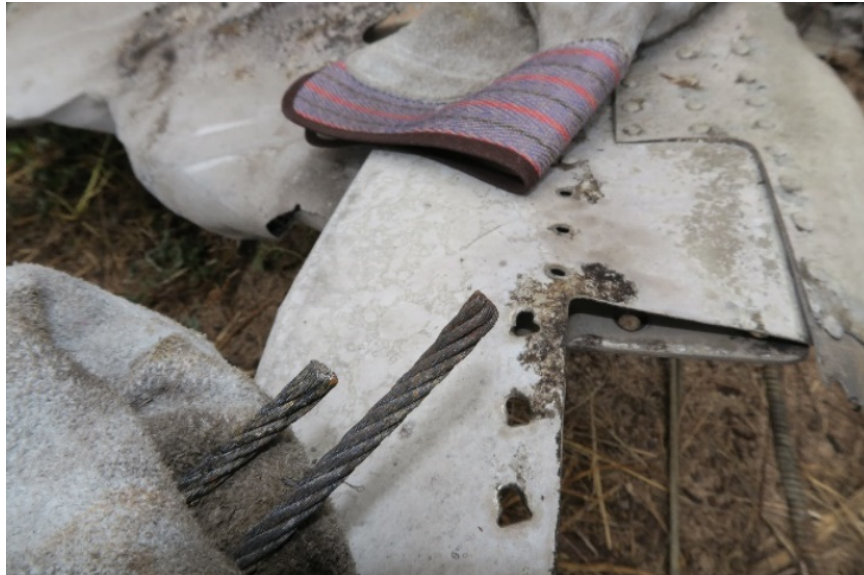
The right wing aileron control cables and a flap Teleflex cable were found cut consistent with victim recovery. (See Figure 77)

Figure 77. Post fire cut right wing aileron control cables. (Photo from: Textron)

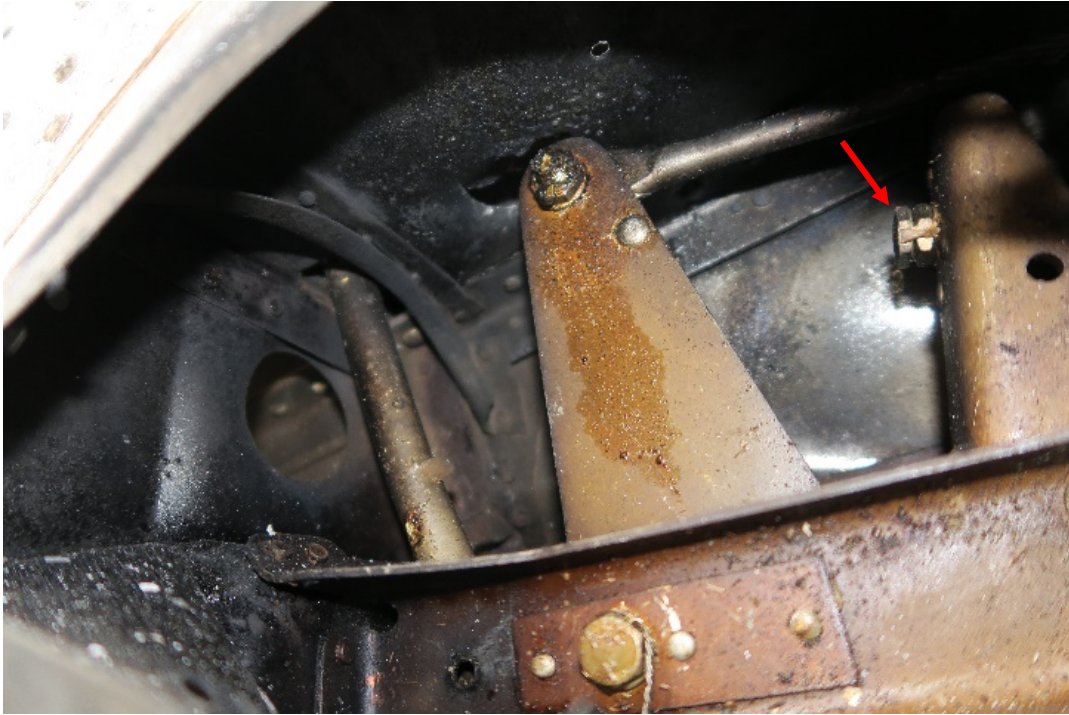
Figure 78. Left wing aileron control aft stop bolt found adjusted to seat. (Photo from: Textron)

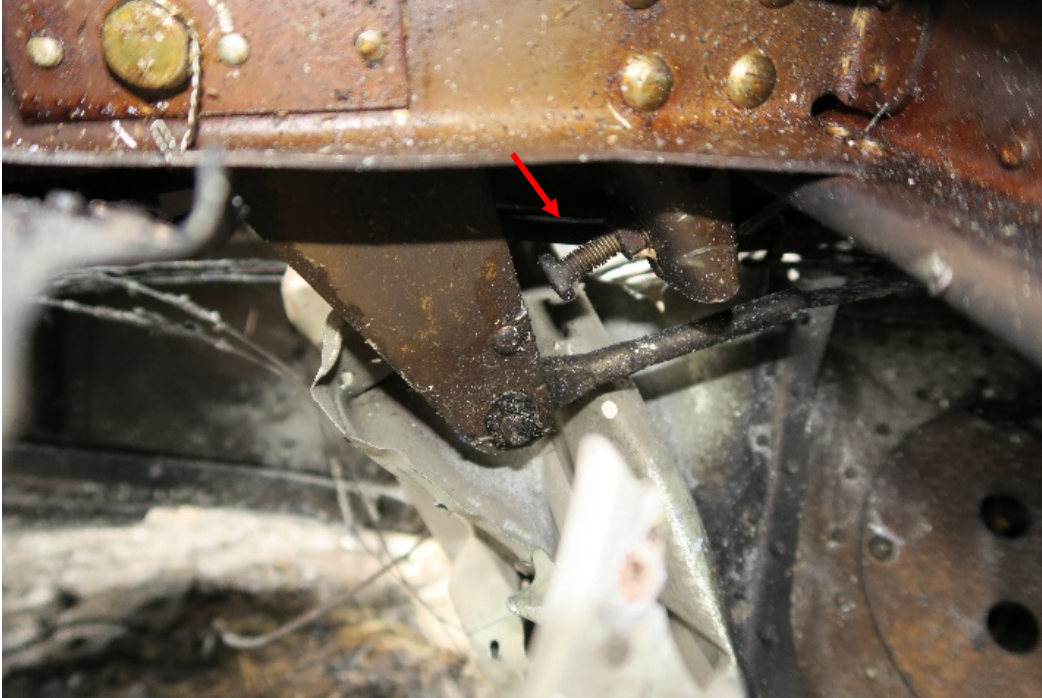
Figure 79. Left wing aileron control forward stop bolt found fully extended. (Photo from: Textron)

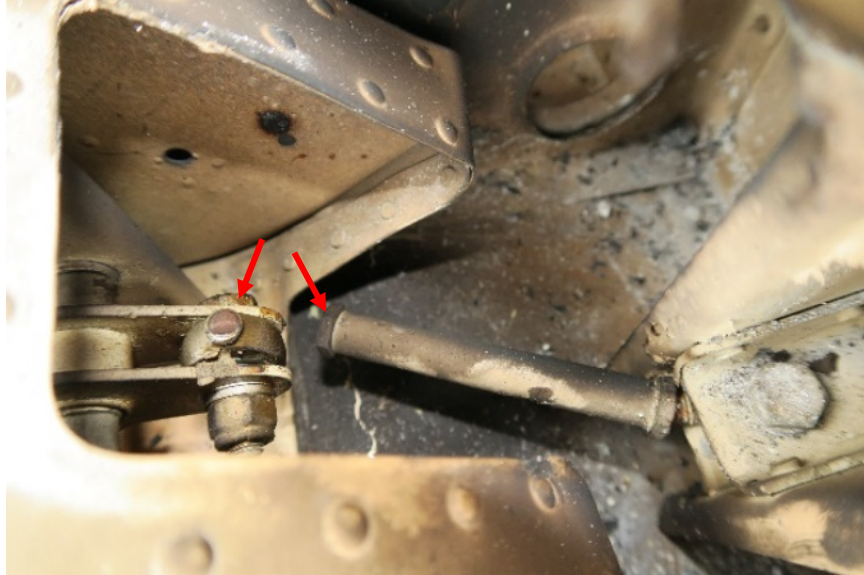
The right wing aileron tab anti-servo rod assembly was found broken and the fracture was covered with fire residue. (See Figure 81)

Figure 81. Right aileron tab anti-servo rod assembly with red arrows indicating the fracture surfaces (Photo from: Textron)

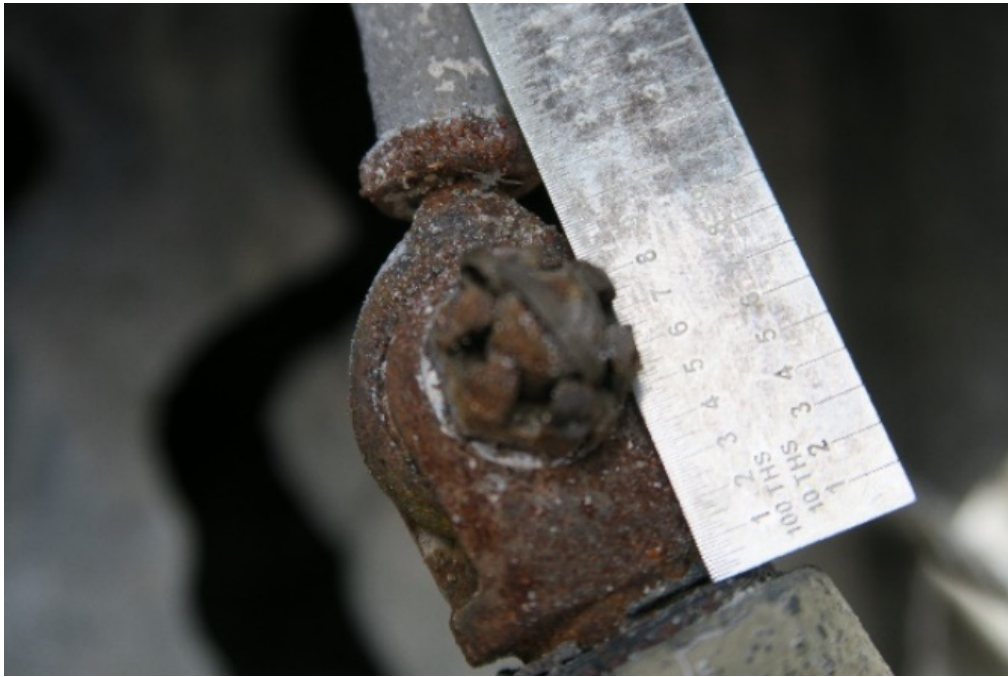
Figure 85. The aileron trim mechanism in the left wing was found extended 0.65 inches, corresponding with the position of the cockpit knob. (Photo from: Textron)

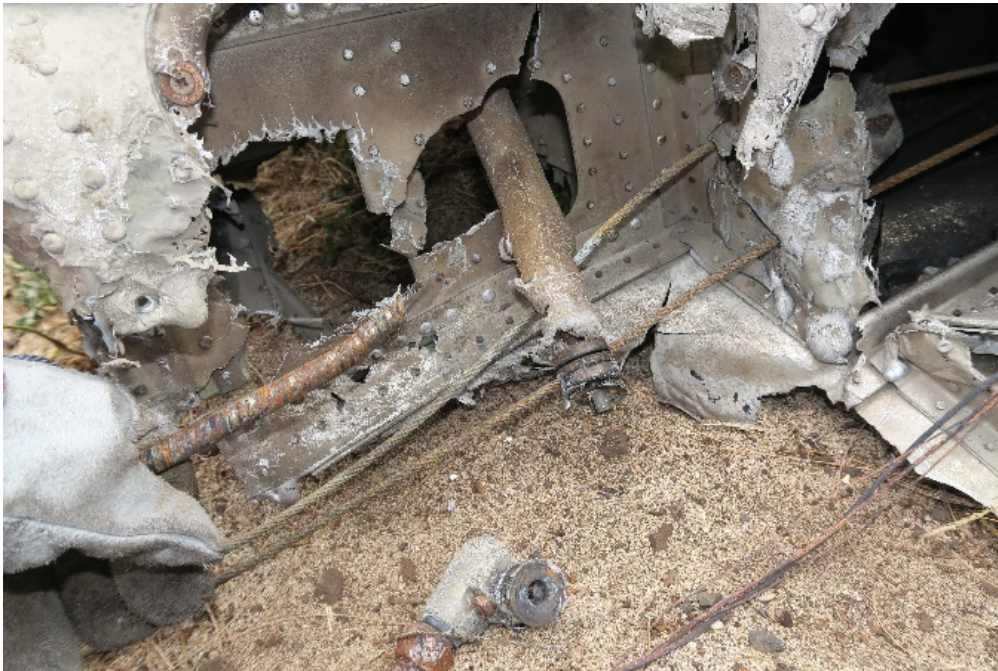
Figure 91. Broken outboard right flap actuator. (Photo from: Textron)
