Engine Failure Investigation for N298DM

Location: Rouge River Near Galice, OR Date & Time: May 31, 2022, 09:28 Local
Registration: N298DM Aircraft: Experimental RV-8 Injuries: 0 / Occupants: 2 Flight Conducted Under:
Part 91: Private Flight.

A detailed investigation was carried out November – December 2022 at Rogue Aviation NW's Hangar at [REDACTED] Grants Pass, OR By Corey Mosley A&P [REDACTED]

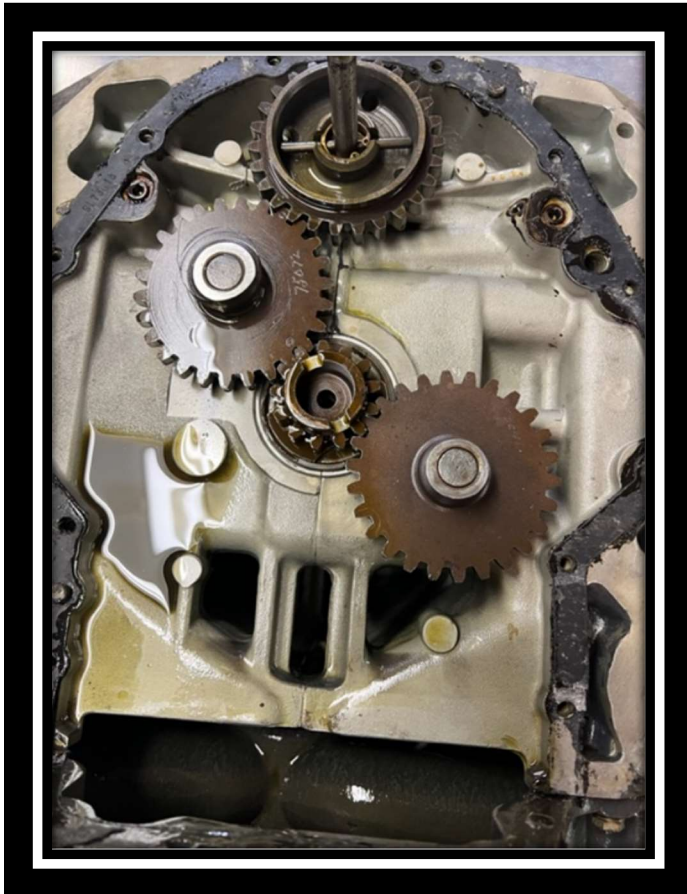
- Lycoming Engine Model: O-320-E2D SN: L-20351-27A
- Removed engine from aircraft and installed on vertical mounted engine stand.
- Remove accessory cover from the aft end of engine.
- See below pictures of engine accessory gears, as removed no did center drive gear was missing retaining bolt from center.
- Removed both Magneto drive gears.

- Removed center crankshaft drive gear, found alignment pin damaged and sheared off, drive gear mounting flange on end of crankshaft also damaged and material missing.
- Found mounting flange steel crankshaft debris in oil sump, missing bolt was not found.
- Oil residue/discoloration present around missing hold down bolt hole on crankshaft center gear bolt indicating bolt may have been missing or not installed since overhaul the prior 98 hours Total aircraft flight and engine time since install.

In my professional opinion after inspecting this aircraft, I Corey Mosley have believe the Root cause of this accident was a mechanical failure of the engine due to the missing bolt in the crankshaft drive gear. The missing Bolt caused the crankshaft gear alignment pin to prematurely fail causing the rotating assemblies to suddenly stop causing the engines no longer providing power and forward thrust to the aircraft resulting of the emergency ditching of the aircraft into the Rogue River.

Figure 1 Crankshaft Gear Missing Hold Down Bolt, Image of gear assembly immediately after accessory cover removed.

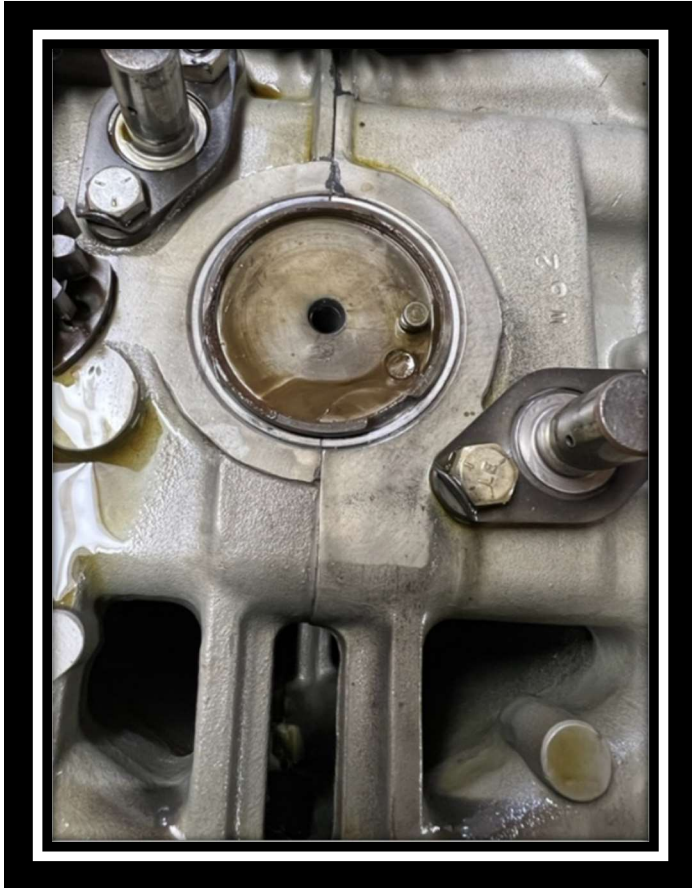
Figure 2 Crankshaft Gear Alignment Pin Sheared off.

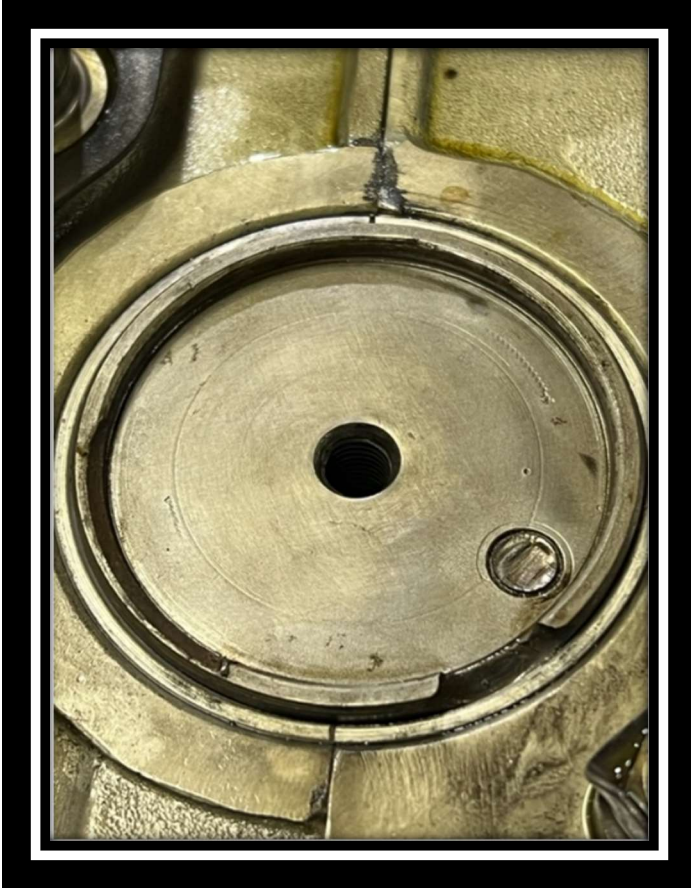
Figure 3 Close Up View of Gear Alignment Pin Sheared off and Missing Crankshaft Machined Gear Boss.

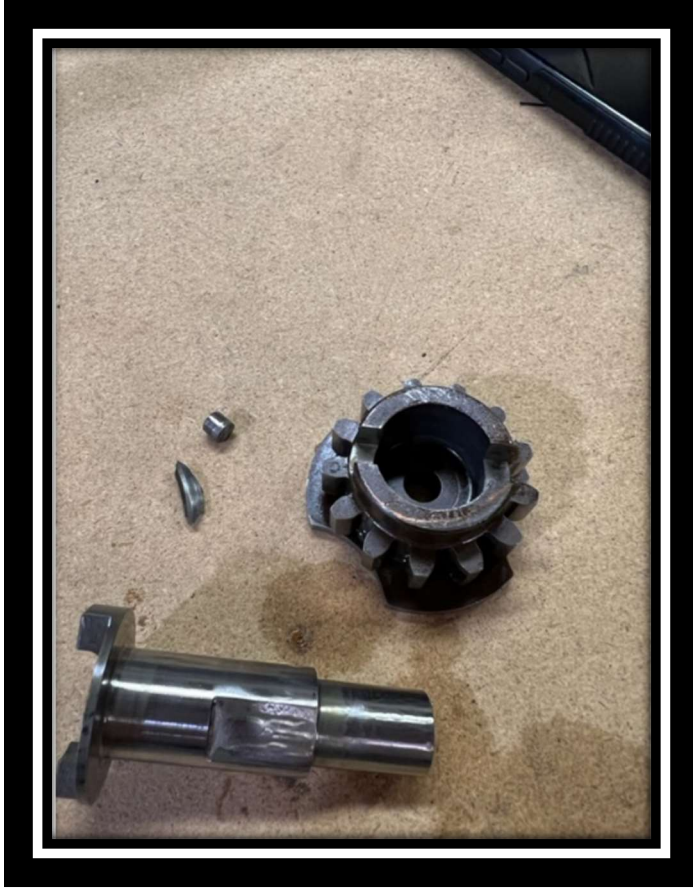
Figure 4 Center Crankshaft Gear, Oil Pump Drive shaft, Sheared Gear Alignment Pin and Material from damaged Crankshaft machined Gear Boss.

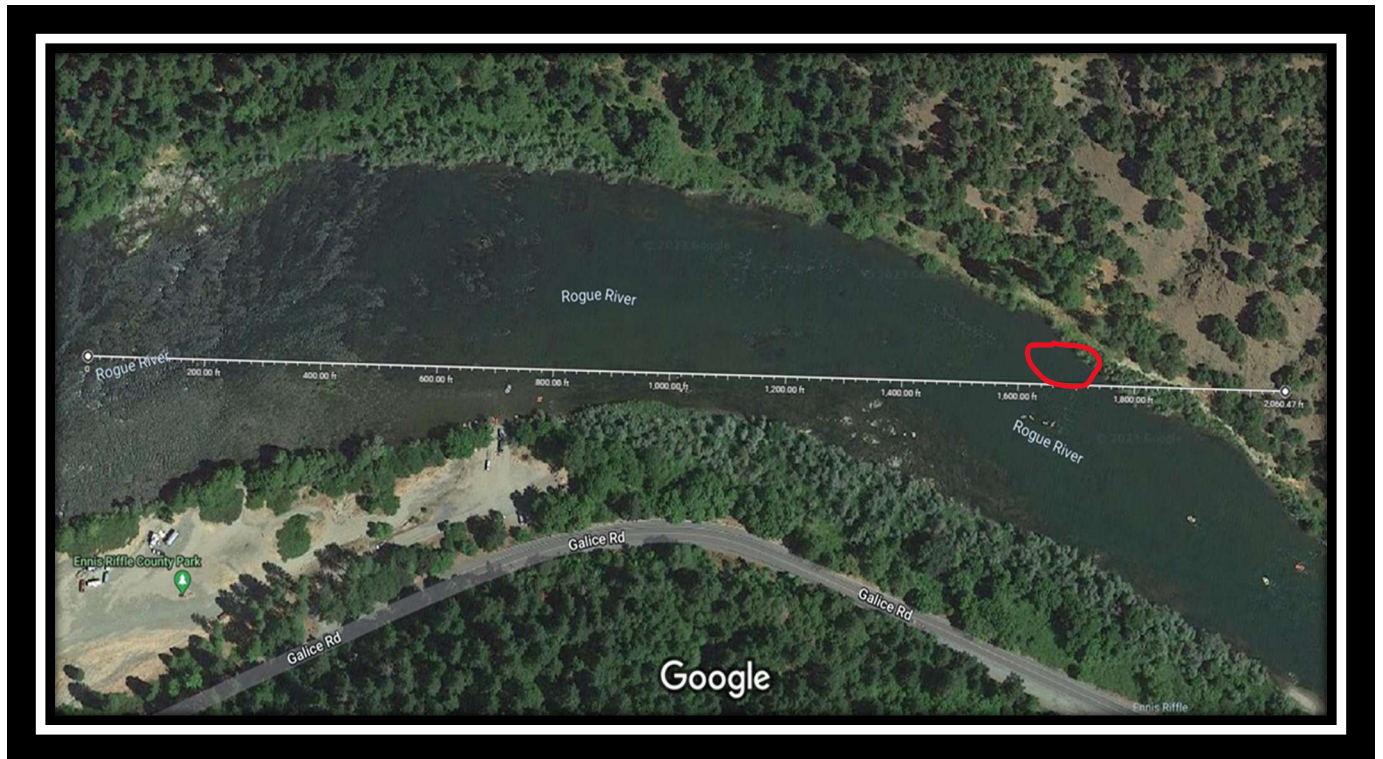
Figure 6 N298DM Came to rest near the 1800 FT mark on this Image.
