NTSB File No. CEN23LA107

Hartzell Air Safety Investigator Field Report

Accident Date: February 12, 2023
Location: Lakeway, TX
Aircraft: Mooney M20K
Aircraft Registration: N304MA
Aircraft Hobbs: 2763.7

Propeller & Turbo Examination

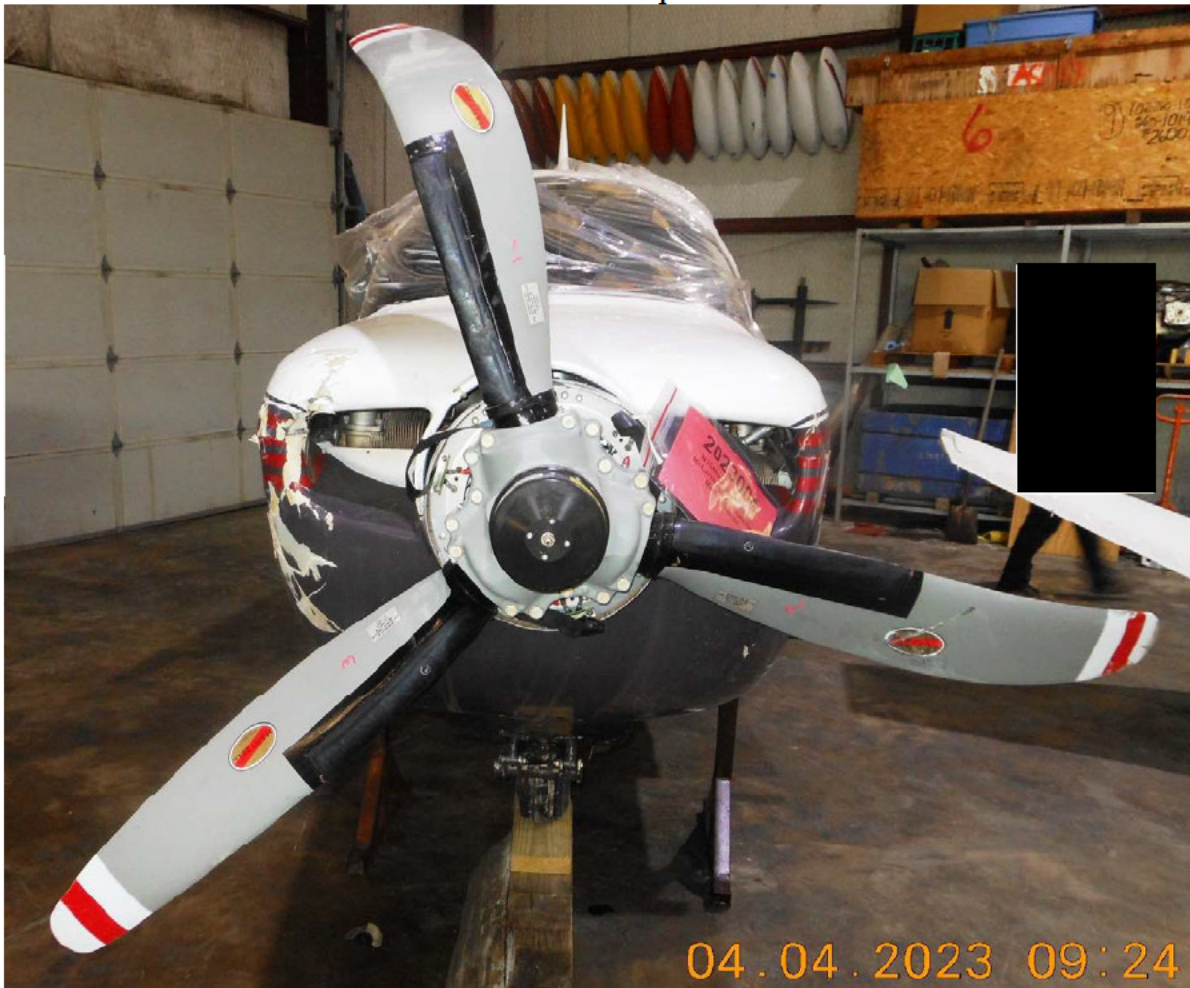
Photo #1 – Propeller

The propeller was not removed from the engine/aircraft for further examination. Blade #1 was bent aft with no remarkable twisting. It had some chordwise/rotational abrasion on the camber side. Blade #2 was bent aft to a lesser degree than Blade #1 and had no remarkable twisting. There was some chordwise/rotational abrasion in the mid-blade region. The abrasion on both Blade #1 and #2 transitioned from chordwise/rotational to spanwise. Blade #3 was bent aft the least amount with no other remarkable damage.

The propeller damage was consistent with a propeller windmilling with power OFF when it struck objects. There were no discrepancies noted on the propeller that would prevent or degrade normal operation. All damage was consistent with high impact forces.

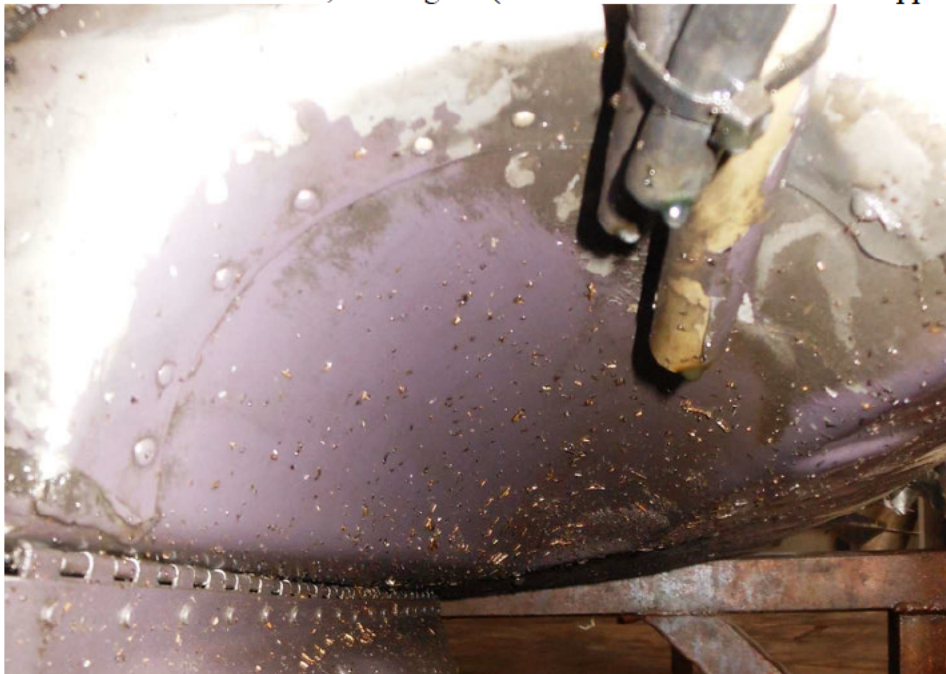
Photo # 2 – Left exhaust tunnel, looking aft (breather and drain tubes seen upper right)

The bottom of the fuselage was wet with oil starting aft of the cowling, behind the left cooling exhaust tunnel continuing to the tail bulkhead. The origin appeared to be from the engine breather and drains hoses in the left cooling exhaust tunnel (Photo #2). The engine/turbo exhaust exited the right tunnel that appeared dry (Photo #3). The exhaust tailpipe internal surface appeared dry with no indication of excessive oil in the exhaust flow. The engine oil dipstick was removed and only had one small drop of oil on the tip.

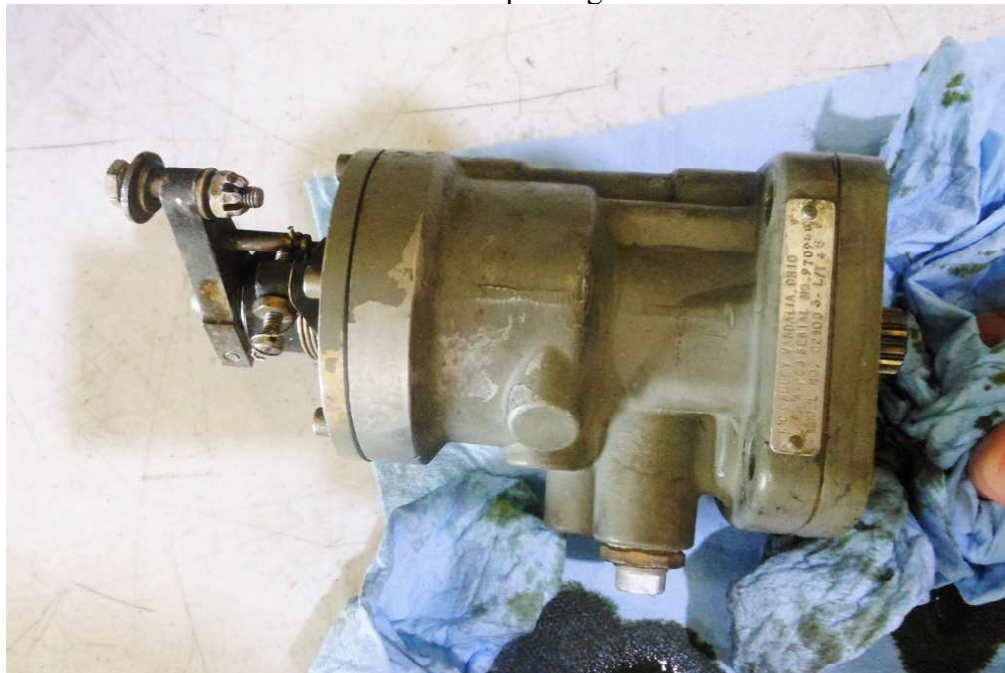
Photo #4 – Propeller governor

There were no indications of oil leaking from the propeller, propeller mounting flange or governor and governor mounting pad. The governor was removed and the pump shaft rotated smoothly by finger force and produced gurgling sounds (Photo #4). The governor control arm rotated smoothly. The governor gasket screen was clear/no debris.

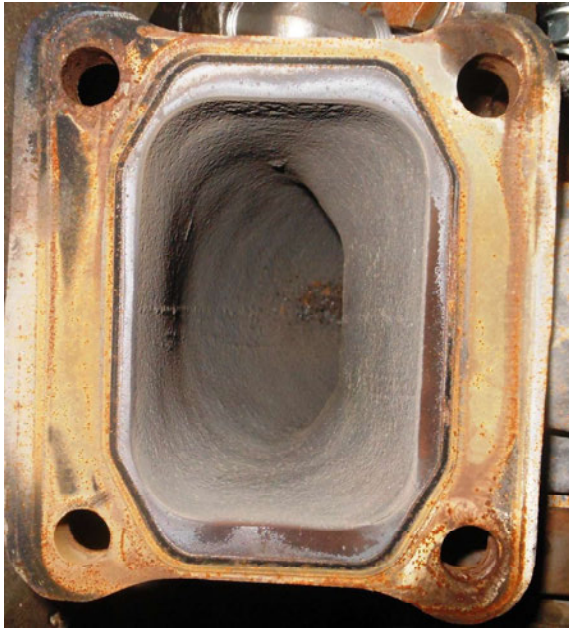
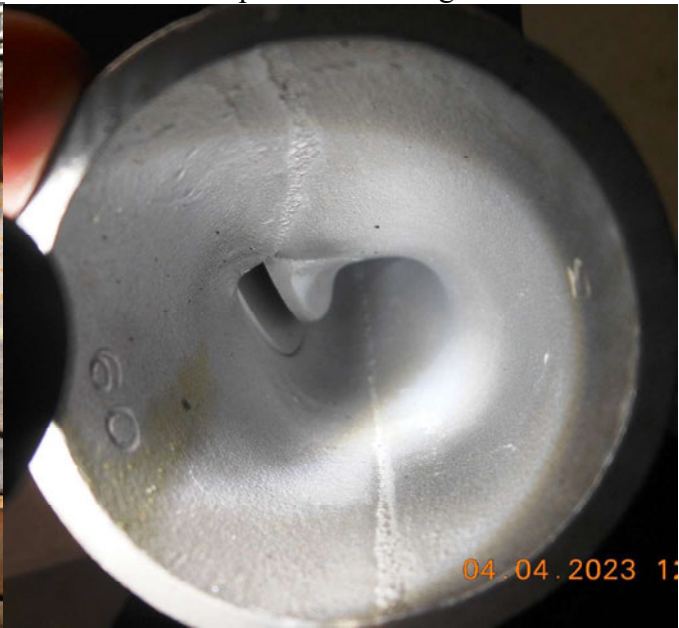
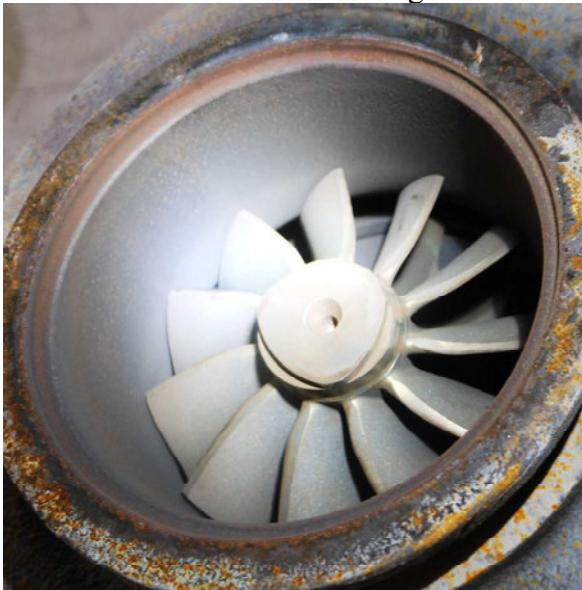
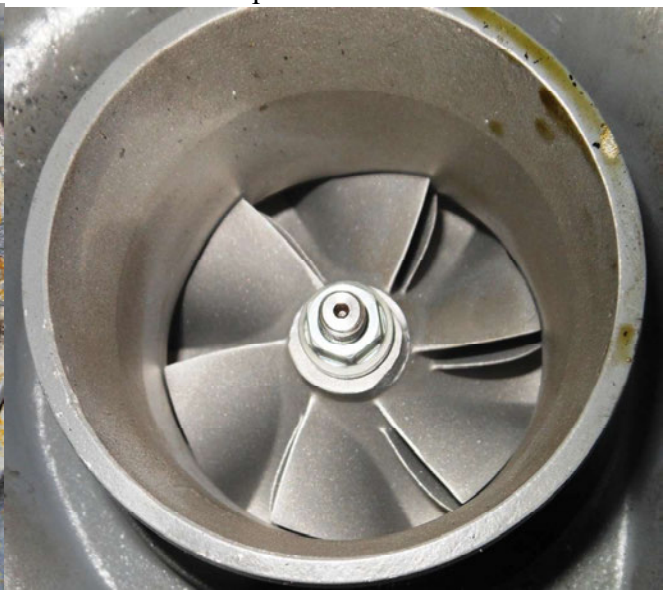
Photo #5 – Turbocharger

The turbocharger appeared intact and undamaged. All oil hoses to/from the turbo appeared secure with no evidence of oil leaks. There was no excessive residual oil in the turbo Center Housing. The turbo compressor inlet, compressor discharge, turbine inlet and turbine exhaust were dry with no evidence of an oil leak (Photo #5). There was no evidence of oil leaking into the intercooler or intake manifold. The turbine wheel spun freely and smoothly by finger force showing continuity to the compressor wheel with no remarkable lateral or longitudinal freeplay. The turbo was not disassembled for further examination.

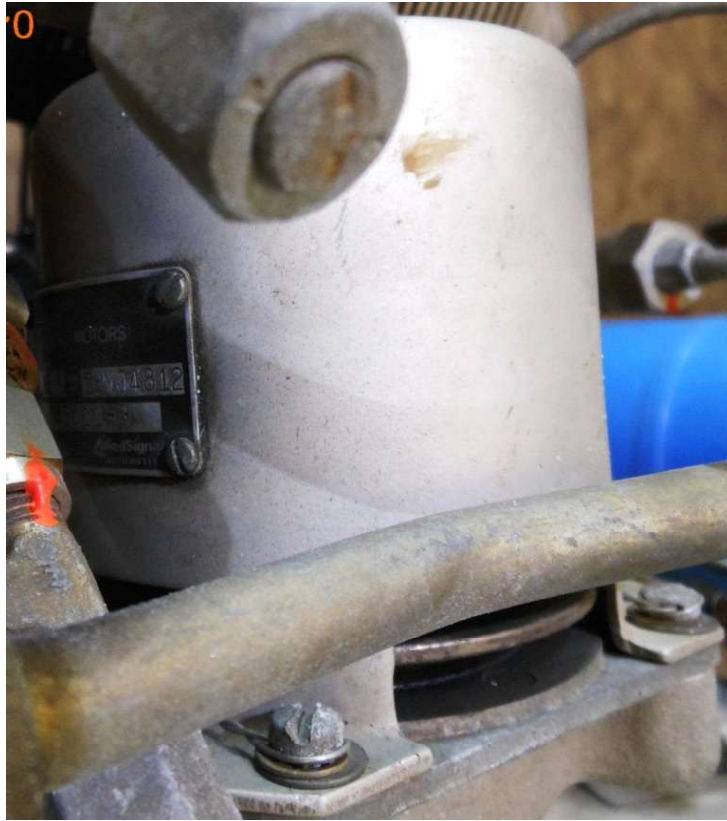
Photo #6 – Pressure Relief Valve

The PRV appeared undamaged (Photo #6) and was removed from the intake manifold/upper deck. The PRV valve head was actuated by hand/finger force; it moved smoothly without binding and returned to the closed position by the internal spring force.

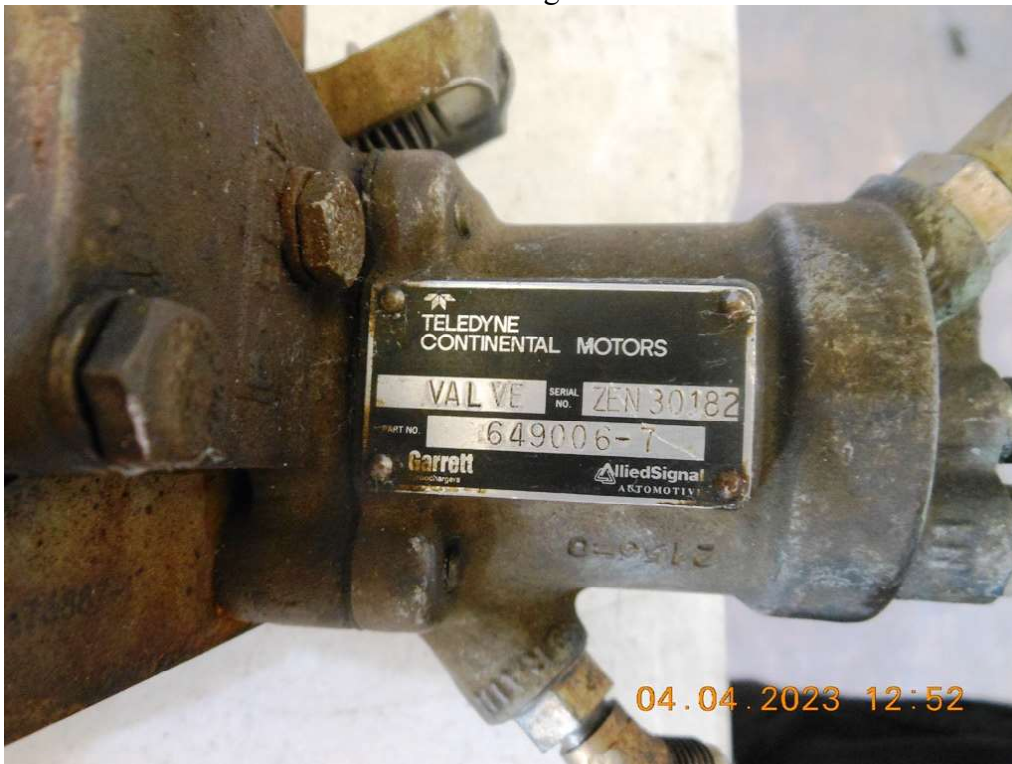
Photo #7 – Wastegate actuator

The wastegate and actuator were removed from the exhaust assembly and actuated with shop air. It actuated smoothly, freely and returned to the open position without assistance and no signs of sticking (Photo #8). There was no evidence of oil leakage on the actuator body (Photo #7).

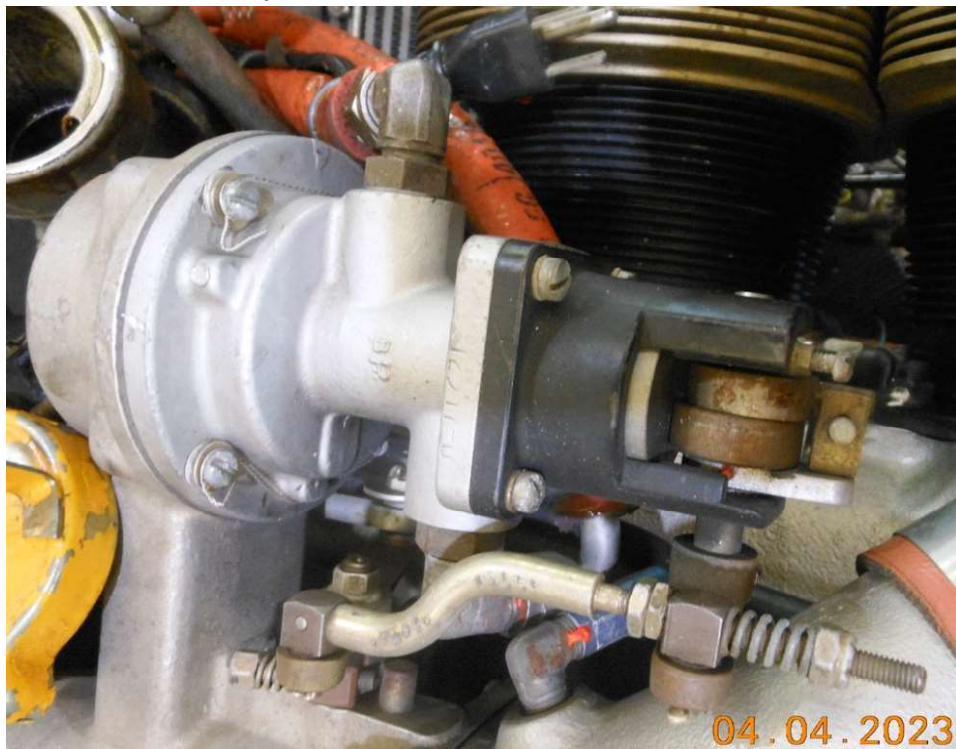
Photo #9 – Variable Absolute Pressure Controller

The Variable Absolute Pressure Controller was not removed from the intake manifold/upper deck (Photo #9). The control arm rotated freely. There were no indications of oil leaking at the controller or any oil hoses between the controller and wastegate actuator.
