North Tarrant Express Mobility Partners Segments 3 LLC Party Submission

North Tarrant Express Mobility Partners Segments 3 LLC Proposed Findings & Recommendations

NTSB Accident File:	WHY21FH005
Incident:	Multi-Vehicle Crash
Date of Incident:	February 11, 2021
Location of Incident:	Fort Worth, TX
Date of Submission:	May 10, 2022

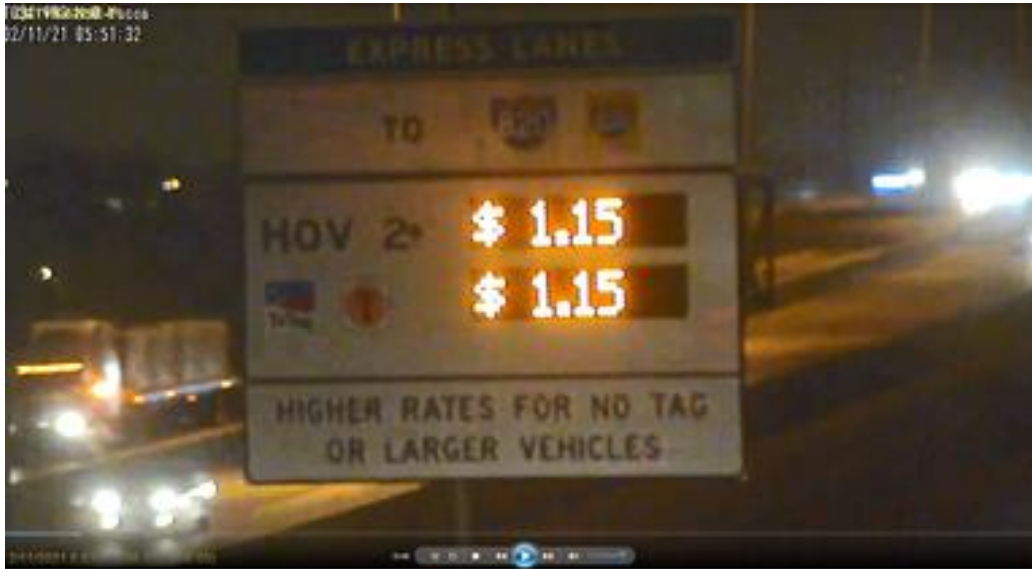
5:51 a.m.:

The observations of NTEMP S3 maintenance technicians is consistent with video footage showing that it began to rain in the area of the accident at approximately 5:57 AM.⁵⁰

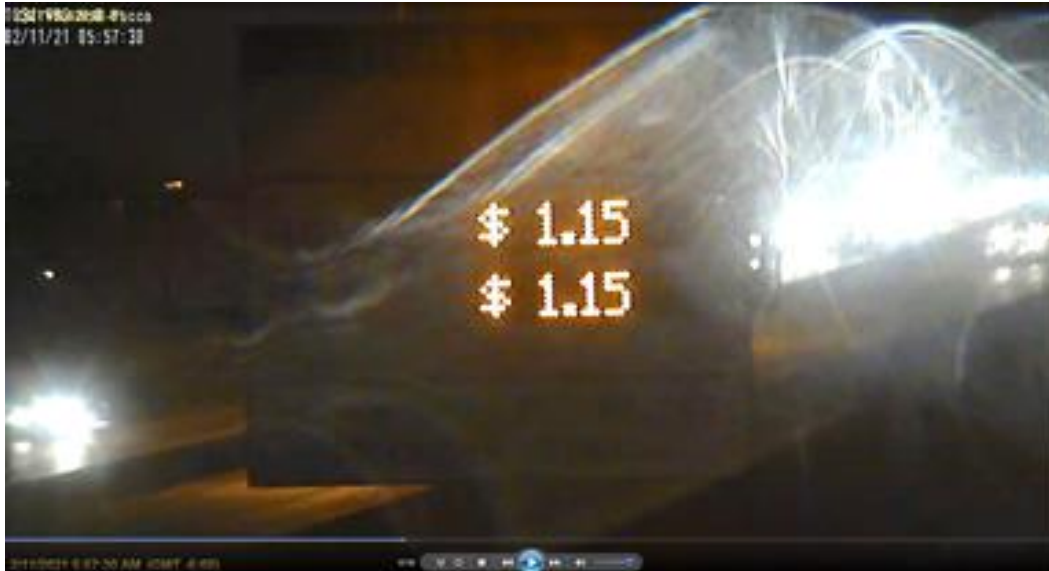
5:57 a.m. (Note halo effect of rain on camera lens):

⁵⁰ Accident video 1559_5229_20210211_0550-610.mp4. Camera is north of Yucca/Northside facing the stretch of road of the incident (SBML towards the camera). A halo effect on camera lens (indicating rain) starts at 5:57:19; slippery pavement confirmed by a spinning semi-truck at 6:00:16 (SB GPL); a semi-truck fish tails at 6:01:25 (SB ML); car fishtails at 6:04:07, 6:04:21, 6:06:54, etc.

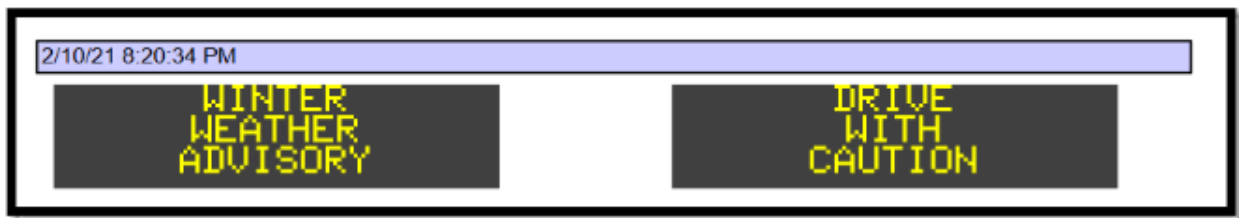
NTEMP S3 also employs Dynamic Message Signs (“DMS”). During this weather event, NTEMP S3 coordinated with TxDOT to ensure that consistent signage was being displayed in the area. Following a call from TxDOT, at 8:20 p.m. on February 10, these signs displayed the cautionary message “WINTER WEATHER ADVISORY” and “DRIVE WITH CAUTION.”

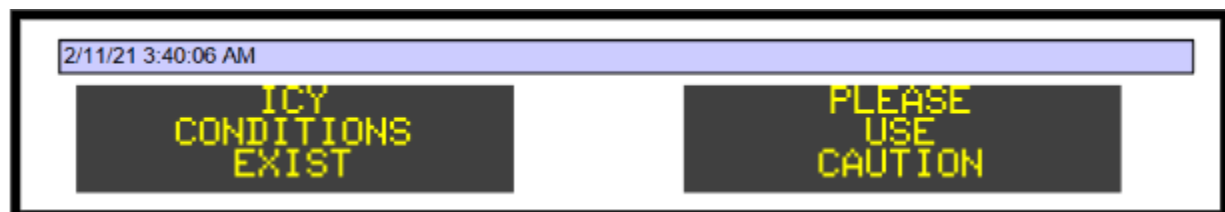
At approximately 3:40 a.m., more than two hours before the accident, the DMS boards for the south-bound tolled lanes displayed the message “ICY CONDITIONS EXIST” and “PLEASE USE CAUTION.”

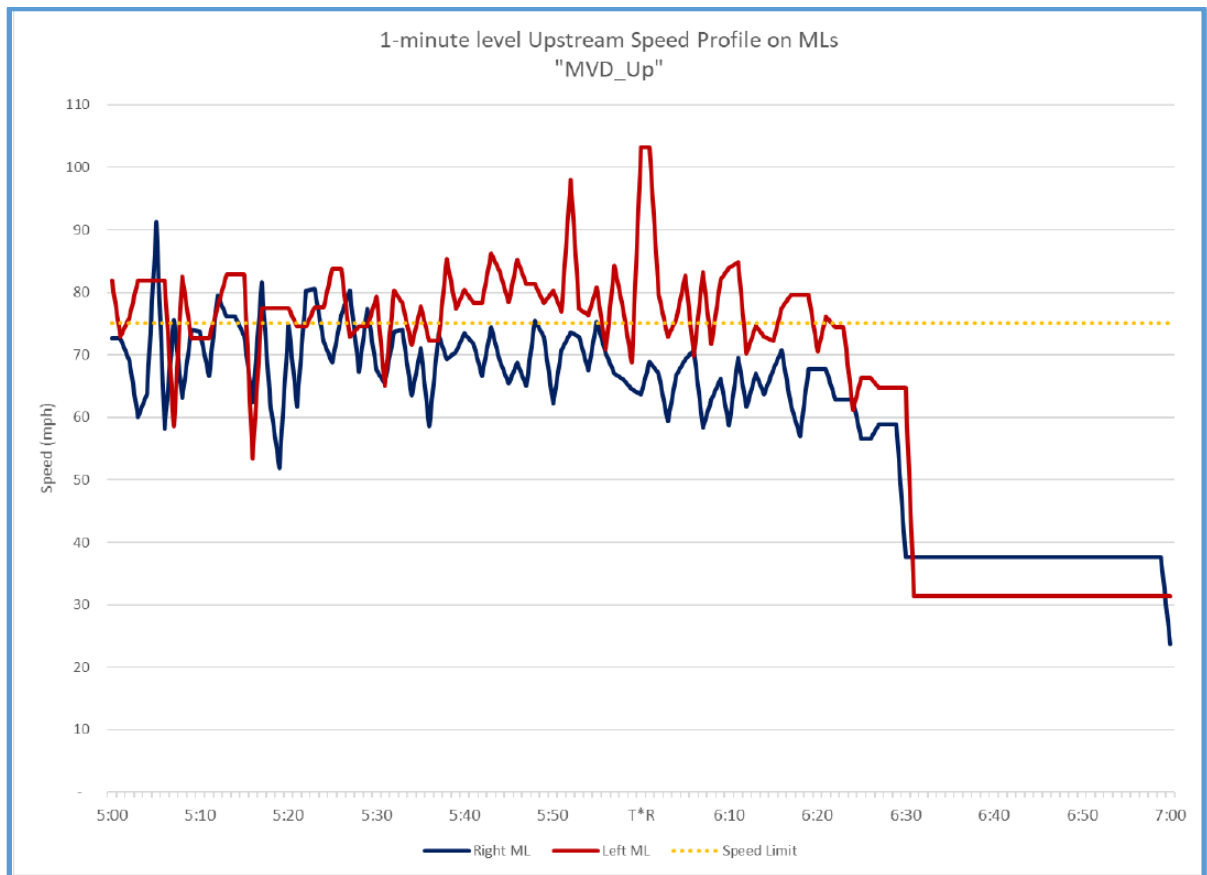
In the below graph of this data, the 1-minute average speeds in the left lane, as the traffic was approaching the area of the accident, significantly exceeded the 75 mph posted speed limit. The average

speed in the left lane at one point less than 15 minutes before the accident, just as it started to rain, exceeded 100 mph.⁵⁷
