AIRPLANE & ENGINE EXAMINATION

WPR17LA104

Firebaugh, California

Lancair Evolution; N846PM

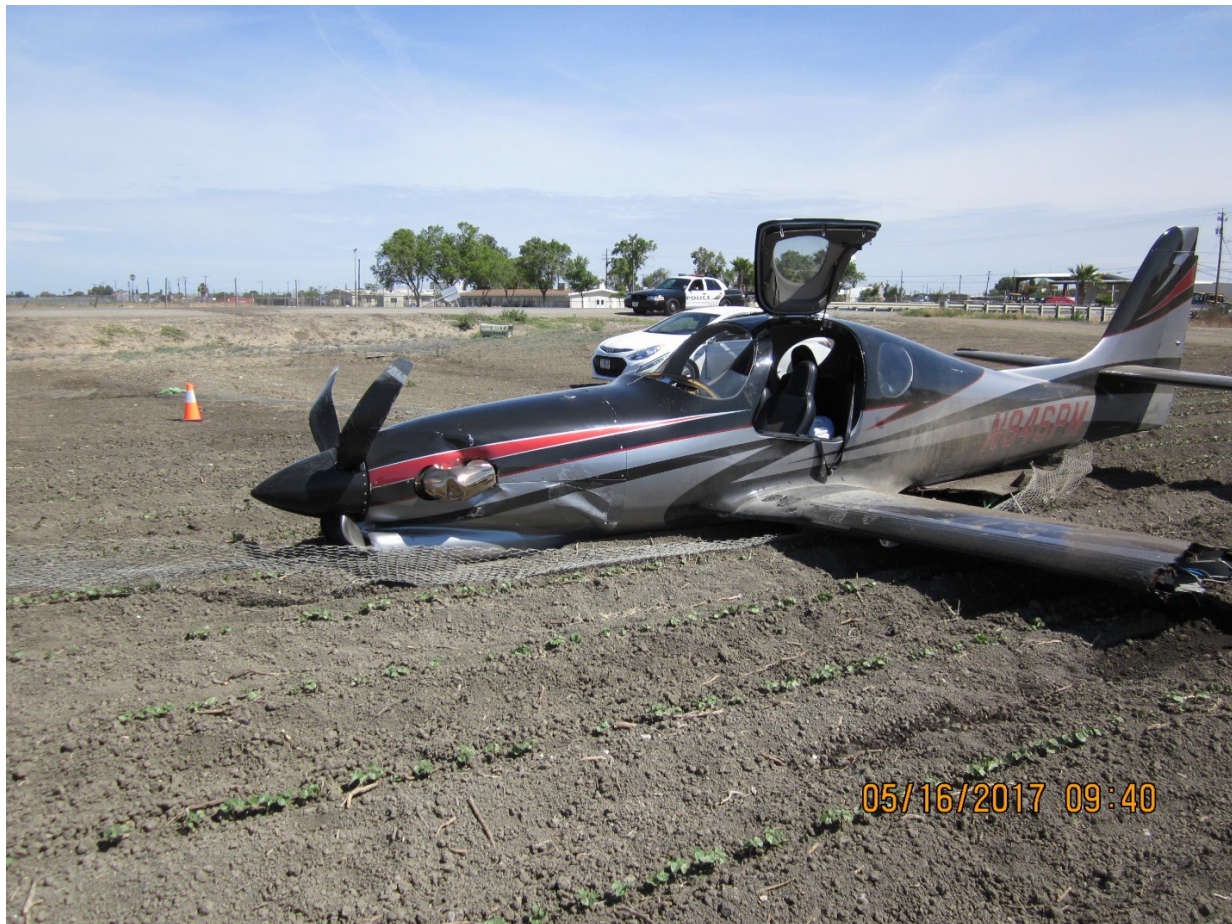
Postaccident examination by a Federal Aviation Administration inspector revealed substantial damage to both wings.

Photo 1: Airplane at rest at accident site
