**NATIONAL TRANSPORTATION SAFETY BOARD**

**AIRFRAME & ENGINE EXAMINATION REPORT**

**WPR18FA210**

**Mooney M20J – N56039**

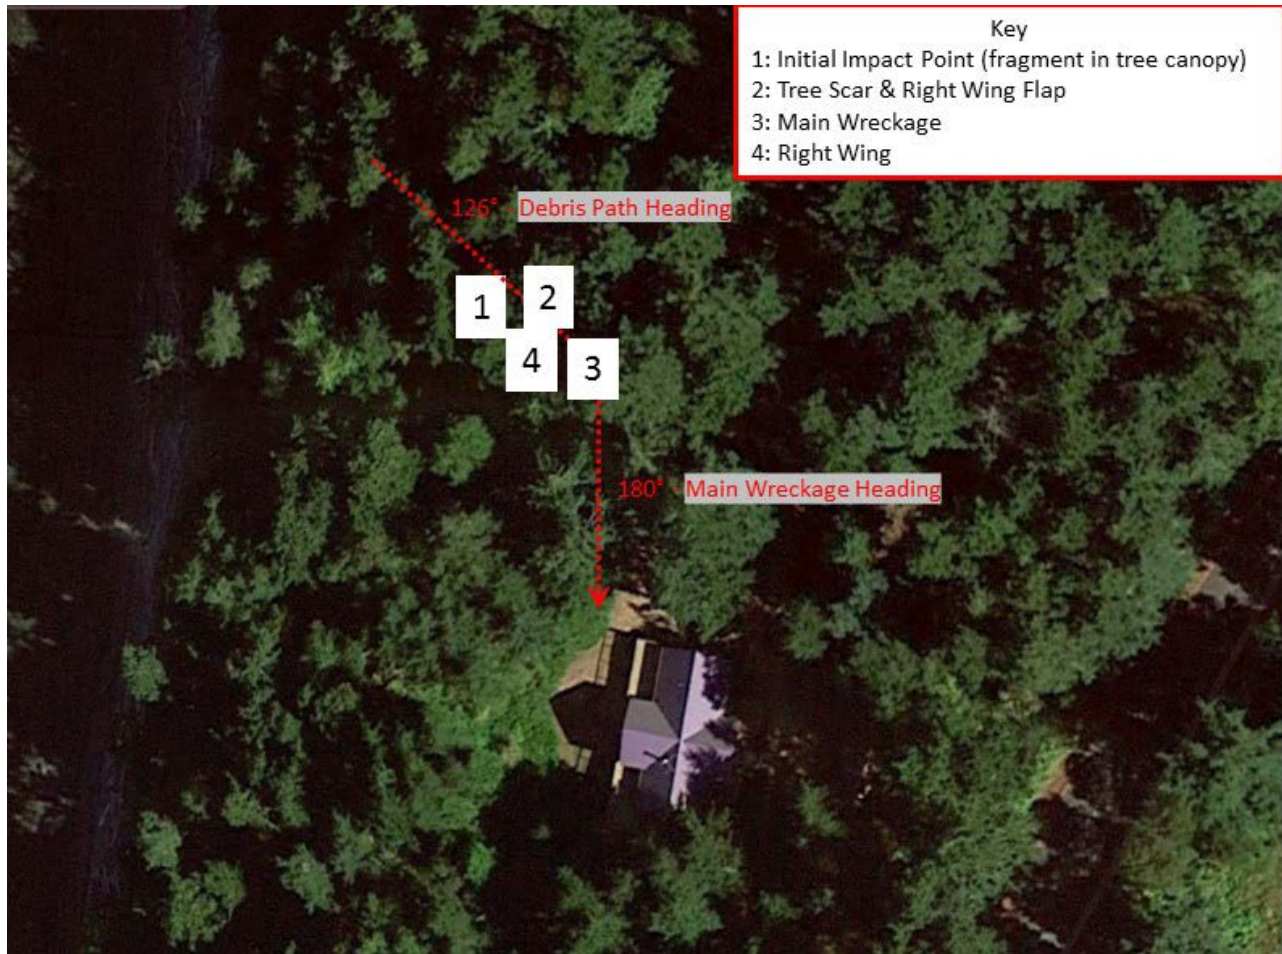
The airplane came to rest in wooded area about 400 ft from the shore. An initial impact point (IIP) was identified by an airframe fragment suspected to be the right wingtip about 100 ft up a tree. The orientation between the IIP and wreckage was 126°. A tree scar that measured about 5 ft in diameter was observed about 40 ft up a brown tree with yellow moss, which was collocated with the main wreckage (see photograph 1). The main wreckage, comprised of all major components, was oriented on a magnetic head of 180° and marked the end of the debris path (see photograph 2). Propeller blade A displayed twisting, bending, nicks, tip curling, and chordwise striations. Propeller blade B exhibited nicks, gouges, minor tip curling, and a slight bend at the blade root.

Photograph 1: Wreckage Diagram

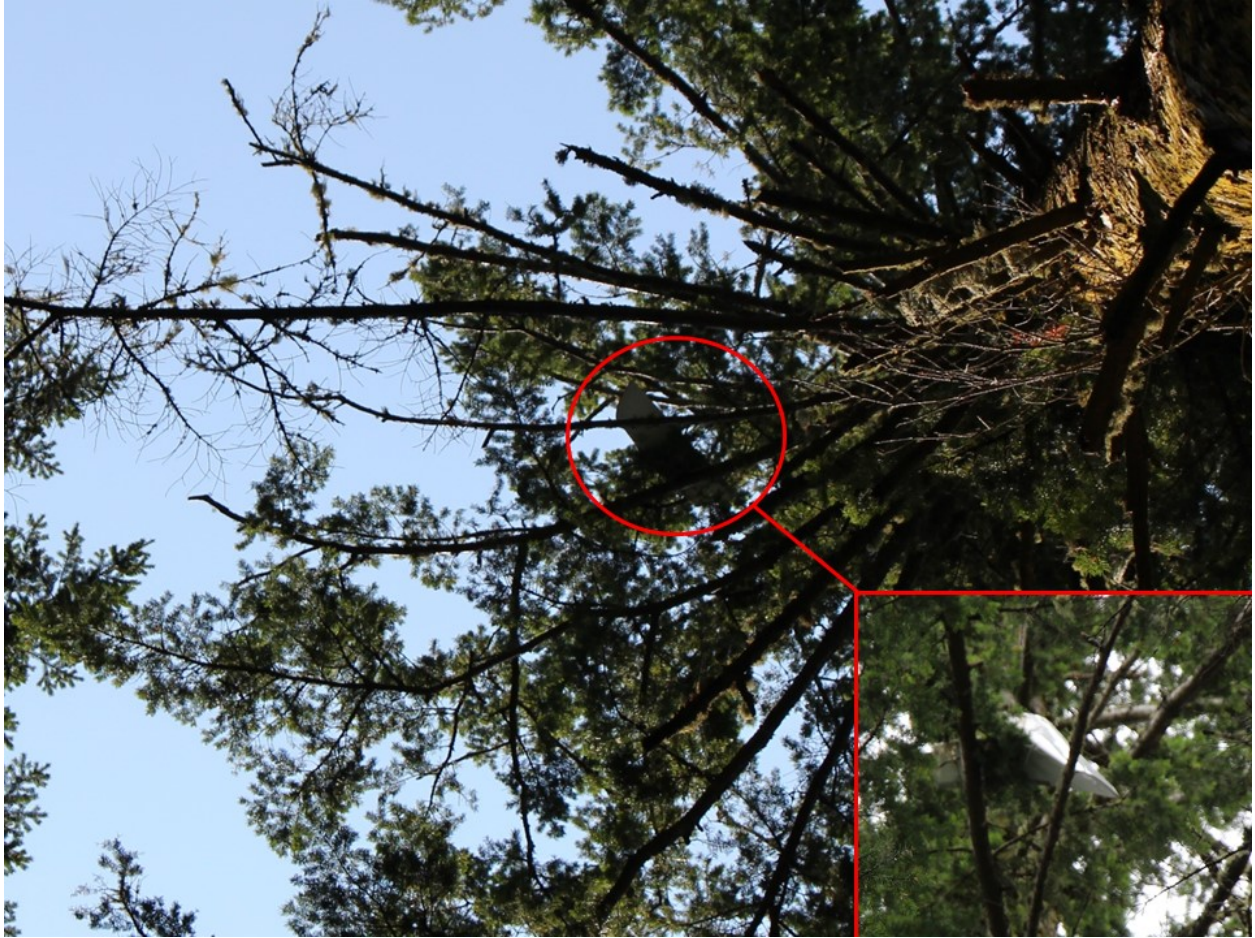
Photograph 2: Airframe Part in Tree Canopy

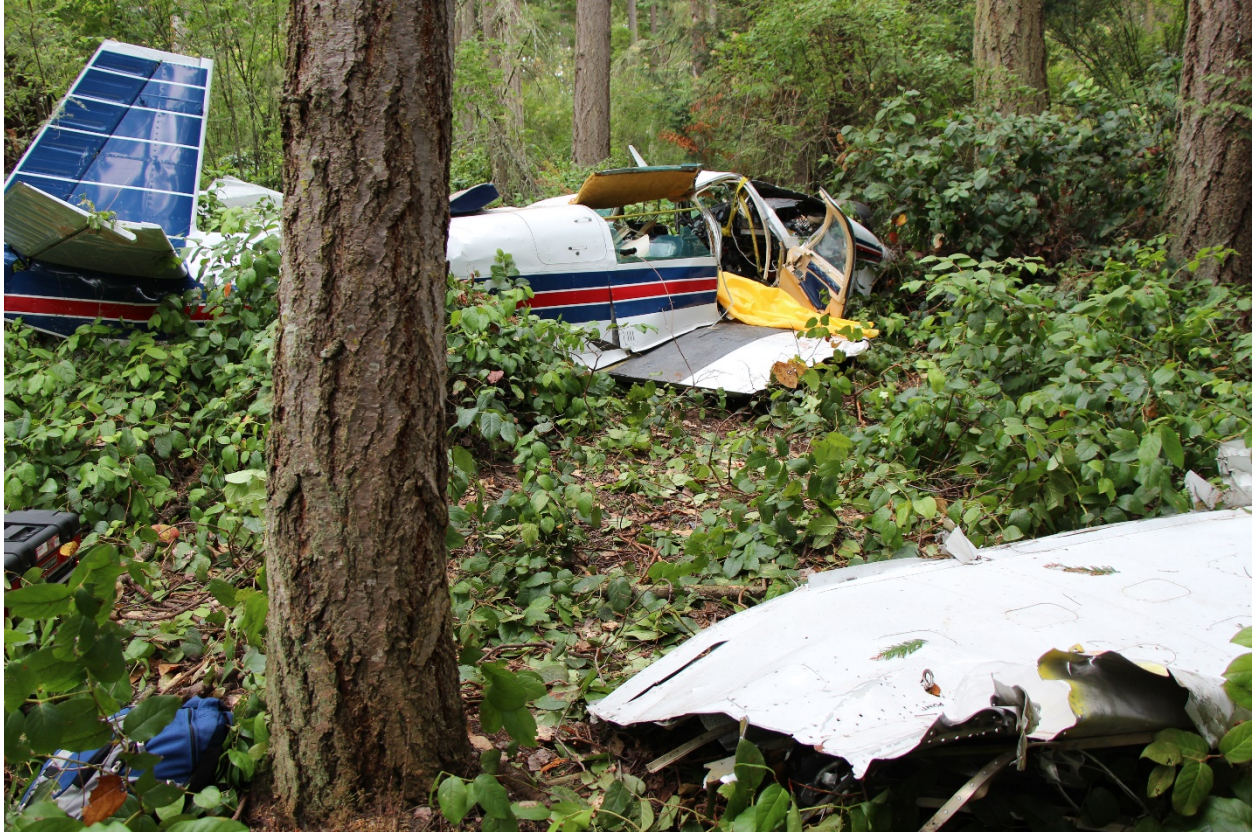
The right wing had separated inboard near the wing root, but came to rest inverted a few feet from the right of the main wreckage. A large gouge was observed at the leading edge about mid-span. The right wing position light was found about 20 feet to the right of the main wreckage, beyond the right wing. The wing flap had separated from the right wing, but was otherwise intact and in the debris path behind the main wreckage and collocated with the scarred tree. Both aileron attachment points were present and secured to the aileron, but aileron movement was restricted. The right wing top skin was torn aft and compressed and displayed a large brown and yellow transfer mark.

Photograph 3: Main Airplane Wreckage with Right Wing in Foreground

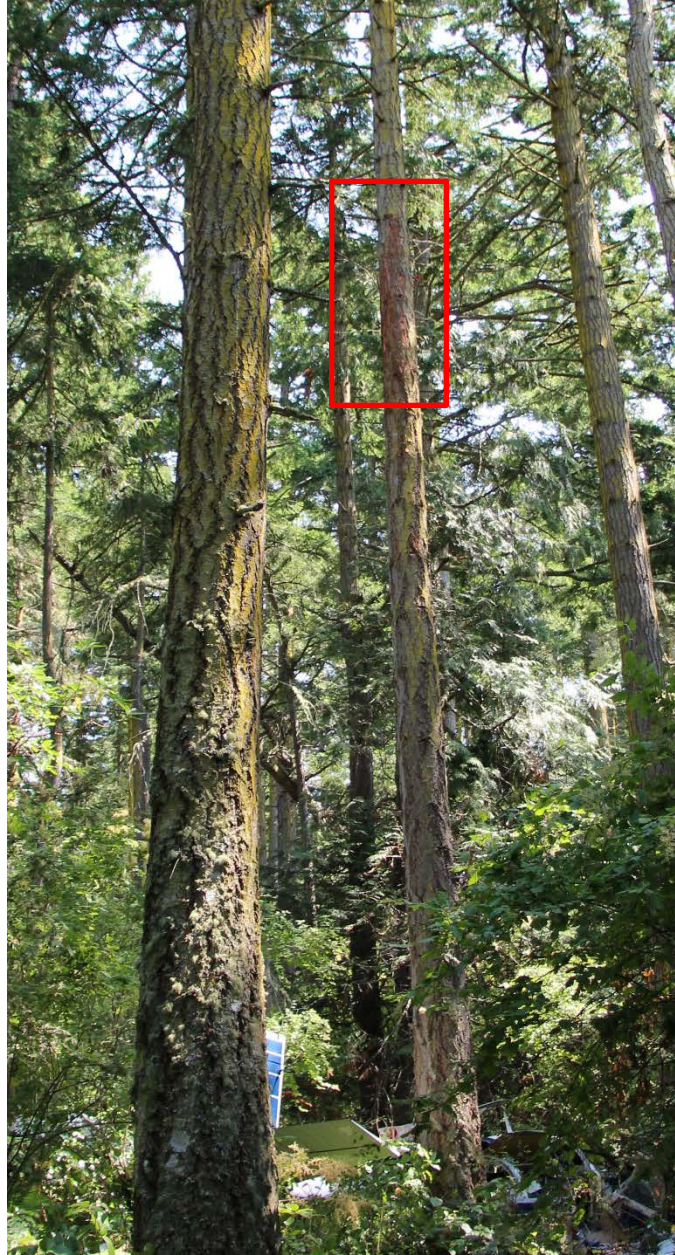
Photograph 4: Tree Scar

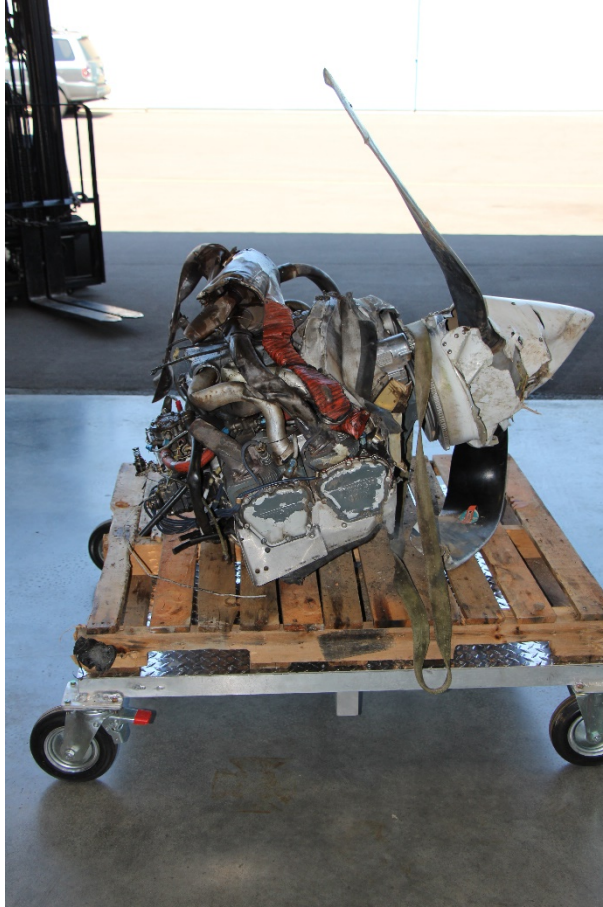
The bottom of the engine case absorbed most of the energy from the impact (see photograph 5). The spinner was crushed and the exhaust manifold was crushed aft. Both the cylinder no. 1 and 3 intake and exhaust tubes remained attached to their respective ports. The cylinder no. 2 and 4 exhaust tubes were displaced and the intake tubes were crushed aft.

Photograph 5: Engine with Propeller

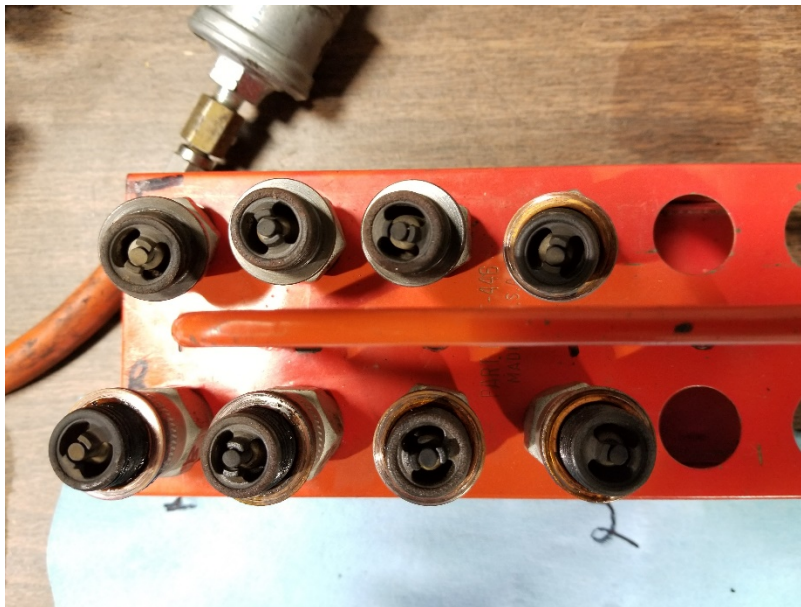
Continuity from the accessory case to the propeller was confirmed and valvetrain movement was continuous when the crankshaft was rotated by hand at the propeller flange. Intake and exhaust compression was observed for each cylinder through a thumb compression test. A borescope inspection of each cylinder did not show any abnormalities at the intake and exhaust valves. The spark plugs, manufactured by Champion, model RHM-38E, were normal in appearance when compared to the Champion Aviation Check-A-Plug chart (see photograph 6).

Photograph 6: Spark Plugs

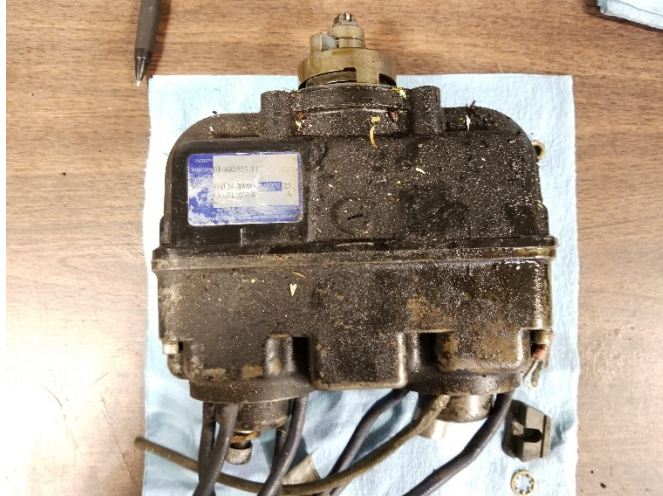
The magnetos, a dual-mag, single drive unit, was manufactured by TCM, model no. D4LN-3000 (see photograph 7). Each lead displayed spark when the magneto was rotated by hand. The oil pick-up screen was free of debris.

Photograph 7: Dual Mag Single Drive Magneto

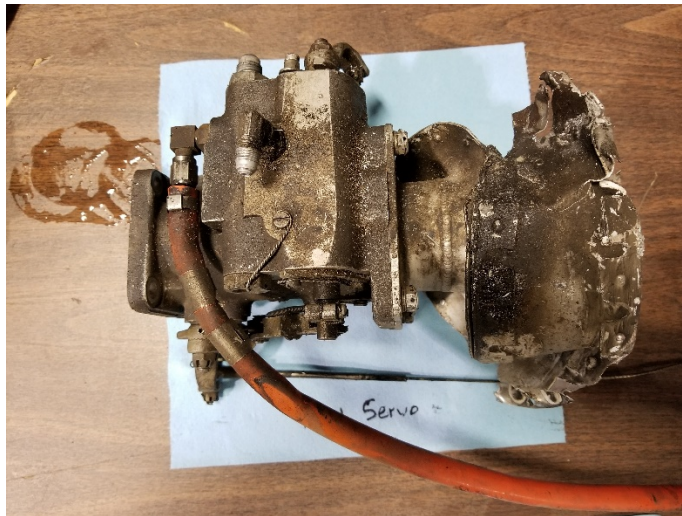
Examination of the fuel servo, a Bendix, model RSA-5AD1, did not reveal any debris in the fuel inlet screen (see photograph 8). The unit condition was unremarkable. The flow divider screen was free of debris and trace amounts of fuel were observed in the diaphragm. The fuel pump, manufactured by AC, expelled air through the outflow port and suction was observed through the inlet port when the pump handle was actuated by hand (see photograph 9). Each of the 4 fuel injector bores were clear.

Photograph 8: Fuel Servo

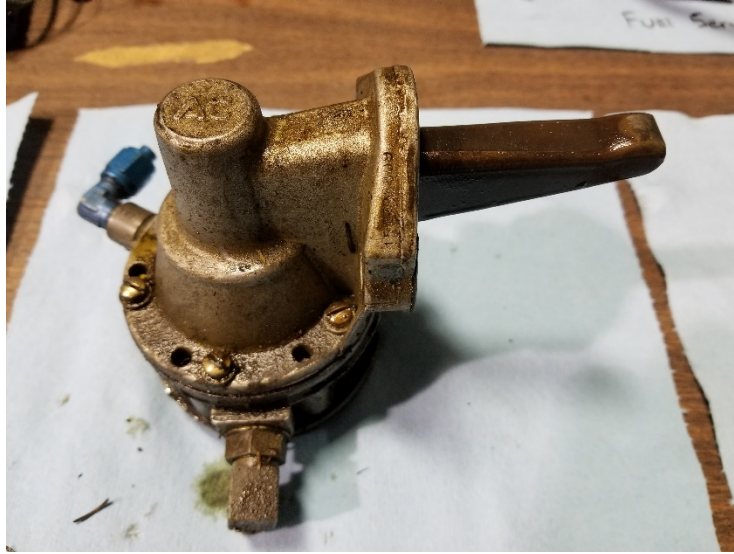
Photograph 9: Fuel Pump
