Collapse of the Fern Hollow Bridge

Pittsburgh, Pennsylvania
January 28, 2022

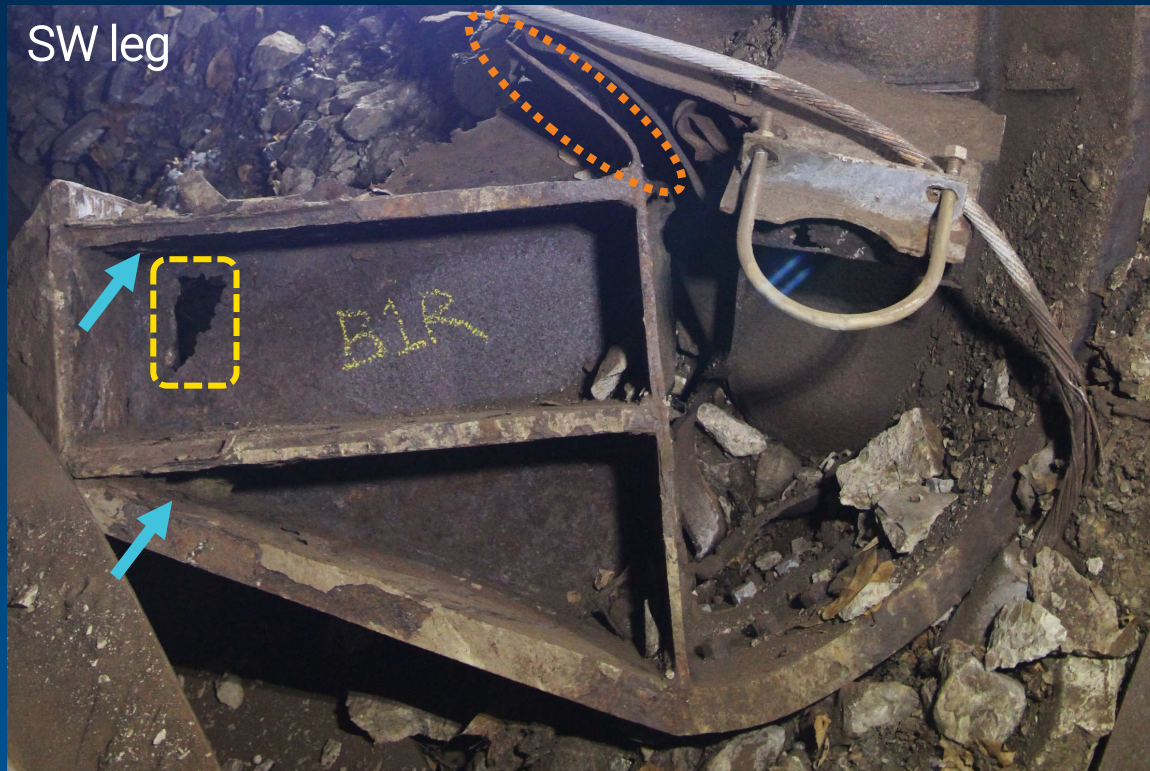
Corrosion – Leg Shoe

Corrosion product build-up

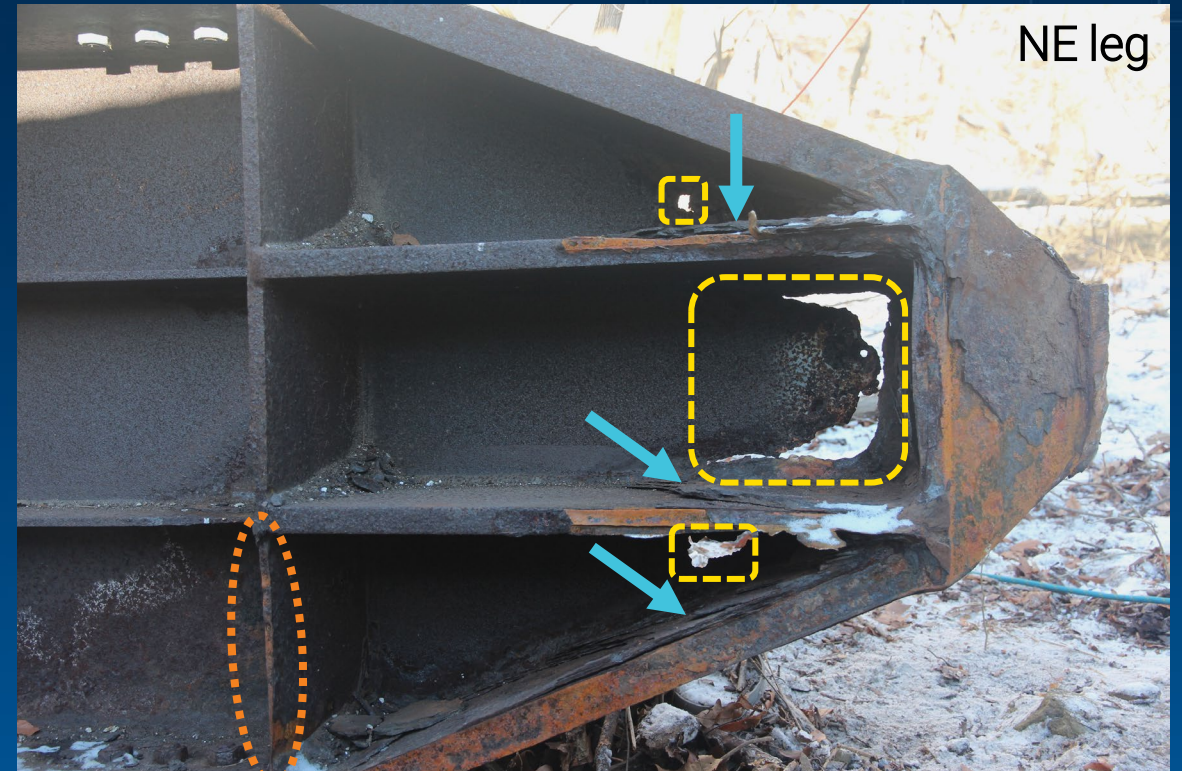
Holes

Transverse tie plate thinning

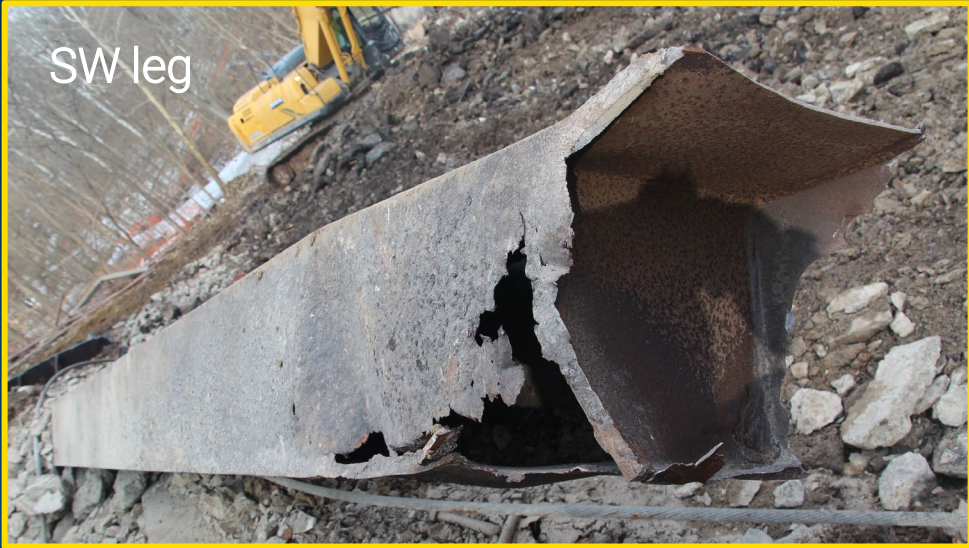
Corrosion – Cross-Bracing

Holes in cross-bracing end

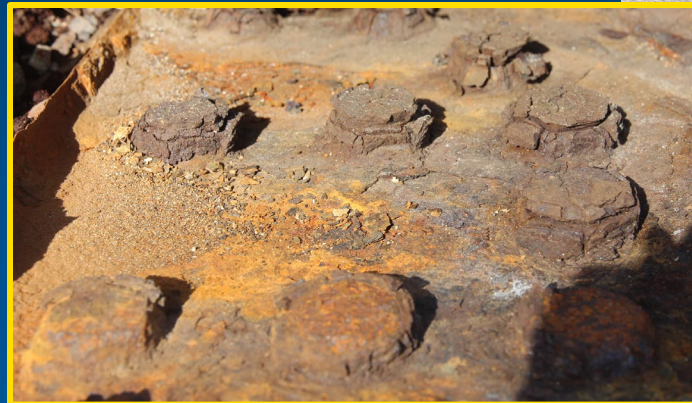
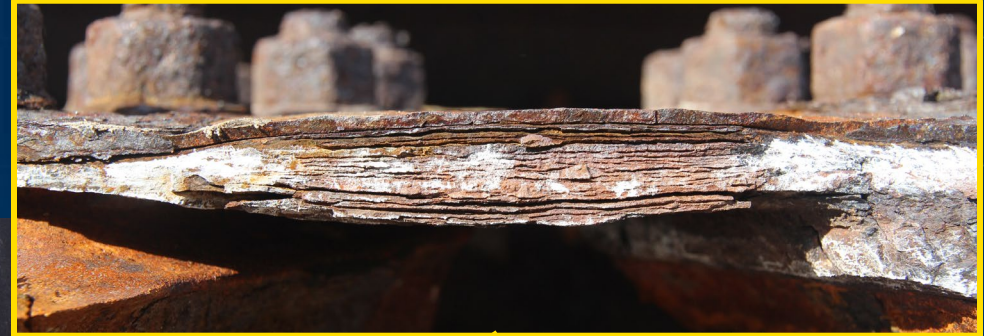
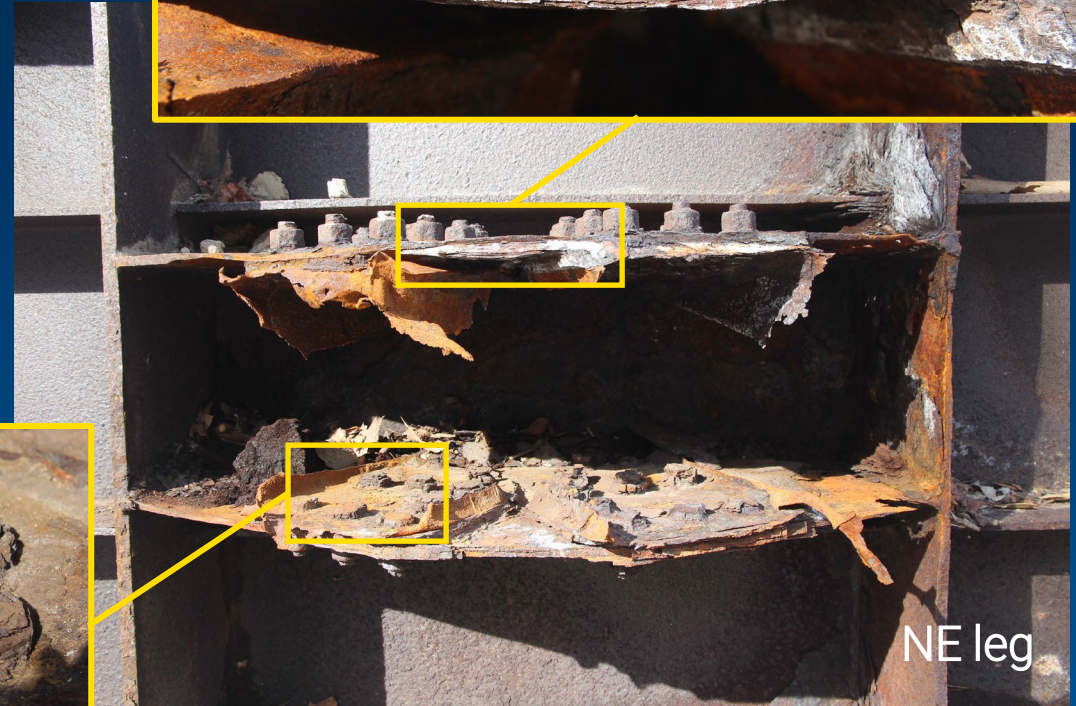
Rusted connecting bolts

Lamellar corrosion in connecting plates

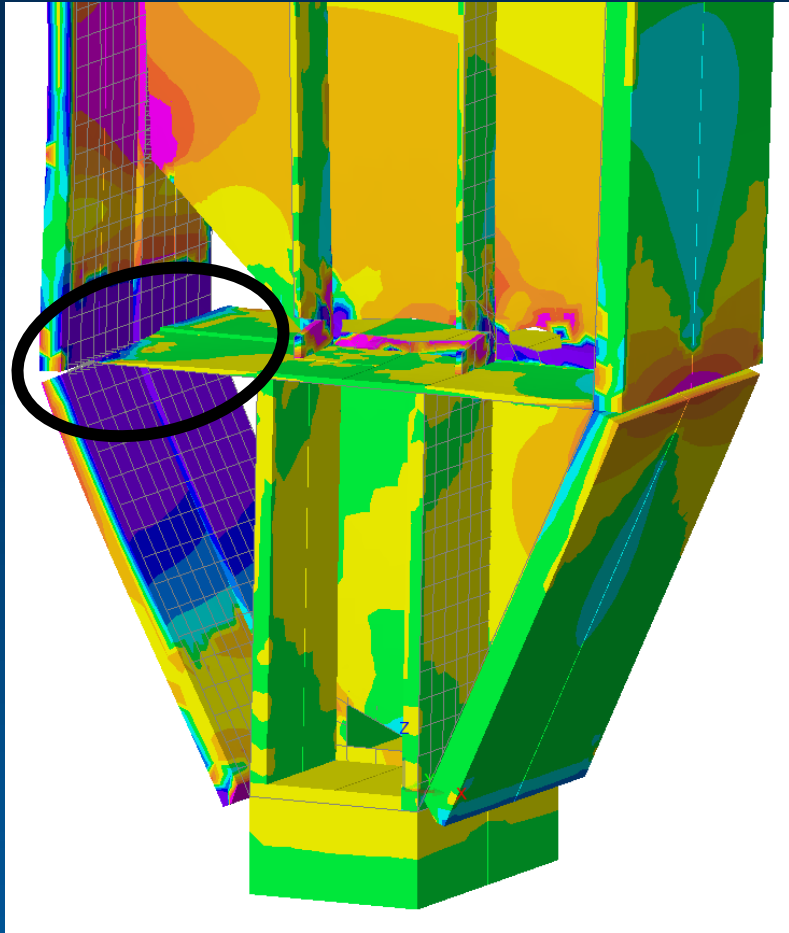
FE Model – Cause of Collapse

- Global behavior of structure during collapse
 - As-designed bridge had sufficient capacity to support all loads
- Local behavior of bottom of legs
 - Model of southwest leg shows corrosion present results in decreased capacity
 - When loaded, separation of transverse tie plate at the flange occurs first

- The southwest leg failed because it had reduced capacity due to extensive corrosion and section loss
 - The collapse initiated at the corroded transverse tie plate
- The following were excluded as factors in the collapse:
 - Use of uncoated weathering steel
 - Materials fabrication
 - Weld quality
 - Bridge design

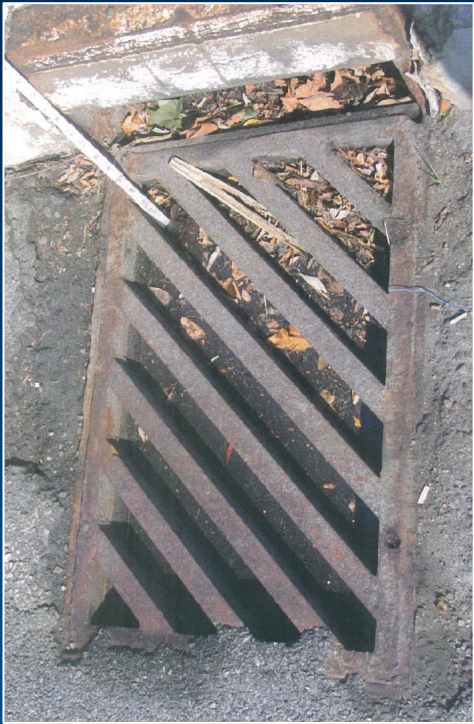
2005

Clogged Drainage Inlets

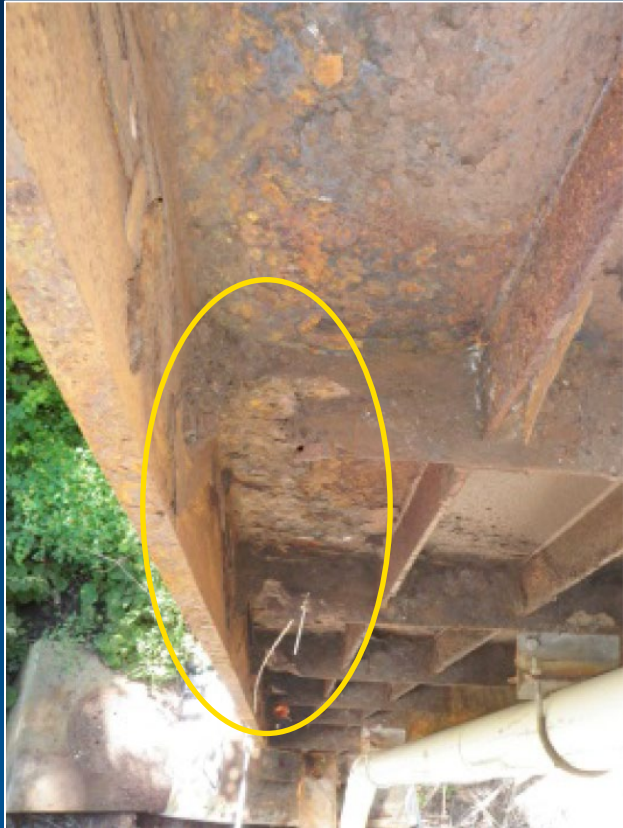
2013

Stiffeners on Southwest Leg

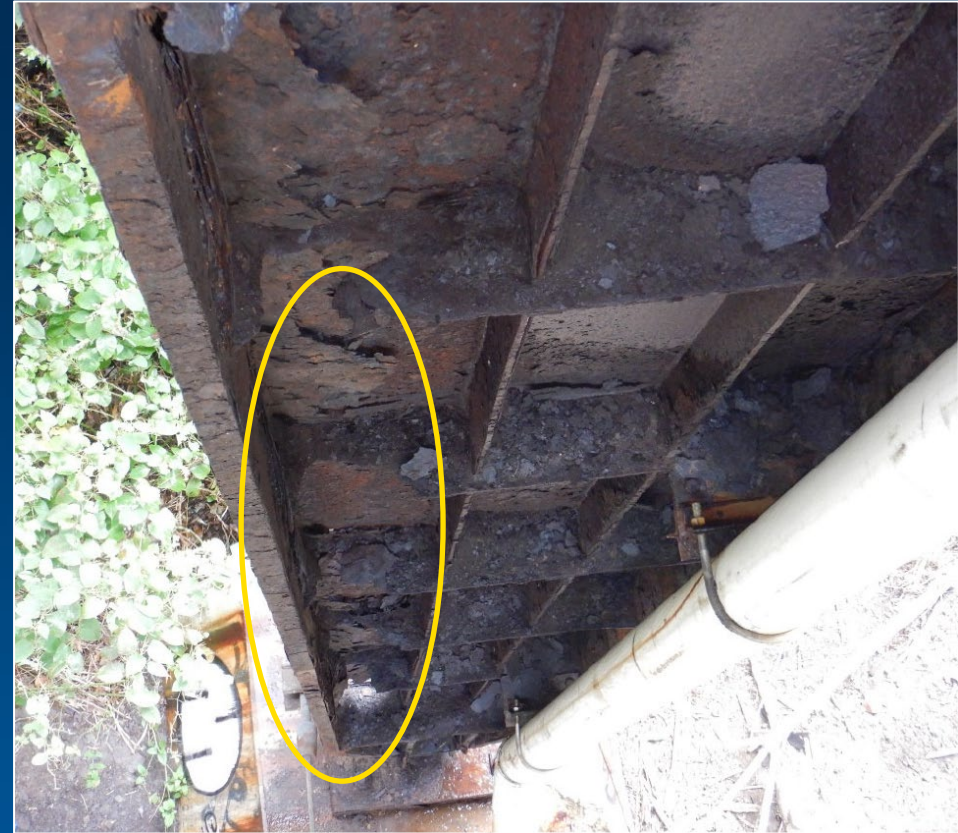
2021

- Significant corrosion and section loss on the southwest leg
- Failure by City of Pittsburgh to act on repeated maintenance and repair recommendations
- Progressive deterioration and structural failure

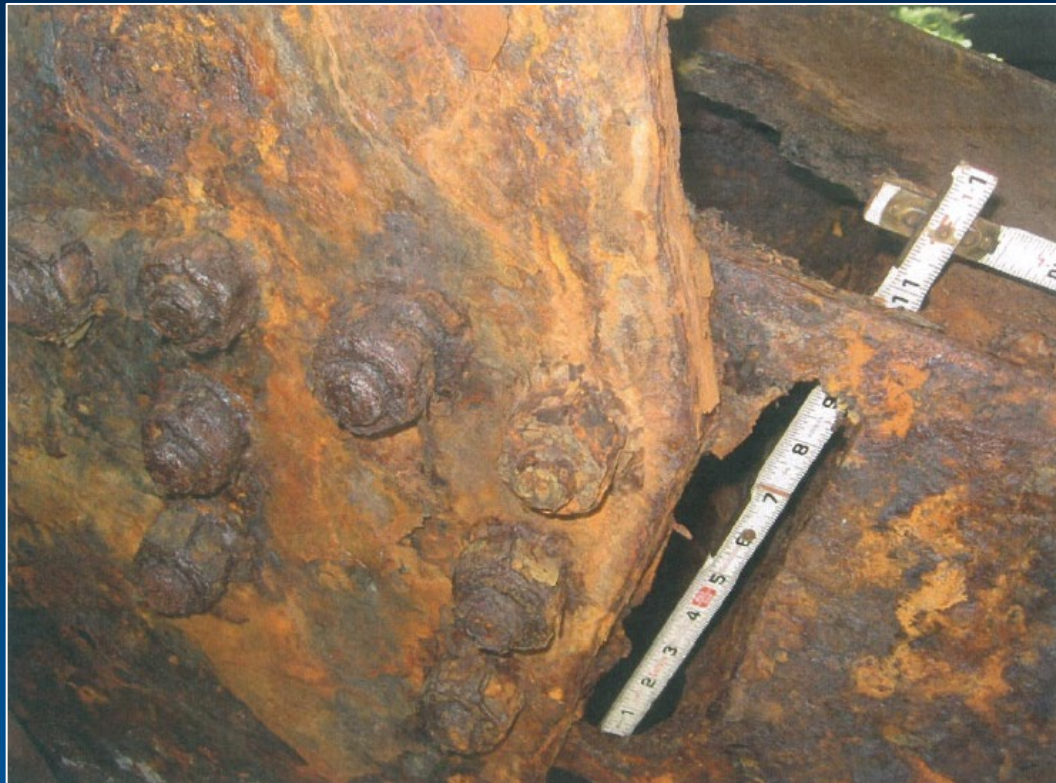
2005 (Southwest Leg)

Cross-Bracing

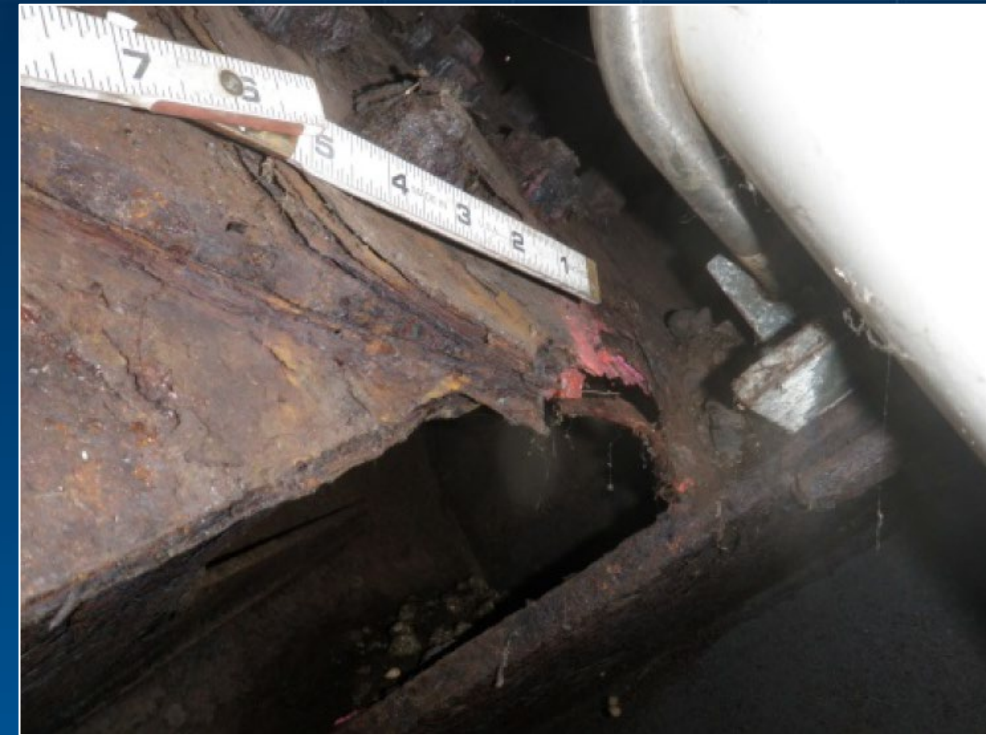
- Failed to:
 - Clean corrosion before measuring
 - Accurately quantify remaining material
 - Accurately rate the general bridge superstructure condition
 - Recommend a structural review of the bridge legs

- Inspectors failed to perform the inspections in compliance with the NBIS
- These failures contributed to the bridge's failure to support the loads it was rated for before the collapse

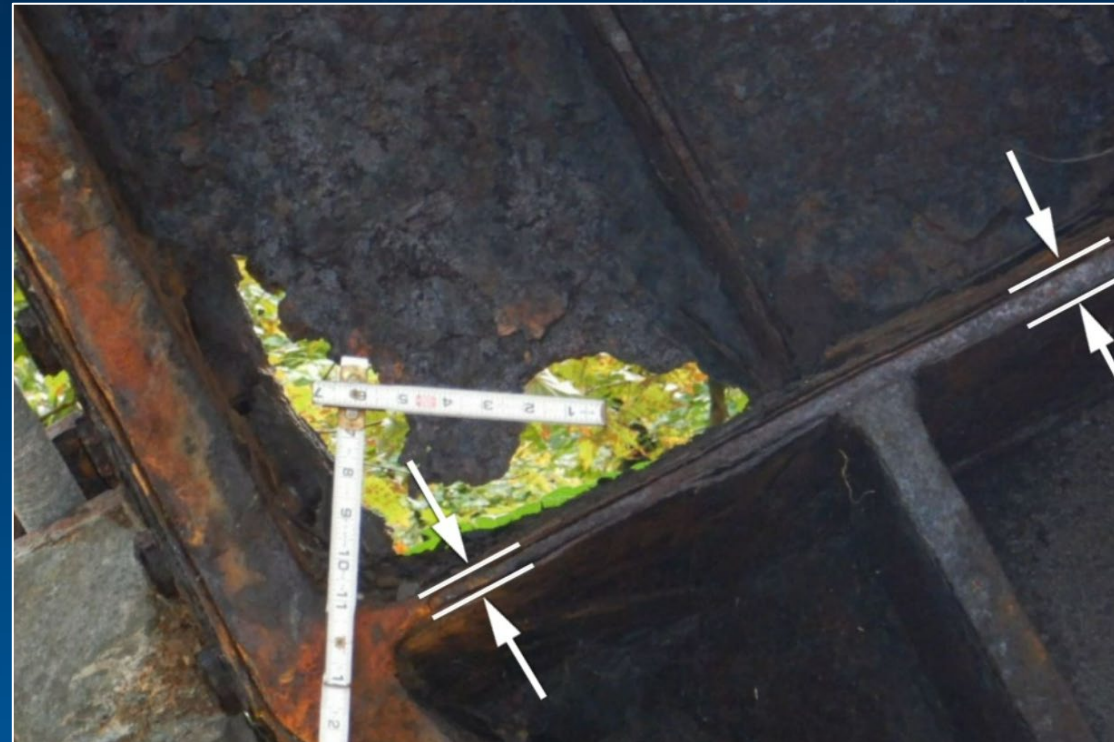
- Except for the transverse tie plates and adjacent web, the bottom 1/3 of the bridge legs were in compression
- Transverse tie plates were critical to structural stability, yet failure risk went unidentified
- Neither the *BIRM* nor the *MBE* address the identification of bridge components in localized tension zones

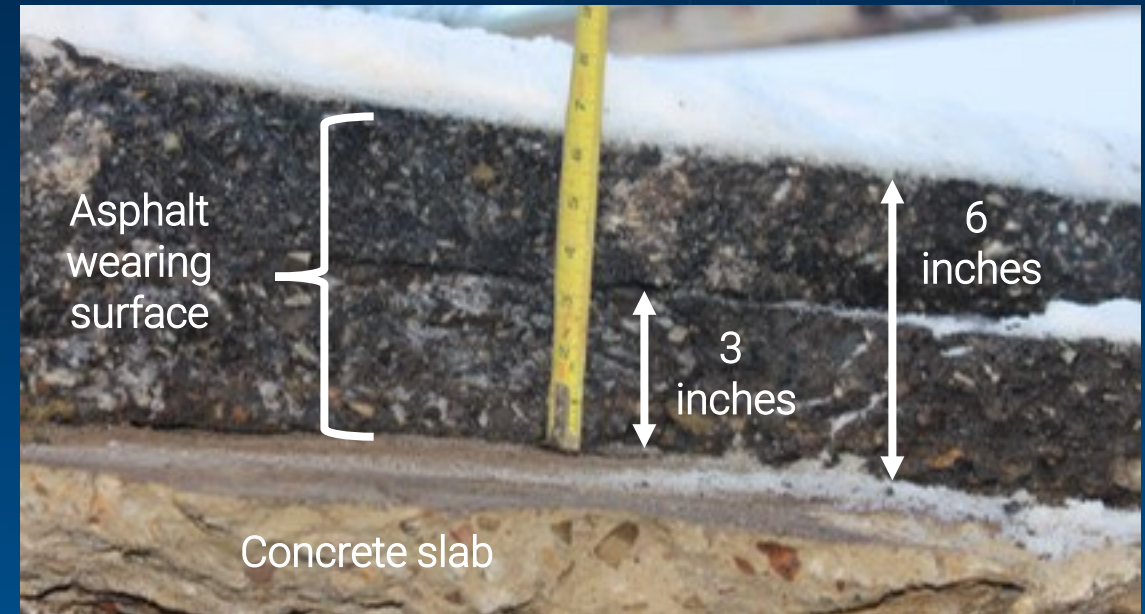
Wearing Surface Thickness

- Thickness of asphalt wearing surface was 3 inches in 2014 load rating
- Postcollapse, the wearing surface thickness was measured to be about 6 inches
- Doubled wearing surface would have resulted in a load posting of less than 26 tons

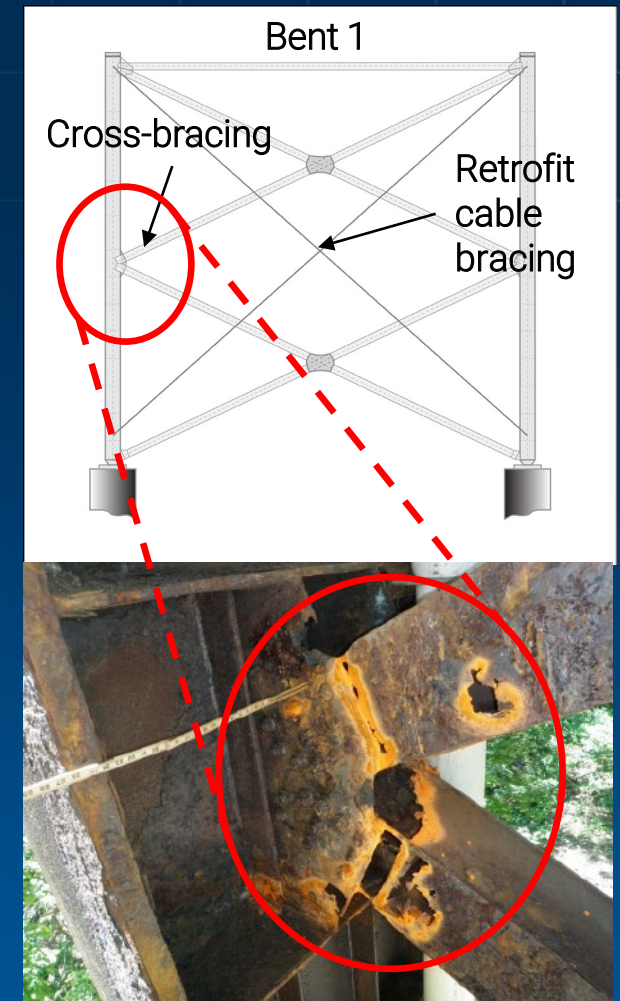
k -factor for the Bridge Legs

- Load rating assumed an incorrect k -factor
 - When the cross-bracing for the legs was intact
- 2013 routine inspection report indicated the cross-bracing exhibited 100% section loss
- Retrofit cable bracing between the legs was not designed to provide lateral support
- k -factor overestimated each leg's capacity

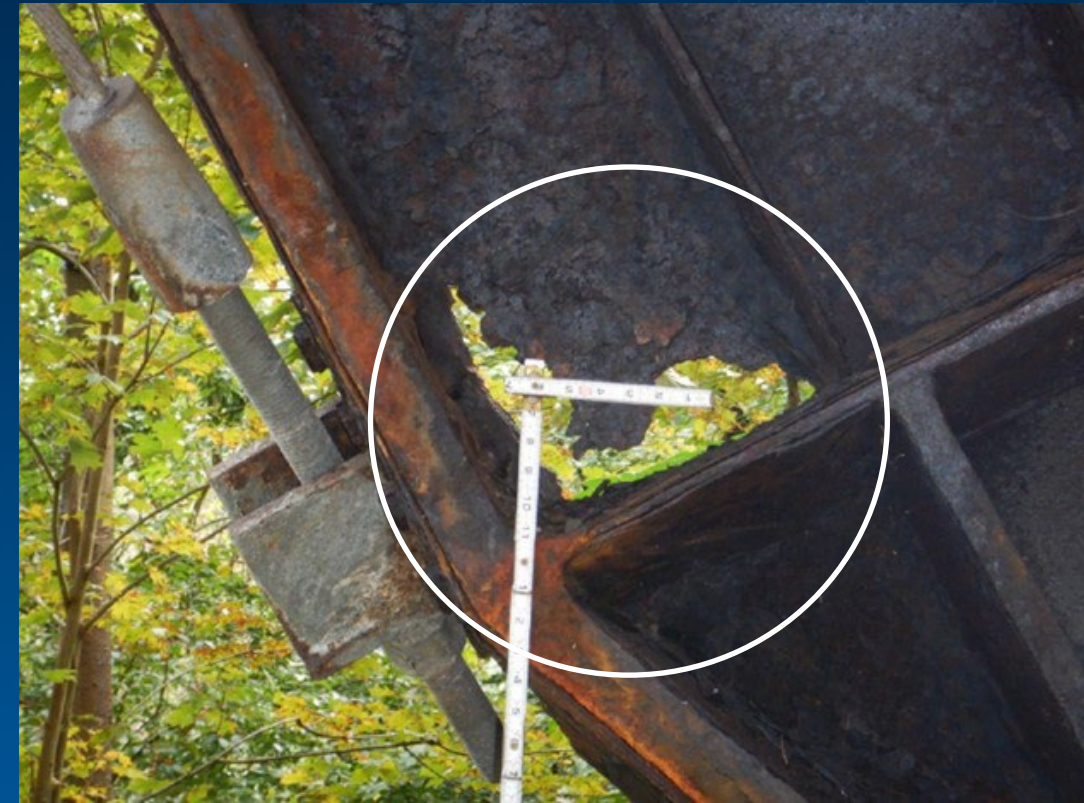
Section Loss of Leg Web

- Distributed the loss material over the entire length of the leg
- Load rating calculated a new equivalent web thickness for the legs
- Resulted in overestimation of the bridge's capacity
