NATIONAL TRANSPORTATION SAFETY BOARD

ENGINE EXAMINATION

WPR18LA278

Howard DGA-15P – N9471H

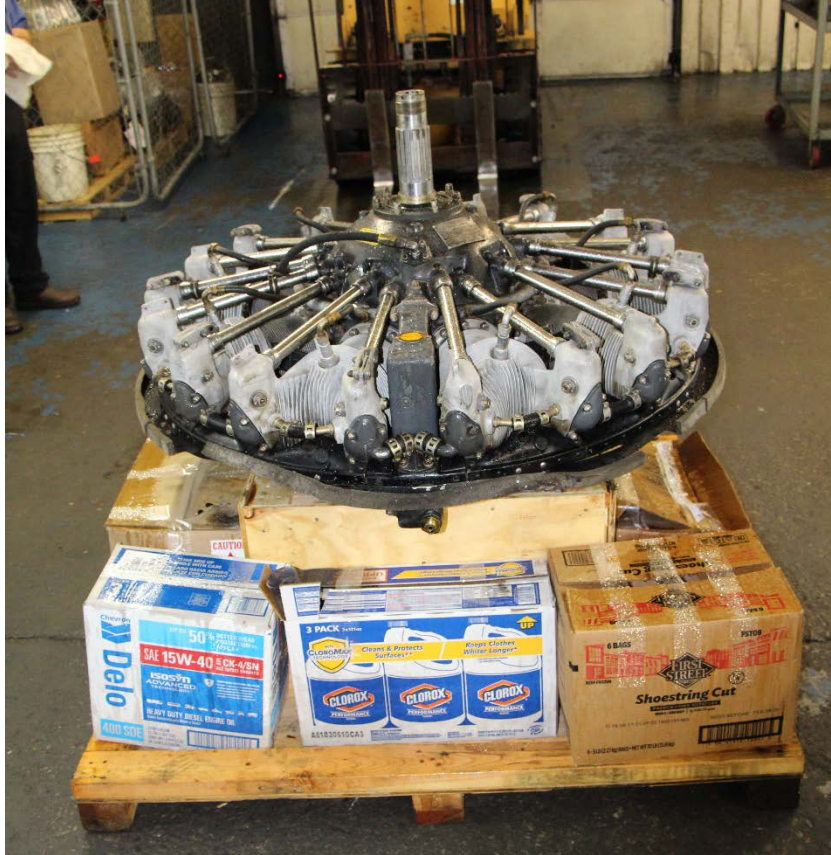
Photograph 2: Engine as Received

A visual inspection of the engine revealed trace amounts of thermal damage to the lower accessory case. The engine's physical condition was otherwise unremarkable. The spark plugs and rocker covers were removed for inspection. Mechanical continuity of the valvetrain was confirmed through rotation of the crankshaft, which was smooth and unremarkable. Crankshaft runout measured about 0.005 inches, which was within the published maximum of 0.006 inches. An inspection of the cam ring was performed through the cam ring inspection plug and did not reveal any evidence of binding. The oil screen showed trace amounts of debris. The front spark plugs were removed and displayed trace amounts of carbon and oil.

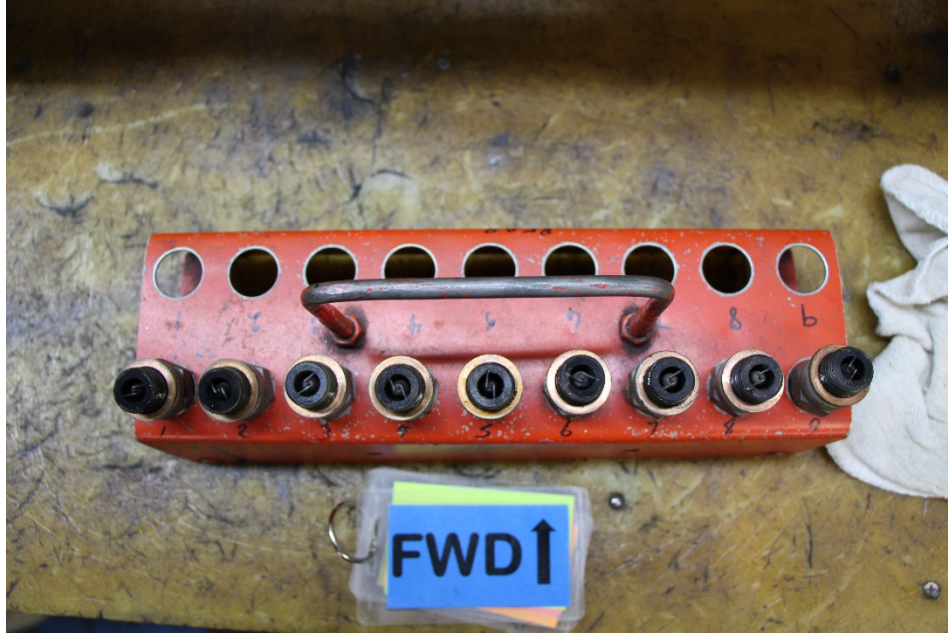
Photograph 3: Forward Spark Plugs

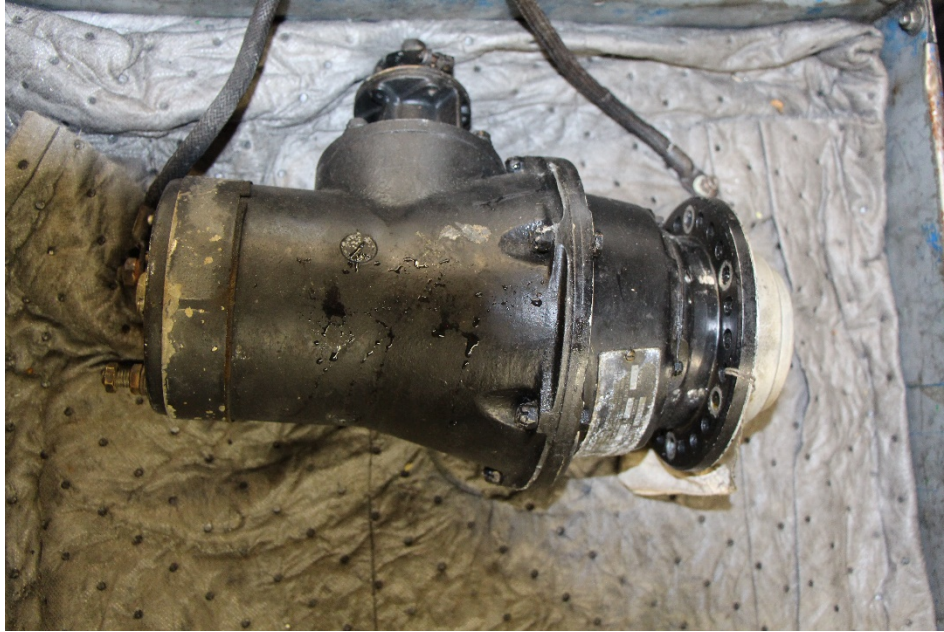
The engine starter was an Eclipse model no. 17, serial number 4. The unit had been removed from the engine and did not display any anomalies.

Photograph 4: Engine Starter

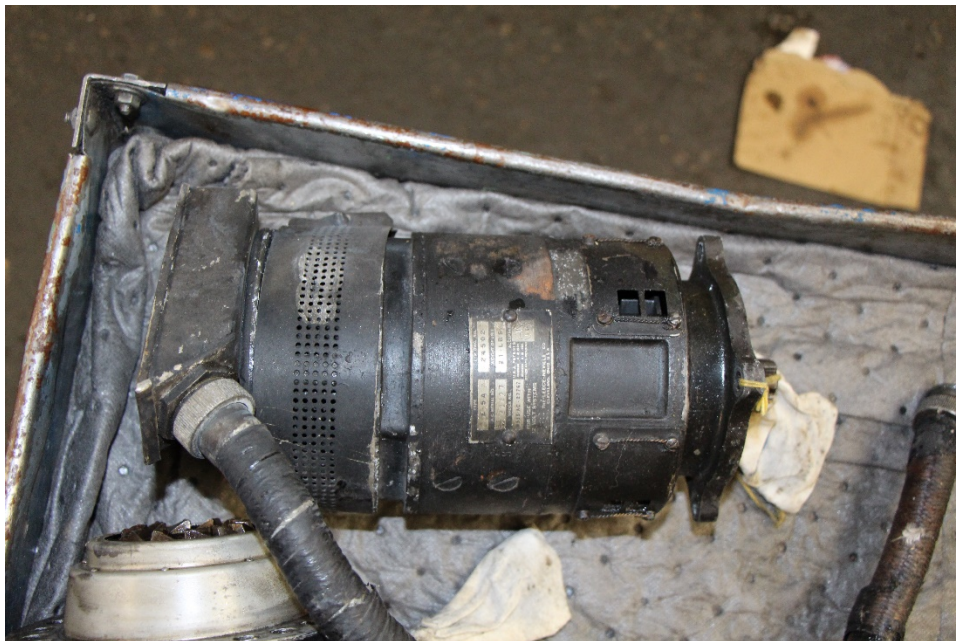
The engine generator was a Leece-Neville Coompany, drawing no. 24502, s/n 21427. The unit did not display any damage.

Photograph 5: Engine Generator

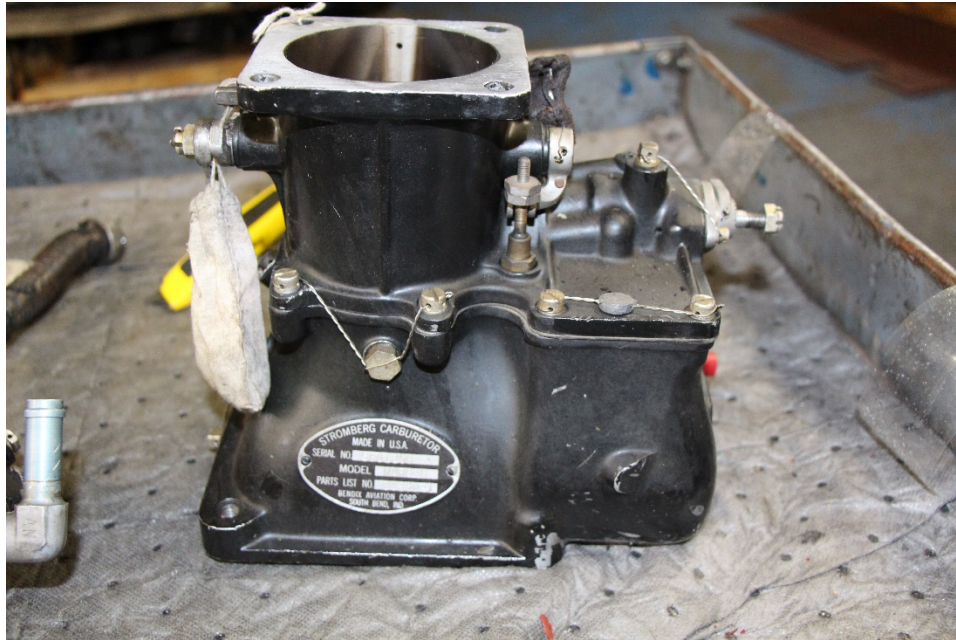
The carburetor was a Stromberg-Bendix, model NAR9-B, s/n 5801259. The unit's mixture control arm moved freely by hand. The throttle function could be rotated to the full open position, but could not return to the closed setting. The unit has been retained for further examination. The mounting flange did not exhibit any evidence of fretting or wear; however, multiple threads in each of the four mounting holes were sheared.

Photograph 6: Carburetor

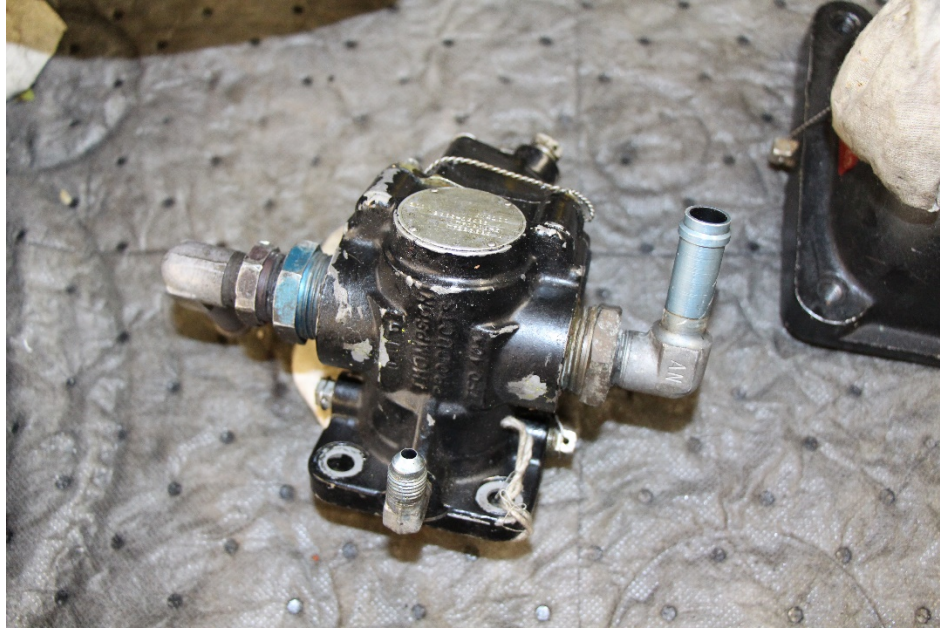
The fuel pump was a Thompson, drawing no. TFD-900-5, s/n TF223693A. The unit did not display any abnormal wear; however, the drive shaft displayed limited rotation. The drive shaft splines and grooves were intact and displayed no play when inserted into the accessory case, which was also unremarkable.

Disassembly of the unit revealed rust along the inside and outside diameters of the rotor liner and surface rust on two of the rotor vanes. However, the valve clearances were within the manufacturer's published clearances. The parts were taken to Quality Aircraft Accessories in Tulsa, Oklahoma on May 22, 2019 by the NTSB IIC for further examination. The body was heated with a torch to remove the rotor liner. Measurements showed that the liner exceeded the manufacturer's published clearances. The bypass flapper valve exhibited a small leak, but was otherwise unremarkable.

Photograph 7: Fuel Pump

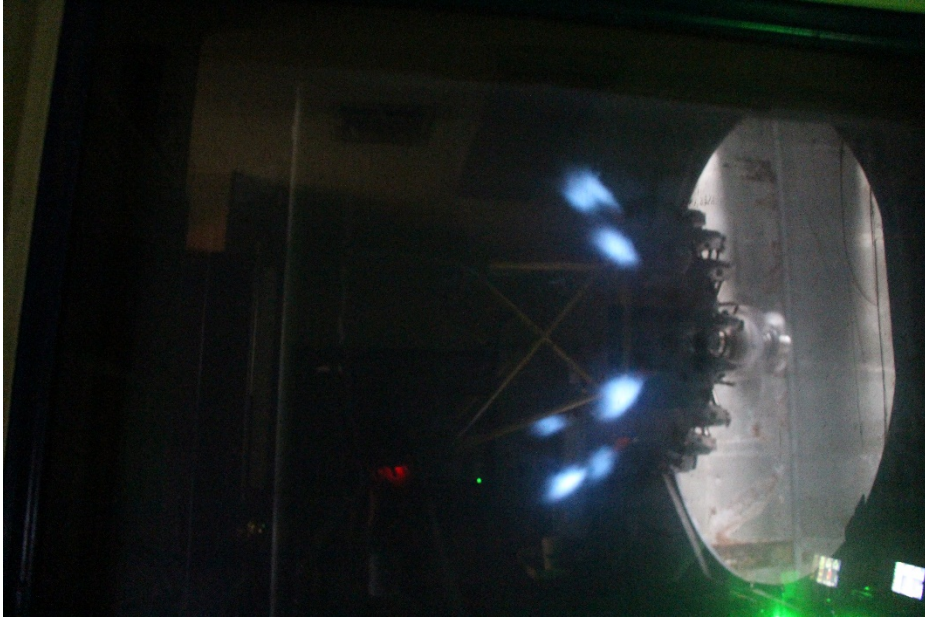
The results of the engine run are included in Appendix A of this examination report. The engine was initially run for 10 minutes at 1,000 rpm and subsequently advanced 200 rpm every 10 minutes. During the 15 minute engine run at 1,800 rpm, the left and right magnetos were shut down individually, which revealed a drop of 60 rpm for the left magneto and 80 rpm for the right magneto. At the time, the ambient temperature was 73° F and barometric pressure was 29.51 inches Hg. Engine power was then advanced to 1,900 rpm for 15 minutes, 2,000 rpm for 15 minutes and finally 2,100 rpm for 5 minutes. The engine’s maximum power achieved during the test was 2,300 rpm for about 1 minute at 37 inches of manifold pressure.

Photograph 9: Engine During Test Run
