NATIONAL TRANSPORTATION SAFETY BOARD

AIRPLANE AND ENGINE EXAMINATION

WPR19FA244

Aircraft: Cessna 172

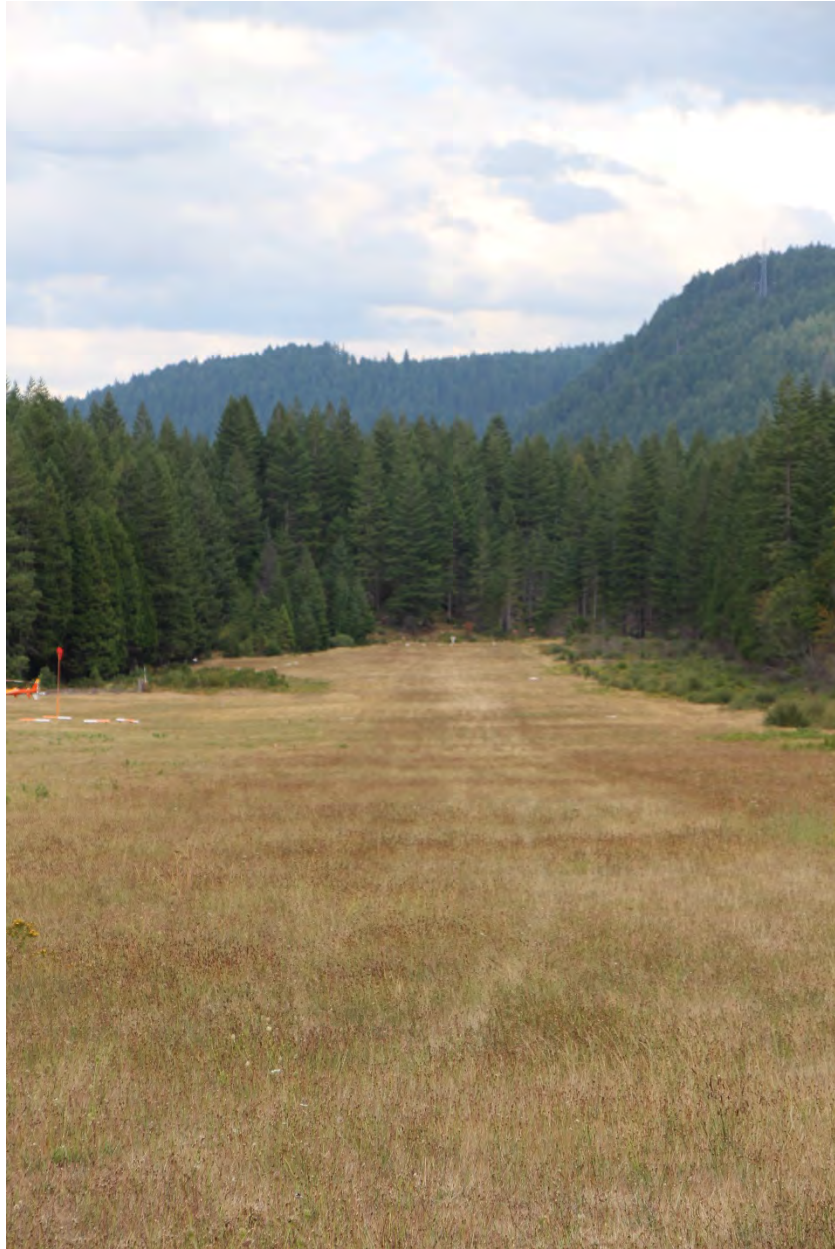
00S was located at an elevation of 1,620 ft above mean sea level and was equipped with one grass runway in a 06/24 configuration. The runway was 2,600 ft long and 90 ft wide. According to the Federal Aviation Administration Chart Supplement that was current at the time of the accident, departures from runway 06 were not recommended, which was also displayed on airport signage along the runway. The departure end of runway 06 was comprised of 134 foot-tall rising terrain and numerous trees (photograph 1).

Photograph 1: Departure End of Runway 06

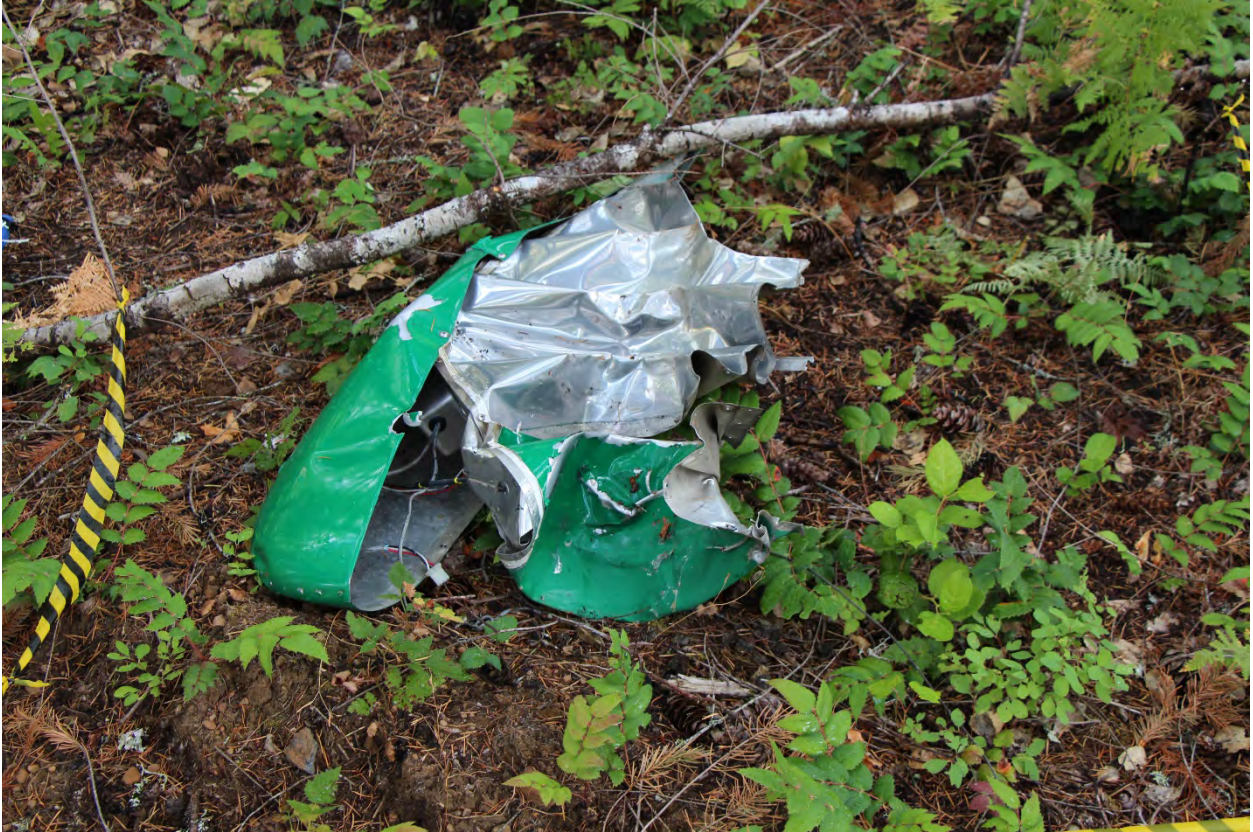
The airplane came to rest inverted in a wooded area about 615 ft east of the departure end of runway 06 and was oriented on a heading of 300° magnetic. The initial impact point (IIP) was marked by an approximate 120 foot tall tree with a severed tree top at a field elevation of 1,754 ft. A section of the left wingtip was found about 40 feet southwest of the IIP and was comprised of an 8 inch long concaved shaped depression in the leading edge of the wingtip (photograph 2). An intermediate impact point was observed along the debris path and marked by several broken tree branches at the top of an approximate 120 foot tall tree about 75 feet southeast of the IIP.

Photograph 2: Left Wingtip

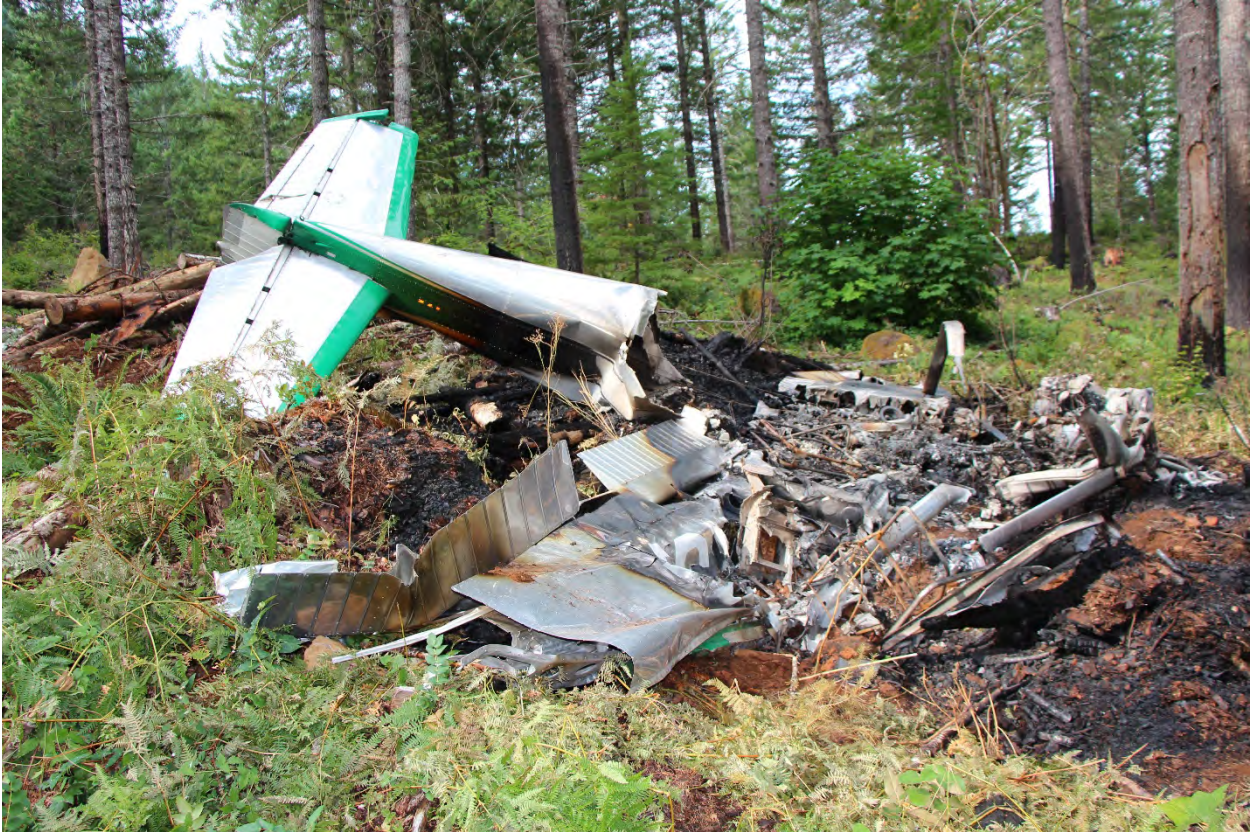
The main wreckage was located about 150 ft beyond the IIP and was mostly consumed by postcrash fire. All four corners of the airplane were accounted for at the accident site (photograph 3).

Photograph 3: Main Wreckage

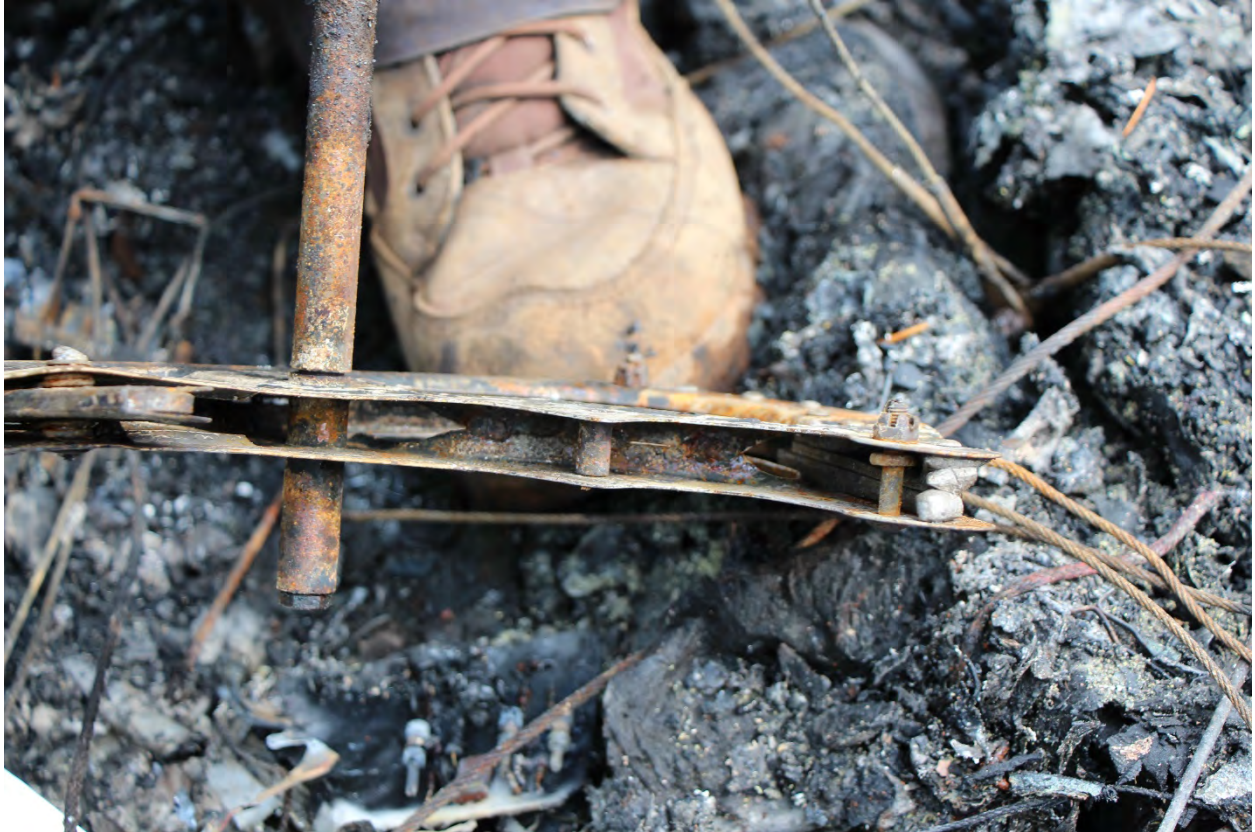
The engine, fuselage and wings were mostly consumed by postcrash fire with the exception of the outboard wings, which exhibited extensive damage. The aft fuselage was intact, but thermally damaged and the empennage, which was comprised of the vertical stabilizer, elevator, and rudder, was intact. Flight control continuity was traced from the rudder, elevator, and aileron flight controls surfaces to the cockpit. Both ailerons exhibited a small range of movement when actuated by hand at the cables and the elevator and rudder displayed a full range of movement over their respective axes. The elevator trim actuator measured 1.2 inches, consistent with a neutral trim setting. The flap handle spring was separated from the flap handle and the ratcheting mechanism was also separated, which precluded a confirmation of the flap setting (photograph 4). Both flap cables remained attached to their respective bell cranks; the left wing flap remained attached to the bell crank through the push pull tube and the right wing flap push pull tube had separated from the right wing flap.

Photograph 4: Flap Handle

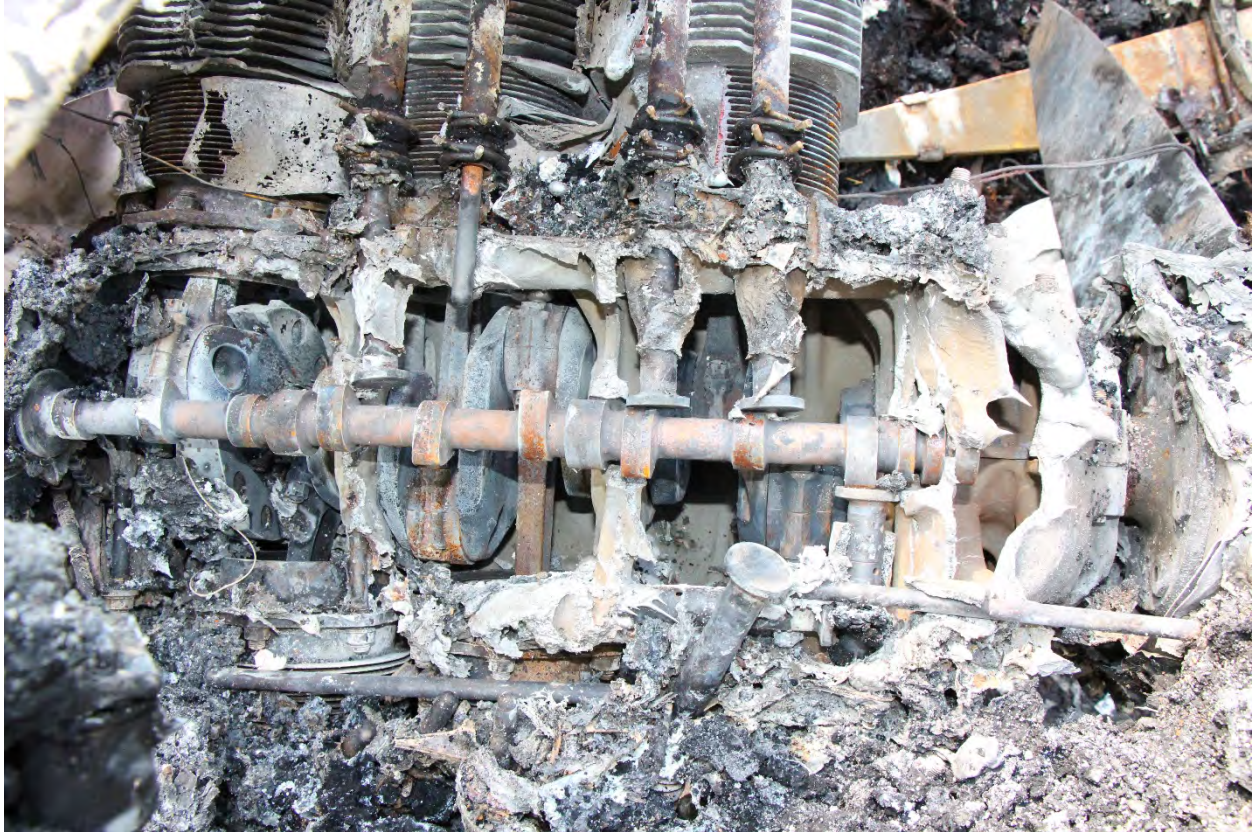
The engine was inverted and the revealed extensive fire damage. Both the oil sump and accessory case were destroyed, which showed the camshaft, crankshaft, and most of the internal parts (photograph 5). The camshaft lobes and valve lifters were unremarkable and the engine did not show any evidence of catastrophic damage. Mechanical movement of the valvetrain and crankshaft could not be verified as the propeller was seized.

Photograph 5: Lower Half of Engine

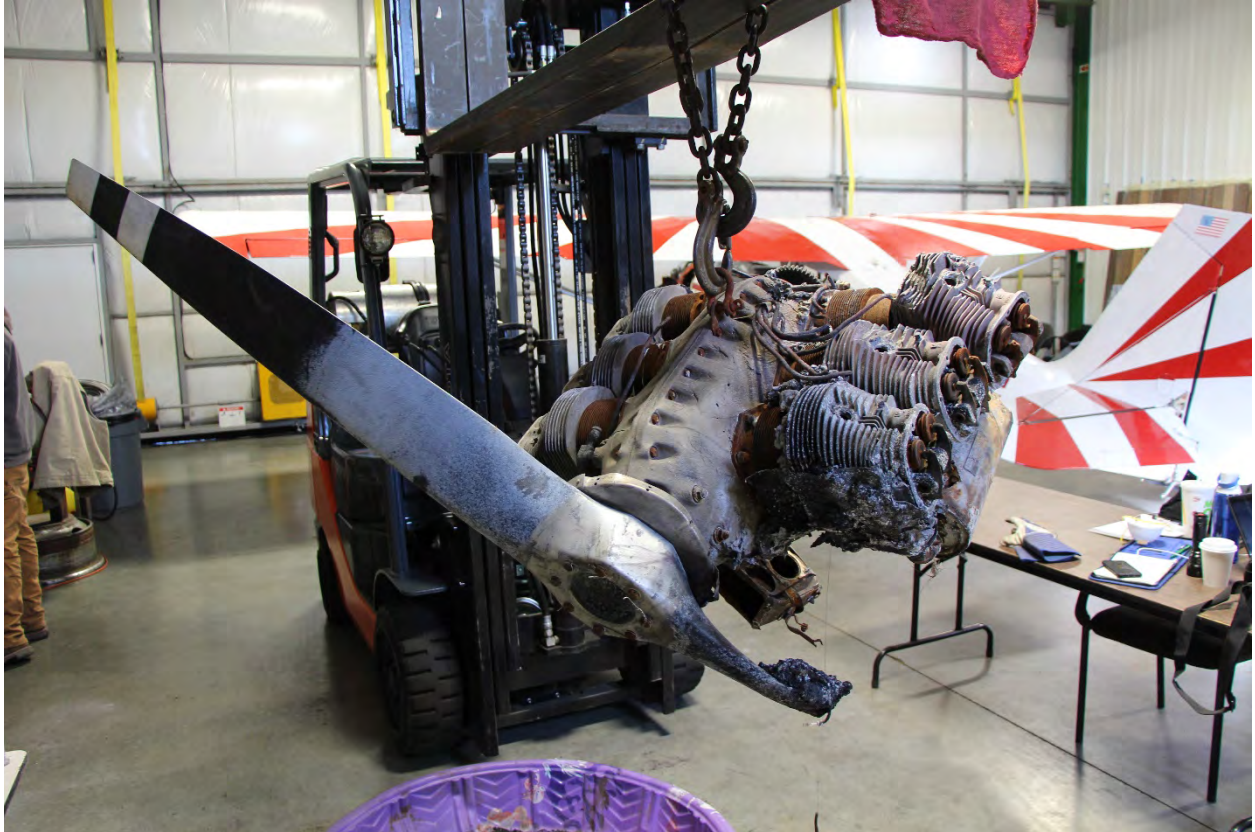
Rotational continuity could not be achieved due to the state of the engine (photograph 6). The top portion of the engine case had sustained some thermal damage, and had sustained fire damage and some bulging near cylinders 5 and 6. Most of the cylinders remained intact with the

exception of the cylinder head to cylinder no. 2, which had partially separated. All of the intake tubes had melted away and the rocker arms were covered in brownish deposits, consistent with rust, and attributed to postaccident fire suppression activities. The engine accessories case, constructed from magnesium, was destroyed by postcrash fire.

Photograph 6: Engine Prior to Examination

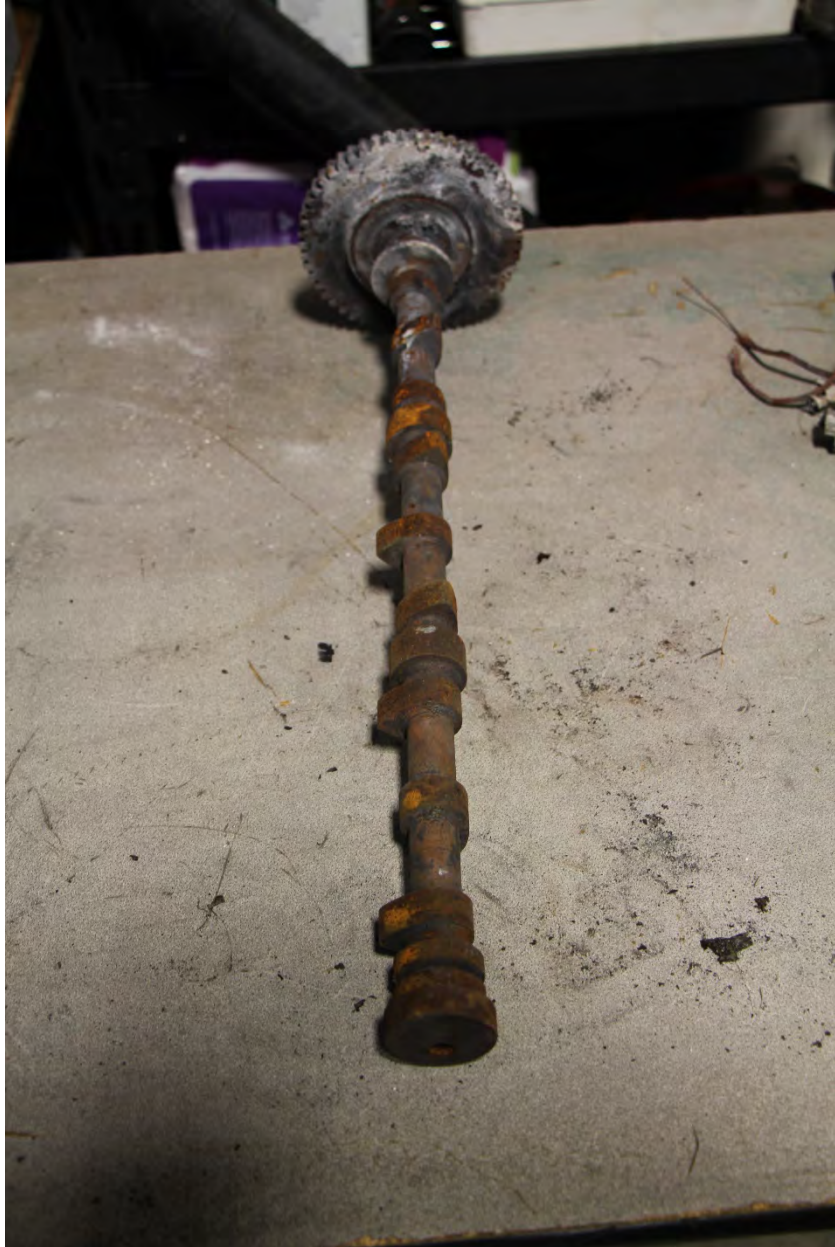
The lower engine case was destroyed by fire, which revealed the crankshaft, connecting rods, and pistons. Several pistons remained within their respective cylinders attached to their connecting rods, which were secured to the crankshaft. Some pistons had melted away, but displayed molten remnants in the cylinders. The camshaft had separated from the engine and was thermally damaged with, but did not display any anomalous wear on any of its lobes with the exception of rust deposits attributed to fire suppression activities (photograph 7). With the exception of fire damage, the valve lifters appeared intact and did not display any unusual wear (photograph 8).

Photograph 7: Camshaft

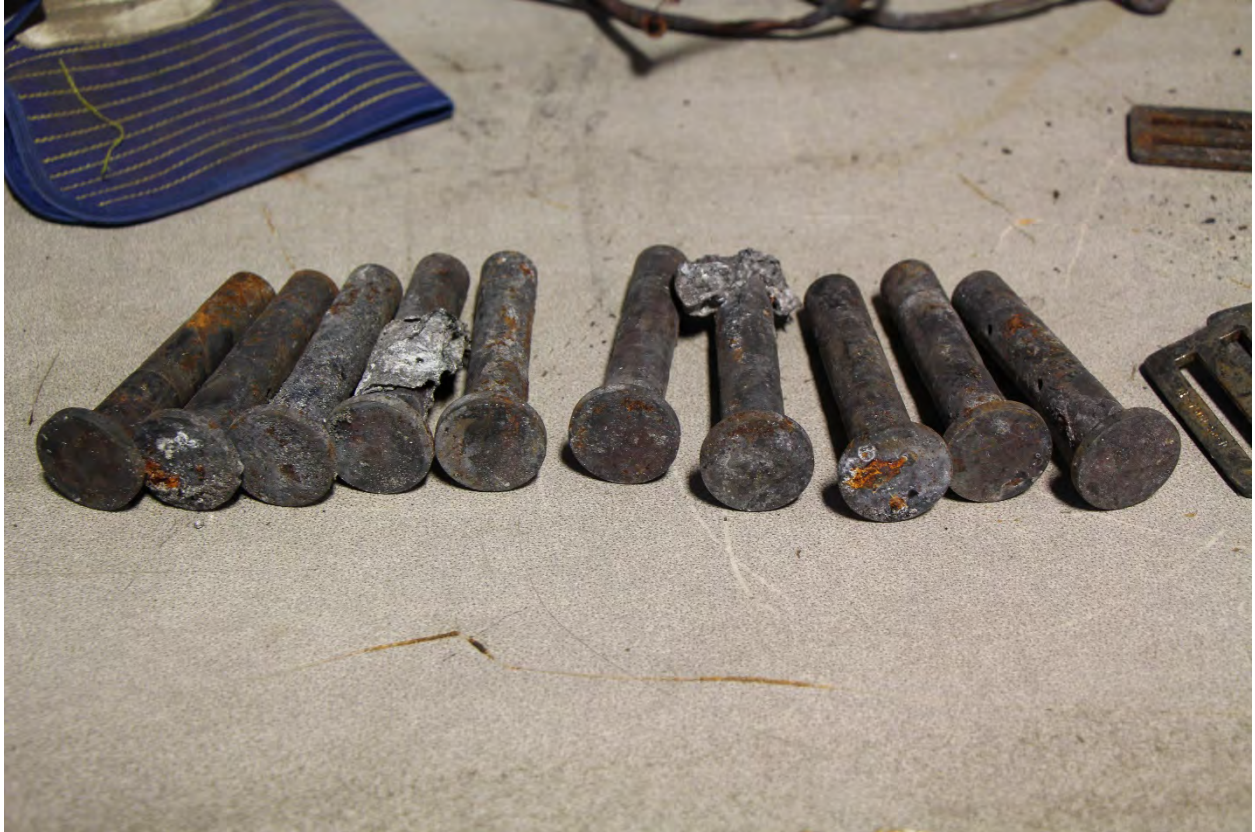
Photograph 8: Valve Lifters

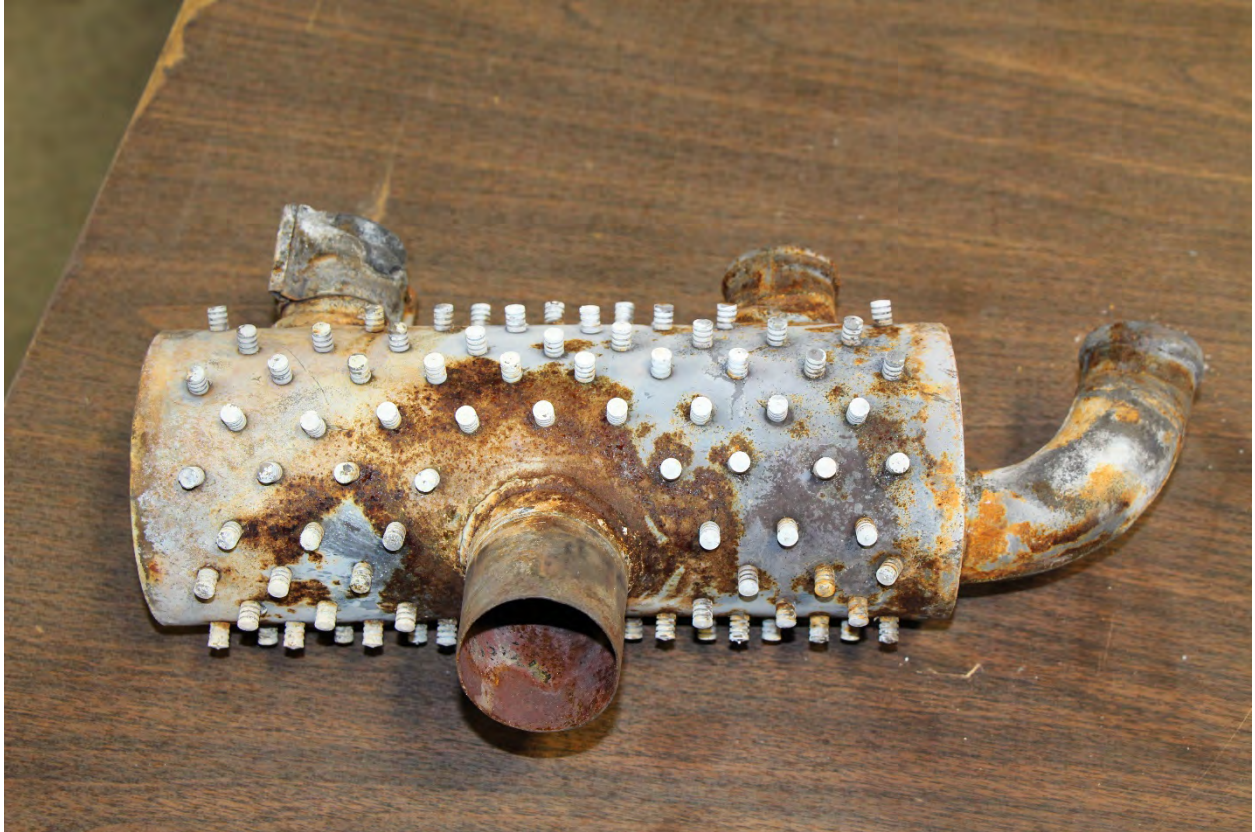
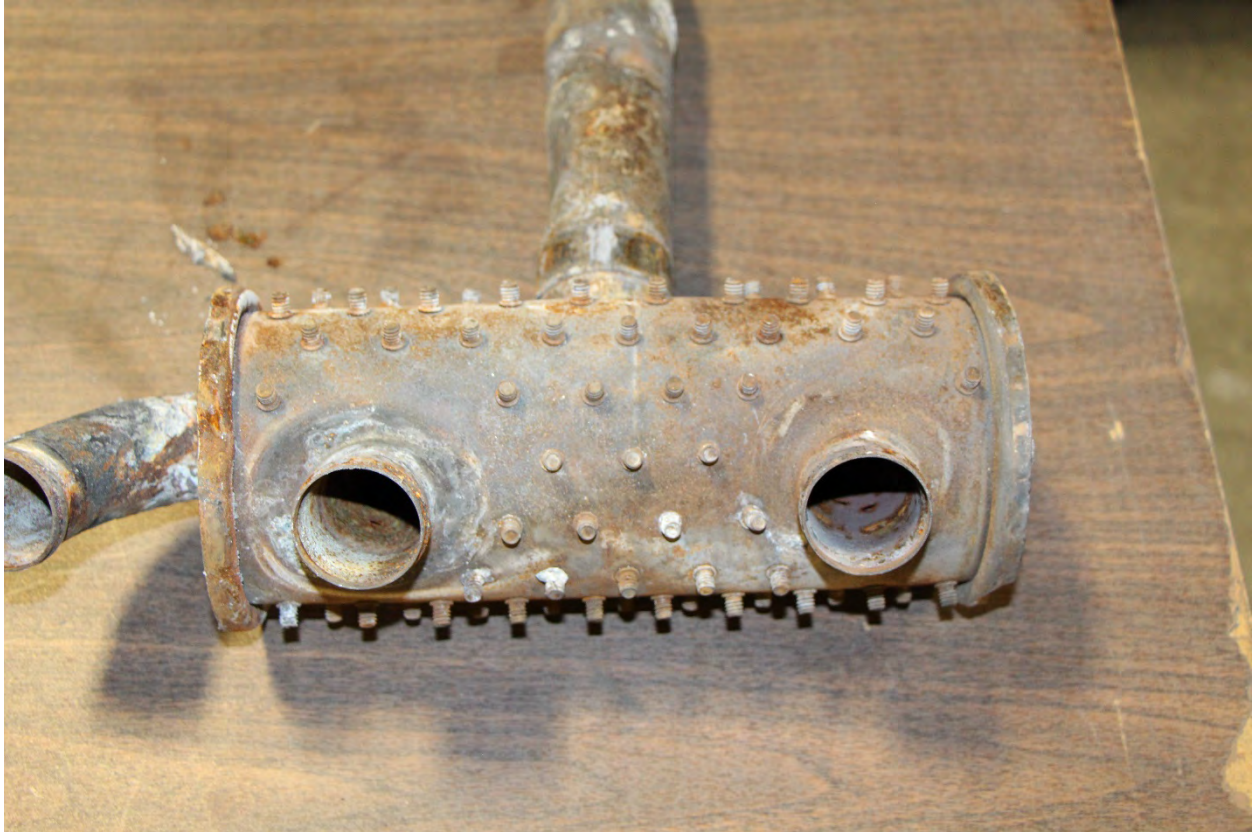
The engine was equipped with two exhausts; one for cylinder nos. 1, 3, and 5 and the other for cylinder nos. 2, 4, and 6. Both exhausts remained attached to their cylinders through the exhaust tubes. The outer shroud to both exhausts were removed and a visual inspection of the exhaust linings did not reveal any cracks or leaks (photographs 9 and 10).

Photograph 9: Exhaust Lining to Cylinder nos. 1, 3, 5

Photograph 10: Exhaust Lining to Cylinder nos. 2, 4, 6

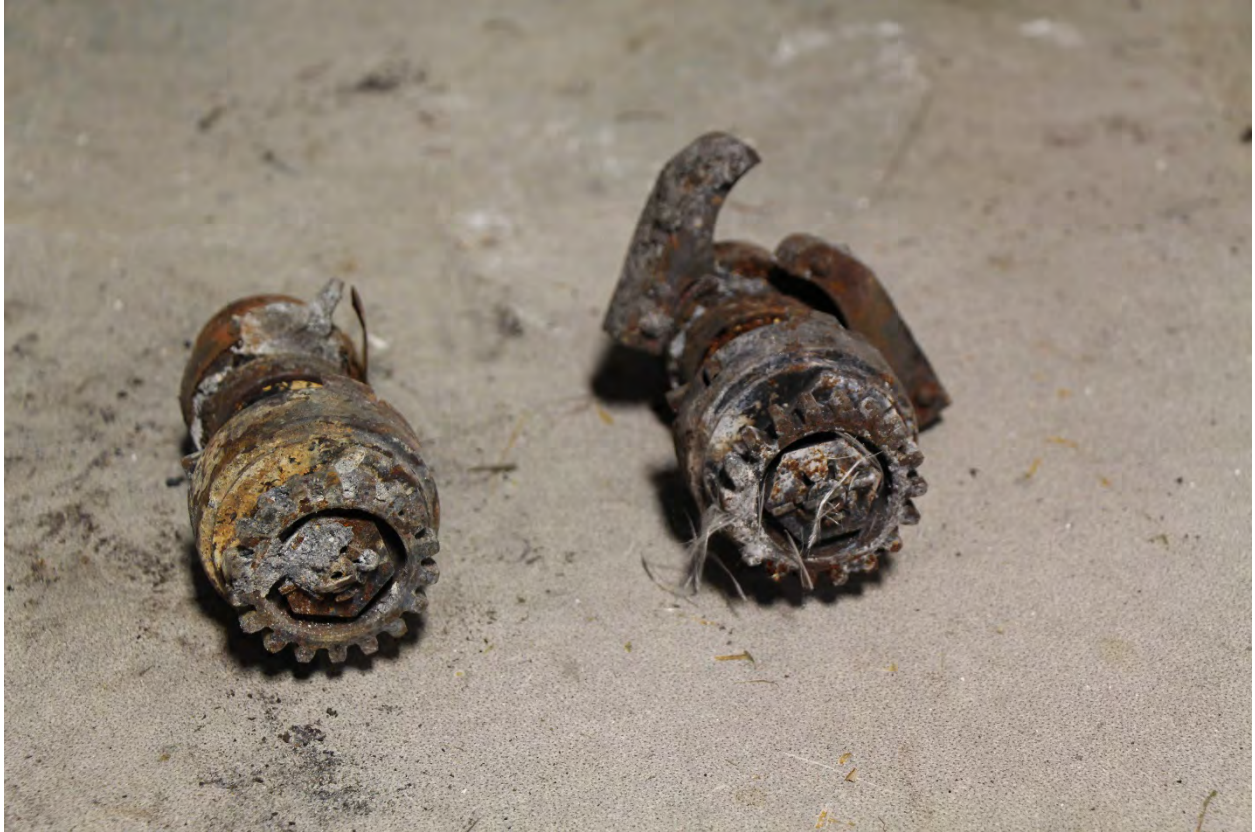
The magnetos (photograph 11) and several accessories were destroyed by postcrash fire. The carburetor had separated from the airbox, and was not recovered, but is presumed to have melted during the postcrash fire. Most of the spark plugs were thermally damaged and the ignition harness was destroyed. Several top spark plugs and one bottom spark plug were removed from their ports. The remaining plugs were either seized to the engine case or inaccessible. The spark plug observations are captured in the table below. Most of the spark plug electrodes were normal in appearance.

Photograph 11: Magneto Remnants

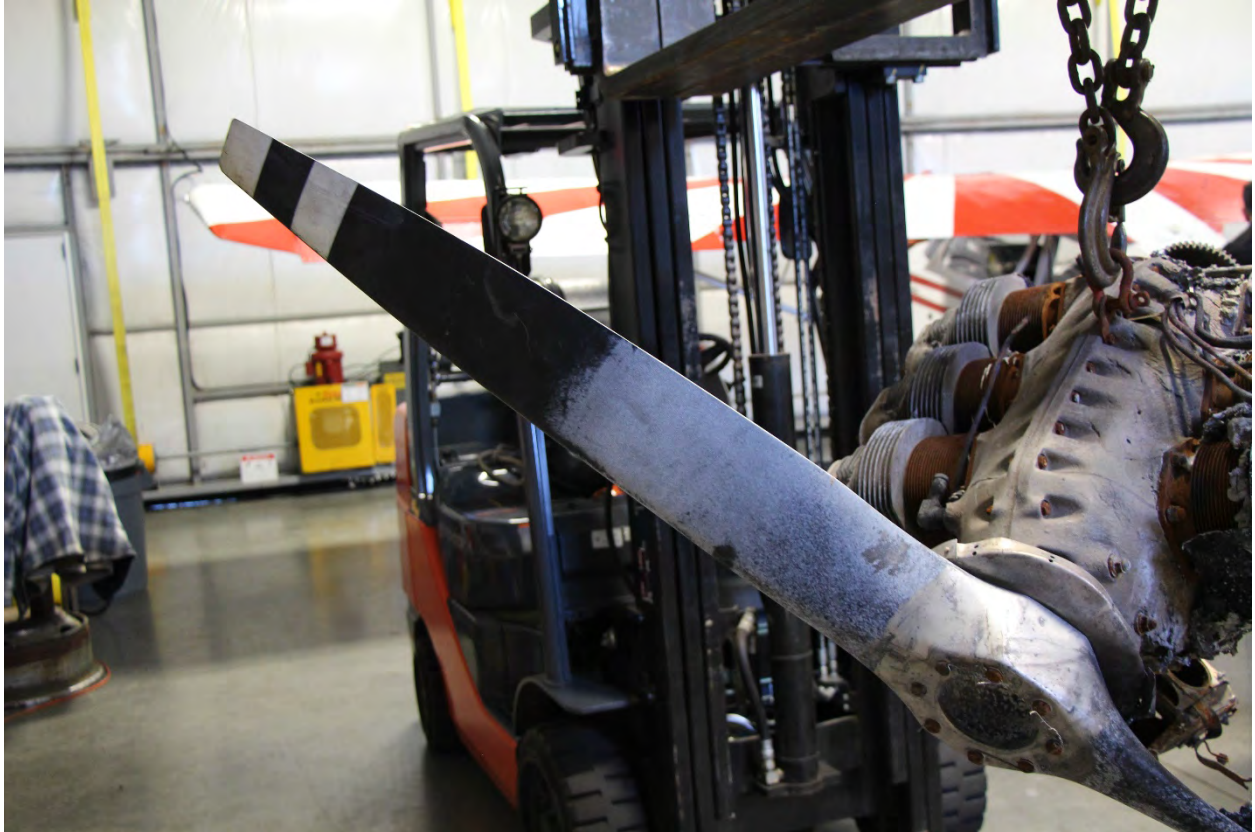
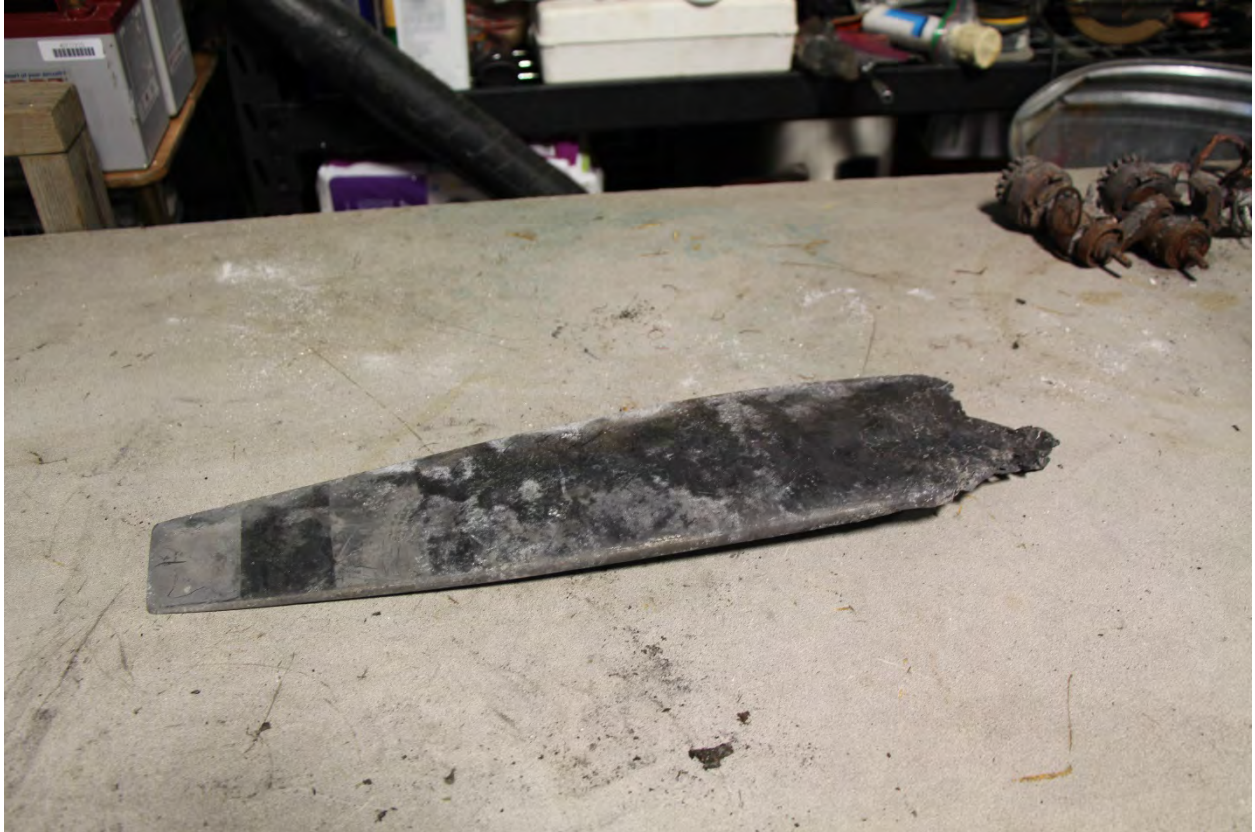
The propeller was thermally damaged and remained attached the engine crankshaft. One propeller blade was unremarkable and the other propeller blade was separated near the blade root with a slight aft bend, but did not display any striations, nicks or gouges (photographs 12 and 13).

Photograph 12: Propeller Blade

Photograph 13: Separated Blade
