Examination Summary

NTSB ACCIDENT NUMBER: ANC19FA012

ANC19FA012 N13LY Raytheon Aircraft Company B200

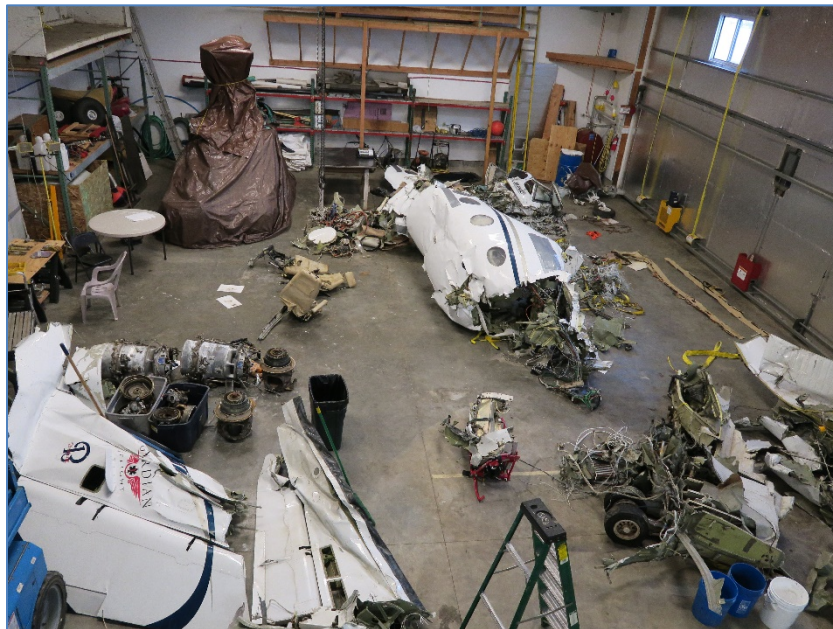
The airplane impacted the ocean waters of Frederick Sound and was located on the ocean floor at a depth of about 500 ft. A cone shape debris field spanned about 1,650 ft on a bearing of 45°, with the lighter debris farther northeast due to the current.

The aircraft impacted ocean waters and was heavily fragmented.

Photo 1 - Accident airplane's wreckage at wreckage layout

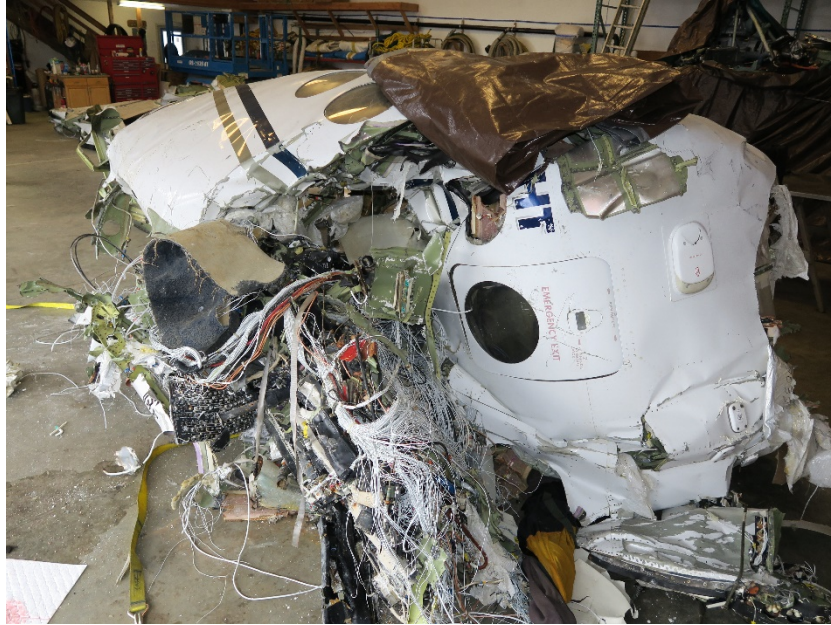
Photo 2- Fuselage at wreckage layout

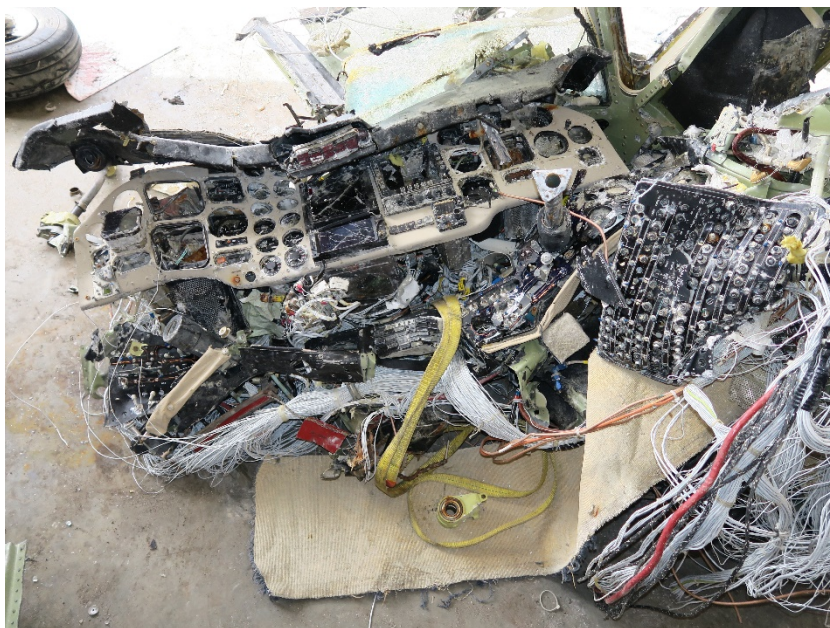
The instrument panel sustained impact damage and partially separated from the aircraft.

- Ignition: Left – Arm, Right – Arm
- Ignition and Engine: Left – On, Right – On
- Avionics Master – Undetermined (loose)
- Left Gen: Undetermined (loose)
- Inverter – Off
- Engine Anti-ice: Left – On, Right – On
- Beacon – Undetermined (fractured)
- Strobe – Undetermined (fractured)
- Recognition – Undetermined
- Tail Flood – Undetermined (fractured and bent upward)
- No Smoke and FSB – On
- Pitot Mic – Normal
- Co-pilot Mic – Normal

Photo 3- Accident airplane's instrument panel

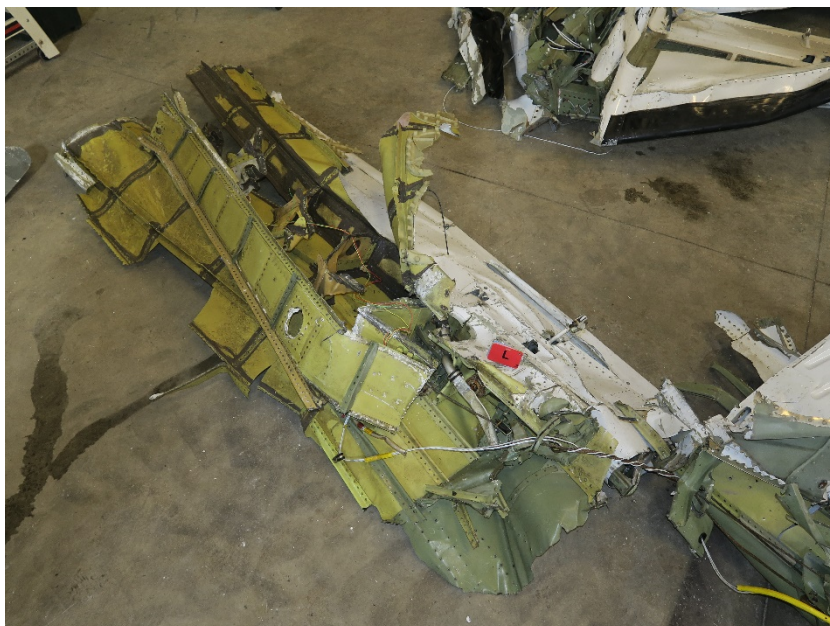
The outboard left wing, which included the left aileron, remained attached to the left wing structure by the aileron and aileron trim control cables. The control cables were observed twisted numerous times at the wing structure fracture.

Photo 4 - Outboard left wing structure

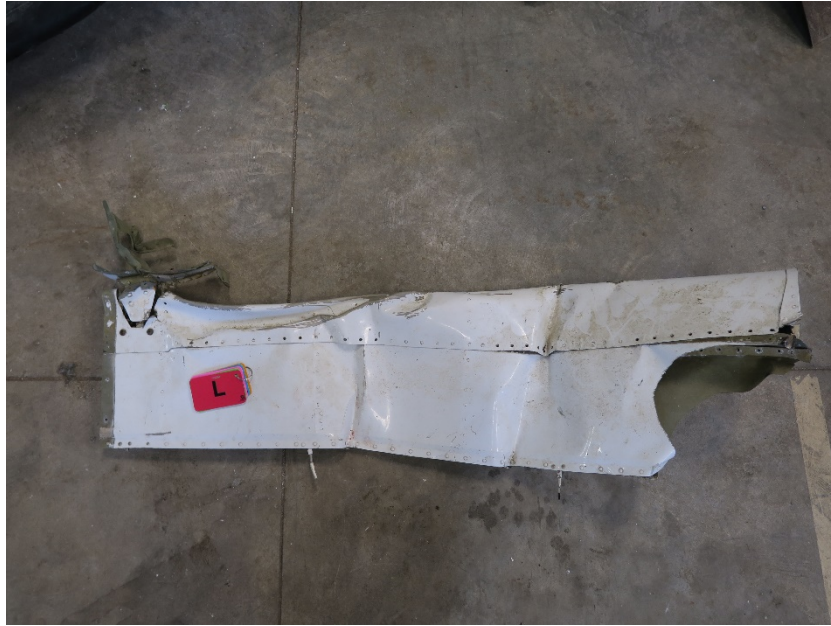
Most of the left aileron remained attached to the outboard left wing. An approximately 3.5' long section of the outboard end of the left aileron had separated and was observed with the wreckage.

Photo 5 - Accident airplane's outboard left aileron

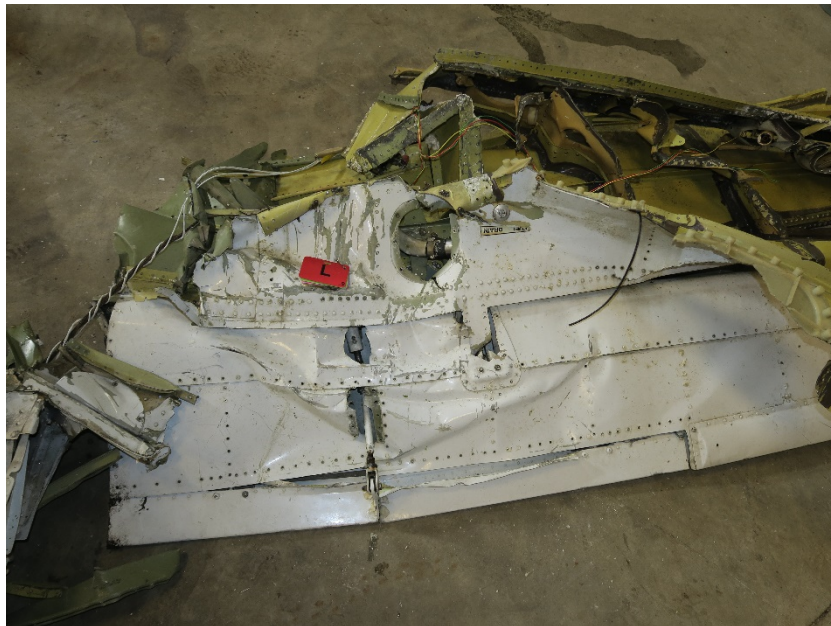
The aileron cables remained attached to the left aileron bellcrank and were continuous to the left wing root. The left aileron trim tab remained attached. The left aileron trim actuator was extended 1.8" which equates to approximately 5° tab down. The aileron trim cables remained attached to the trim actuator and were continuous to the left wing root.

Photo 6 - Left aileron trim actuator

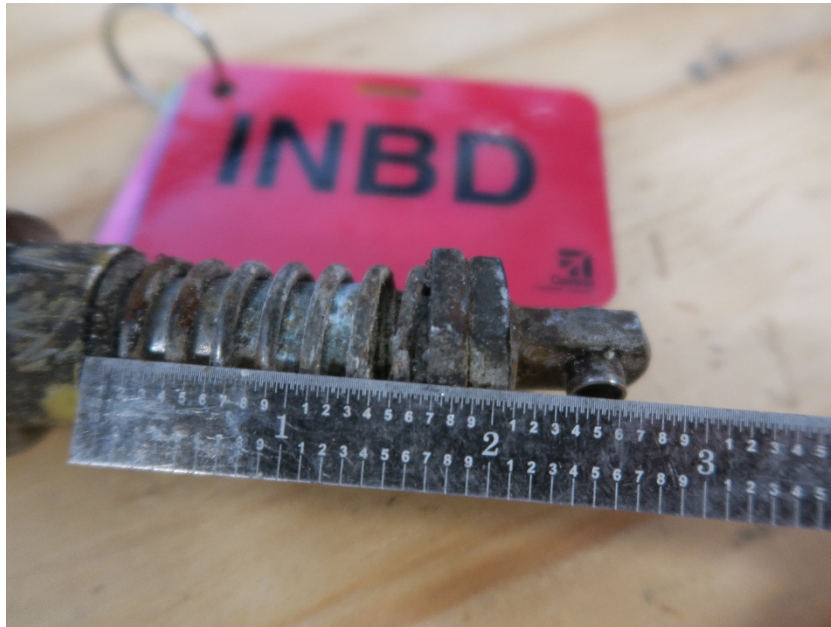
The left inboard flap actuator was extended 2.55" which equates to about 0-10° extended. The flap actuator flex drive cable was fractured at the inboard flap actuator. The left outboard flap actuator was extended 2.95" which equates to about 10° extended. The flap actuator flex drive cable was partially separated, stretched and the strands were separated near the outboard flap actuator assembly. Due to the impact damage to the flap actuator flex cable the flap actuator measurements was not deemed a reliable source of preimpact flap settings.

Photo 7 - Left inboard flap actuator

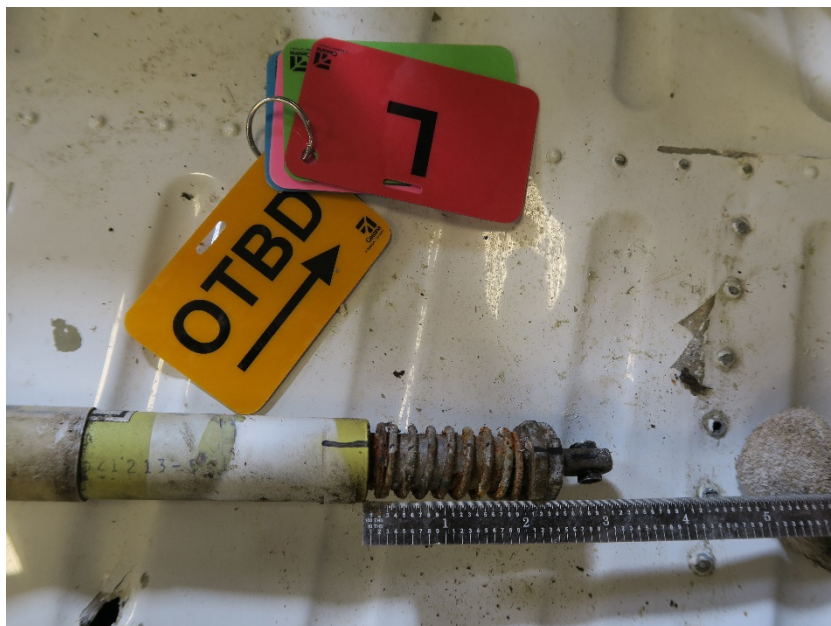
Photo 8 - Left outboard flap actuator

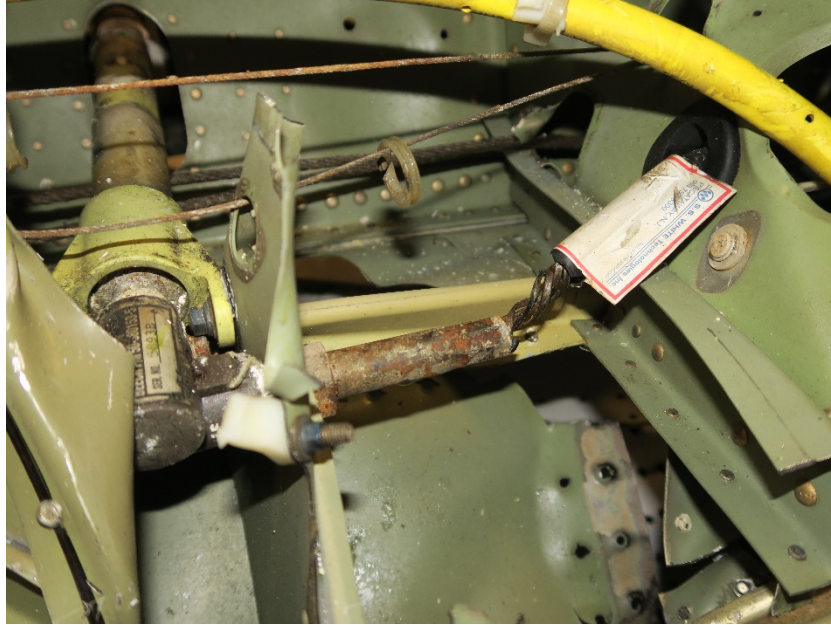
Photo 9 - Flap flex drive cable

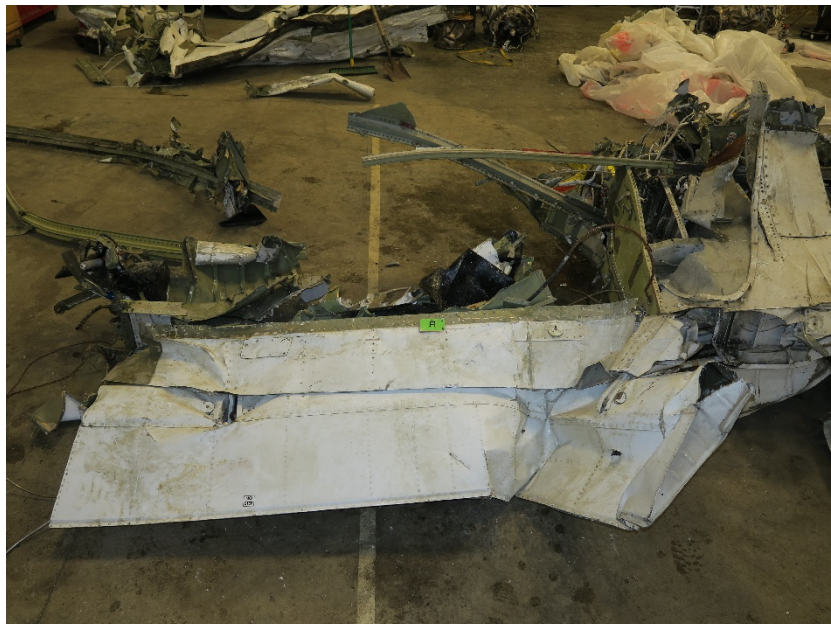
The right wing was heavily fragmented and appeared to sustain more impact damage than the left wing. The right wing structure was separated into multiple sections. The first major section included the inboard flap and aft spar section fragment from the wing root to the nacelle.

Photo 10 - Right inboard wing section

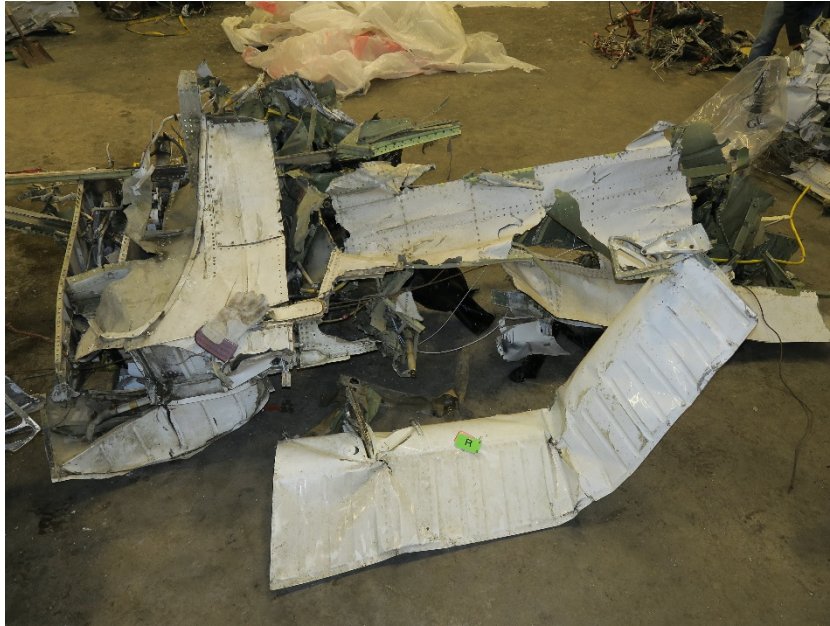
The next section of the right wing included the aft portion of the right engine nacelle and the right main landing gear along with about an 8' long section of the wing outboard of the nacelle. The outboard right flap was separated from the wing structure.

Photo 11 - Right engine nacelle and right outboard flap

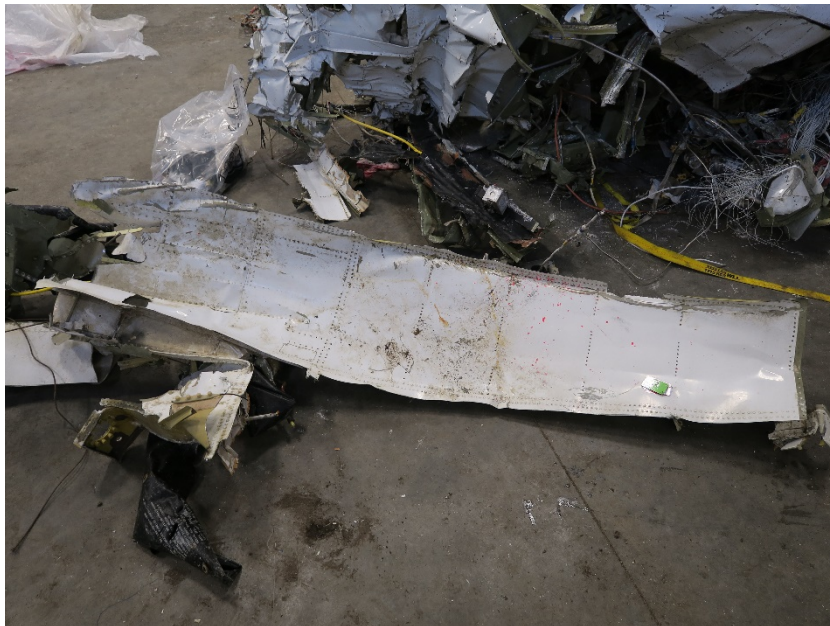
The remaining outboard right wing structure consisted of about a 10' x 3' section of the top wing skin with the right aileron bellcrank attached. The right aileron bellcrank was found fractured. One of the right aileron control cables was continuous from the fractured bellcrank to the wing root. The other right aileron control cable was cut by recovery personnel about 3" from the bellcrank; the remaining length of cable was continuous to the wing root.

Photo 12 - Outboard right wing top skin

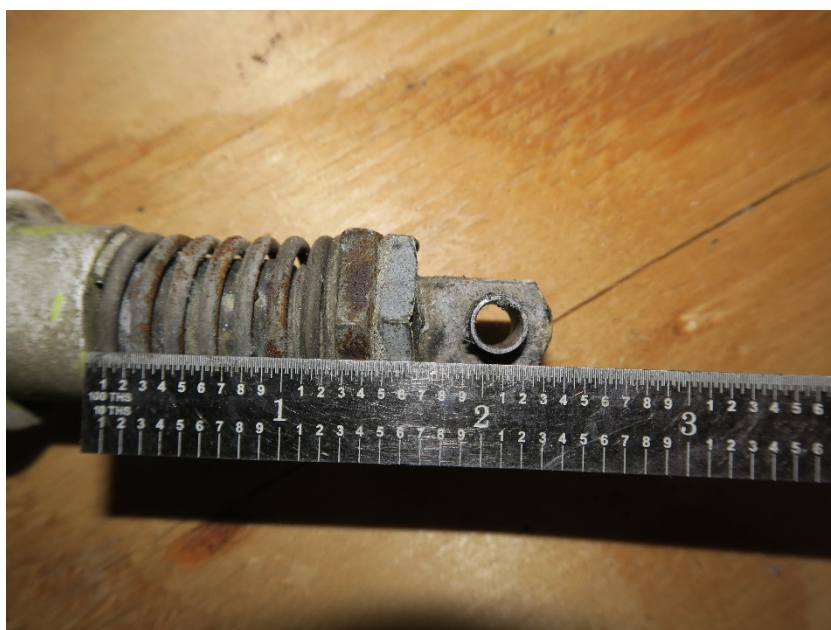
The right inboard flap actuator was extended 2.10" which equates to 0° extended (fully retracted). The flap actuator flex drive cable attachment fitting was fractured and separated at the right inboard flap actuator. The outboard right flap actuator was extended 1.70" which also equates to fully retracted. The outboard right flap actuator flex drive cable remained attached to the outboard right flap actuator.

Photo 13 - Right inboard flap actuator

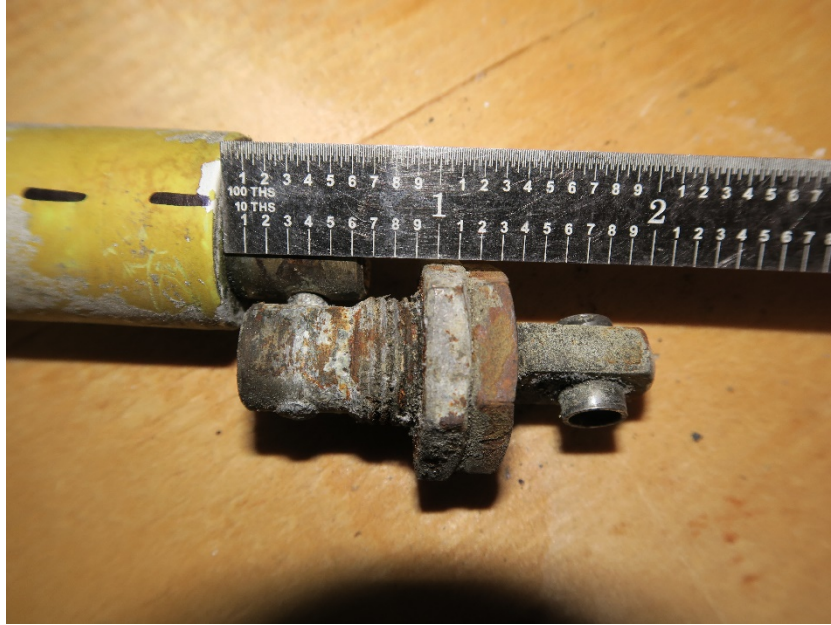
Photo 14 - Right outboard flap actuator

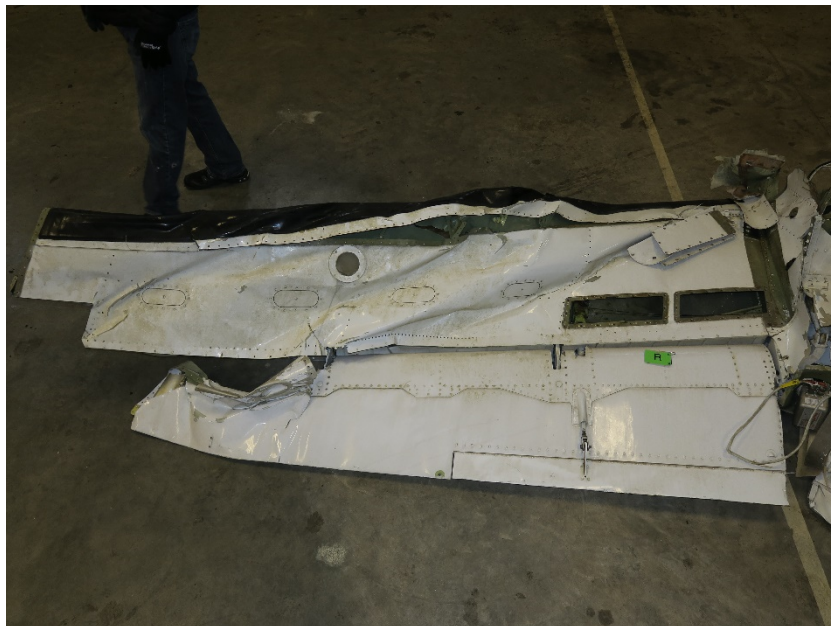
The top portion of the tail, which included most of the right horizontal stabilizer, right elevator, and about a 3' section of the left elevator, was separated from the vertical stabilizer. About 2' of the outboard right elevator was not observed.

Photo 15 - Right horizontal stabilizer and elevator

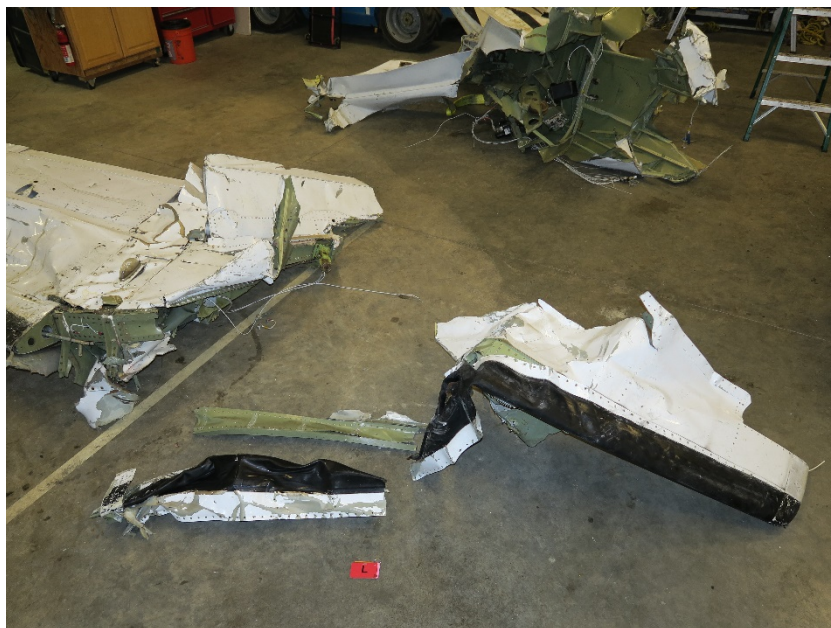
About a 4' long section of the left horizontal stabilizer leading edge skin and forward spar fragment were found separated from the structure. The remainder of the outboard left horizontal

stabilizer, about a 6' long section, was bent downward. The remainder of the left elevator was not observed.

Photo 16 - Left horizontal stabilizer

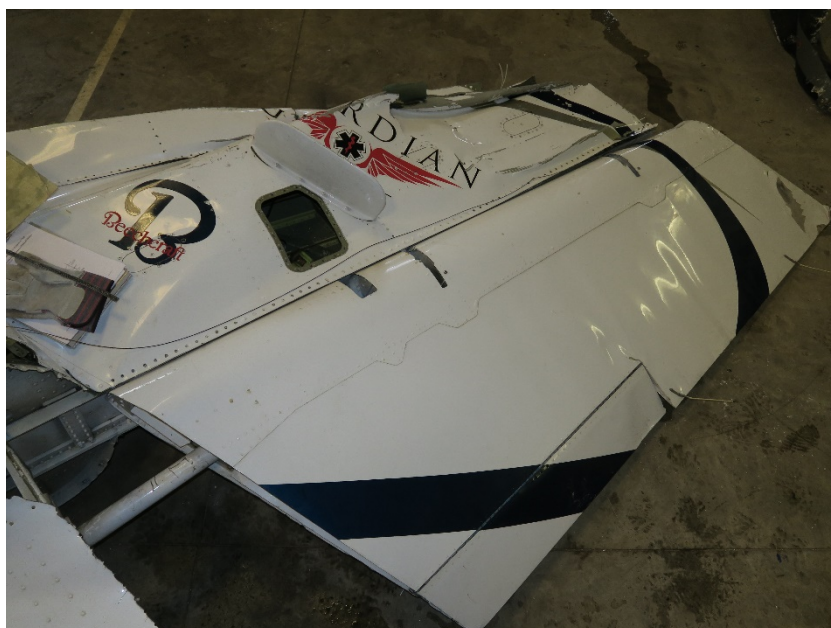
The vertical stabilizer separated and exhibited leading edge impact damage. The rudder remained attached to its attach points and was relatively undamaged.

Photo 17 - Vertical stabilizer and rudder

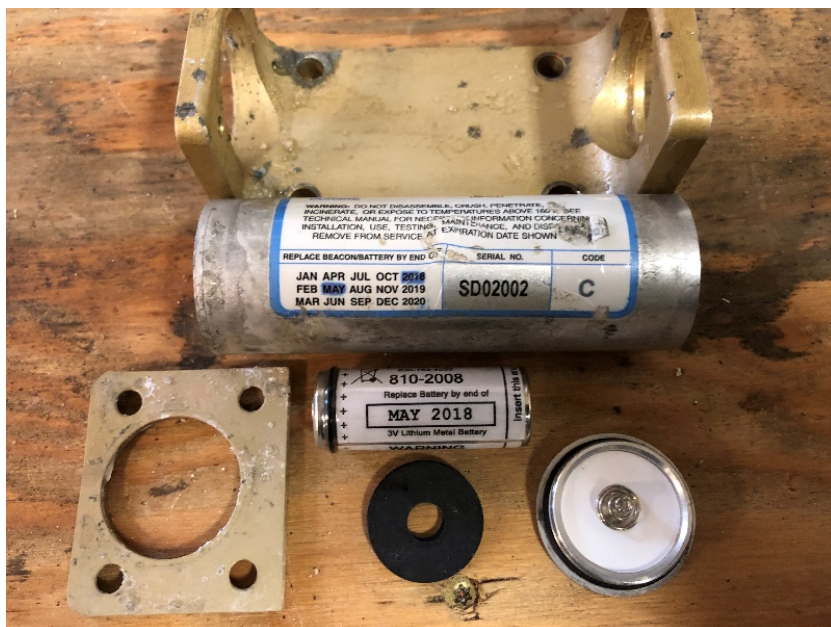
- Dukane DK-120
- Expired May 2018

Photo 18 – Dukane DK-120 underwater beacon

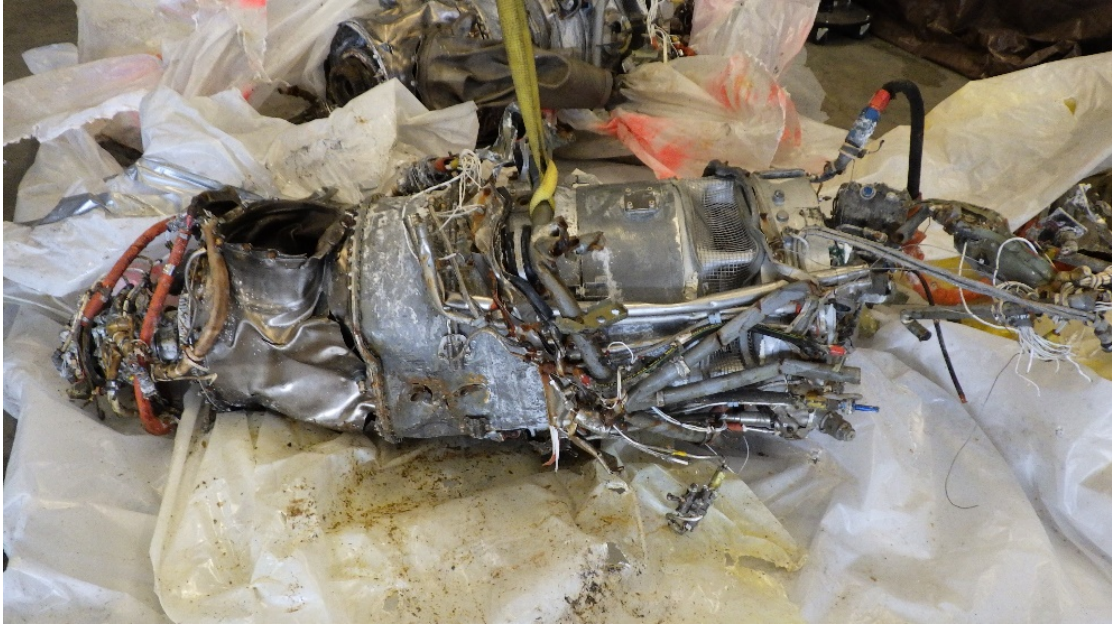
The LH engine was received wrapped in plastic. Removal of the plastic, revealed the engine with parts of the airframe mount, some airframe accessories, wiring harnesses, and firewall still attached. The external surfaces of the engine were covered with environmental debris. The Gas Generator and Power Section modules data plates confirmed the engine S/N RX0633.

Photo 19 - Left engine

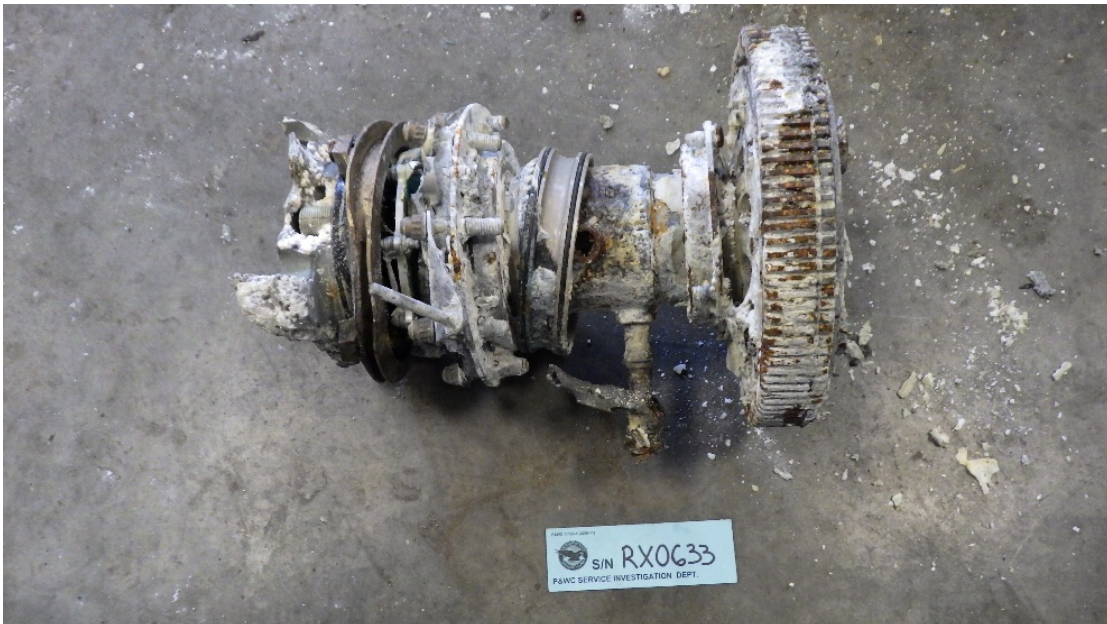
The propeller hub flange and beta ring were still attached to the reduction gearbox (RGB) gear-train. The RGB housings had dissolved. The gears were visible and covered with environmental debris, but were not damaged. The 1st and 2nd stage planet gears could be rotated. The No. 4 bearing oil nozzle tip had been partially removed due to rotational wear. The compressor rotor and the power turbine (PT) rotor / propeller shaft were seized.

Photo 20 - Left engine propeller hub flange and beta ring

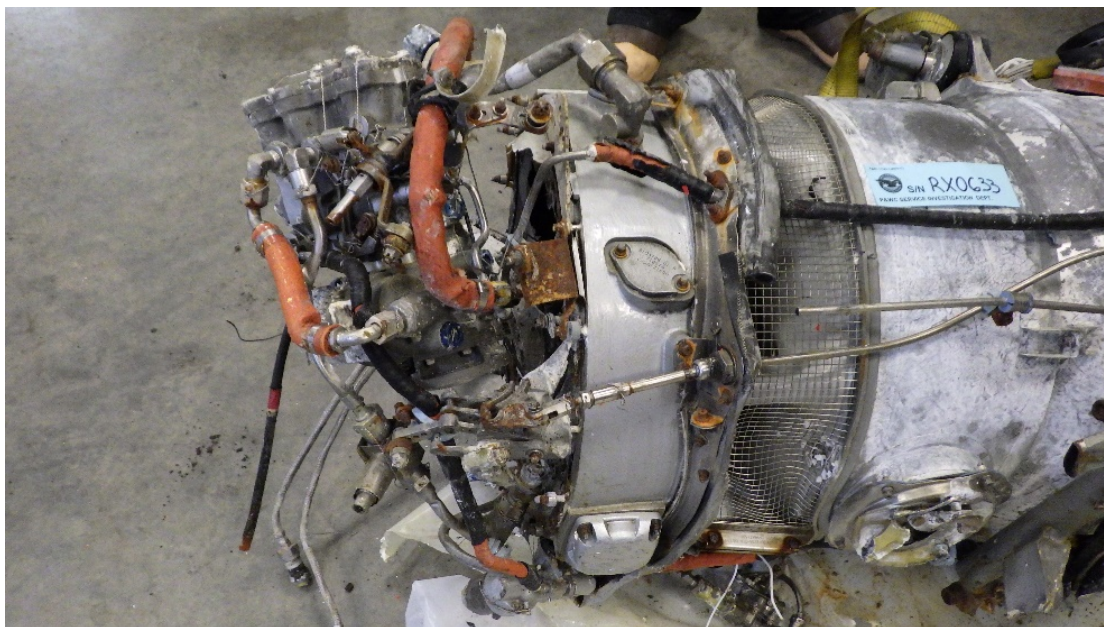
The Accessory Gearbox (AGB) housing had dissolved and most of the gears were not found. A portion of the inlet screen had rolled over on itself and a portion of the screen had been compressed inwards. The internal gas path of the inlet case was covered with environmental debris. Some compressor 1st stage blades found deformed without evidence of pre-impact Foreign Object Damage (FOD).

Photo 21 - Left engine accessory gearbox

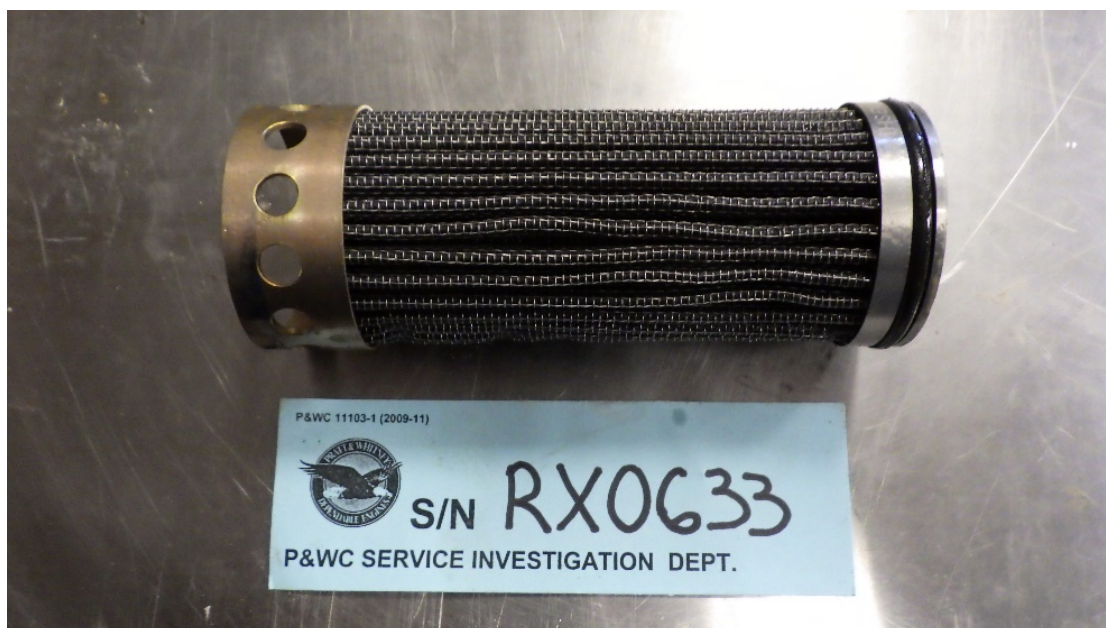
The RGB and AGB Chip Detectors were not received. The oil filter was clean and did not show signs of metal contamination. Both Ignition Plugs were still secured and tightened.

Photo 22 - Left engine oil filter

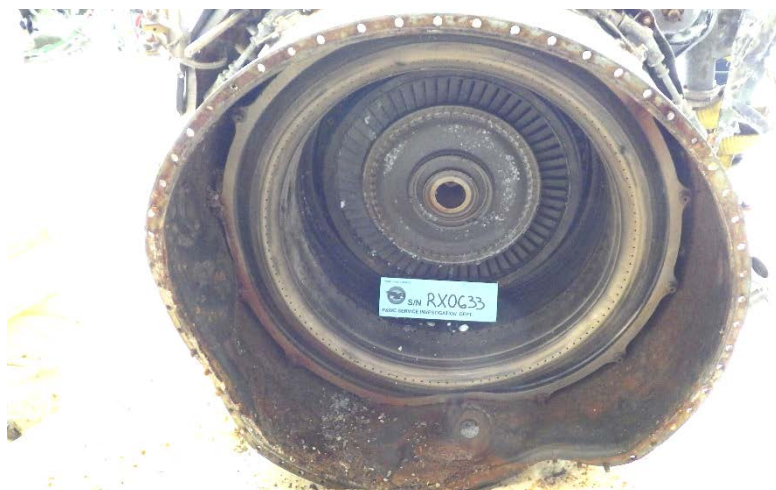
The Compressor Turbine disk downstream showed some rotational rubbing on the disk in the firtree region and under the blade platform. Some rotational contacts were also observed at the lip of disk center bore. The Compressor Turbine Shroud Segments presented a light rub, but exhibited normal operational wear. The Compressor Turbine Vane Ring was removed and found in good condition. It showed no signs of FOD. However, it was covered with environmental debris. The Combustion Chamber Liners were found to show mechanical damages from impact, but no evidence of any burning or overtemperature exposure was observed. Otherwise, they showed only operational wear. The Small Exit Duct was found in good condition.

Photo 23 - Left engine compressor turbine disk

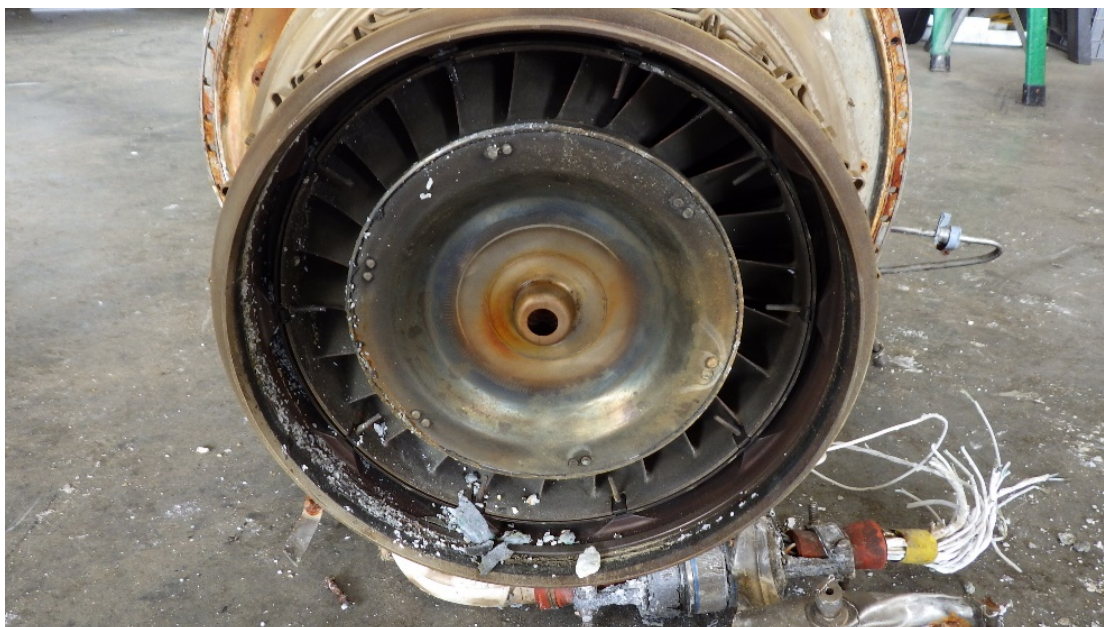
The Power Turbine (PT) vane ring and the Inter Turbine Temperature (ITT) Probes, Busbar, and Harness were found in good condition. The PT vane ring was removed and presented on the upstream side rubbing on the inner wall, around the center button and on the rivets. The PT vane ring presented on the downstream side exhibited on the shroud housing deep circumferential grooves from contact with the knife edges of the PT blades shroud tips. The PT vane ring inner and outer walls both showed circumferential rubbing contact from the PT blades firtree region and the edges of the shroud tips respectively. The 1st stage PT blades upstream showed rotational rubbing at the firtree region, the blade shrouded tips and the upstream side of the blade shroud tips. Due to access limitations, the 2nd stage PT blades were examined on the downstream side through the exhaust duct ports. The 2nd stage PT blades showed a rotational score at mid airfoil on some blades.

Photo 24 - Left engine power turbine vane ring

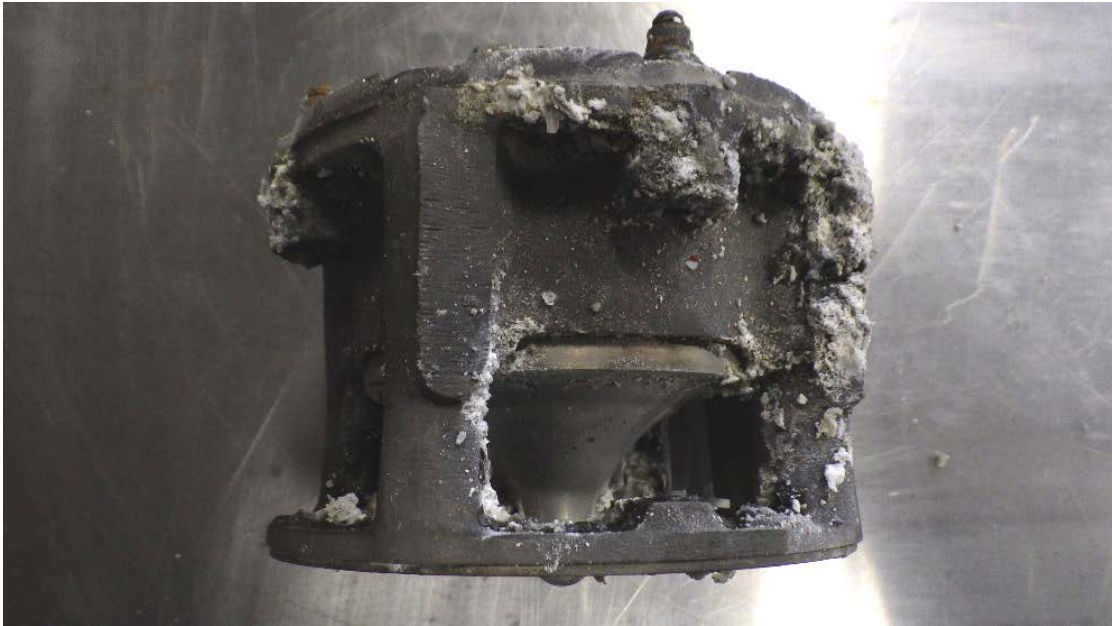
The Compressor Bleed Valve (BOV) was removed and was found in the open position. The piston and the housing were covered with environmental debris. The piston moved freely through its full range of travel.

Photo 25 - Left engine compressor bleed valve

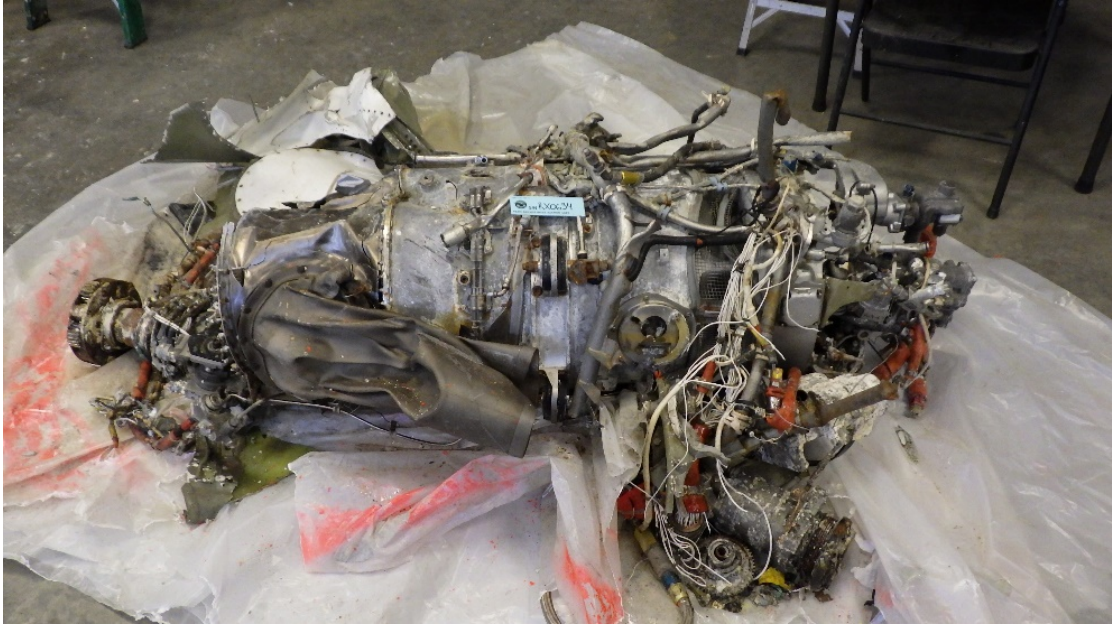
The RH engine was received wrapped in plastic. Removal of the plastic, revealed the engine with parts of the airframe mount, some airframe accessories, wiring harnesses, and firewall still attached. The external surfaces of the engine were covered with environmental debris. The Gas Generator and Power Section modules data plates confirmed the engine S/N RX0634.

Photo 26 - Right engine

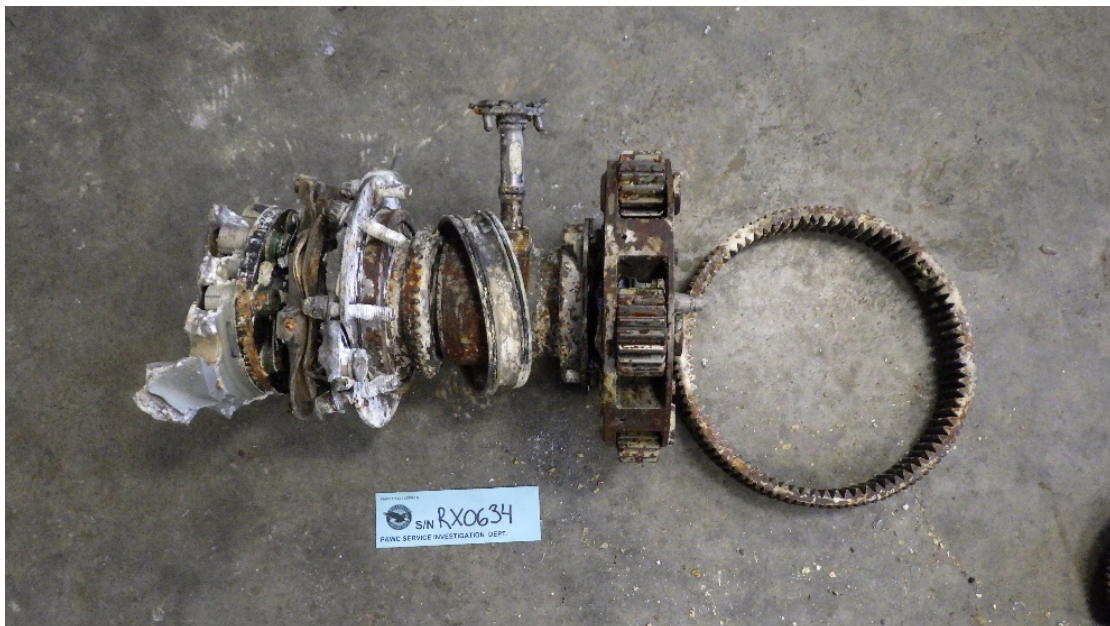
The propeller hub flange and beta ring were still attached to the RGB gear-train. The RGB housings had dissolved. The gears were visible and covered with environmental debris, but were not damaged. The 1st and 2nd stage planet gears could be rotated. The No. 4 bearing oil nozzle tip displayed rotational wear. The compressor rotor and the power turbine (PT) rotor/propeller shaft were seized.

Photo 27 - Right engine propeller hub flange and beta ring

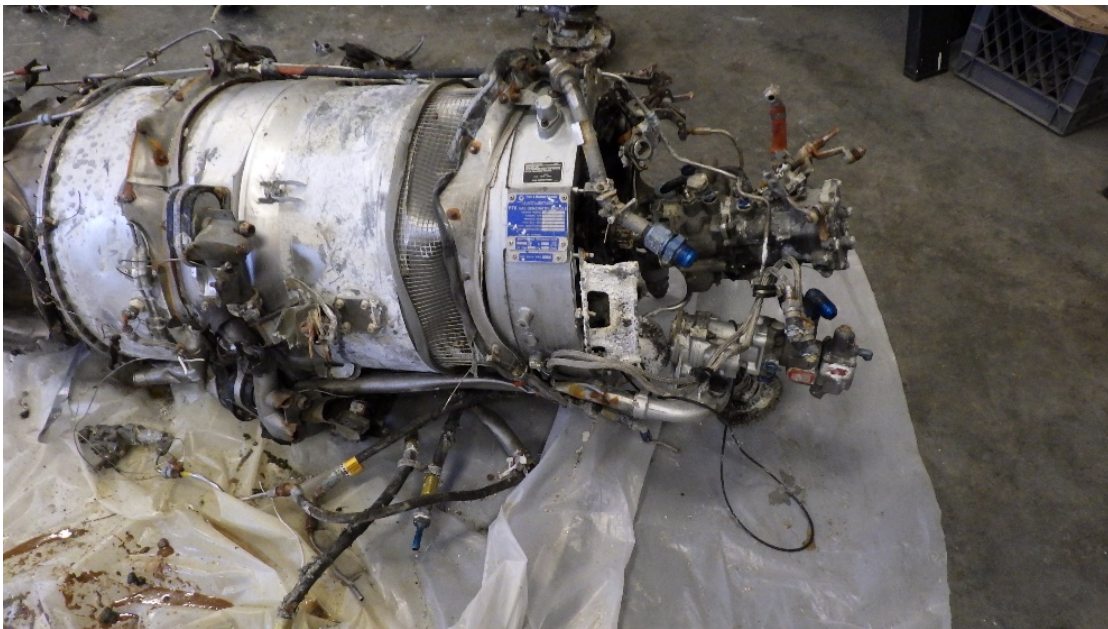
The Accessory Gearbox (AGB) housing had dissolved and some of the gears were not found. The external scavenge pump was found hanging loose due to the complete dissolution of the AGB housing. A portion of the inlet screen had rolled over on itself, with a portion of the screen had been compressed inwards and punctured. The internal gas path of the inlet case was covered with environmental debris. Some compressor 1st stage blades found deformed without evidence of Foreign Object Damage (FOD).

Photo 28 - Right engine accessory gearbox

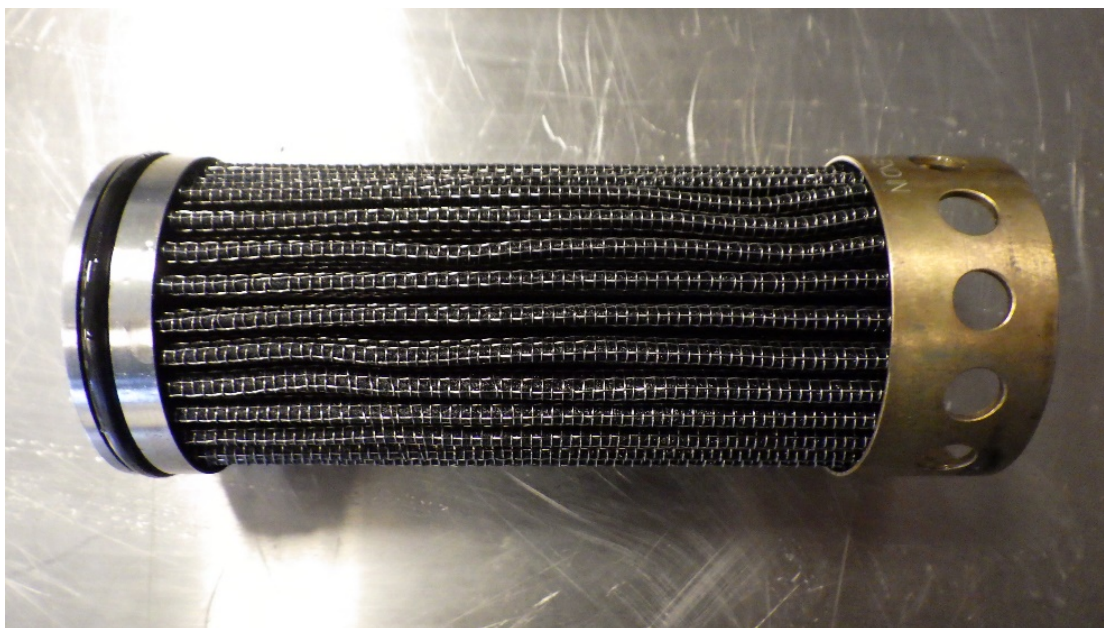
The RGB and AGB Chip Detectors were not received. The oil filter was clean and did not show signs of metal contamination. Both Ignition Plugs were secured and tightened. One of the leads was fractured. The exciter box was found still attached to the airframe mounting strut and was mechanically damaged with both ignition leads fractured at their respective boss.

Photo 29 - Right engine oil filter

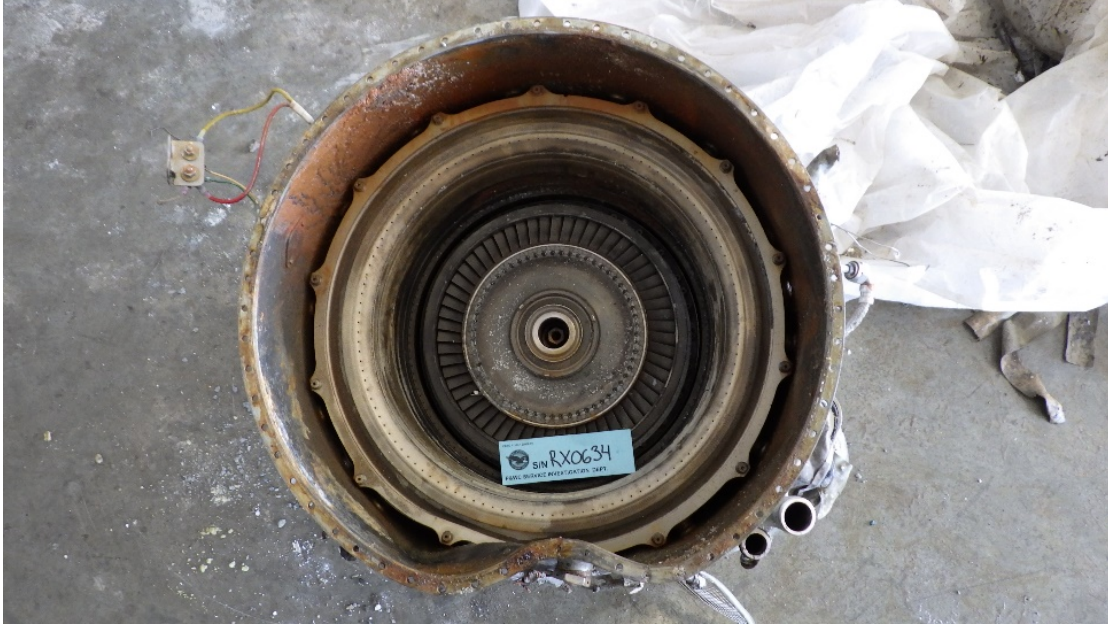
The Compressor Turbine disk downstream showed some rotational rubbing on the disk in the firtree region and under the blade platform. Some rotational contacts were also observed at the lip of disk center bore. The Compressor Turbine Shroud Segments presented a light rub, but exhibited normal operational wear. The Compressor Turbine Guide Vane Ring was removed and found in good condition. It showed no signs of pre-impact FOD. However, it was covered with environmental debris. The Combustion Chamber Liners were found to show mechanical damages from impact, but no evidence of any burning or overtemperature exposure was observed. Otherwise, they showed only operational wear. The Small Exit Duct was found in good condition.

Photo 30 - Right engine compressor turbine disk

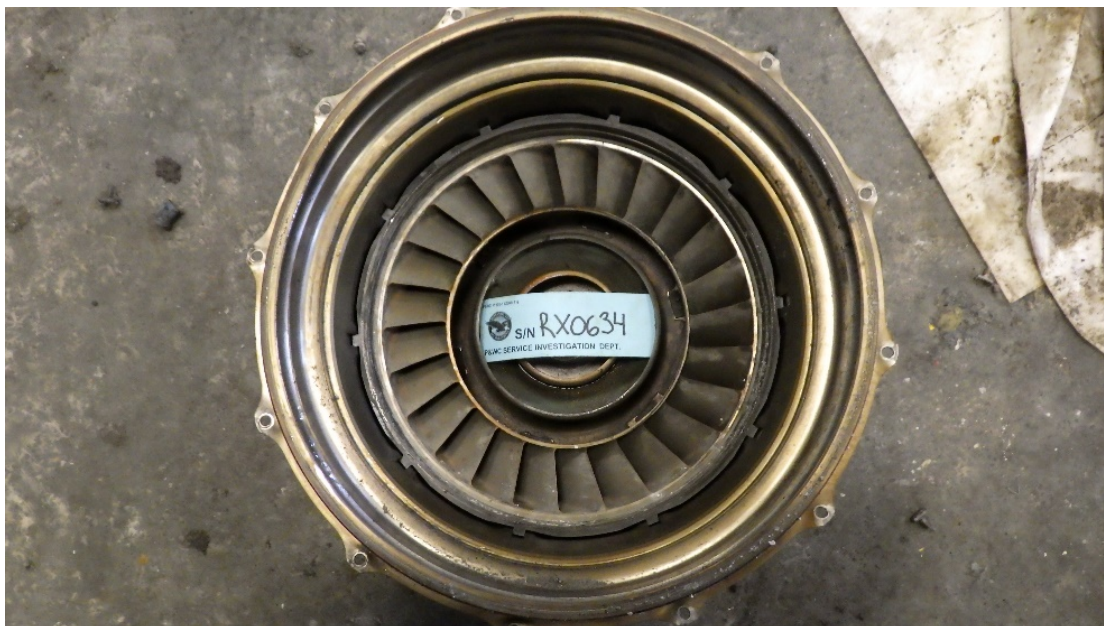
The Power Turbine (PT) vane ring and the ITT Probes, Busbar, and Harness were found in good condition. The PT vane ring was removed and presented on the upstream side showing rubbing on the inner wall, around the center button and on the rivets. The PT vane ring presented on the downstream side exhibited on the shroud housing deep circumferential grooves from contact with the knife edges of the PT blades shroud tips. The PT vane ring inner and outer walls both showed circumferential rubbing contact from the PT blades firtree region and the edges of the shroud tips respectively. The 1st stage PT blades upstream showed rotational rubbing at the firtree region, the blade shrouded tips and the upstream side of the blade shroud tips. Due to access limitations, the 2nd stage PT blades were examined on the downstream side through the exhaust duct ports. The 2nd stage PT blades showed only normal operational wear.

Photo 31 - Right engine power turbine vane ring

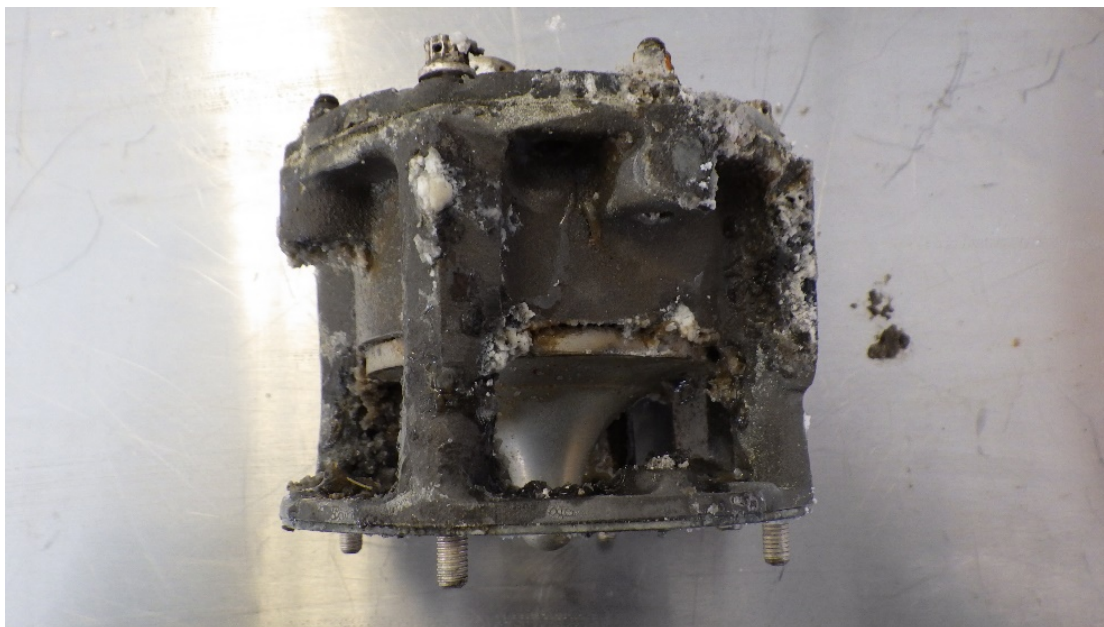
The Compressor Bleed Valve (BOV) was removed and was found in the open position. The piston and the housing were covered with environmental debris. The piston moved freely through its full range of travel.

Photo 32 - Right engine compressor bleed valve
