Examination Summary

NTSB ACCIDENT NUMBER: ANC19FA012

ANC19FA012 N13LY Raytheon Aircraft Company B200

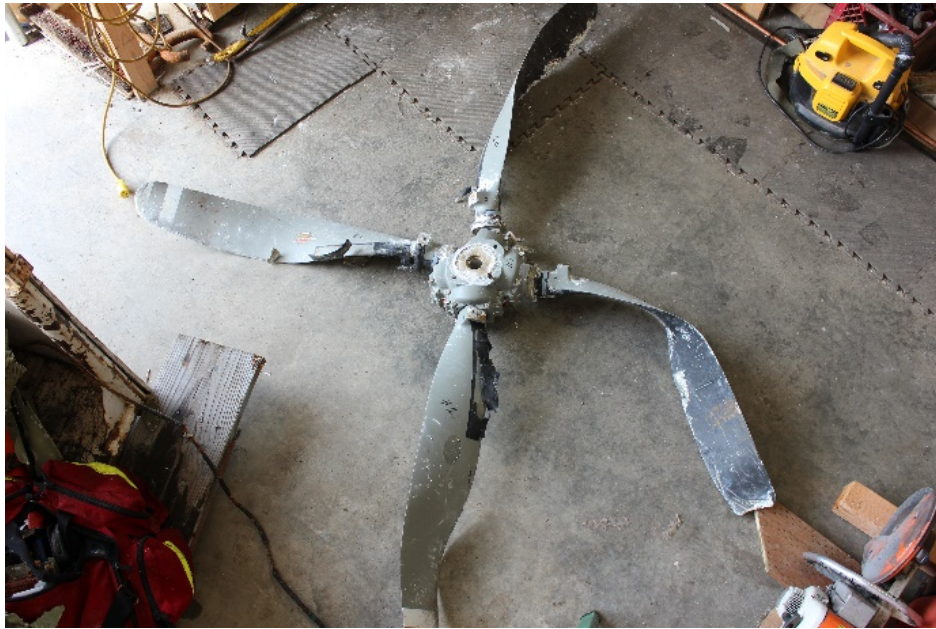
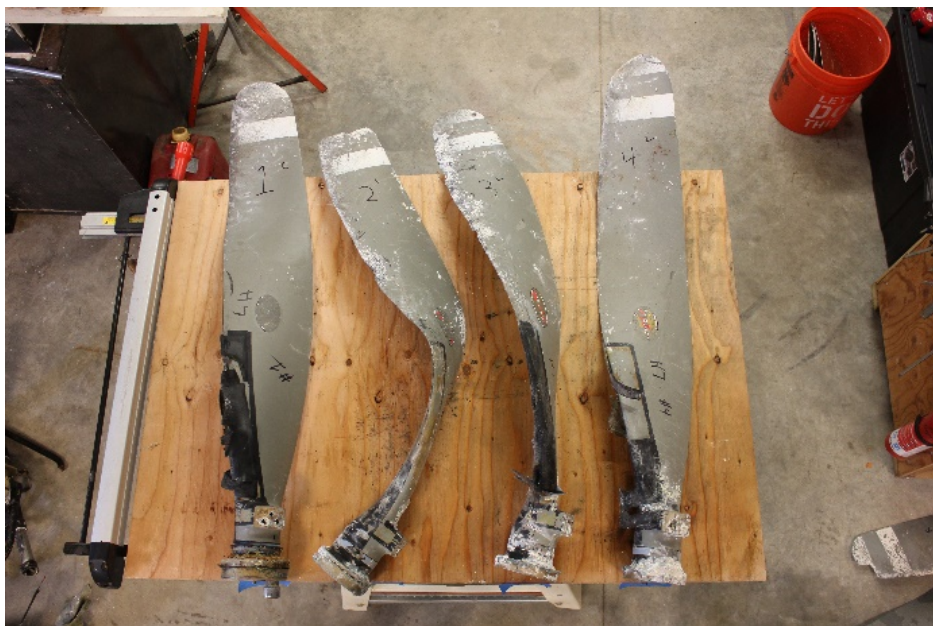
- Blade 1 – exhibited torsional twisting
- Blade 2 – exhibited torsional twisting, leading edge gouging and missing tip
- Blade 3 – exhibited torsional twisting and leading edge gouging
- Blade 4 – exhibited torsional twisting

Photo 33 - Left propeller

Photo 34 - Left propeller blades

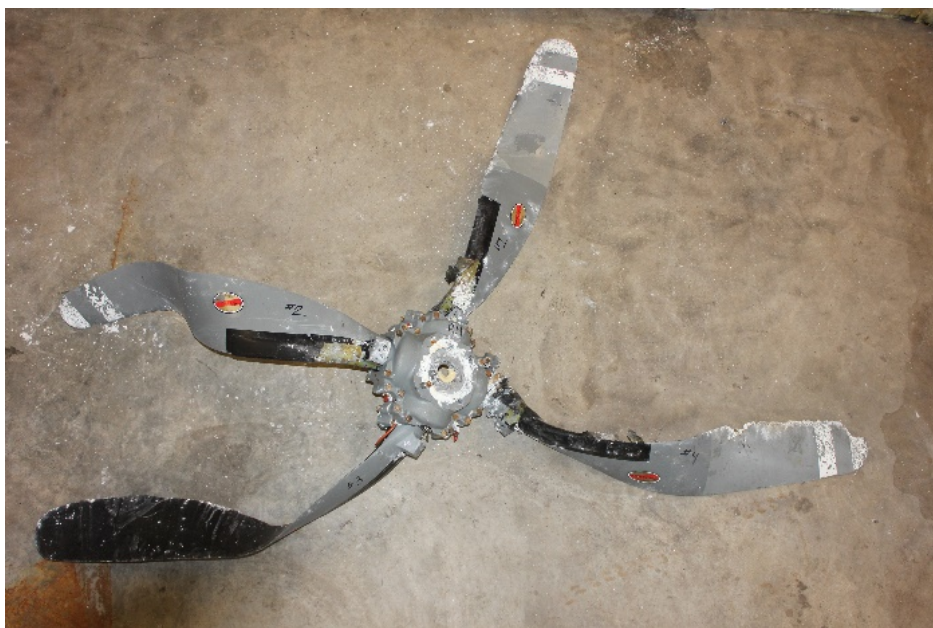
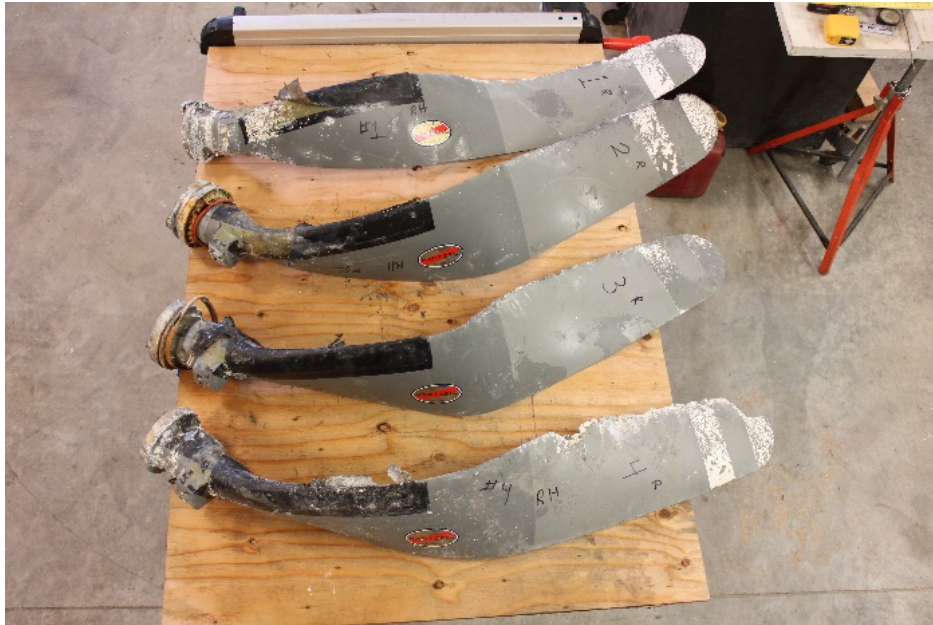
- Blade 1 – exhibited torsional twisting and leading-edge gouging
- Blade 2 – exhibited torsional twisting and leading-edge gouging
- Blade 3 – exhibited torsional twisting and leading-edge gouging
- Blade 4 – exhibited torsional twisting and leading-edge gouging and a portion of the tip was missing

Photo 35 - Right propeller

Photo 36 - Right propeller blades
