NATIONAL TRANSPORTATION SAFETY BOARD

**Field, Airframe and Engine
Examinations Summary**

NTSB Number:	ANC19FA033
Location:	Ketchikan, Alaska
Date:	July 11, 2019
Aircraft:	N5840P PA-24-180
Investigator-in-Charge (IIC):	Noreen Price
Parties to the Investigation:	Lana Boler, FAA Aviation Safety Inspector IIC Kathryn Whitaker, Air Safety Investigator, Piper Aircraft Mark Platt, Sr Air Safety Investigator, Lycoming Engines

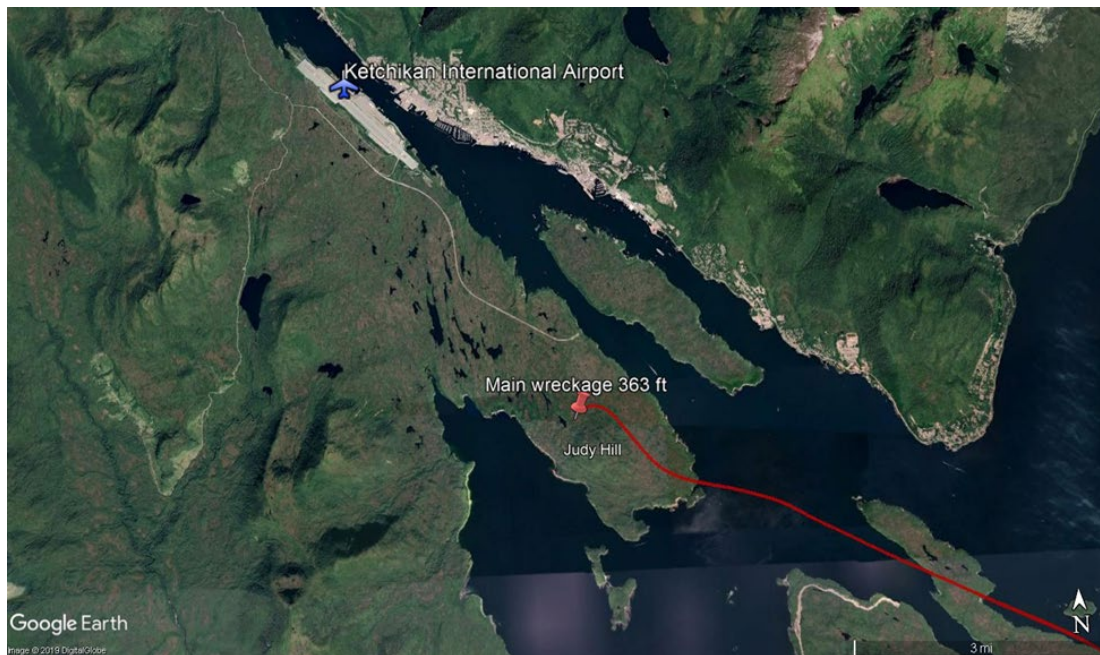
Figure 1. GPS track

A review of downloaded GPS data from airplane's Garmin GPSMap 396 revealed that the airplane flew a mostly direct route to the KTN terminal area. At 1418, north of Judy Hill, the airplane started turning left from a 322° track toward the southwest. The airplane descended from 775 ft to 447 ft GPS altitude during the left turn and the last groundspeed data was 118 knots. Refer to figure 1.

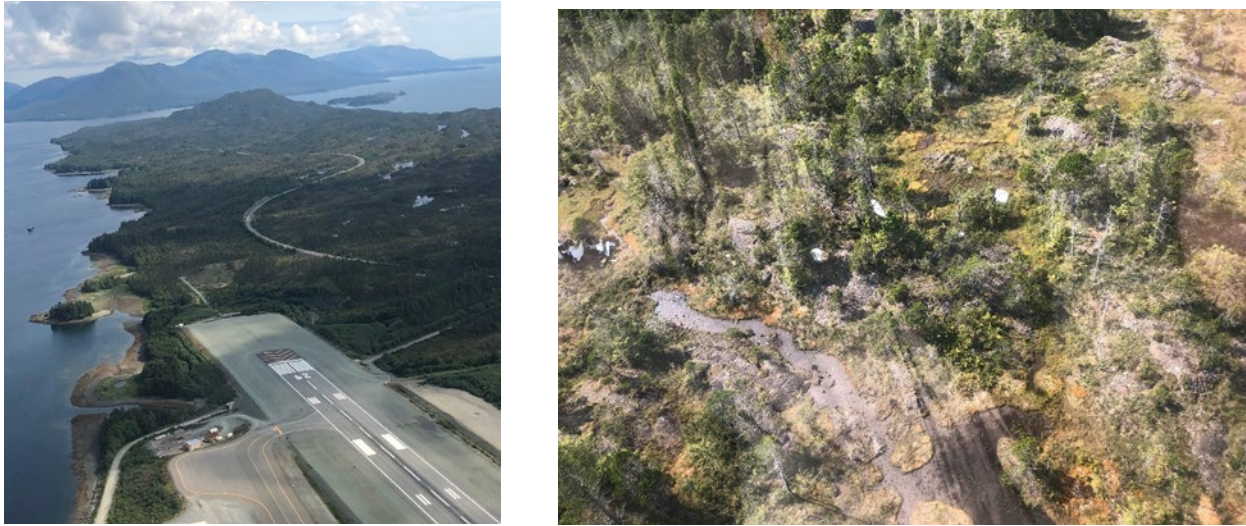
Figure 2. Judy Hill view to the east (left) and aerial view of wreckage.

The NTSB and FAA IICs travelled to the scene of the accident on July 13, 2019. The wreckage was spread over 300 ft in a linear track of 193° at an elevation averaging 380 ft on the northwest side of Judy Hill. The hill is the highest terrain on the south side of the KTN and has a peak of 814 ft. The accident site consisted of relatively level marshy muskeg covered ground that was lightly treed and contained variable shrubs and large rocky outcroppings. All of the airplane's major components were located at the scene.

An aerial view of the wreckage revealed initial impact of a group of trees that had tops knocked off in a southwest direction. A view from the southwest looking northward indicated a 28-degree angle cut in the treetops at the initial impact location. (55.3018, -131.6512) White paint flakes were observed at the base of the trees. Propeller cuts were observed on two broken tree sections. Refer to figures 2 and 3.

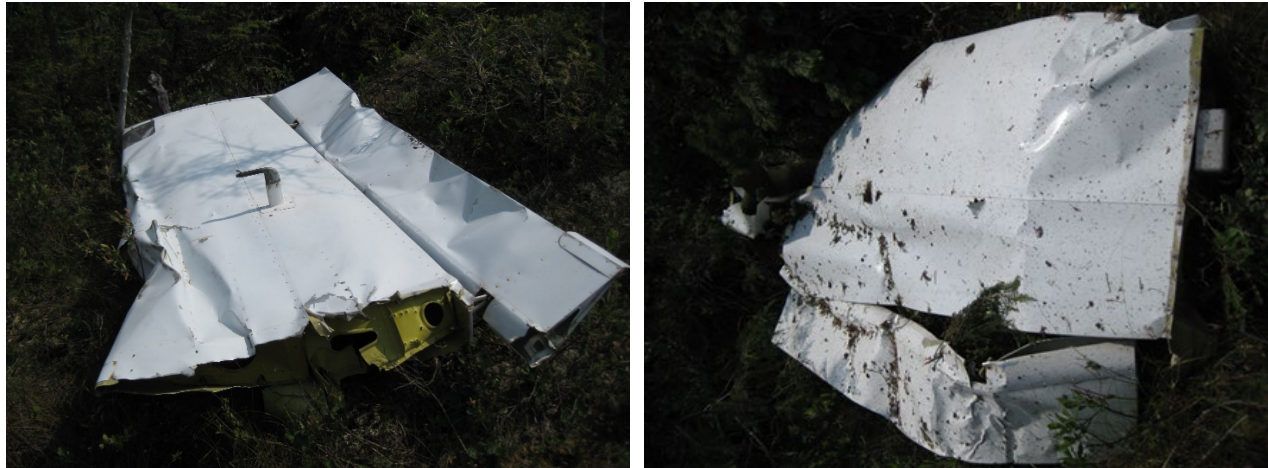
Figure 6. Underside of left wing outboard section (left) and right wing section

The first airplane section in the debris field nearest the initial impact, was the left outboard wing section, which had an indentation on the leading edge consistent with tree impact. The separation fractures indicated

rearward deformation of the spar. The aileron was attached and exhibited minor buckling throughout. A green engine cowling with crush damage was laying on the ground about 20 feet down the debris field.

The right outboard wing section was located about 45 ft from the left wing section. The wing tip was not present, and the aileron was attached. The aileron control rod was missing and fractured at connecting end. The aileron control cable nuts were broken at the bellcrank. A large tree like elliptical compression was evident at the leading edge. The fractured spar and torn skin were deformed in a rearward direction.

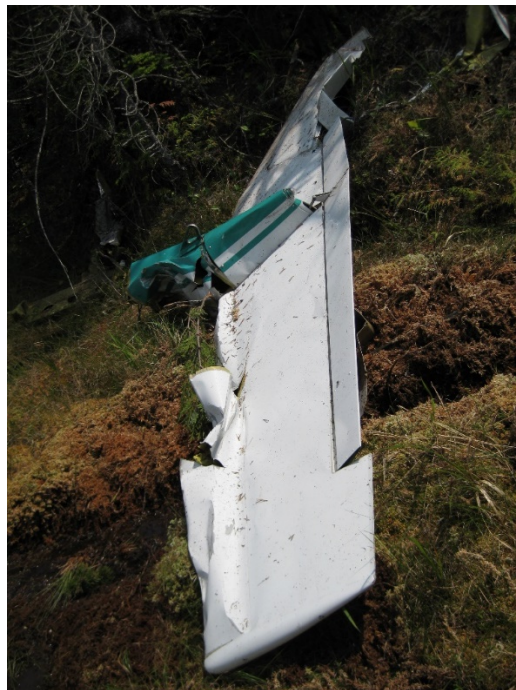
Figure 7. Stabilator and tail cone

The stabilator was located inverted about 100 feet from the right wing section and had the anti-servo tab attached. The left side leading edge had semicircular indentation indicative of a tree strike and spanwise leading edge compression. The anti-servo tab was deformed with a 90 degree bend on the right side.

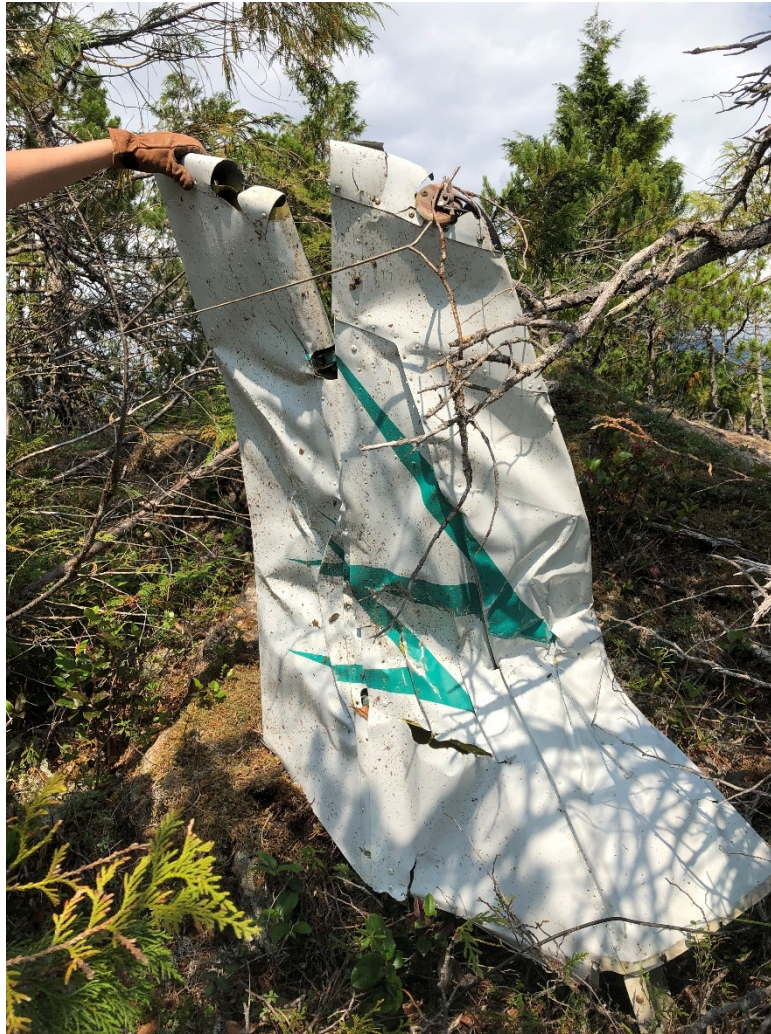
Figure 8. Vertical stabilizer and rudder

The vertical stabilizer was located about 80 feet south of the stabilator with the rudder attached. The stabilizer and rudder each exhibited top down compression buckling on the right side at their mid spans.

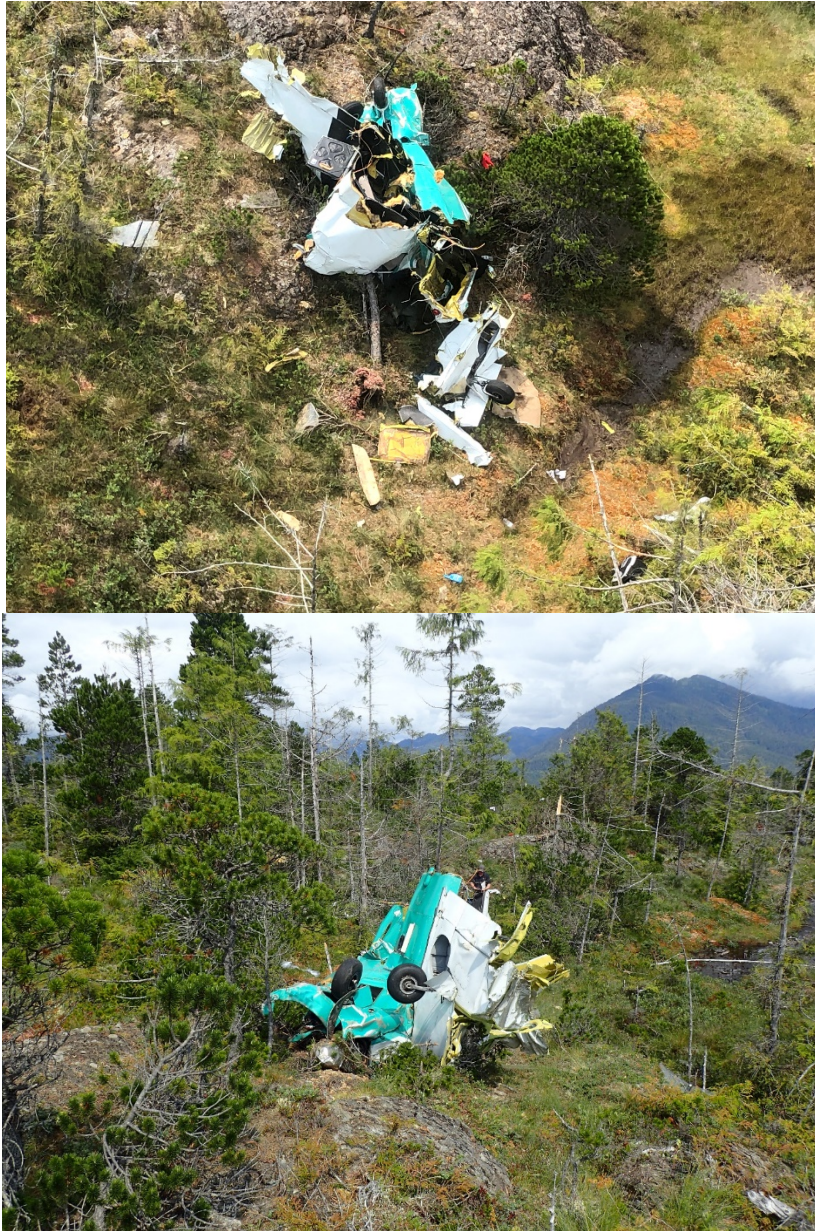
Figure 9. Main wreckage, fuselage and cabin

The fuselage came to rest at the end of the debris path up against a rock outcropping and a large, toppled tree in a mostly inverted attitude heading 190°. The forward fuselage was resting in a level, inverted, slightly nose downward attitude on the ground, and the rear fuselage fractured behind the front seats and jutting upward. The right inboard wing and landing gear were attached to the fuselage and the left inboard wing section and landing gear was separated and held to the fuselage by control cables. The empennage was separated from the fuselage at the rear bulkhead and was hanging downward toward the ground. The engine and propeller were attached to the forward fuselage but displaced leftward and crushed into the surface.

The cockpit seats were in place and the pilot seat belts were intact and unfastened. The instrument panel was intact. The flap handle was in the retracted position.

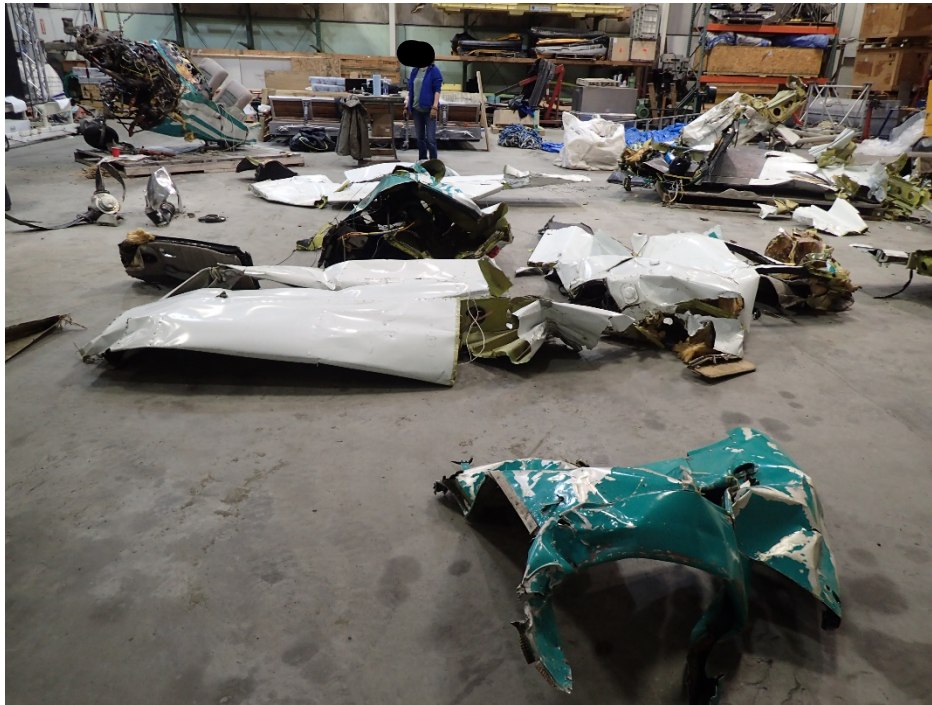
Figure 10. Airframe wreckage examination

The forward fuselage section had the roof section separated at the bottom of the upright supports and the doors separated from their mounts. The wind screen and windows were not present. The cockpit flight instruments and controls were intact with minor buckling at the center section. The cockpit flight controls exhibited continuity from both control columns and rudders to the aileron, elevator and rudder control cables to recovery cuts in the cables aft of the front seats about FS 136. The aileron chains were observed in tact. The flap handle was in the down (retracted) position and the landing gear switch was up. The landing gear emergency extension handle was extended fully, which corresponded to the gear fully extended position.

The aft fuselage section consisted of the center wing spar, floor, right cabin wall and baggage door. The right inboard wing section was attached and the flaps were in the retracted position. The flap control cables were in place and attached to their respective bellcranks. Extensive impact crush damage was evident at the right aileron bellcrank area. The right wing main and rear wing spars were deformed in an aft direction with deep elliptical accordion crush areas, indicative of tree strike in forward flight. The right outboard wing section was separated about 4 feet outboard of wing root. The aileron remained attached. A semi-circular impact dent consistent with a tree strike was evident at the leading edge outboard of the separation.

The left wing separated from the fuselage at its attachment points and exhibited spar deformation in a rearward direction. The flap was separated at the connecting brackets. The left outboard wing section separated at WS 97 and exhibited a semi-circular crush indentation just outboard of the separation. The left aileron was attached and exhibited minor deformation.

The empennage was separated from the fuselage at FS 157 and exhibited minor buckling throughout and a large indentation on the right side forward of the stabilator. The stabilator section was separated from the empennage with the aft tail cone in place. The balance weight was intact and the anti-servo tab was attached. The stabilator trim barrel was extended 1.25 inches which correlates to nose up trim. The right side leading edge exhibited a large semi-circular dent indicative of a tree strike in forward flight. The stabilator left tip indicated impact crush damage and the outboard section was partially separated at the trailing edge with tension signatures at the rivet line. The vertical stabilizer was separated from the empennage at the lower rivet line and exhibited some bending deformation and crush damage at the leading edge and right side. The rudder was attached and rudder control horn was fractured at the cable attachment points with overload signatures.

Flight control continuity was established from the cockpit control cable ends to the stabilator, rudder and left and right ailerons, with the exception of the right rudder cable end at the rudder horn attachment, which was not located. The flaps were in the retracted position and the control cables and bellcrank were continuous. Various fractures in the control rod ends and bellcranks exhibited dull dimpled surfaces and deformation consistent with overload failure. Numerous control cable skin tears were evident in the empennage, indicative of flight control connectivity at the time of impact.

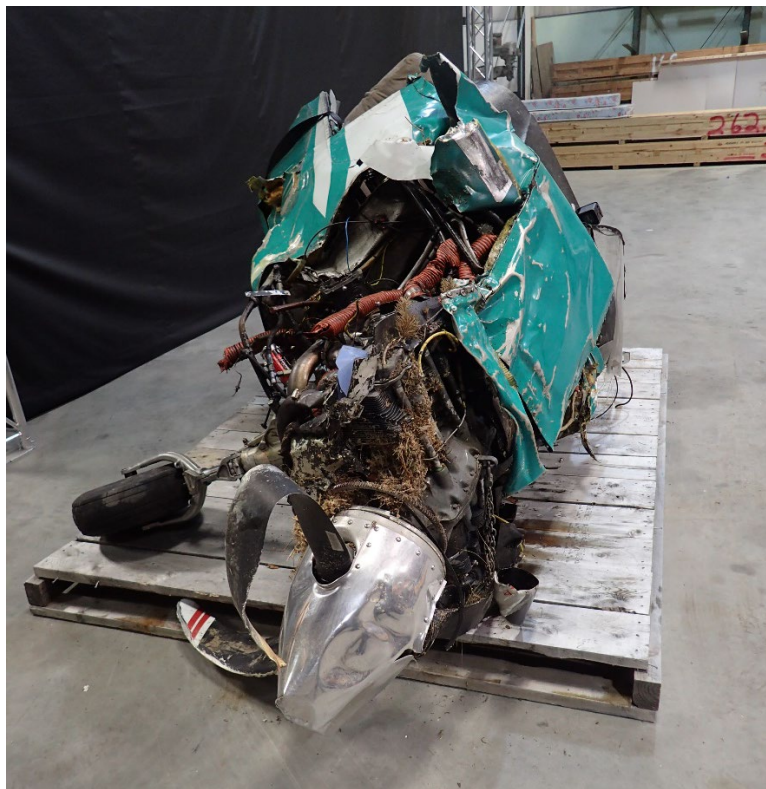
Figure 11. Engine, propeller and forward fuselage

The engine remained attached to the airframe and mounts and the propeller remained attached to the flange. An external visual examination of the engine revealed packed dirt and organic matter throughout the engine and accessories. There was no evidence of pre mishap catastrophic mechanical malfunction or fire. The no. 2 cylinder exhibited impact damage and was missing a rocker box cover and push rods.

The accessory section exhibited impact damage. The carburetor, right magneto, engine driven fuel pump and propeller governor were displaced from their mounts with fractured attachment plates that exhibited overload deformation signatures.

The propeller was removed, and the engine crank shaft manually rotated through an accessory drive. The crank shaft rotated smoothly, and compression was obtained in the proper firing order. All rocker valves moved with normal lift action. The number two cylinder rocker lift action was verified at the tappet.

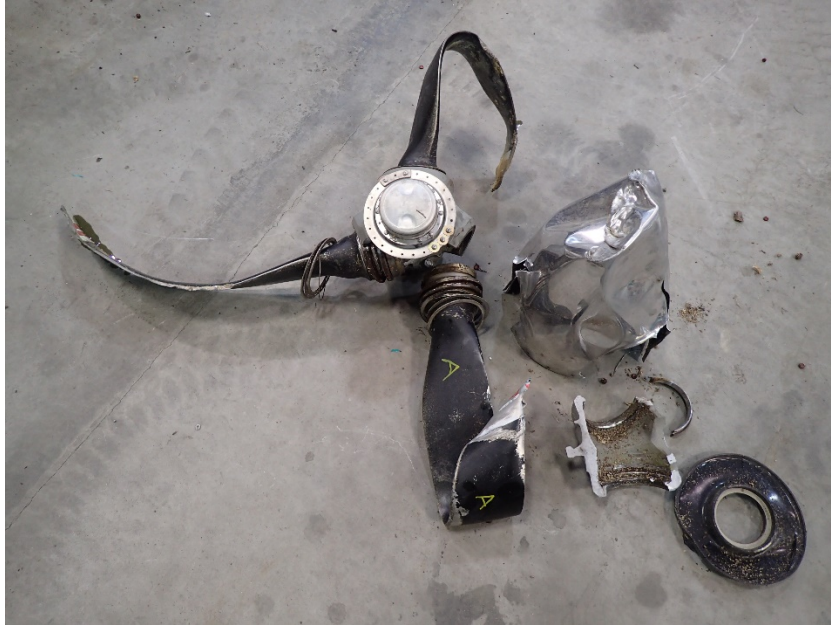
Figure 12. Propeller

The propeller spinner exhibited impact crush damage. The propeller blades were loosely attached to the hub. The propeller hub had been fractured due to the absorption of impact energy. The flywheel was fractured, and the ring support had been displaced. The propeller blades were marked as A, B and C for narrative purposes. Propeller blade “A” was situated in the fractured hub socket and deformed forward in a 360° curl

at the outer half. Extensive chordwise scratches, deep leading edge cuts, and a minor trailing edge S bending was present. A section of propeller blade tip had been torn off. Blade “B” was loose in the hub and bent inward and forward at the mid span with significant impact damage on the leading edge. A section of propeller blade tip had been torn off. Blade “C” was deformed the least, with a forward span wise bend and leading-edge impact marks. The propeller blade signatures, together with tree cuts at the scene, are consistent with impact with engine power on.
