CEN23LA107

FUEL FLOW TRANSDUCER EXAMINATION

A. ACCIDENT

Location: Lakeway, Texas
Date: February 12, 2023
Time: 0958 Local Time
Airplane: N304MA - Mooney Aircraft Corp. M20

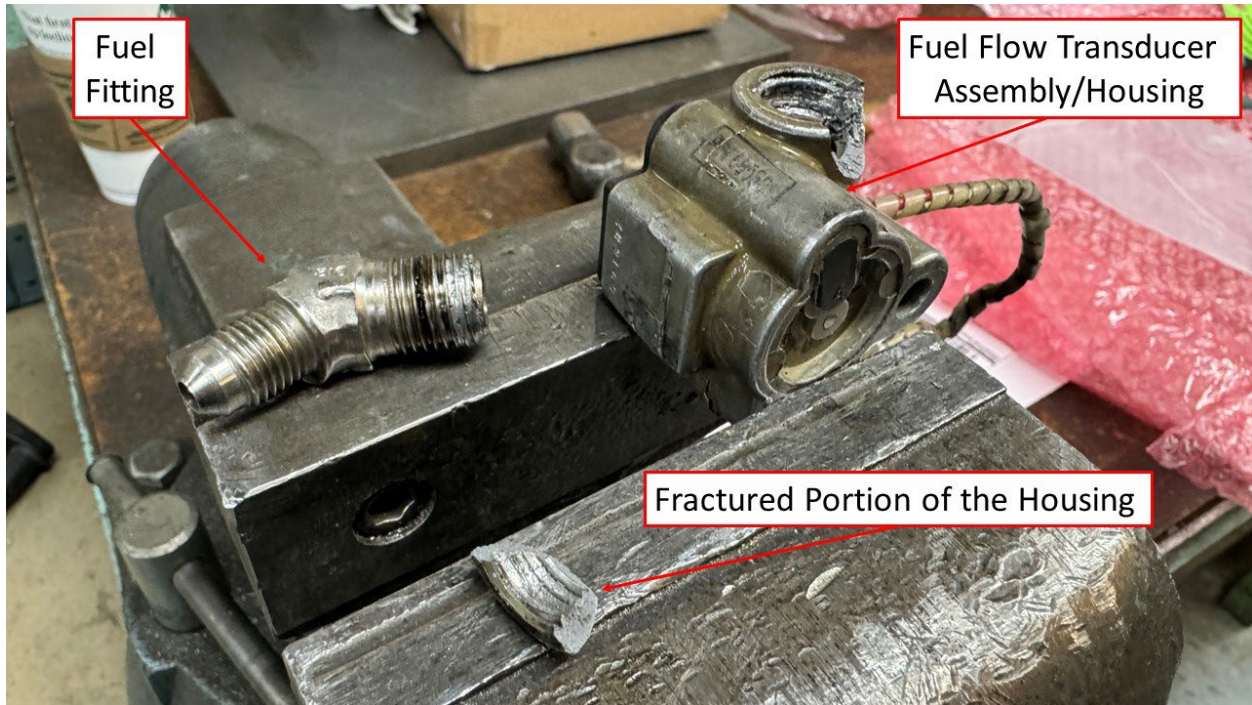
Removal of the fittings was required to facilitate functional testing of the fuel flow transducer. One fitting was removed, however, during removal of the other fitting, excessive force was needed. Penetrant oil was applied to the fitting, and it was moved clockwise and counterclockwise multiple times. When a second attempt to remove the fitting was made, while rotating it in a counterclockwise direction, the housing of the fuel flow transducer fractured. Due to the fractured housing, functional and leak testing of the unit was unable to be performed. Portions of the threaded area of the housing was observed within the threaded area of the fitting.

Figure 1: View of the fuel flow transducer, one fitting, and fractured portion of the housing.
