1
2 **ERA23FA001**

3 **October 1, 2022**

5 **Cessna 172**

6 **NTSB EXAM NOTES**

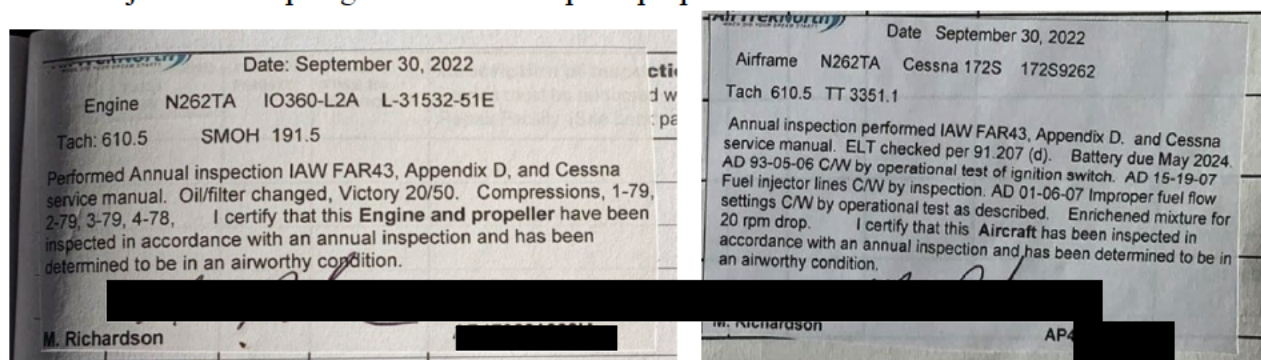
Figure 1 Airframe and Engine Records.

45
46 Maintenance records discovered at the operator in Duluth, MN. Brought up to accident site by FAA
47 Inspectors. Last mx records. Note the day of last maintenance. It was the day before the accident. Check
48 this out in a little more detail. Note to Lycoming and Textron.

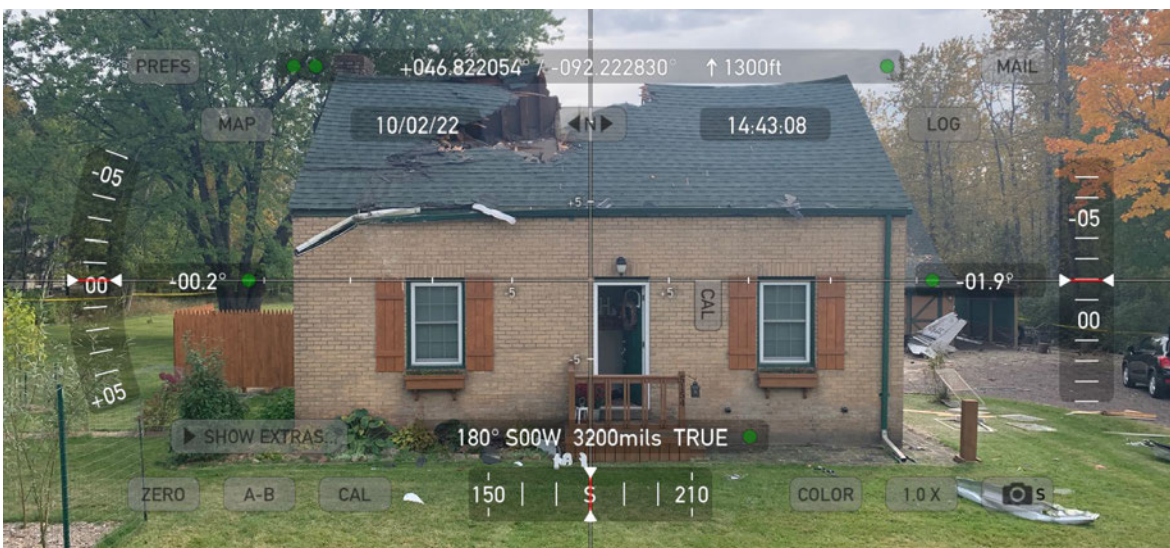
60 The airplane impacted the front facing roof of a two-story house at an elevation of about 1,300 ft,
61 and on a heading of about 208°. The airplane was in a 35° left bank as it impacted the structure
62 based on the wing and left landing gear imprint on the house as it passed through. It passed
63 through two upstairs bedrooms as the occupants of the house, a husband and wife slept, and then
64 struck terrain before coming to rest inverted between a vehicle and a detached garage. There was
65 no post-crash fire. The wreckage path was oriented on a magnetic heading of 205° and was about
66 200 ft in length. All major components of the airplane were located within the wreckage site. The
67 left wing was found in the front of the house. The wife reported that she pulled red glass out of
68 her hair. (Nav/Position Light) The occupants suffered minor injuries.

Figure 2 Front of house damage

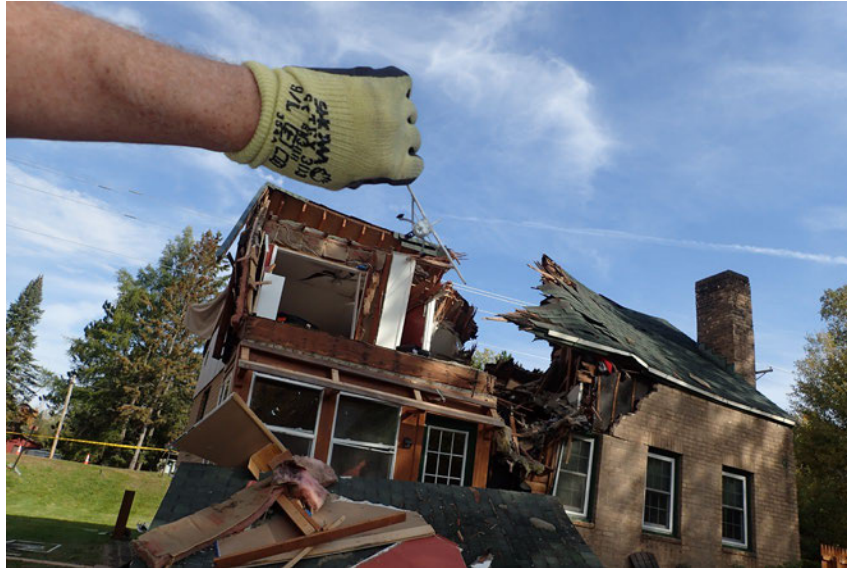
Figure 3 Back yard of house damage with airplane model and approx. angle for reference.

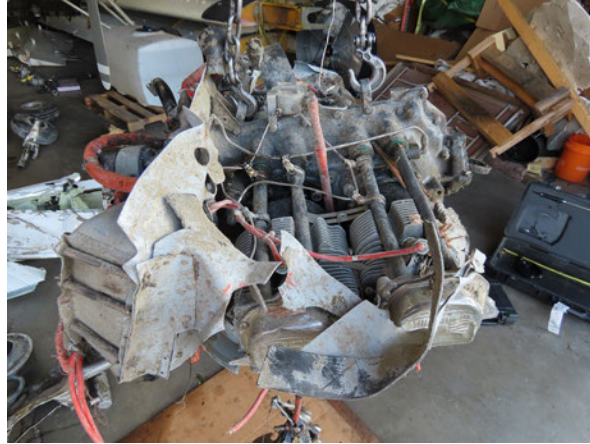
88 The engine separated during impact and was found lying next to the main wreckage in front of
89 the truck. Engine impact damaged- No. 2 cyl. No holes in the case. Damaged rocker-box covers.
90 Several 720 ° of rotation were conducted through the accessory drive and crankshaft control
91 continuity was established. All rockers, valves and most pushrods appeared normal and were well
92 lubricated. Each of the cylinder was tested for compression and suction. Several pushrods damaged.
93 Champion Spark Plug Chart: All spark plugs normal wear.

Figure 4 Engine prior to internal examination

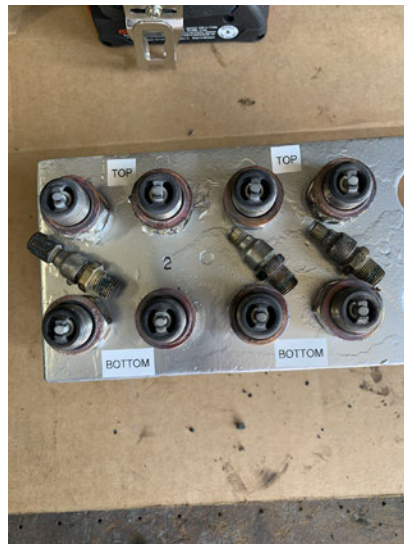
Figure 5 Spark Plugs

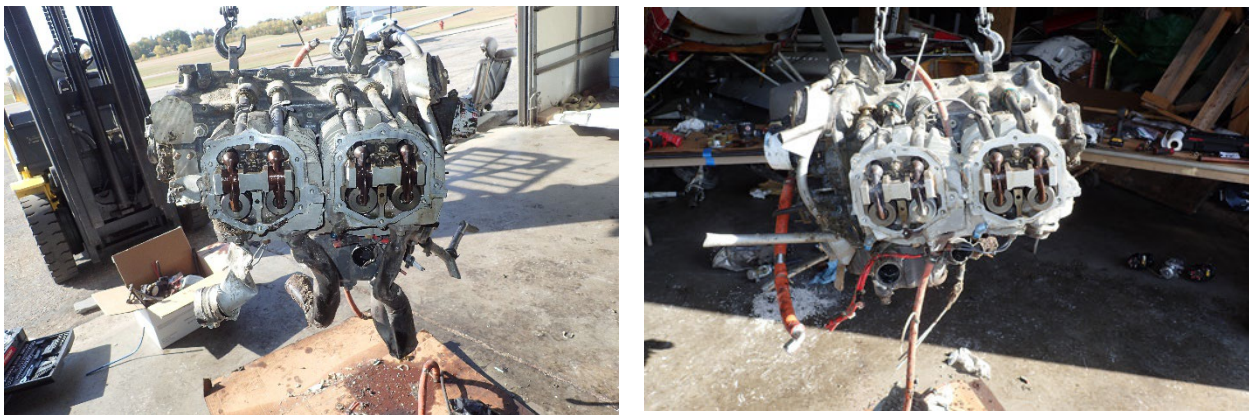
Figure 6 Engine with valve covers off.

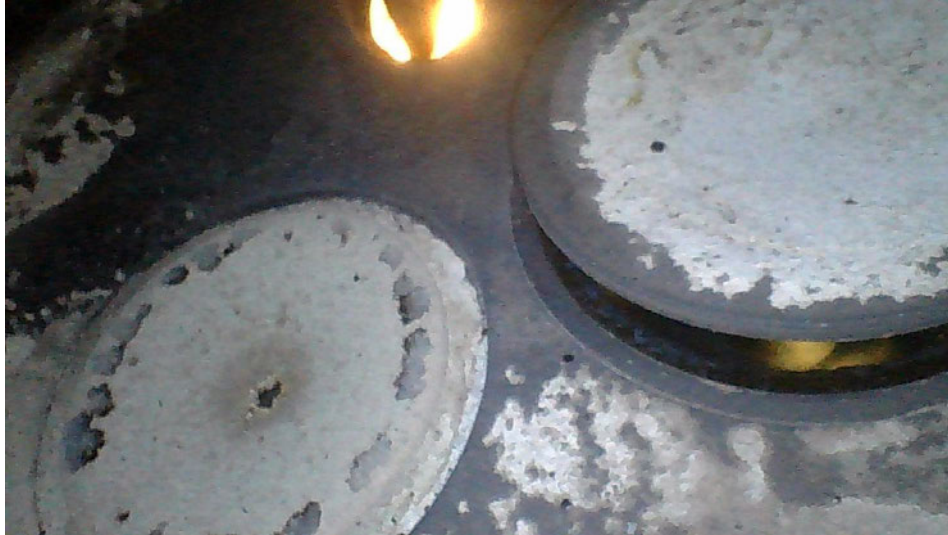
Figure 7 Borescope of No. 4 Typical of all 4 pistons, valves, and cylinders.

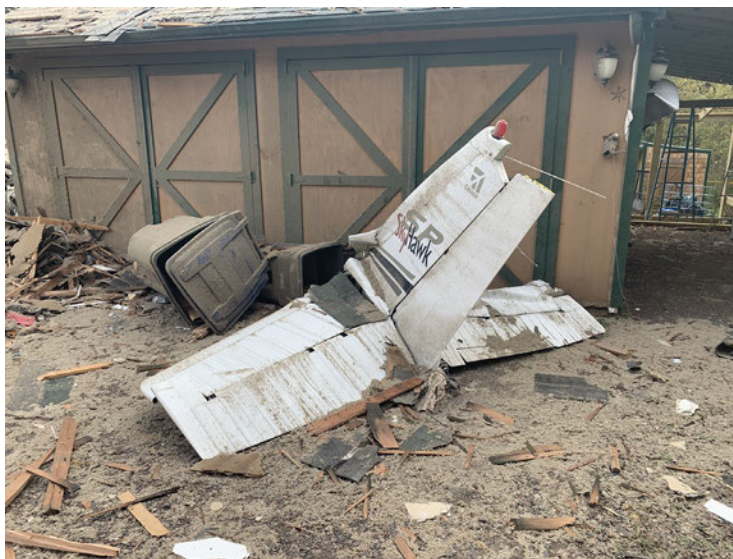
111 The empennage separated from the fuselage and was found in front of the barn. It was in
112 remarkably good condition. All the flight control surfaces remained attached and functioned
113 normally when manually operated.

Figure 8 Tail/Empennage

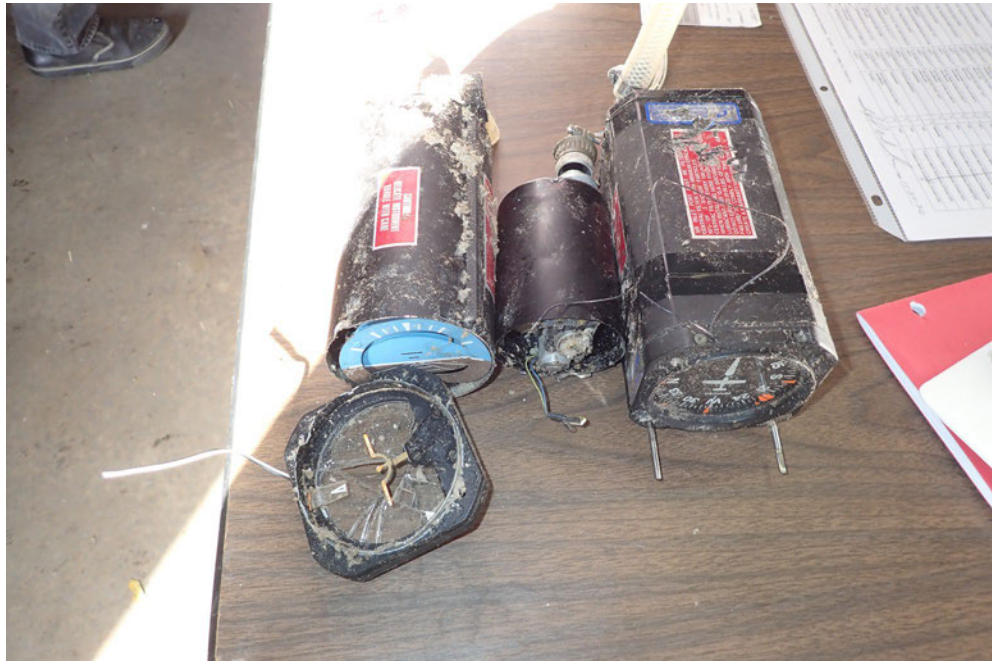
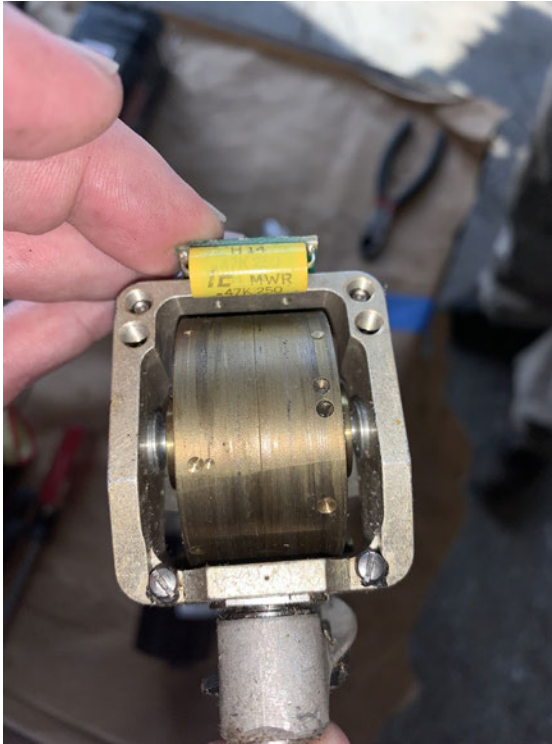
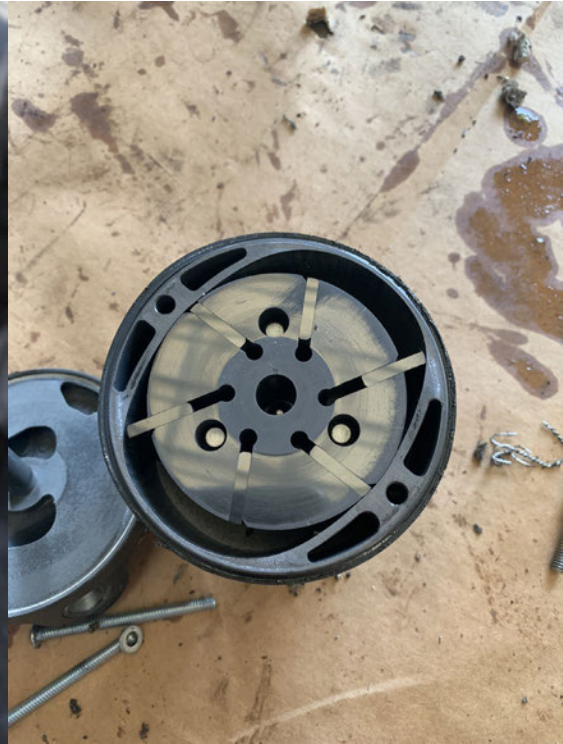
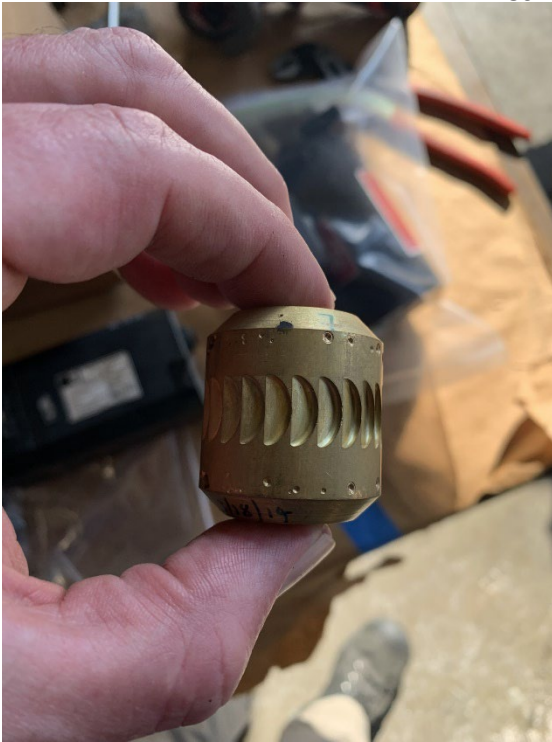
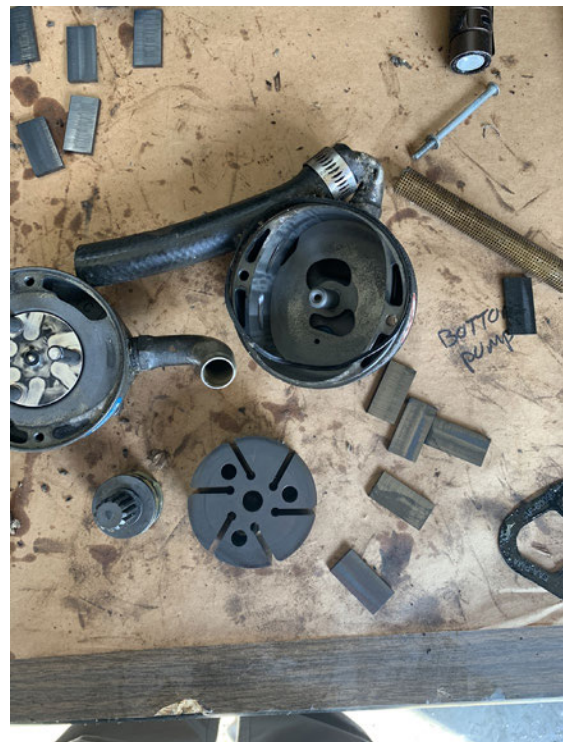
170 The attitude indicator, directional gyro, and turn coordinator: The gyros were capable of smooth
171 rotation and rotational scoring was noted on the electrically powered turn coordinator gyro, there
172 was no rotational scoring noted on the air powered attitude indicator gyro or directional gyro.
173 The vacuum manifold was examined, and the diaphragms displayed normal operating signatures.
174 All manifold and hose lines were free of breaks and leaks not impact related. Continuity was
175 established and air flowed freely and operated the gyros.

Figure 9 Vacuum pump and gyros. First photo at top prior to disassembly

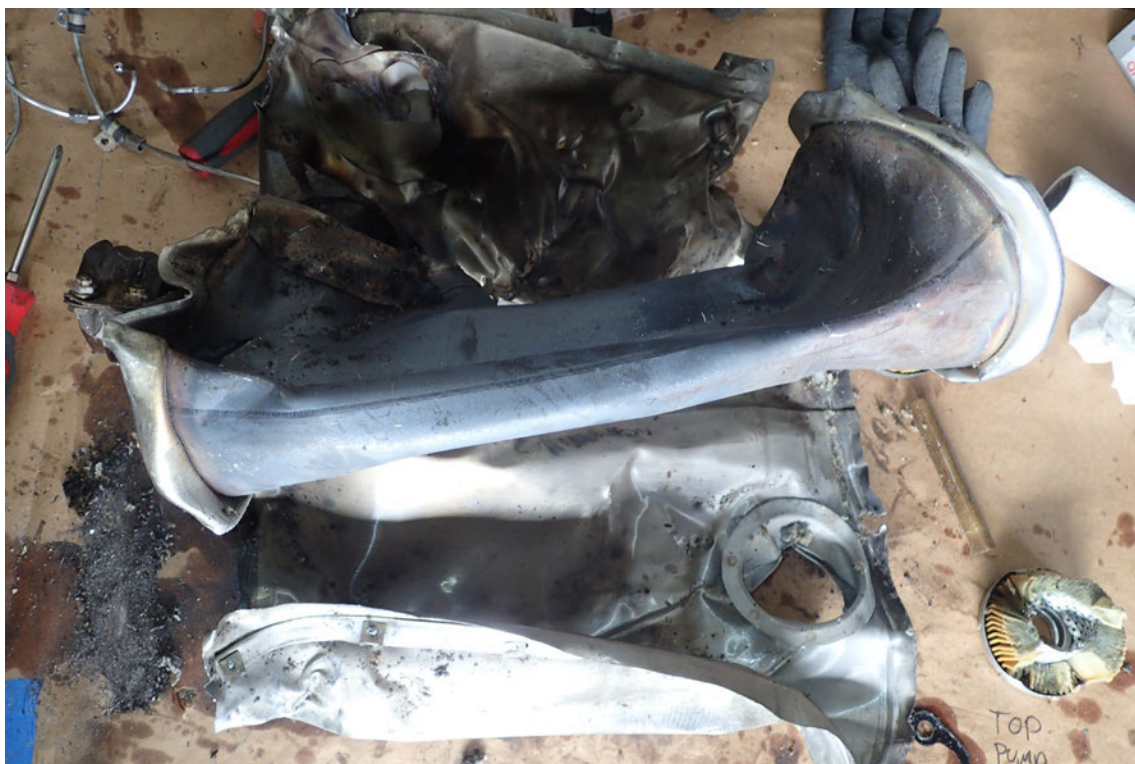
193 Checked to ensure muffler was not pre impact compromised (CO) No pin holes or cracks or
194 exposed seams observed. Muffler Assembly appears relatively new.

Figure 10 Muffler and heat shroud

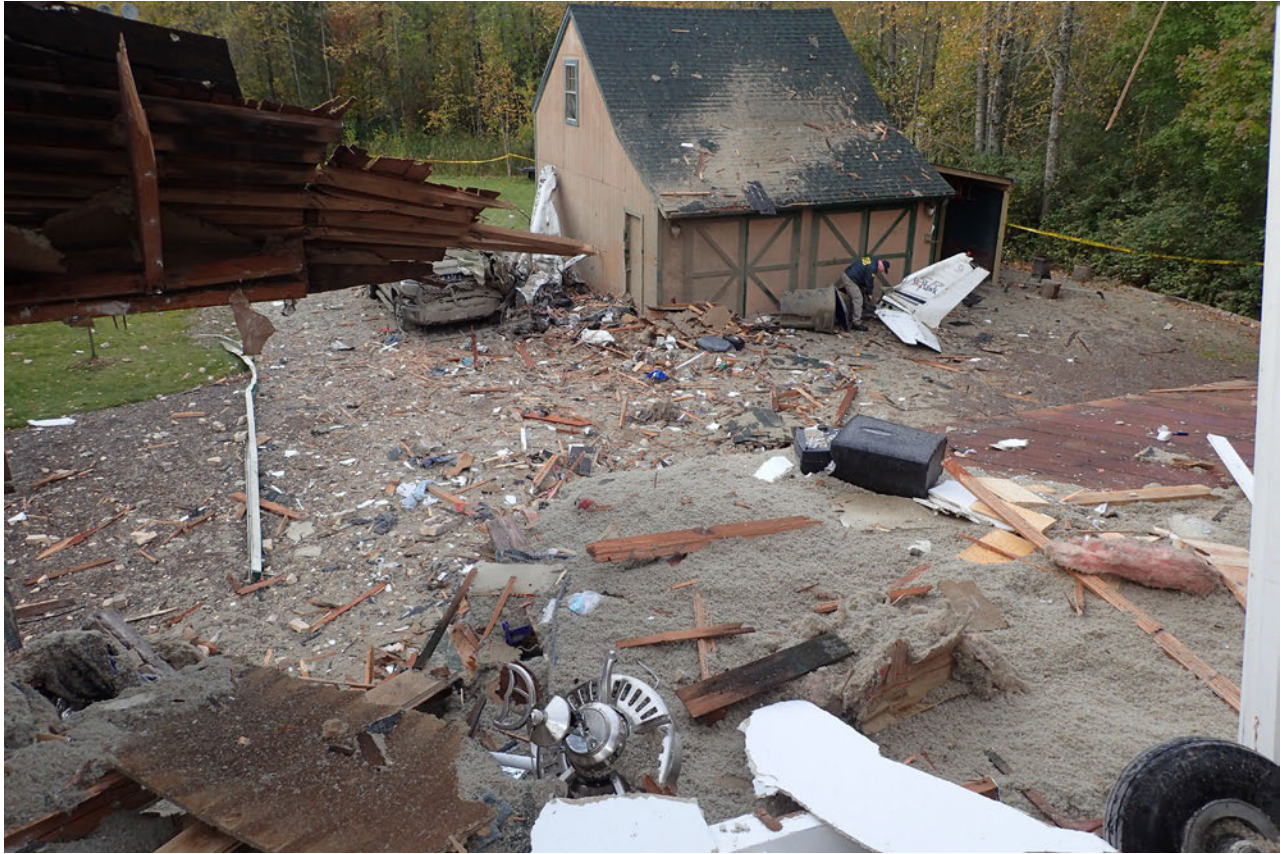
202 *Figure 11 View of accident site take from exit hole of second story of house.*
