NTSB Accident Number CEN19FA122

INVESTIGATION SUMMARY

Location: Kingsland, Texas
Date: April 21, 2019
Time: 1443
Aircraft: Rans S-7S Courier experimental
Registration: N25TX

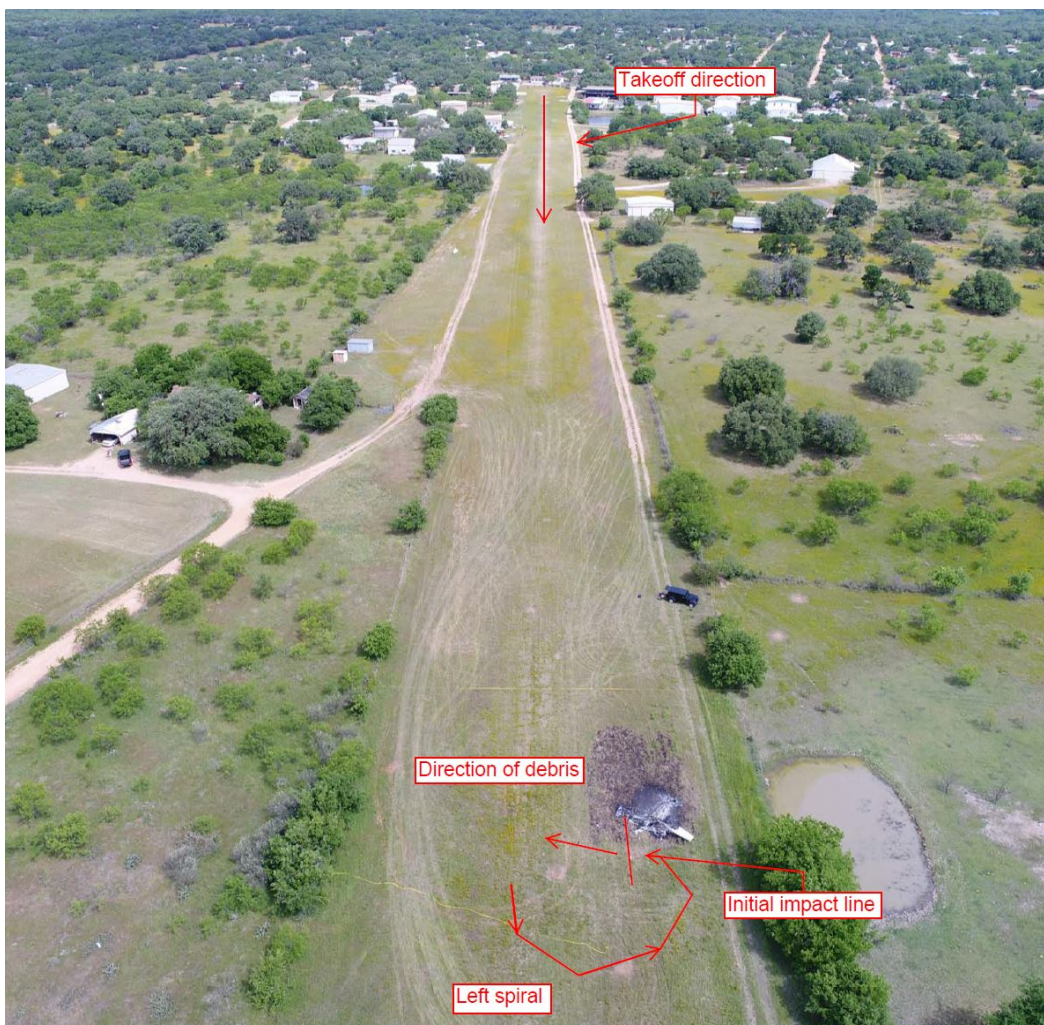
The airplane departed to the south on runway 16 and impacted the ground at the end of the runway (figure 1).

Figure 1 – Aerial view of accident site with notation

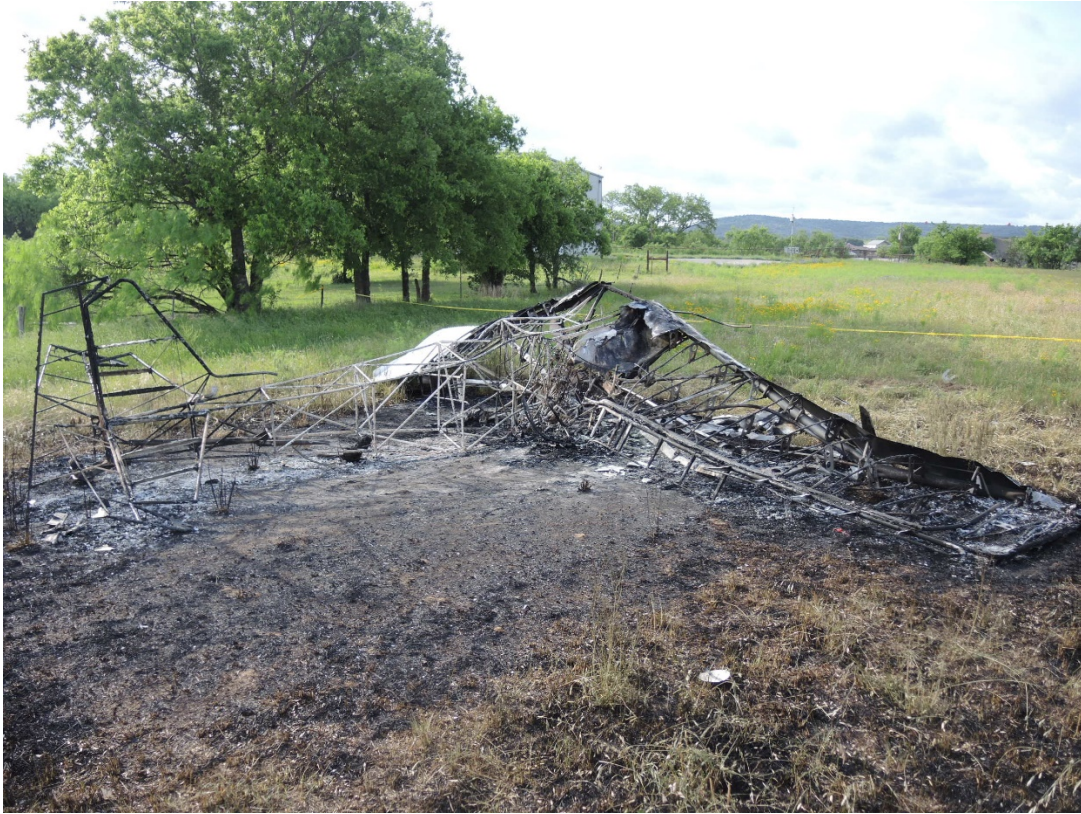
Figure 2 – Wreckage from back right side

The wing struts were bent and damaged by fire. The cockpit and forward fuselage area was crushed forward and damaged by impact and fire.

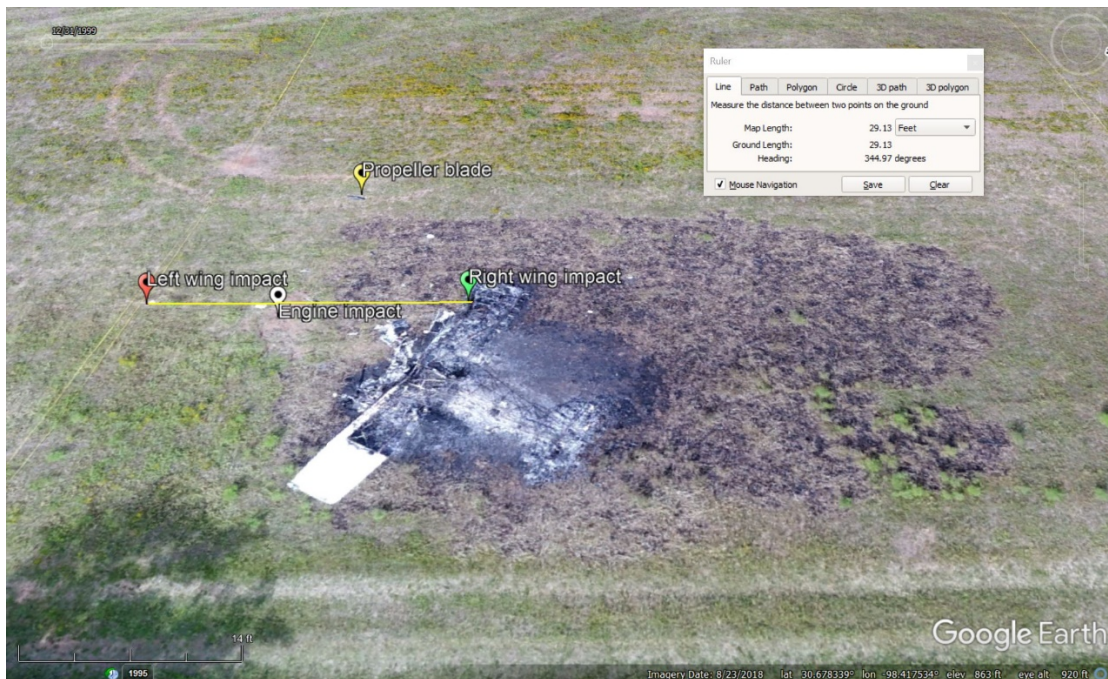
Figure 3 – Accident site with measurement

The first impact mark was defined be a small impact in the dirt which contained the left wing tip red lens and the pitot tube. About 12-14 ft north of that was the engine impact crater was at least 1 distinct propeller slash mark and debris from the nose/cowling/engine and one full propeller blade. Dirt from the crater was displaced to the west, consistent with the initial impact momentum being toward the west. Underneath where the right wing came to rest was a small impact mark and divot consistent with the right wing tip impacting the ground. The left/right wing and engine impact craters were aligned on a 166 heading; the airplane would've been pointed on a 255 heading. The main wreckage was north of that and came to rest pointed on a 190 heading. The evidence is consistent with the airplane in a left turn when the left wing hit the ground, followed by the engine then the right wing. The airplane continued to rotate counterclockwise and the momentum took it backward to the final resting location.
