National Transportation Safety Board
Washington, D.C. 20594

Date: November 2, 2020
To: Robert Hall, Director
Through: Sean Lynam, Chief, Pipeline and Hazardous Materials Division
From: Sara Lyons, Pipeline Accident Investigator
Pipeline and Hazardous Materials Division
Subject: Atmos Energy's Party Submission Containing Pre-Decisional Information
Investigation of Natural Gas-Fueled Explosion of Residence, February 23, 2018
Dallas, Texas (PLD18FR002)

Supplement
to
Atmos Energy Corporation's
Proposed Findings, Probable Cause, and
Recommendations to
the National Transportation Safety Board

Docket No. PLD18FR002
Relating to Natural Gas-Fueled Explosion
3534 Espanola Drive in Dallas Texas
February 23, 2018

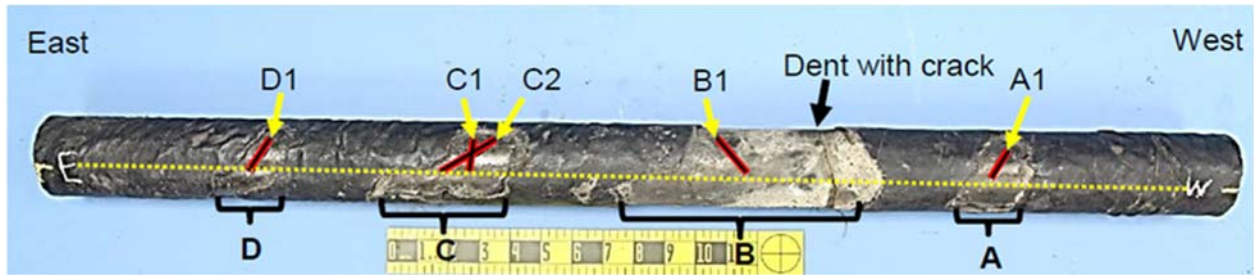
1. **The probable cause of the explosion on February 23, 2018 was the unreported damage to a 2” steel main located in the alley behind 3534 Espanola Drive by third-party excavation during the installation of a sewer lateral in 1995/1996.**
 - a. Post-accident excavation confirmed the 2” main was cracked in the area it had been gouged, bent, and dented by mechanized equipment, and was otherwise in good condition.
 - b. The crack on the 2” main was located directly underneath a sewer lateral which was just 1 ½ inches above the top of the of the damaged main.
 - c. The 2” main would not have failed but for this third-party damage.

Figure 1 — Damaged main from the NTSB Materials Laboratory Factual Report 18-067 showing gouges (A1, B1, C1, C2, and D1) and location of dent and circumferential crack

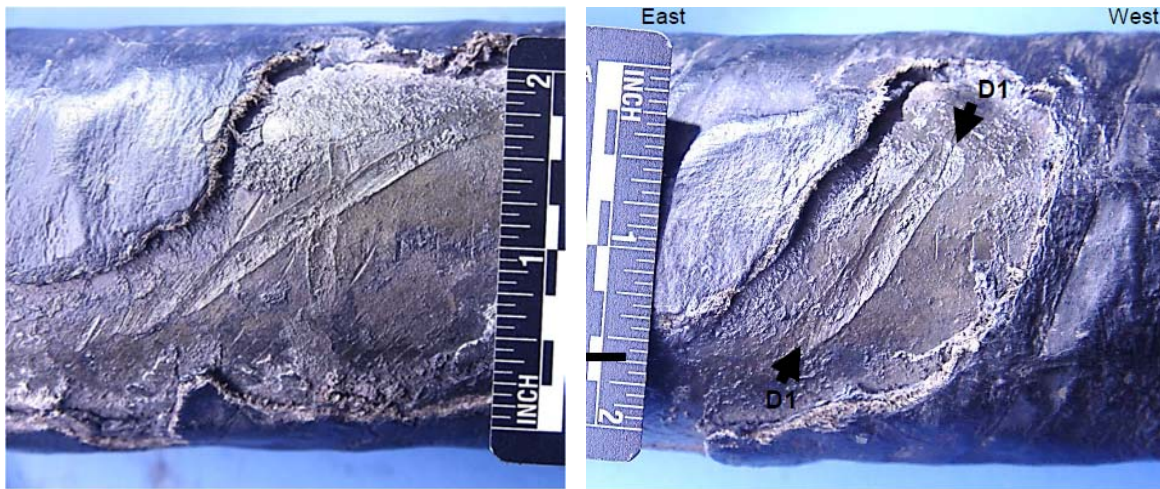
Figures 2 and 3 - Showing gouges in the main caused by third-party damage

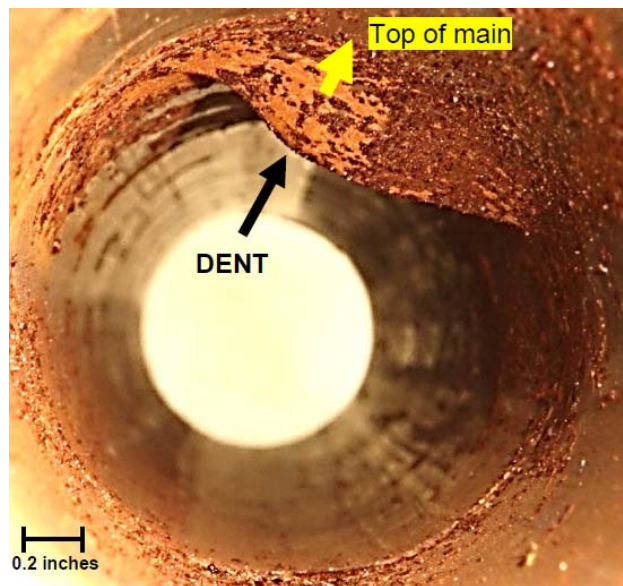
Figure 4 - Inside view of the damaged main and the location of the dent. The superficial oxidation occurred after it was removed from the alley and exposed to the air.

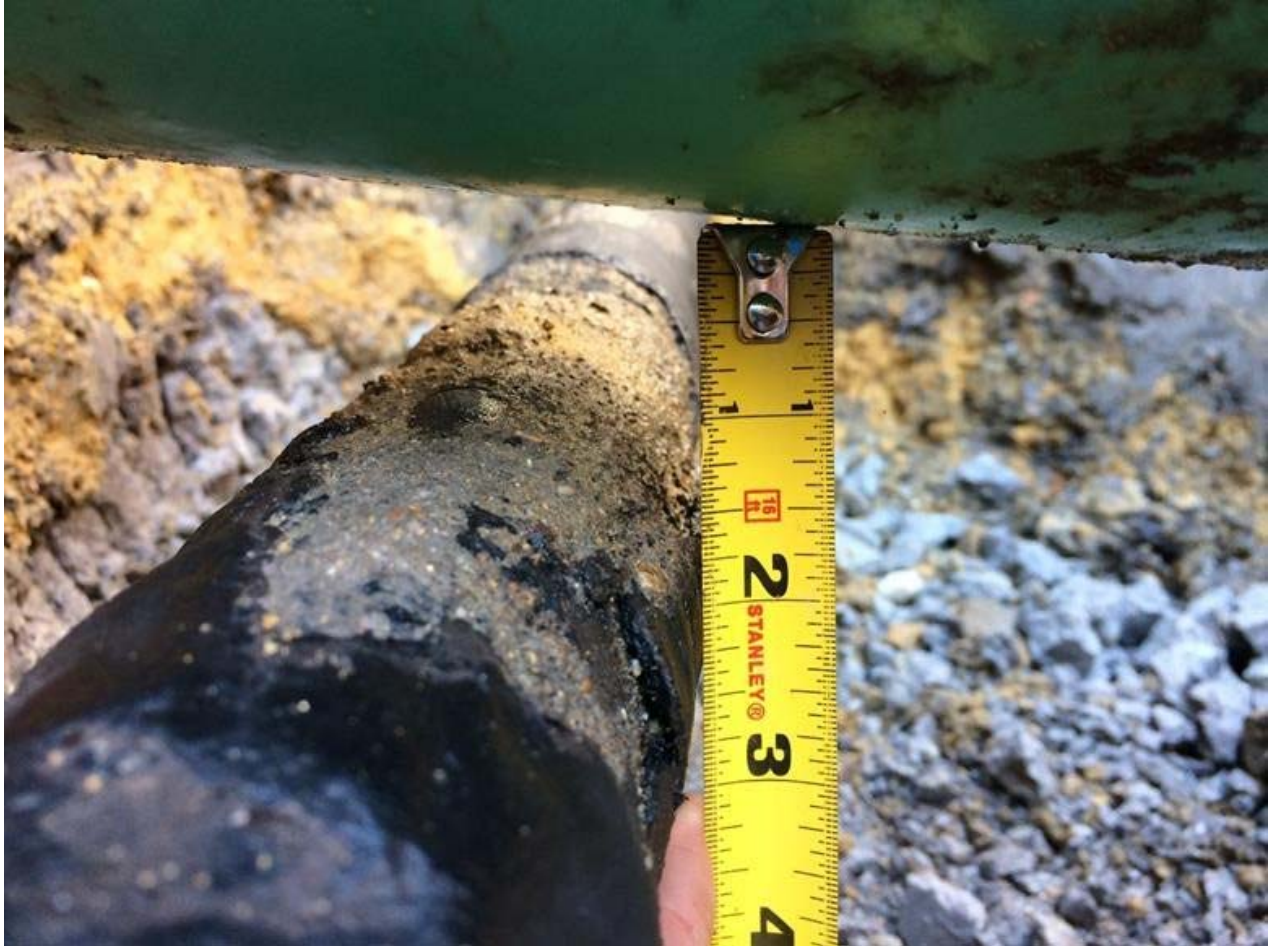
Figure 5 — Separation of 1.5” between the damaged top of the gas main and the bottom of the sewer lateral.

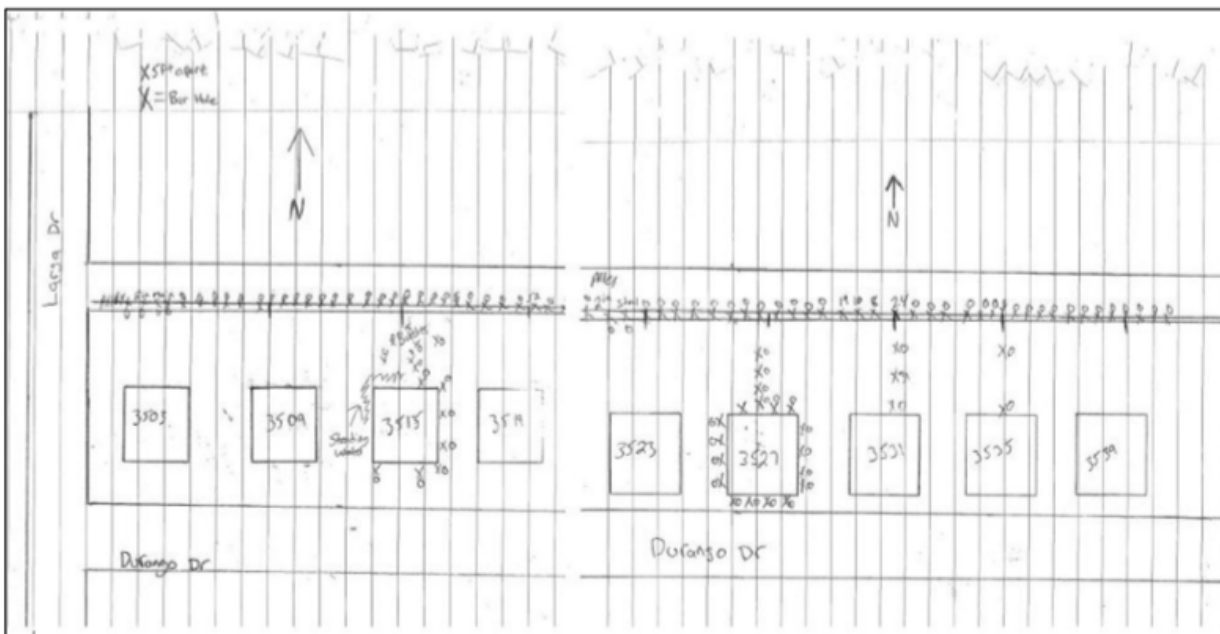
difficult conditions. This response began with technicians performing an extensive bar-hole test along the Durango/Espanola alley and checking the sewer clean-outs along the alley. No leaks were identified behind 3534 Espanola and no evidence of gas migration was detected from the damaged main prior to the accident.

Figure 6 - Bar hole testing results at 3515 and 3527 Durango and in the alley between the 3500 Block of Durango Drive and Espanola Drive on Thursday, February 22, 2018. As noted in the upper left corner, "X" indicates the location of the bar hole test; "0" indicates that no gas was detected.

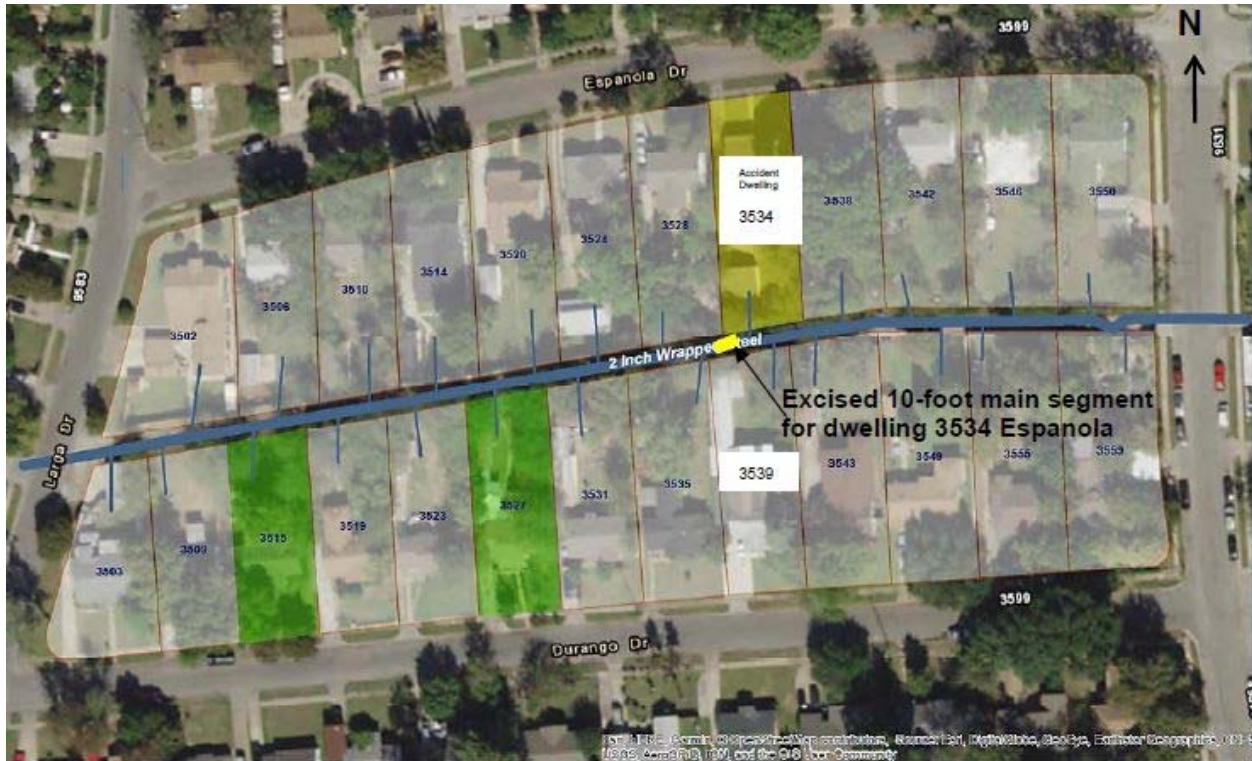
Figure 2 —Image showing accident dwelling (in yellow) relative to where damage was discovered on a portion of the Main in the alley. The location of the unrelated house fires on Wednesday (3527 Durango) and Thursday (3515 Durango) are shown in green.

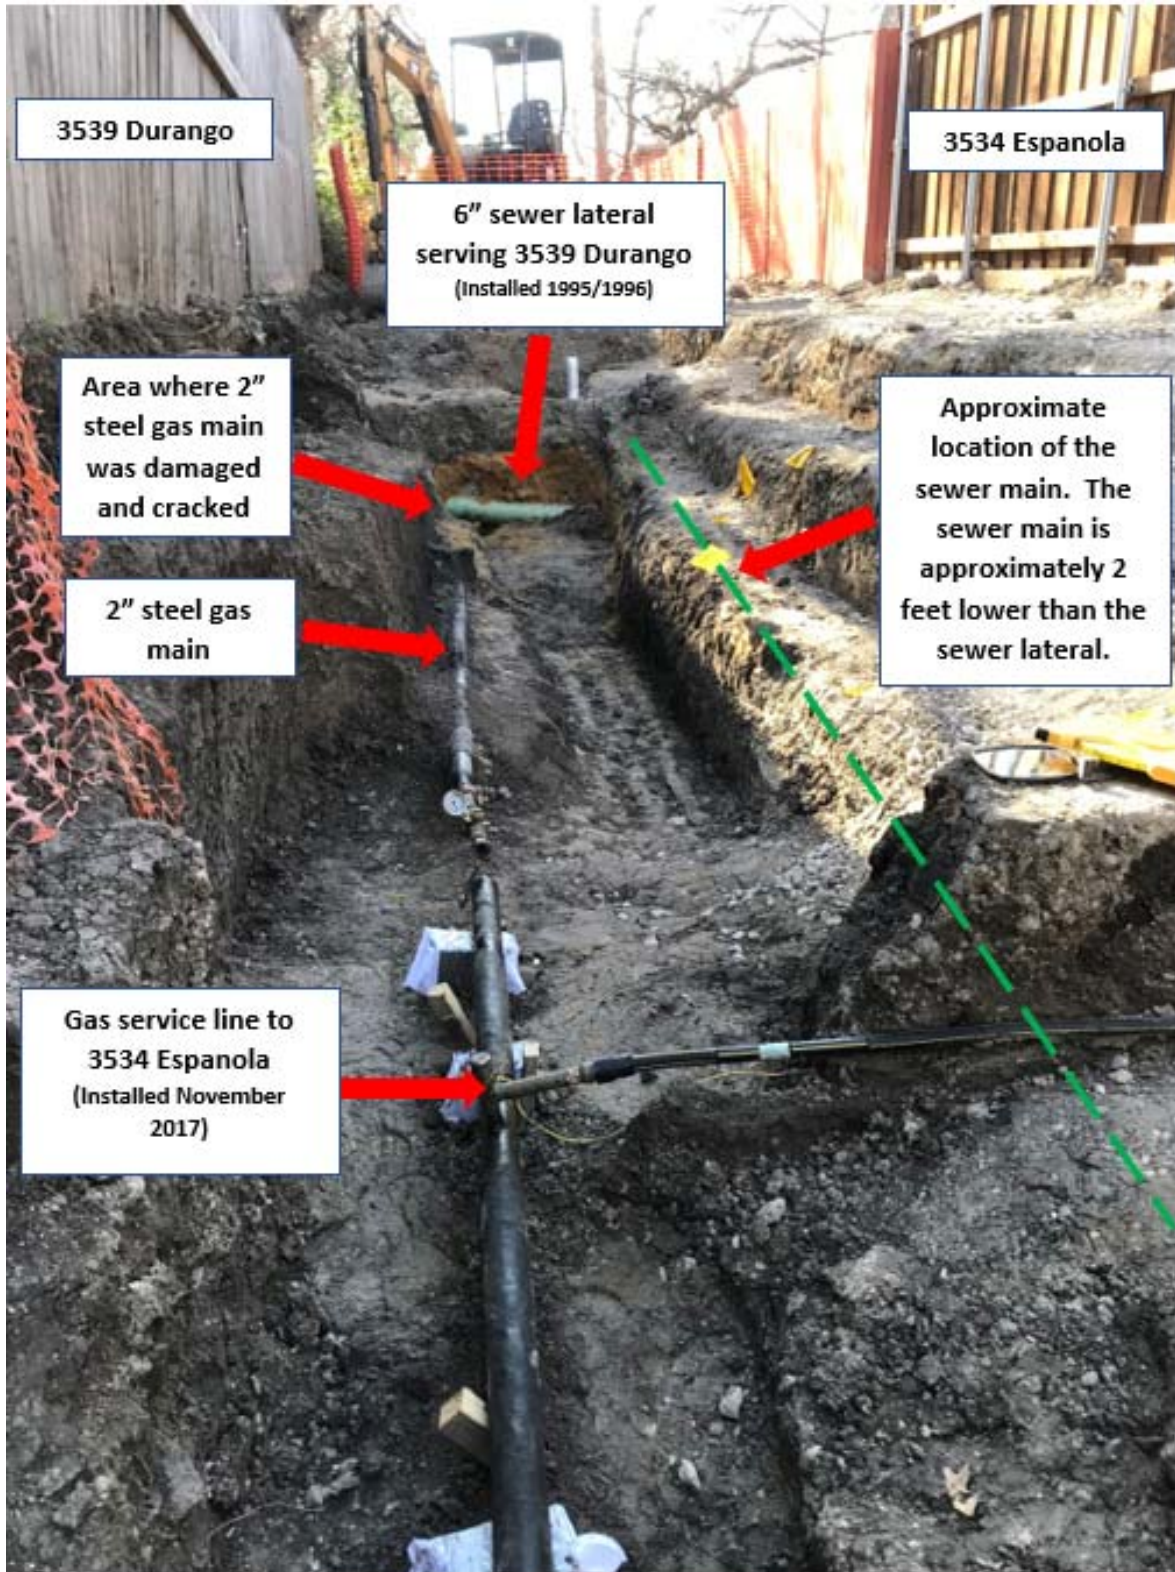
Figure 3 — NTSB field work excavation view of the alley looking west. Note the proximity of the green sewer lateral to the Main and the sand packing around the sewer lateral.

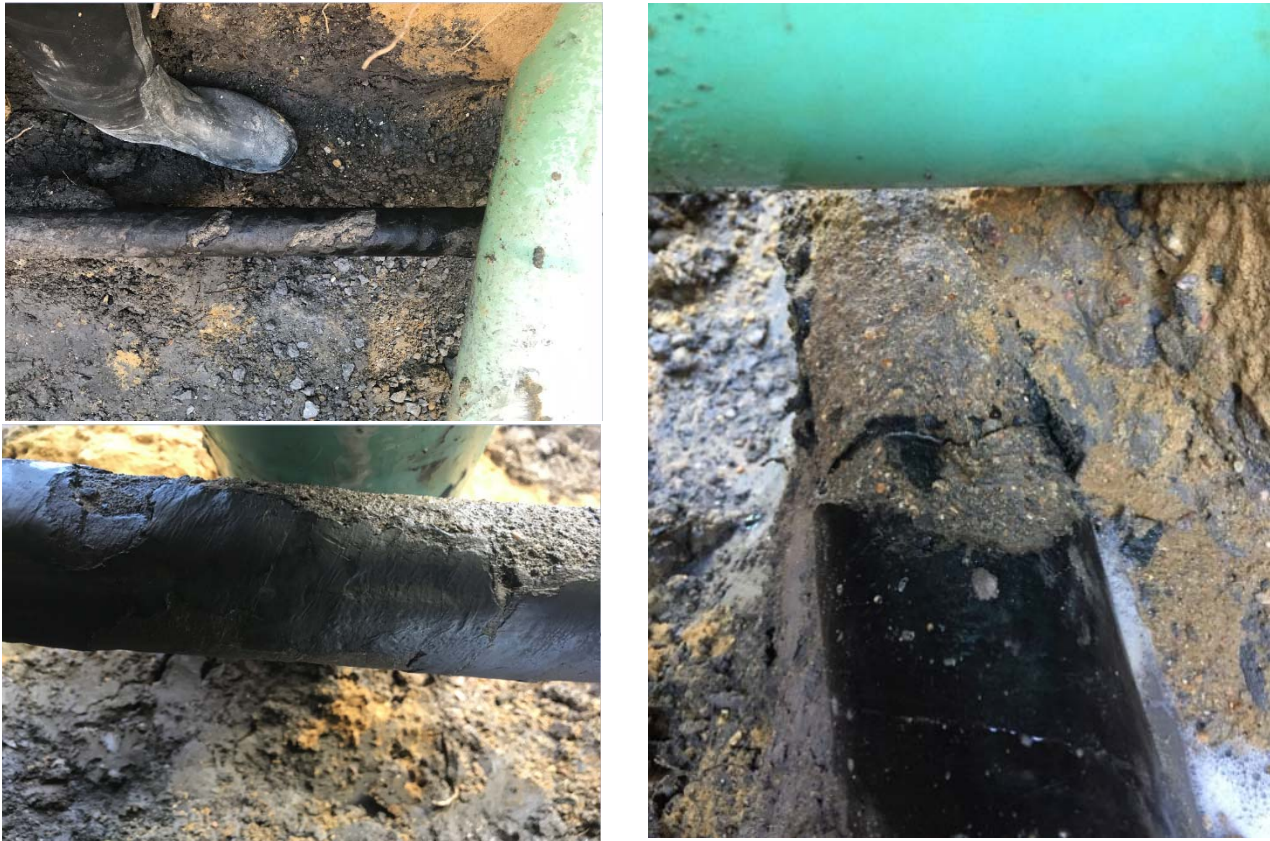
When the Main was exposed behind 3534 Espanola Drive (Figure 3), it revealed a circumferential crack on the top of the Main (Figure 4), directly underneath a sanitary sewer lateral serving 3539 Durango Drive. The Main was also bowed downward with the crack intersecting a dent.³ The 6” sewer lateral was approximately one and one-half inches above the top of (and perpendicular to) the Main. (Figure 5). The coating on the Main was damaged in the area directly beneath (and to both sides of) the sewer lateral. (Figure 6). A 10-foot segment of the Main containing the circumferential crack was removed and preserved for further testing and examination at the NTSB’s materials laboratory (the “**Damaged Main**”).

Figure 4—Damaged section of the Main relative to the sewer lateral serving 3539 Durango and the circumferential crack.

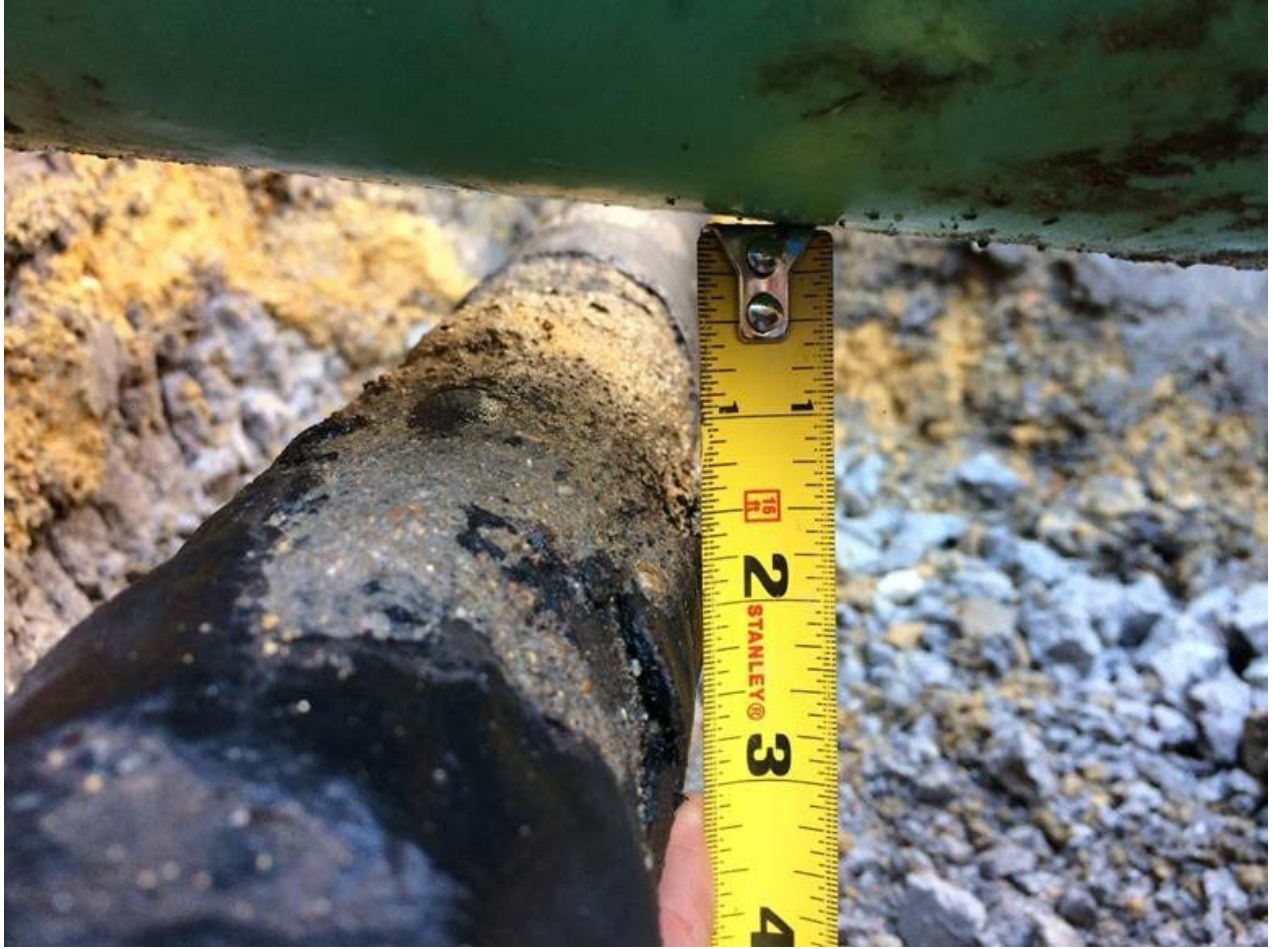
Figure 5 — Separation of 1.5" between the damaged top of the Main and the bottom of the sewer lateral.

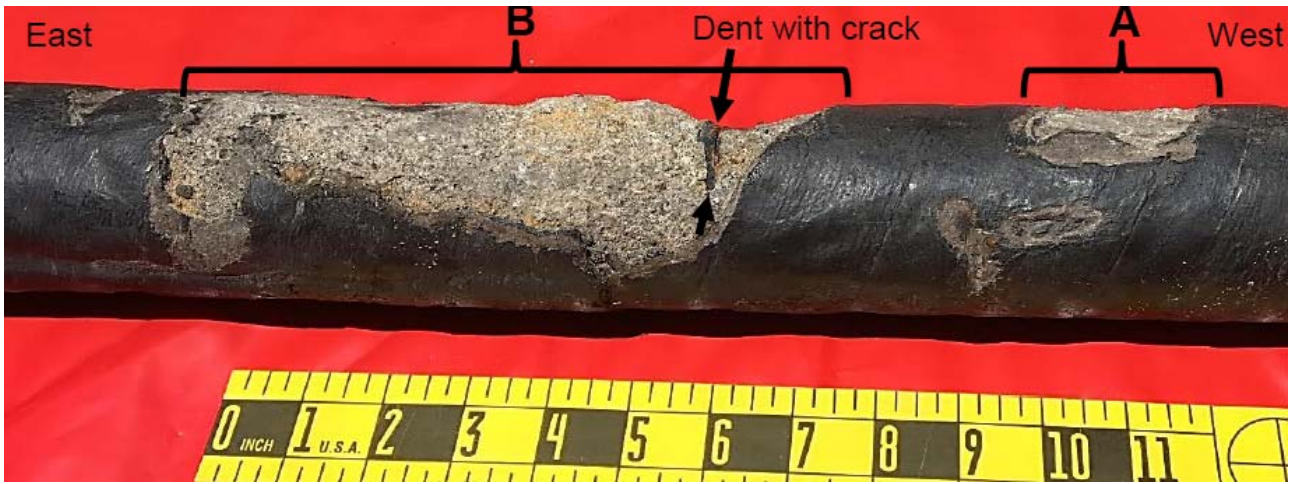
Figure 6 — Depiction of the circumferential crack and dent from the NTSB Materials Laboratory Factual Report 18-067

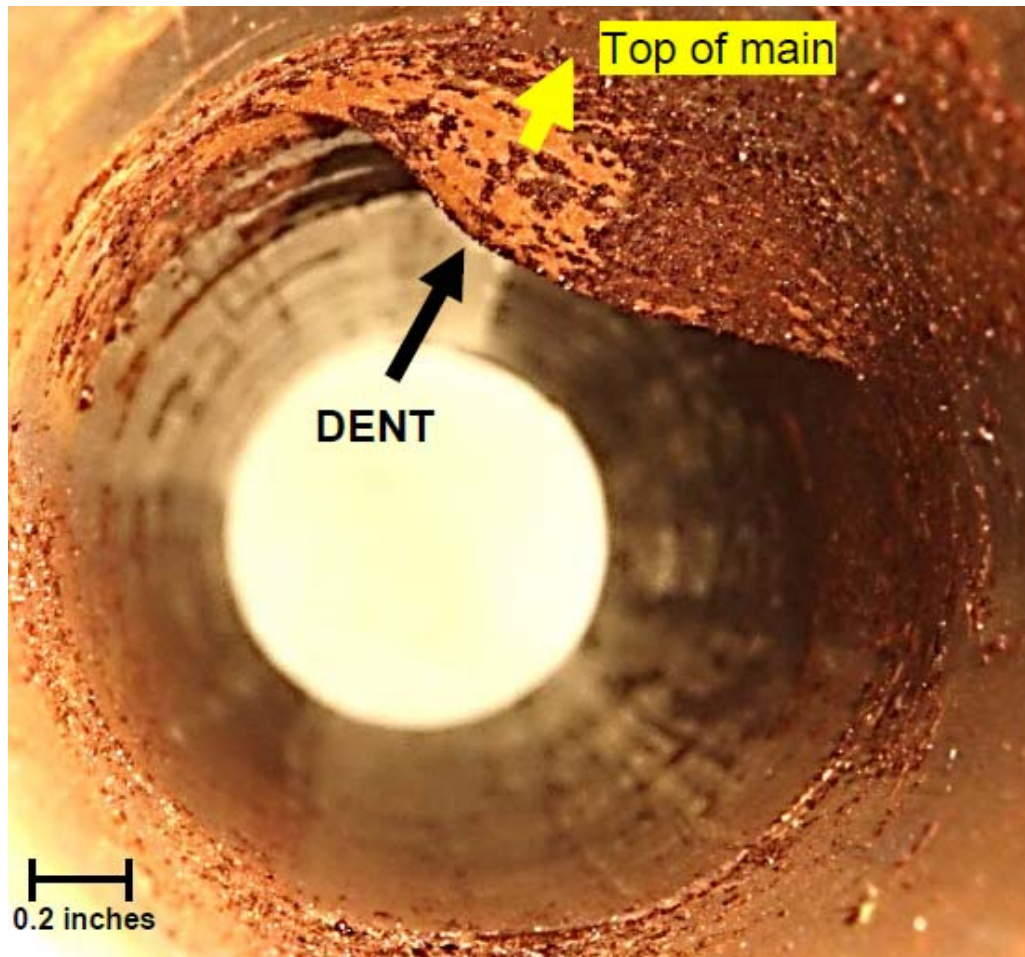
Laboratory testing⁴ by the NTSB confirmed the through-wall crack extended approximately halfway around the circumference of the pipe and intersected a large dent. There was a 20% reduction in wall thickness at the point of the dent. The deformation in the pipeline wall (Figure 7) compromised the integrity of the pipe making it susceptible to cracking and failure.⁵

Figure 7 — Inside view of the Damaged Main and the location of the dent. The superficial oxidation occurred after it was removed from the alley and exposed to the air.

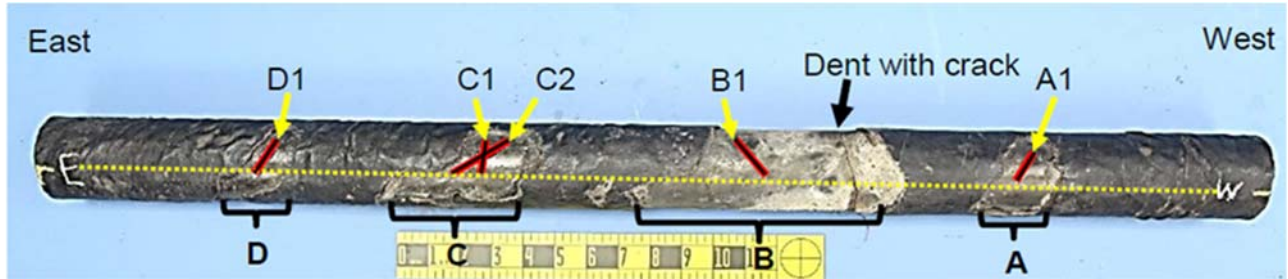
The Damaged Main was coated with a coal-tar enamel spiral wrap. This coating was damaged in four areas (on the top side below the sewer lateral) and covered in a hard, compacted, adherent deposit (Figure 8).

Figure 8—Damaged Main from the NTSB Materials Laboratory Factual Report 18-067 showing gouges (A1, B1, C1, C2, and D1) and location of dent and circumferential crack

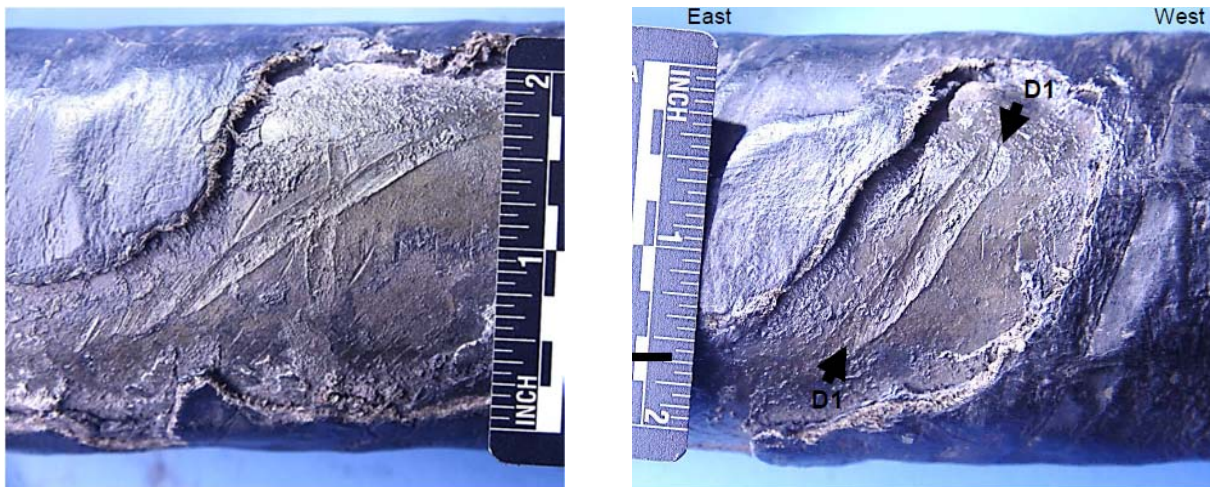
Laboratory testing revealed multiple metal gouges where the pipe coating had been damaged. The damage seen on the pipe is consistent with a backhoe or other mechanized excavating equipment used to dig and install utility line and contained the hard, compacted, adherent deposits in areas where the coating was damaged. When the hard deposits were removed, each of the four areas contained at least one major gouge in the metal (Figures 9 & 10).

PHMSA explains that such gouges “usually happens when the teeth of a backhoe scrape across the pipe.”⁶ The sharp edges of the gouge act as stress concentrators and “pose a threat to the integrity of the pipe.”⁷

Figures 9 and 10 Damaged Main—Showing gouges after removing hard deposit.

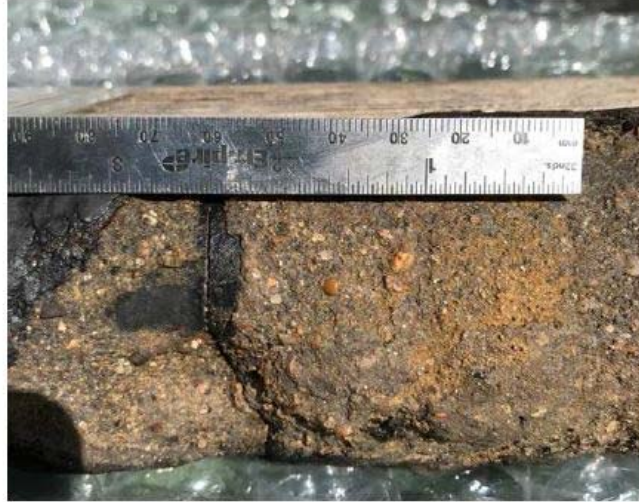
Figure 11 NTSB's Preliminary Report

The NTSB's Preliminary Report showed the circumferential crack covered in a hard, compacted, adherent deposit—not corrosion (Figure 11).

Circumferential crack in steel 2-inch-diameter pipeline.

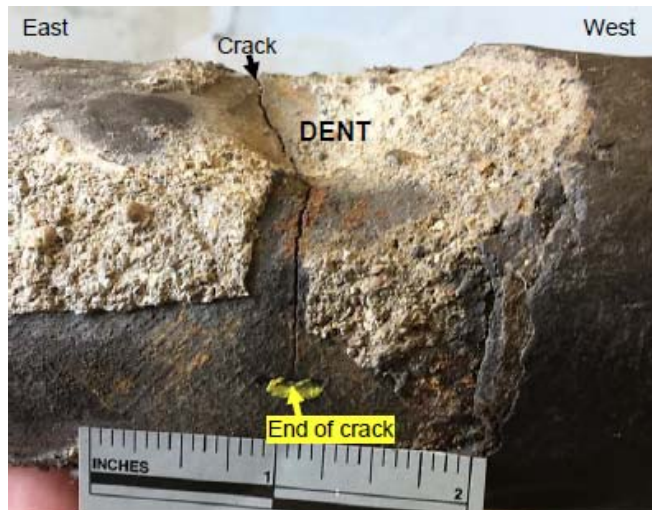
A different view from the NTSB laboratory analysis shows the hard deposit adhered to surface of the pipe and shows the dent caused by excavation damage.

Figure 12— Showing a crack that intersected the dent with deposits removed from the areas outside the dent.

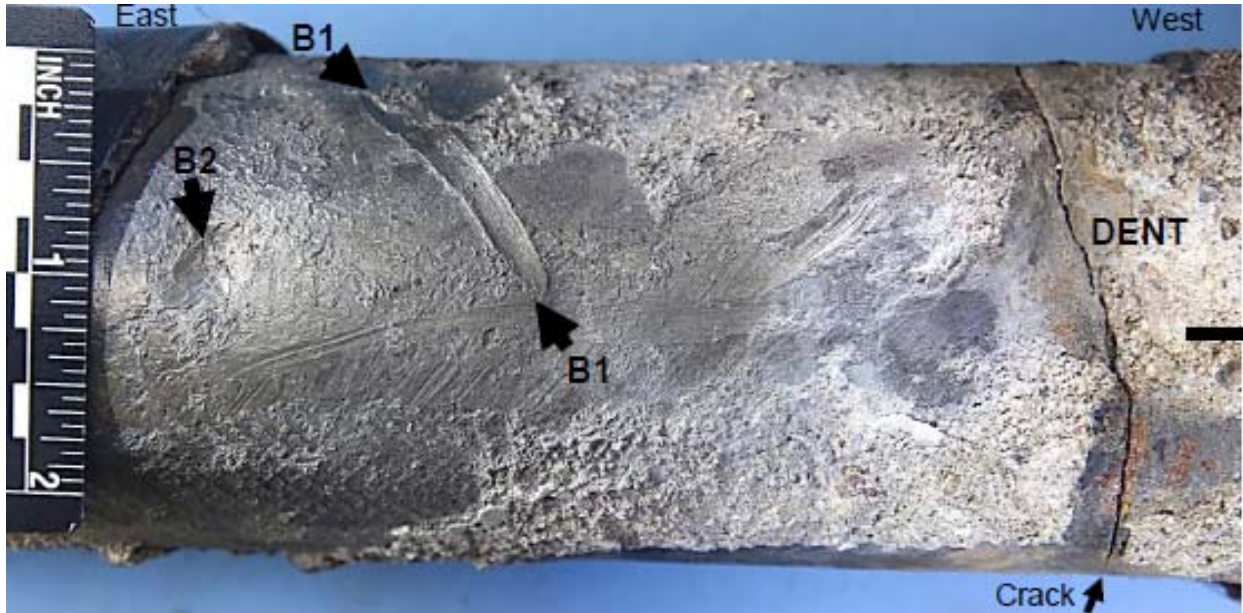
The undamaged portion of the pipe was in good condition—coated and cathodically protected. There were no other leaks in the Main, and the hard deposit was not present on any other undamaged portion of the Main (Figure 13).

Figure 13— Showing the pipe surface after the hard deposit was removed (NTSB Materials Laboratory Factual Report 18-067)

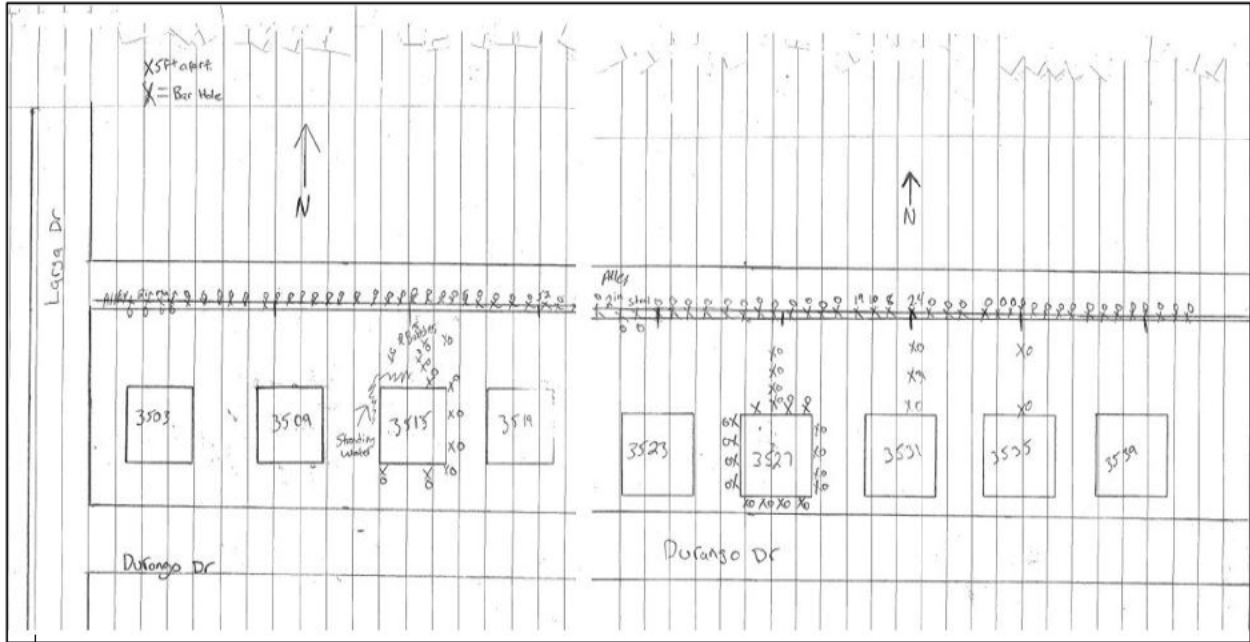
Figure 15— Bar hole testing results in the alley between the 3500 Block of Durango Drive and Espanola Drive at Thursday, February 22, 2018 (Attached as Exhibit C to the Appendix)

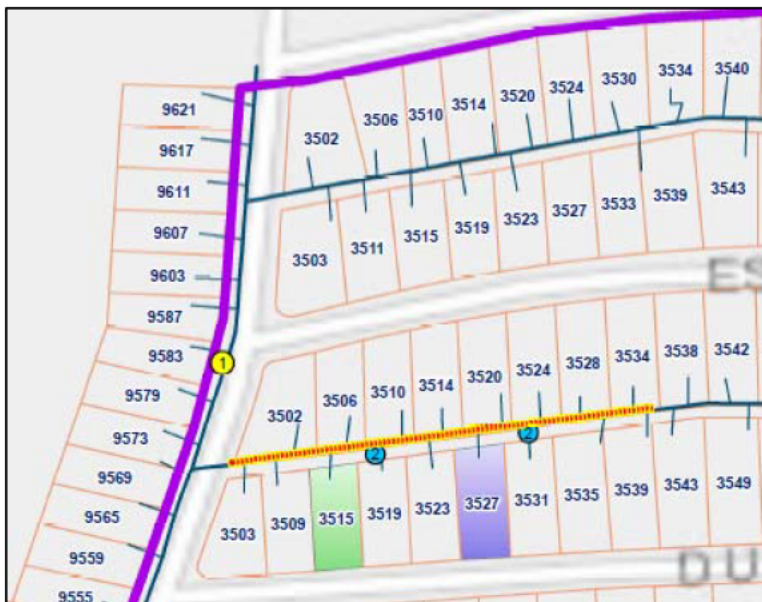
line. Figure 16 shows the approximate location of this leak in relation to the Main. The leak was monitored, and a company crew was called to eliminate the hazard by replacing the service line.⁵³

Figure 16—Leaks as of the afternoon on Thursday, February 22. (Attached as Exhibit D to the Appendix)
