**BEFORE THE NATIONAL TRANSPORTATION SAFETY BOARD**

**NTSB Accident Number RRD23LR007**

**Proposed findings, probable cause, and safety recommendations in connection with the Norfolk Southern Railway employee fatality that occurred while performing a shove movement during industrial switching operations near Cleveland, Ohio on March 7, 2023.**

**Final Submission**

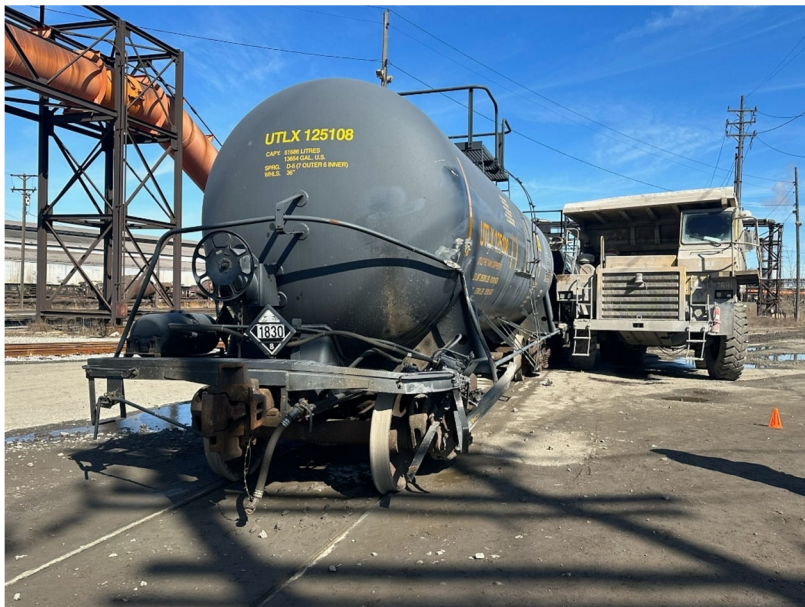
As a result of the accident, the Conductor that was riding the leading railcar during the shoving movement was fatally injured.

**Figure 1** – Post-accident photo of the highway/railroad grade crossing collision (*Photos courtesy of BLET*)

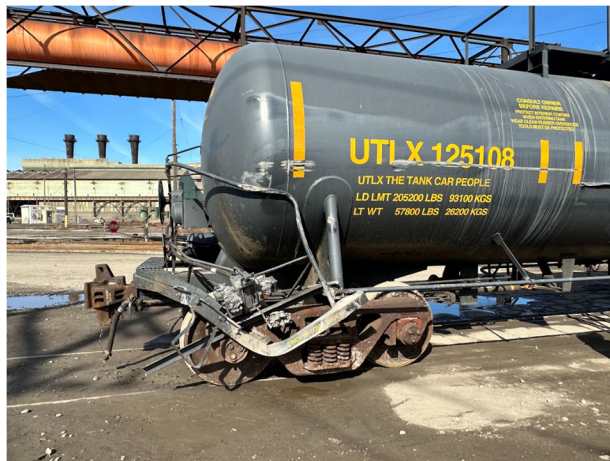
**Figure 3** - Photo of damaged platform and steps on the railcar that was being ridden by the Conductor at the time of the accident  
(Photo courtesy of BLET)

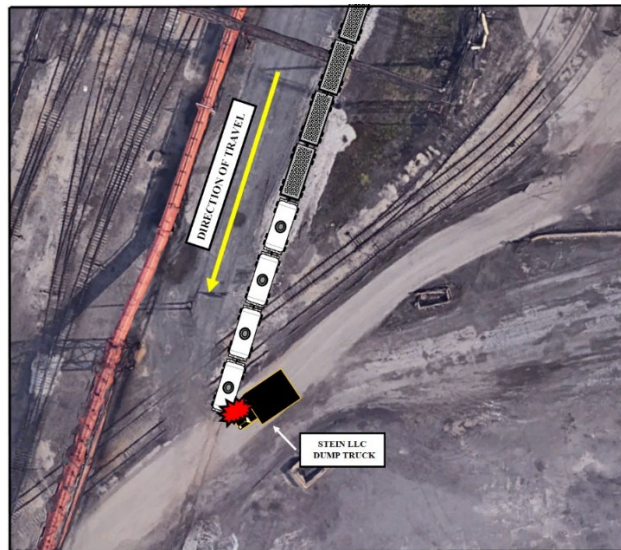
Figure 4 – Schematic of accident site (Courtesy of Google Earth and BLET)

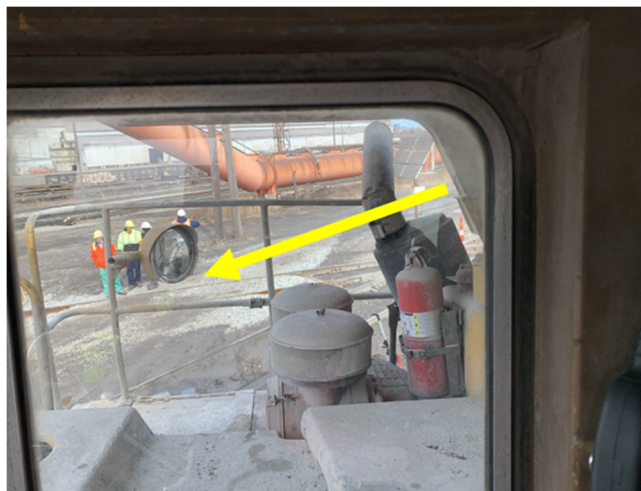
Post accident investigations at the accident site revealed that the Stein, LLC dump truck had an extremely limited, angled view of approaching railroad traffic at the highway/railroad grade crossing where the accident occurred (see **Figure 5**).

**Figure 5** – Post accident re-enactment view from the Stein, LLC dump truck driver's seat with arrow added depicting angle of NS C75B106's approach path (Photo courtesy of NTSB)

Additionally, after the accident, Stein, LLC requested that Cleveland-Cliffs, Inc. make modifications to the highway/railroad grade crossing where the accident occurred. Once these modifications were made, it allowed the Stein, LLC dump trucks to approach the highway/railroad

grade crossing at a 90° angle. This dramatically improved the Stein, LLC dump truck driver's line of sight and ability to see approaching railroad traffic.
