CLEVELAND-CLIFFS CLEVELAND WORKS LLC¹

Before the National Transportation Safety Board

NTSB Accident Number: RRD23LR007

FINAL SUBMISSION

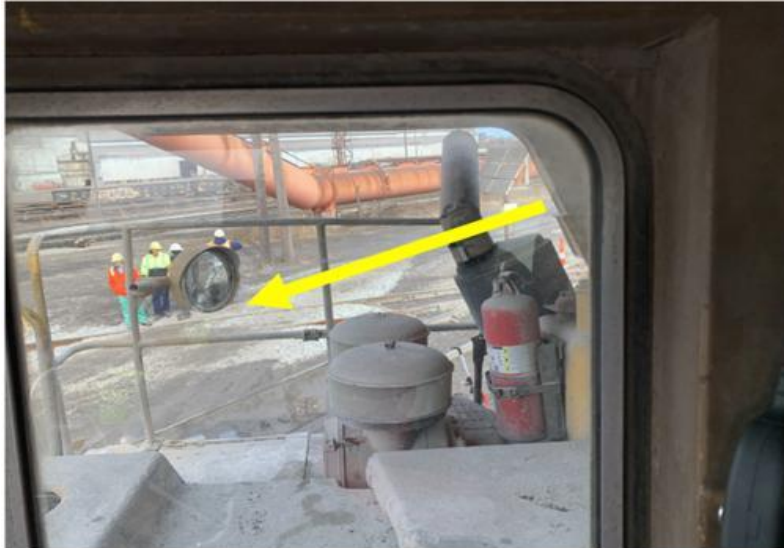
Post-accident investigations at the accident site revealed that the Stein dump truck had a limited, angled view of approaching railroad traffic at the private grade crossing where the accident occurred (see **Figure 1**).

Figure 1 – A post-accident re-enactment view based on the “estimated” stopped position of the Stein dump truck, as determined by NTSB, from the perspective of the driver’s seat. The arrow depicts the angle of approach of the NS C75B106’s train (*Photo courtesy of NTSB*)

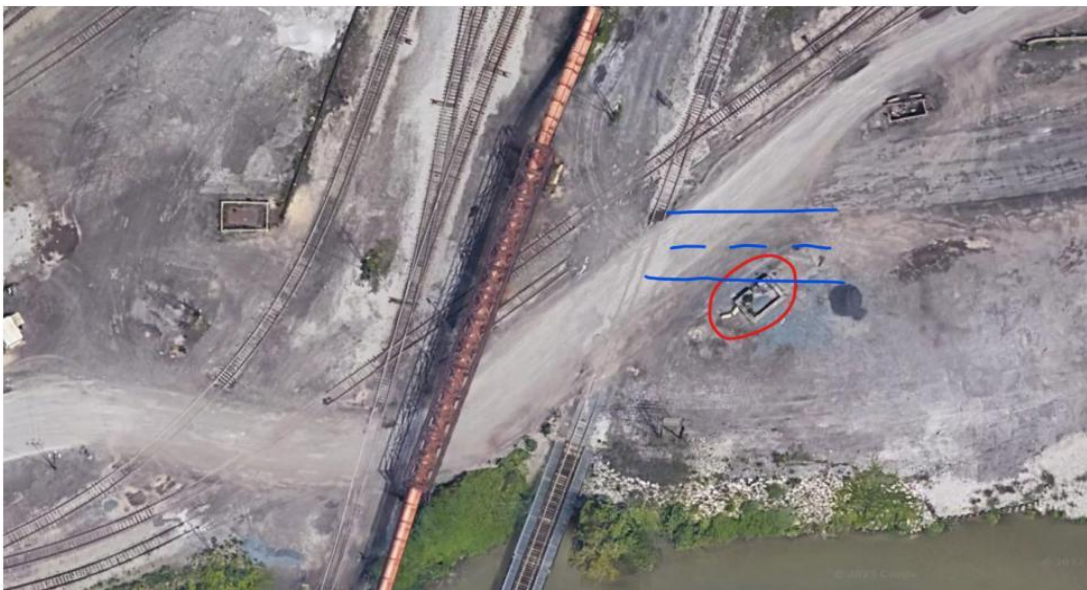
[Stein figure.]

"After the accident, Stein asked Cliffs to remove a concrete structure that prevented us from crossing the NS rail crossing at a 90 degree angle. It was about 15'x10'x5' and looked like it was a foundation of an old building that is no longer there. The attached picture is a Google Maps screenshot from before the structure was removed. I circled the structure in red that was removed and the blue roadway shows the new crossing angle for the track if traveling from east to west. Since Cliffs made this change and added additional lighting, our equipment operators' line of sight in the area of the NS track has improved. Prior to operations starting back up, Stein site management met with Stein employees who worked in this area and reiterated the company's rail safety practices and procedures and commitment to safety. Stein also audited and surveyed all of the rail crossings within the Cleveland plant post-accident and shared its findings with Cliffs."

Cleveland-Cliffs Cleveland Works disagrees with certain critical characterizations in Stein's email. The above image was provided by Stein, which shows an aerial

view of the crossing where the incident occurred. The red circle identifies the concrete foundation of an electrical vault bypass to the east of the railroad track. The road that the Stein trucks travel after picking up a load of raw materials was drawn in blue by Stein. While the removal of the concrete foundation helps to achieve an improved angle of approach, this alignment represented by the blue lines was possible prior to the removal of the foundation. The presence of the concrete foundation did not impede Stein trucks from being able to maneuver their trucks to be able to achieve a near perpendicular angle of approach to the private grade crossing, allowing for improved field of view of the railroad tracks. [See Figures 2 and 3 below]

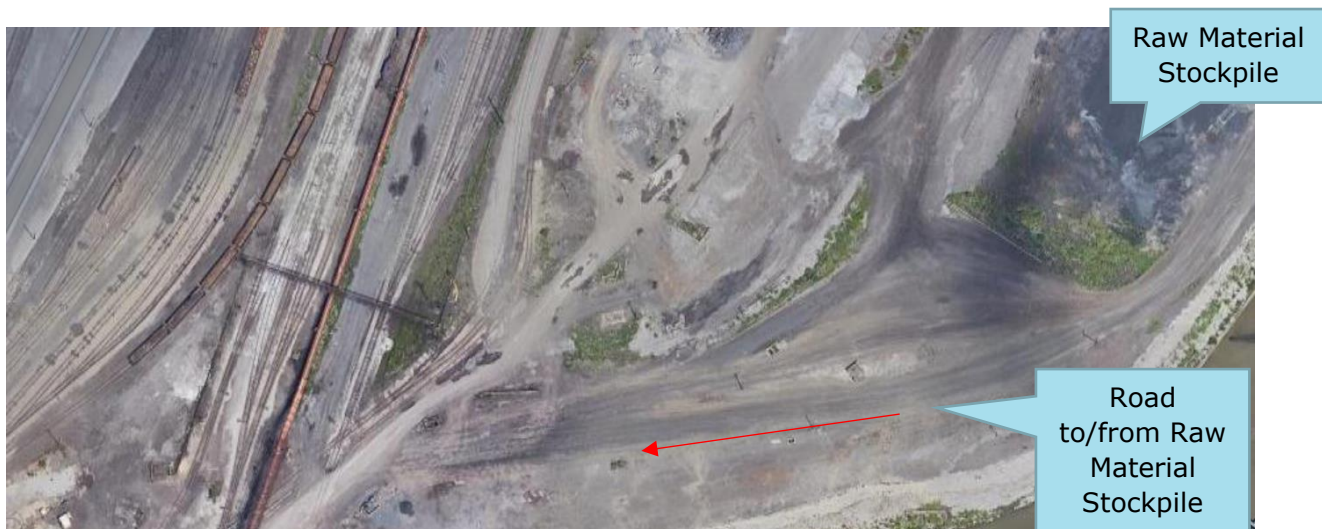
Figure 2 (from Google Earth). The square structure does not interfere with this approach.

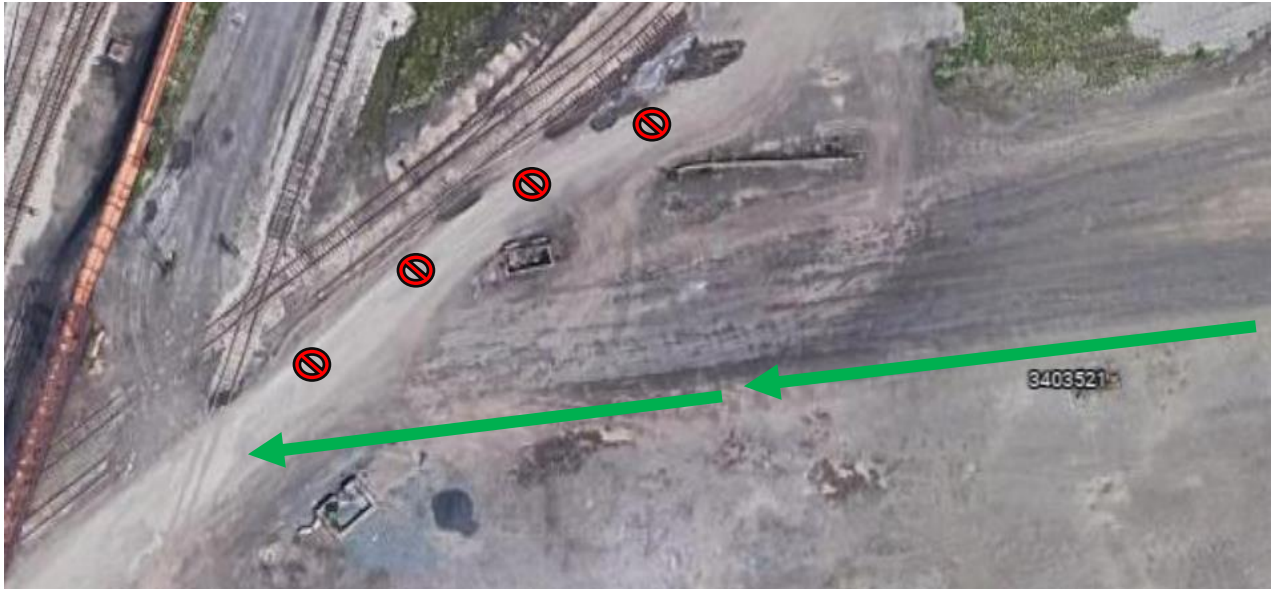
Figure 3 (from Google Earth). The green arrows depict the travel path that Stein vehicles use from the Raw Material Stockpile. The red closed circles depict the Old Bottle Repair Road which converges onto the haul road. The Old Bottle Repair Road was not being used by Stein at the time of the incident.

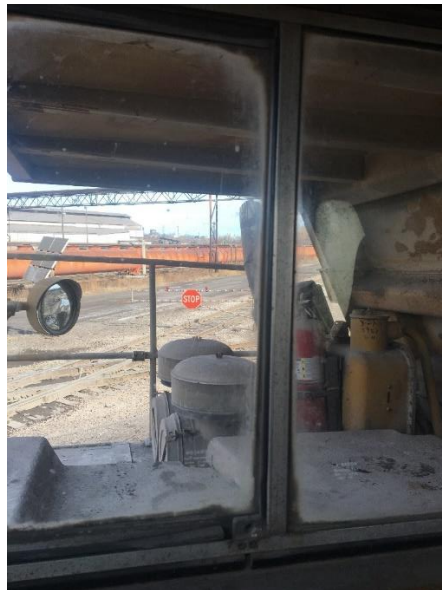
The field of vision of the Stein truck driver at the private grade crossing is affected by a number of factors, including the position and orientation of the truck relative to the private grade crossing and the body positioning of the truck driver as he looks to his right or left. This is due in part to the partially obscured view looking out of the right side of the cab given the presence of truck components (pre-cleaners, exhaust, fire extinguisher, and structure of the dump bed). See Fig.4

Figure 4 The view from operators' seat of the Caterpillar 796 (looking to the right)

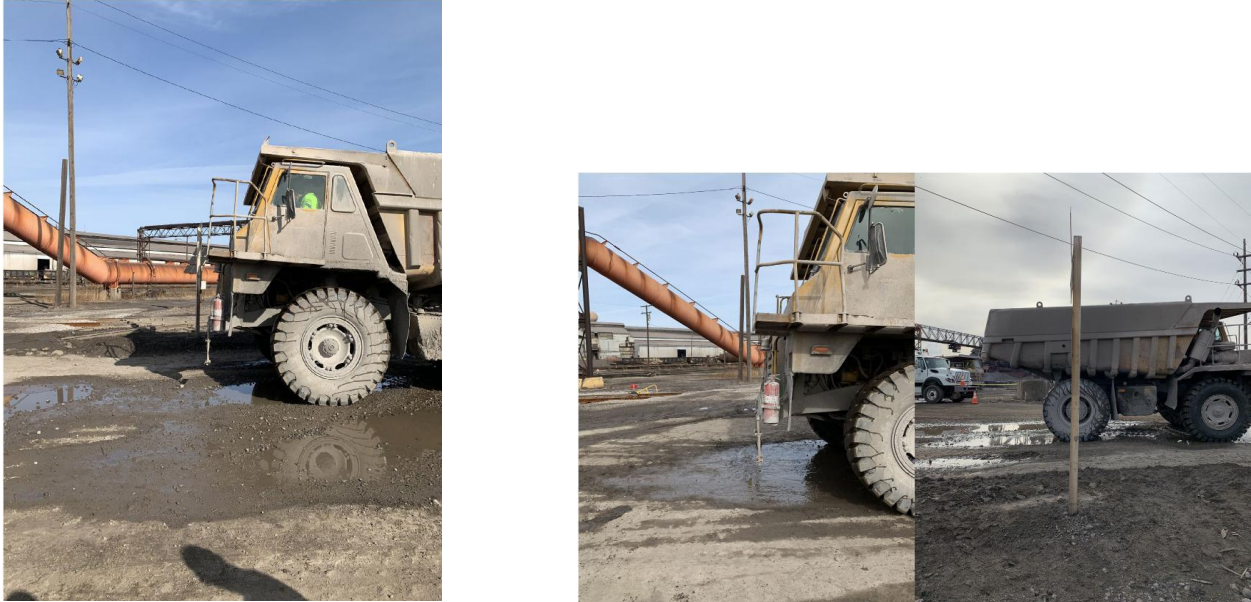
As noted in Section 8.0 Grade Crossing Visibility Observations of the NTSB System Safety Group Report (RRD23LR007), approximate field of view determinations were made as part of the investigation and took into consideration both conservative and estimated truck positions (herein referred to as the "Conservative Position" and the "Estimated Position"). At the Conservative Position, the Stein driver stopped at or

parallel to the stop sign. At the Estimated Position, the Stein driver stopped several feet beyond the stop sign, and closer to the NS tracks.

Figure 5 The photo on the left represents NTSB’s Conservative truck position (stopped at or parallel to the stop sign) while the photos on the right represent NTSB’s Estimated truck position (stopped several feet beyond the stop sign).

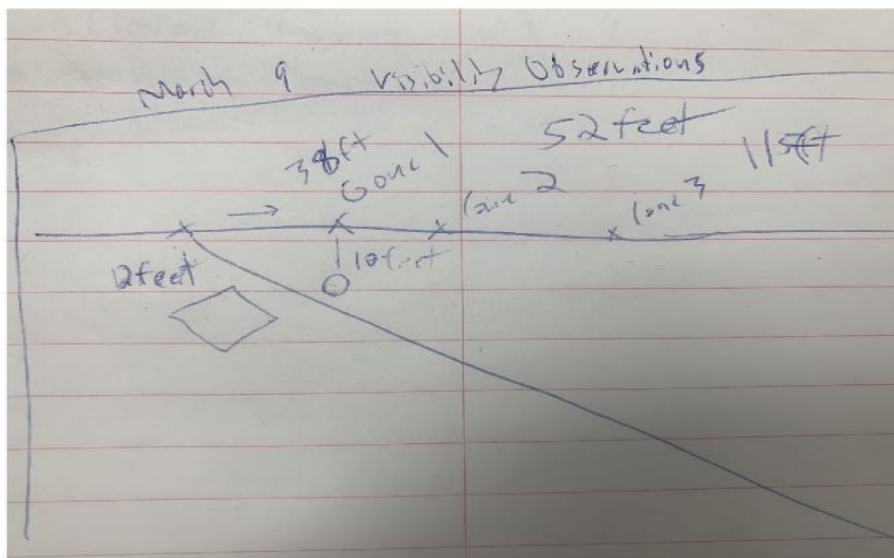
Based on measurements made by NTSB (See Fig. 6), if the Stein driver stopped at the Conservative Position and leaned forward to improve his field of vision

given the partially obscured view out of the right cab window, the driver would have been able to see approximately one hundred fifteen (115) feet down the track.

NTSB also estimates that if the Stein driver stopped at the Estimated Position, the driver would have been able to see approximately thirty-eight (38) feet down the track, assuming that the driver did not lean forward to garner an improved field of vision.

NTSB further concludes that from the Estimated Position, the driver would have been able to see approximately fifty-two (52) feet down the tracks, if he had leaned forward in the cab of his truck to see between the truck components that partially obscure the view out of the right side of the cab.

Figure 6. The above figure is a photo of a hand drawn sketch by the System Safety Group Chairman. The rail is depicted by a horizontal line, and the road is depicted by an angled line that intersects it from below. Three cones were placed to indicate measurements from the crossing, as described in Section 8.0 of NTSB’s System Safety Group report. The square represents the truck, and the circle represents the stop sign with crossbucks. Note that the figure is not drawn to scale.

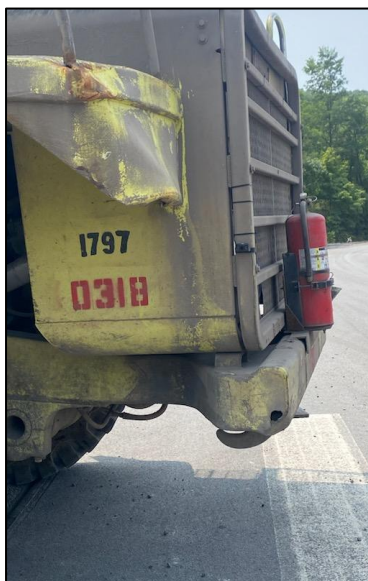
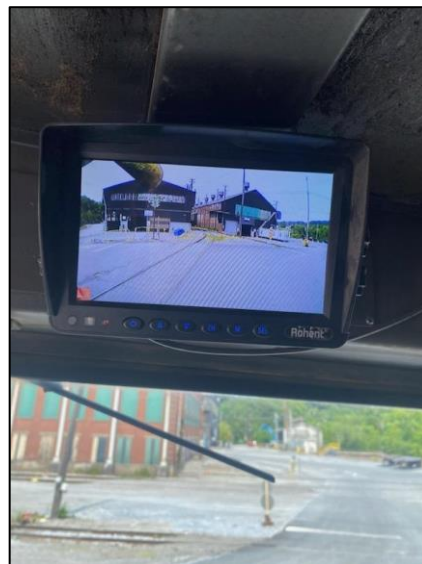
Figure 7 Example of added camera and monitor to help assist in field of vision.

- Investigate and determine feasibility of other enhancements to vehicles to improve detection and/or improve visibility associated with compromised field of vision or blind spots, including but not limited to railroad crossings, pedestrian areas, close clearances, through camera and monitoring systems (See Fig. 7), presence sensing equipment, or other applications related to heavy equipment operations.
