**Before the National Transportation Safety Board
Office of Railroad, Pipeline and Hazardous Materials Investigations
NTSB Accident Number – RRD23LR007
Accident Date – March 7, 2023**

**Stein, LLC's Submission of
Proposed Findings, Probable Cause, and Safety Recommendations in connection
with the collision of a Norfolk Southern Railway train and a Stein truck on the grounds of
Cleveland Cliffs - Cleveland Works in Cleveland, Ohio**

FINAL SUBMISSION

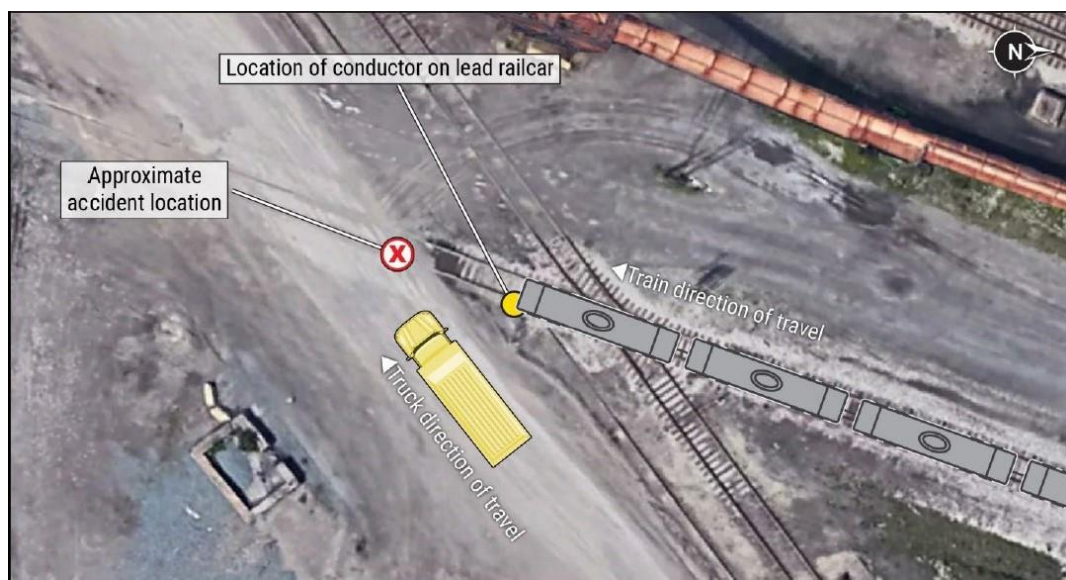
There are multiple sections on the grounds of CC-CW where train tracks intersect with roads that are used by cars and trucks. In the location of the accident, there is an intersecting road where vehicles were forced to approach and cross the train track at an angle. Exhibit 1 depicts the track and angle of crossing:

- (3) Change the angle that trucks and cars approach, and then cross, the intersection of this train track and road. The angle has changed since March 7th, and the change improved safety at the intersection. However, further improvement is possible.

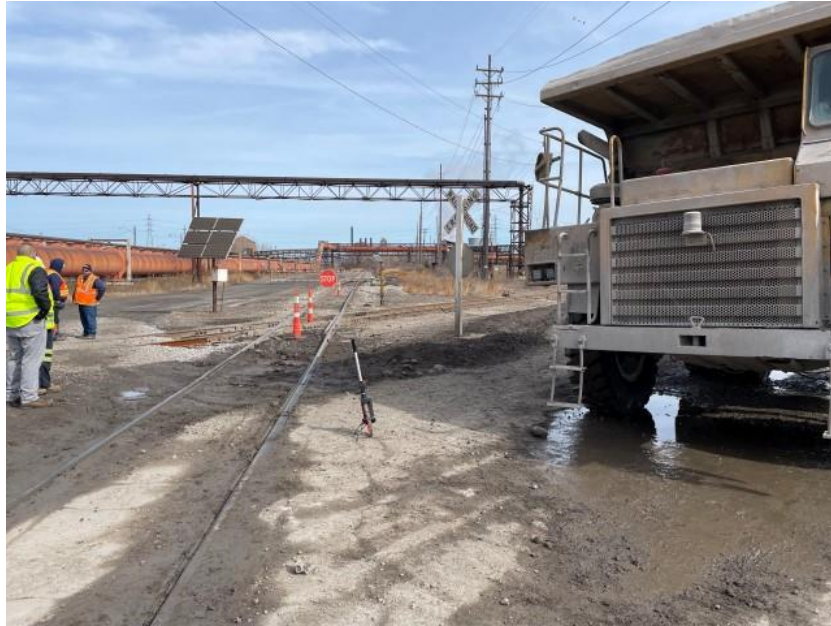
The train track is straight for over 100 yards as it approaches this intersecting road. If a person is traveling down that track on a train, there are no obstructions to viewing vehicles approaching and crossing the intersection. Exhibit 2 depicts a view looking down the train track:

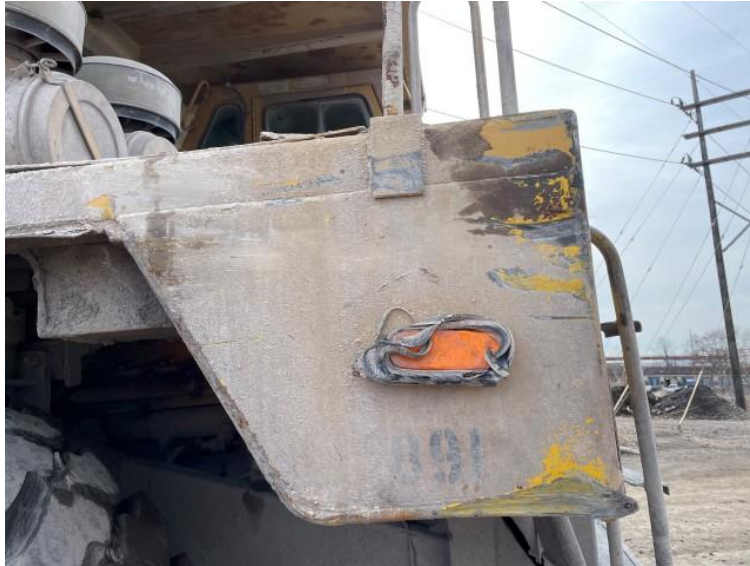
In addition, although the Stein dump truck was damaged when it was hit by the NS train, the damage was relatively mild. Exhibit 3 depicts the damage to the truck:

The lack of damage to the front right passenger side of the Stein dump truck indicates the truck was close to, but not on, the track when it was struck. Stated differently, if the front passenger side of the Stein dump truck extended onto the track, the damage to the truck would have been far more extensive.

The lack of damage to the Stein dump truck is noteworthy here because the NS conductor was pinned between the NS train and the truck. If the NS conductor had been standing in the middle of the running board on the front end of the lead tank car, he would not have been pinned in that position. The dump truck never extended that far onto the track. The physical evidence suggests the NS conductor was positioned on the far corner of, or perhaps on the side of, the lead tank car. Under Norfolk Southern Rule 217(a), the NS conductor “must be stationed at, on or ahead of the leading end of movement to . . . observe conditions ahead . . . [and maintain] radio communication . . . to the Engineer[.]”

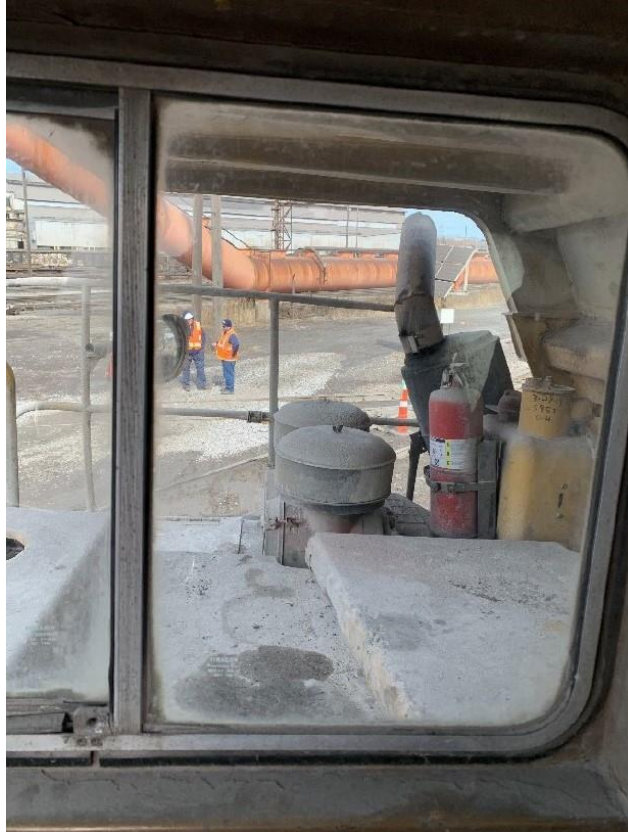
In its post-accident analysis, the NTSB investigators pulled the Stein dump truck slightly past the stop sign, to the location that appears in the video. Exhibit 4 depicts what a driver can see from this location during the day:

Critically, the NTSB “investigative group determined . . . this field of view best approximated that of the truck driver on night of the accident.” In this position, the NTSB found a driver can see approximately 38 feet to their right. Since the NS train was traveling 14.6 feet per second, it follows the NS train was **not** within the Stein driver’s field of vision when he stopped and looked to his right. This fact is proven by the 3 seconds the Stein dump truck moved forward before it was struck by the NS train. During those 3 seconds, the NS train was traveling at 10 MPH and covering 14.6 feet per second. That means the NS train traveled 43.8 feet during those 3 seconds. Because the Stein truck driver could only see 38 feet to his right when stopped at the sign, the NS train was **never** within the Stein truck driver’s view because the NS train was at least 43.8 feet to the right.
