NATIONAL TRANSPORTATION SAFETY BOARD

ONSCENE EXAMINATION

WPR20FA063

Aircraft: Cessna T182 Skylane

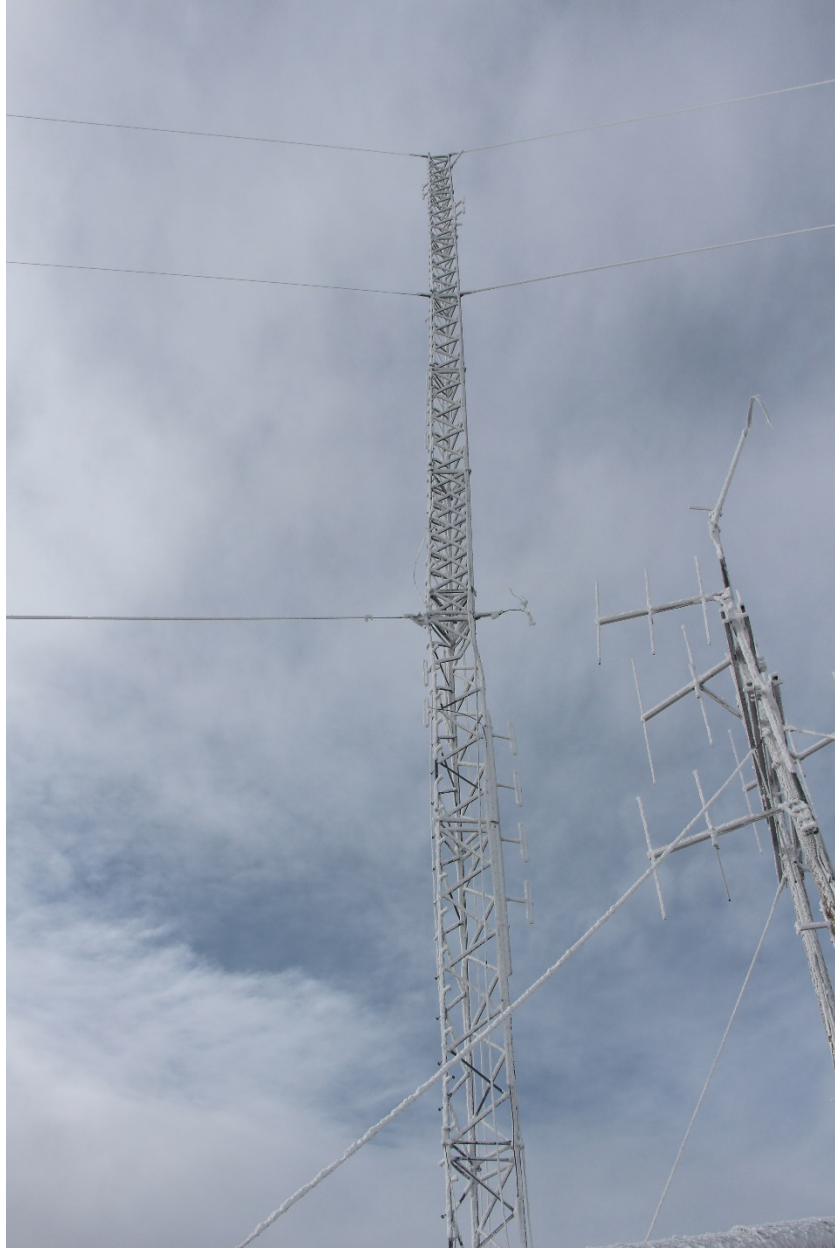
The tower was owned and operated by Yellowstone County and its height was 185 ft. According to Federal Aviation Administration (FAA) Advisory Circular 70/7460-1L, under Chapter 2.1 “Structures to be Marked or Lighted,” “Any temporary or permanent structure, including all appurtenances, that exceeds an overall height of 200 feet above ground level or exceeds any obstruction standard contained in 14 CFR Part 77 should be marked and/or lighted. However, an FAA aeronautical study may reveal that the absence of marking and/or lightning will not impair aviation safety. Conversely, the object may present such an extraordinary hazard potential that higher standards may be recommended for increased conspicuity to ensure aviation safety.” The excerpt continues to describe FAA action on structures that are less than 200 ft above ground level. “The FAA may also recommend marking and/or lighting a structure that does not exceed 200 ft above ground level or 14 CFR Part 77 standards because of its particular location.”

An FAA Sectional Chart valid from September 12, 2019 to March 26, 2020 did not list the tower as an obstacle. The FAA sectional chart legend lists the lowest obstruction marked on the sectional chart as “Above 200 ft agl.”

Photograph 1: Radio Tower

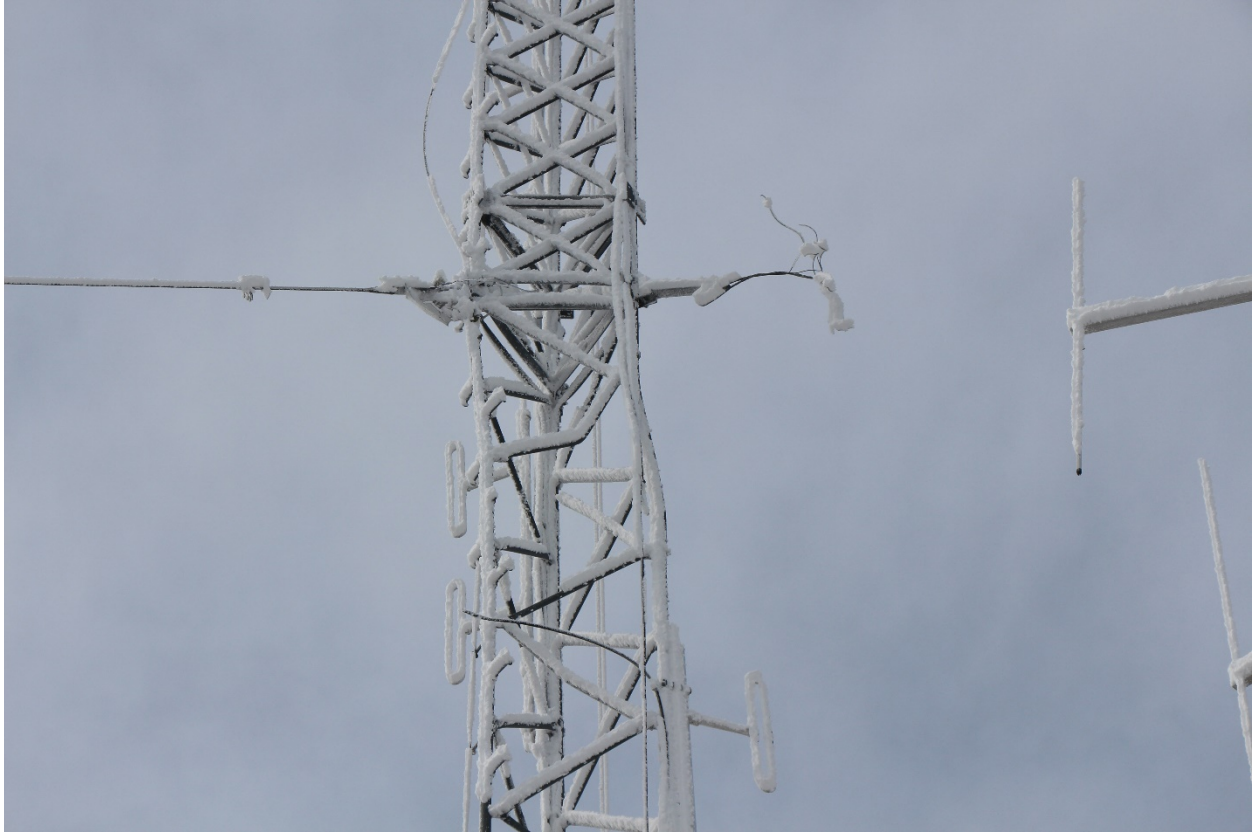
The airplane was located in mountainous terrain area at an elevation of about 4,252 ft mean sea level. All major sections of the airplane were accounted for at the accident site. The initial impact point (IIP) was marked by several bent cross members and a broken guy wire about 65 feet high on an approximately 185 foot-tall radio tower. Several sections of the outboard left wing were located about 100 ft north of the tower and two pieces displayed longitudinal signatures consistent with impacting a wire. The remaining section of left wing was found in the debris path about 300 ft from the main wreckage. Several airframe and engine fragments were distributed along the energy path, which was oriented on a heading of about 295° magnetic. A 5 foot-long intermediate ground scar was located about 120 ft from the main wreckage. The main wreckage was located about 600 ft northwest of the IIP in a coulee and comprised of the right wing, fuselage, empennage, and engine and oriented on a heading of 122° magnetic.

Photograph 2: Radio Tower Damage

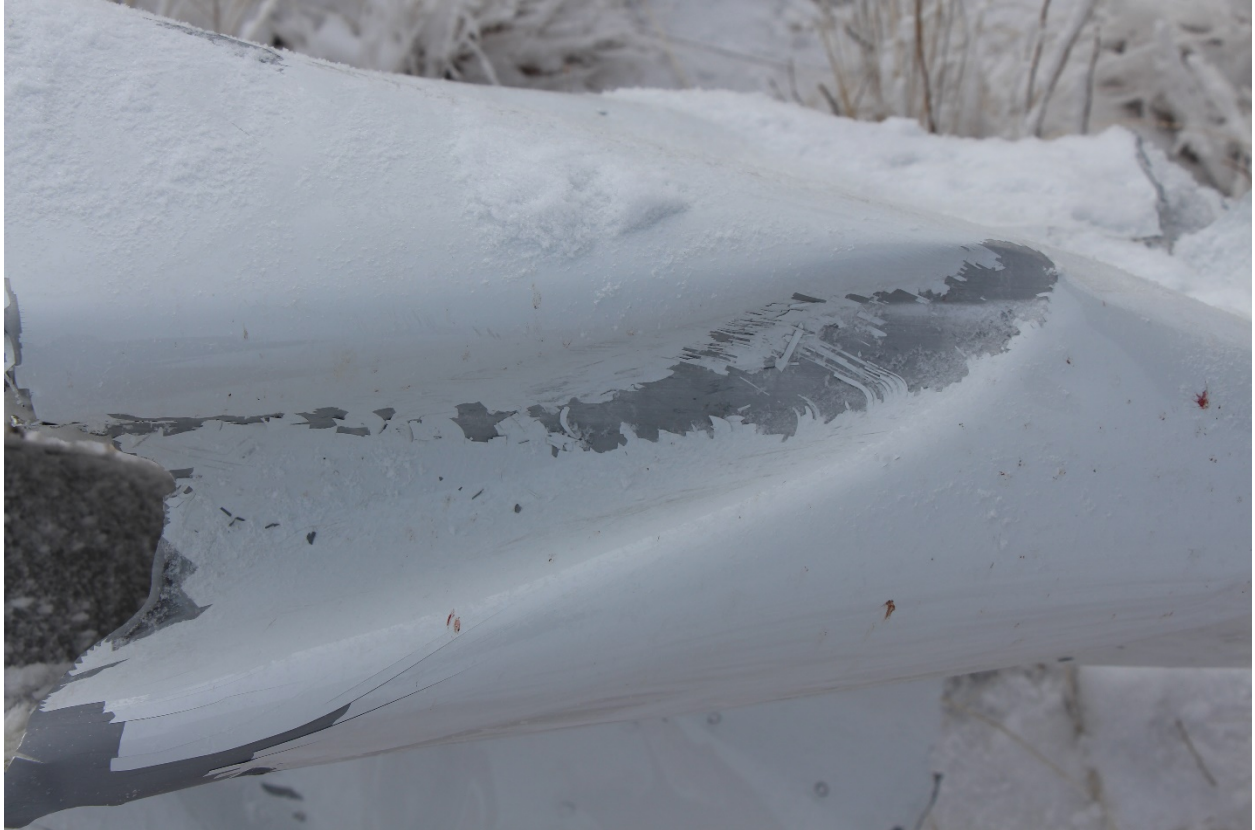
Photograph 3: Longitudinal Signature on Left Wing

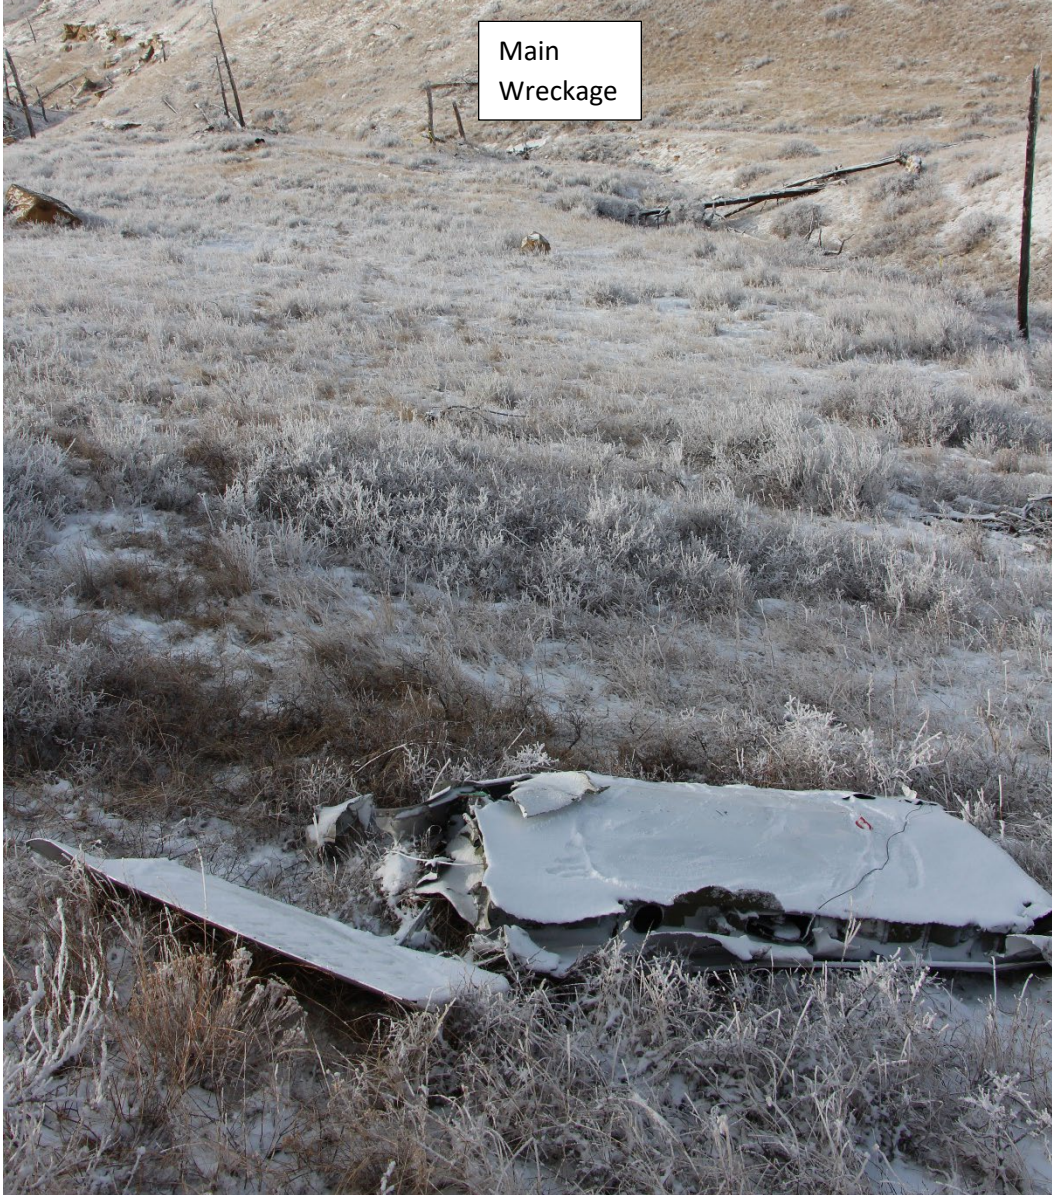
Photograph 4: View of Left Wing in Foreground Facing Main Wreckage

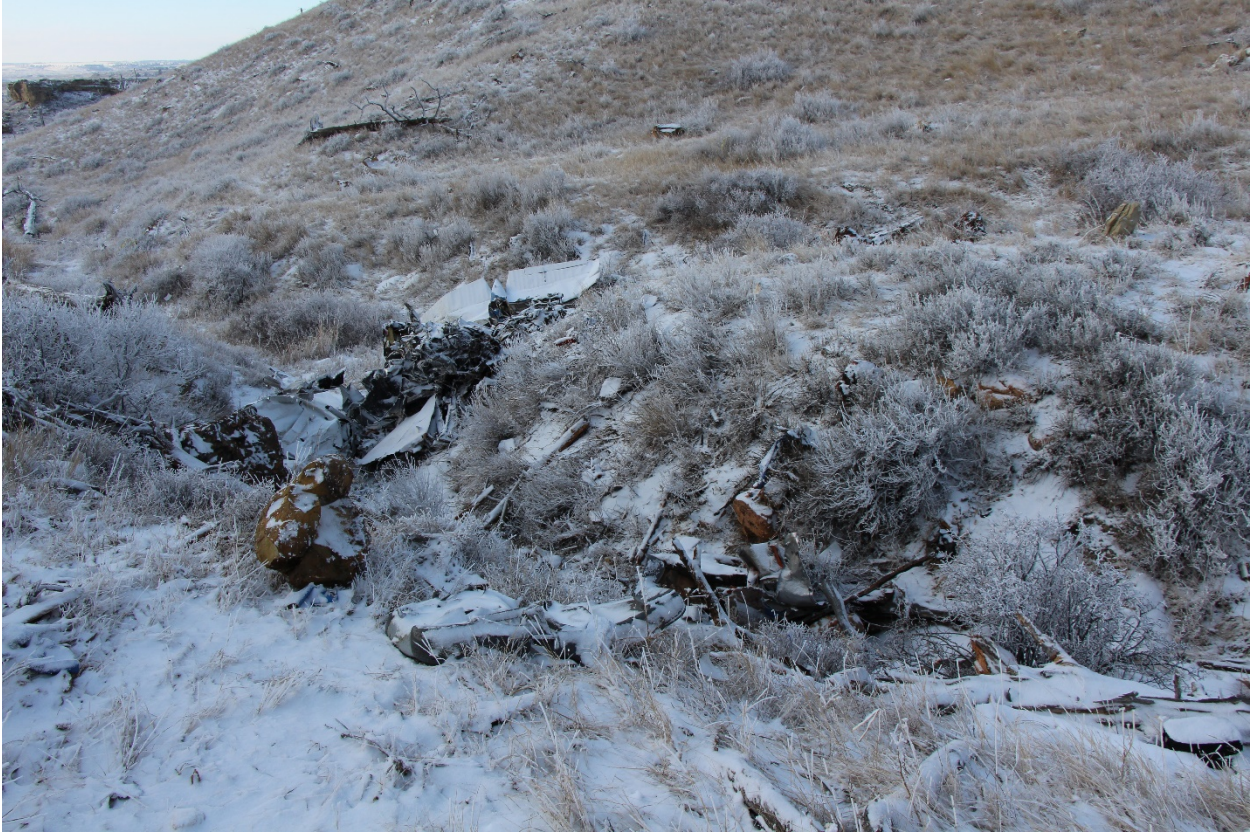
One propeller blade separated from the blade hub and was located along the debris path. The other propeller blade remained attached to the blade hub and was collocated with the main wreckage.

Photograph 5: View of Main Wreckage
