Timothy W. Monville
Sr. Air Safety Investigator
OAS-Eastern Region Aviation

Date: August 2, 2023

Subject: ERA23LA191, Record of Conversation/Interview

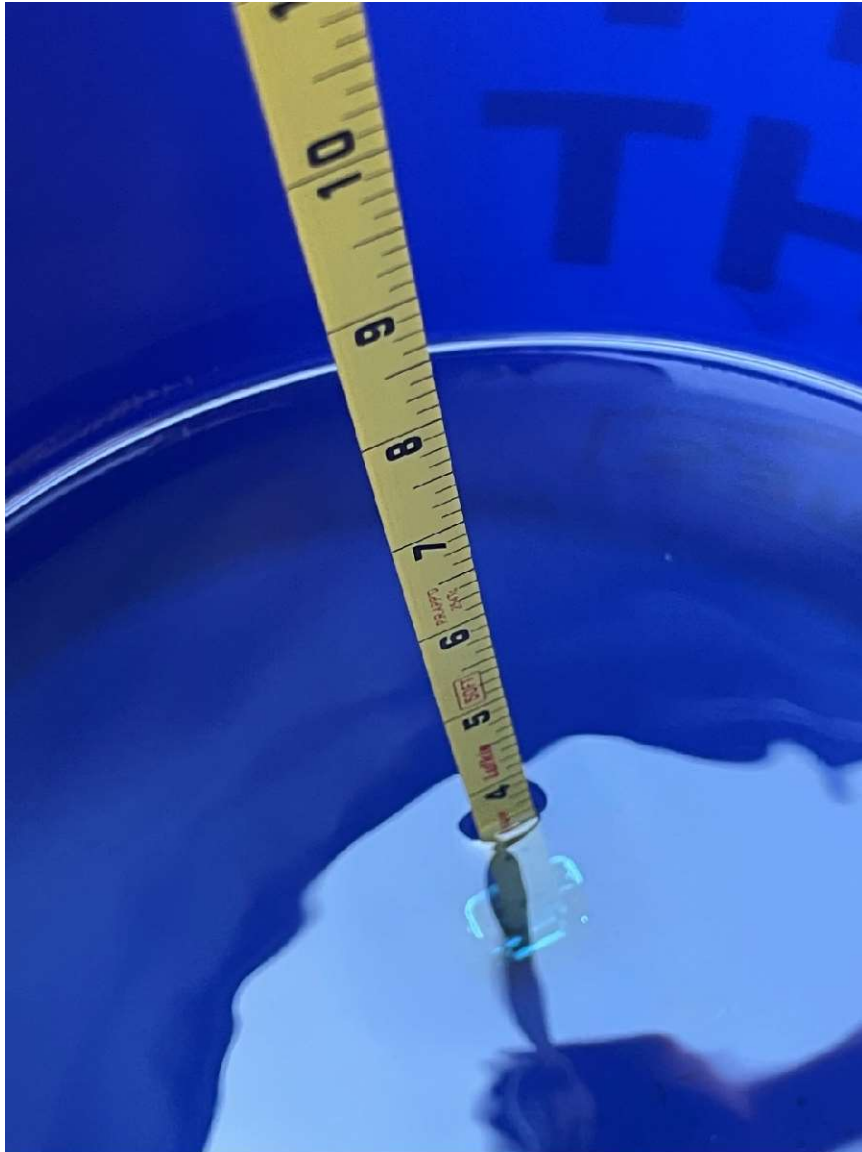
Both fuel tanks were breached, though during the on-site investigation they drained fuel from the right wing fuel tank into a 5-gallon bucket and the depth of fuel was 3.5 inches (Figure 1). He was asked to get the diameter of the bucket and in a later produced Inspector Statement indicated the diameter was 11.75 inches. He indicated that the airframe fuel strainer was drained and found to contain about 40 milliliters of fuel (Figure 2). The airframe fuel strainer was torn from the firewall and the supply line was kinked (Figure 3).

Figure 1: FAA Digital Photograph. View of the Level of Fuel Drained From the Right Wing Fuel Tank Into a 5-Gallon Bucket.

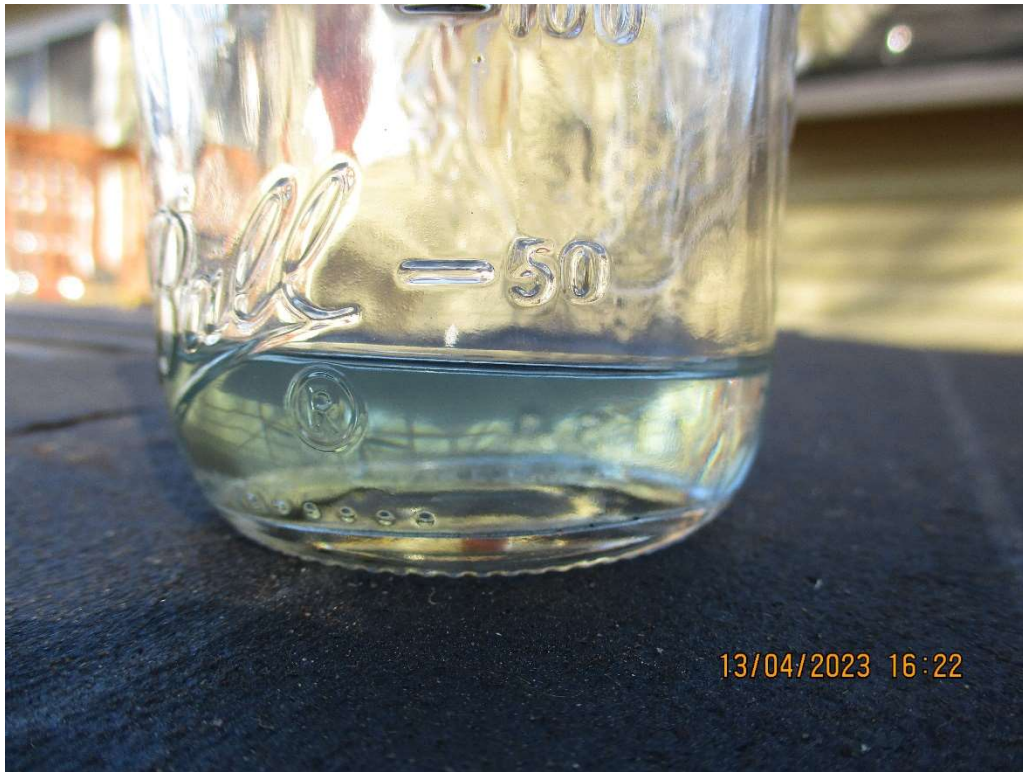
Figure 2: FAA Digital Photograph. View of the Fuel Drained From the Airframe Fuel Strainer. Note the value was about 40 milliliters.

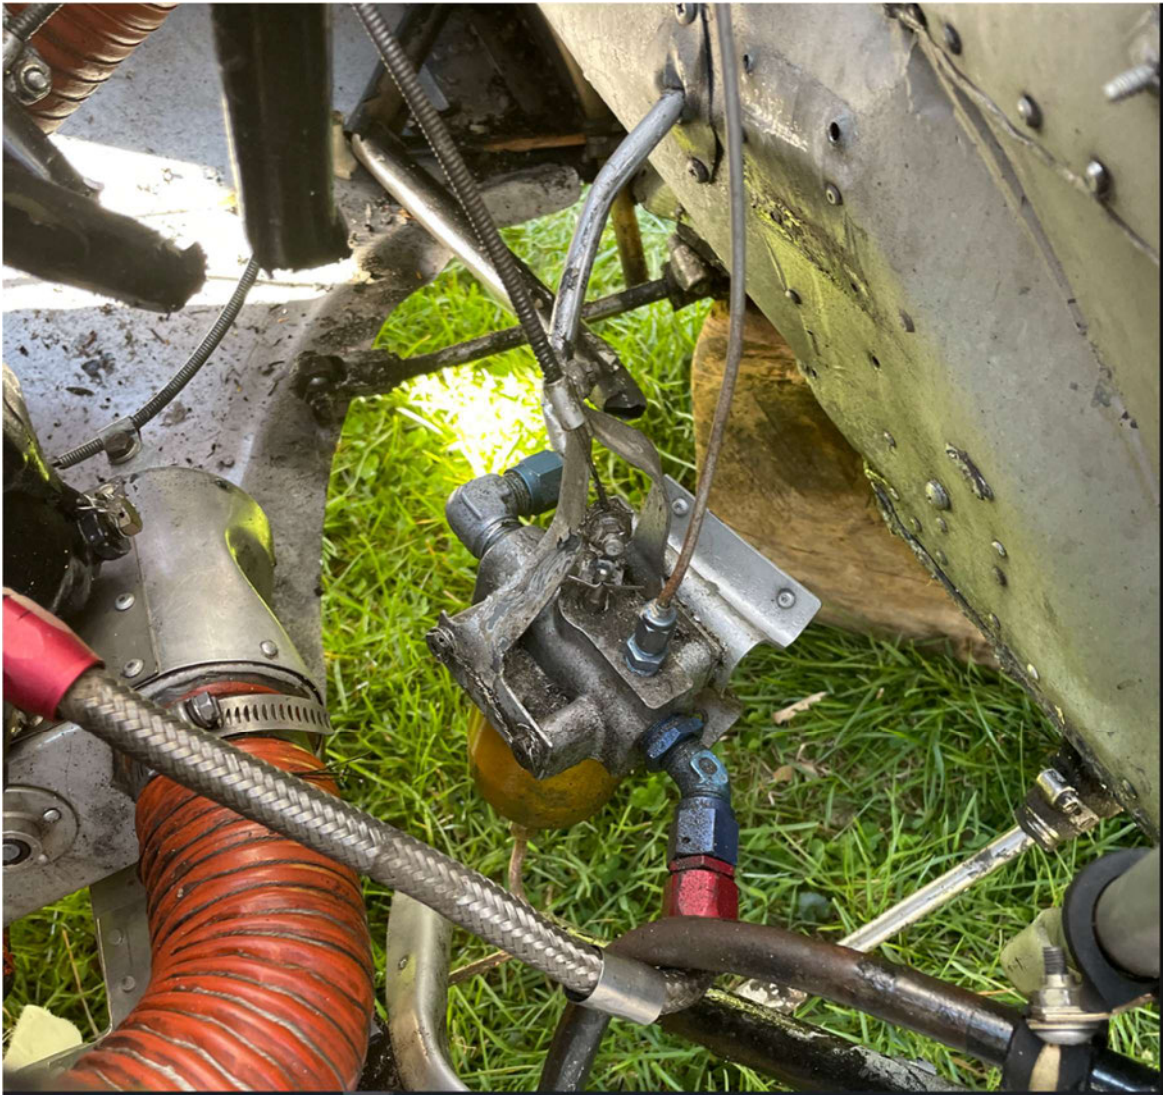
Figure 3: FAA Digital Photograph. View of the Separated Airframe Fuel Strainer. Note the Damaged Fuel Inlet Line.
