## **NTSB Regulatory Interpretation Request Operating Practices Response**

**On April 1, 2021, the NTSB posed the following two similar questions:**

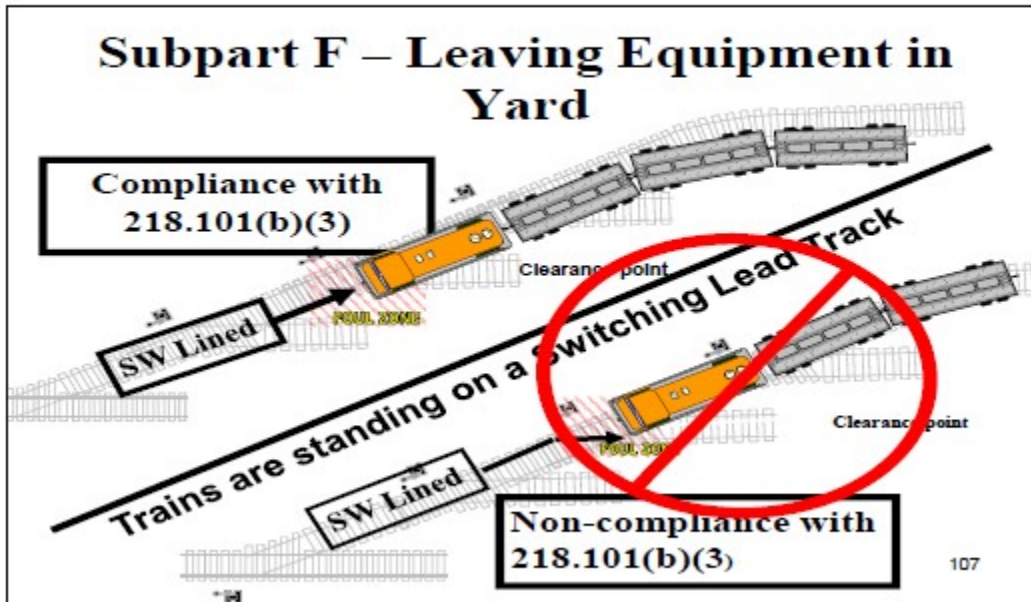
**The (DPU) rear end of the train, located on the lead track, was in the foul of track 6802. However, it was not in violation of 218.101 due to the position of the track 6802 switch. The 6802-track switch was lined for the lead in compliance with the following 218.101(b)(3) rule:**

**Therefore, since the track 6802 switch was lined for the lead, there is no fouling violation and is in compliance with the 218.101(b)(3) exception.**

**The following Operating Practices Compliance Manual diagram depicts 218.101(b)(3):**

The above diagram closely reflects the La Mirada accident scenario.
