National Transportation Safety Board

ERA24NA237

WRECKAGE IDENTIFICATION

Location: Lake Champlain, Vermont
Date: January 27, 1971
Time: 1955 Local
0055 UTC
Airplane: Aero Commander 1121, N400CP

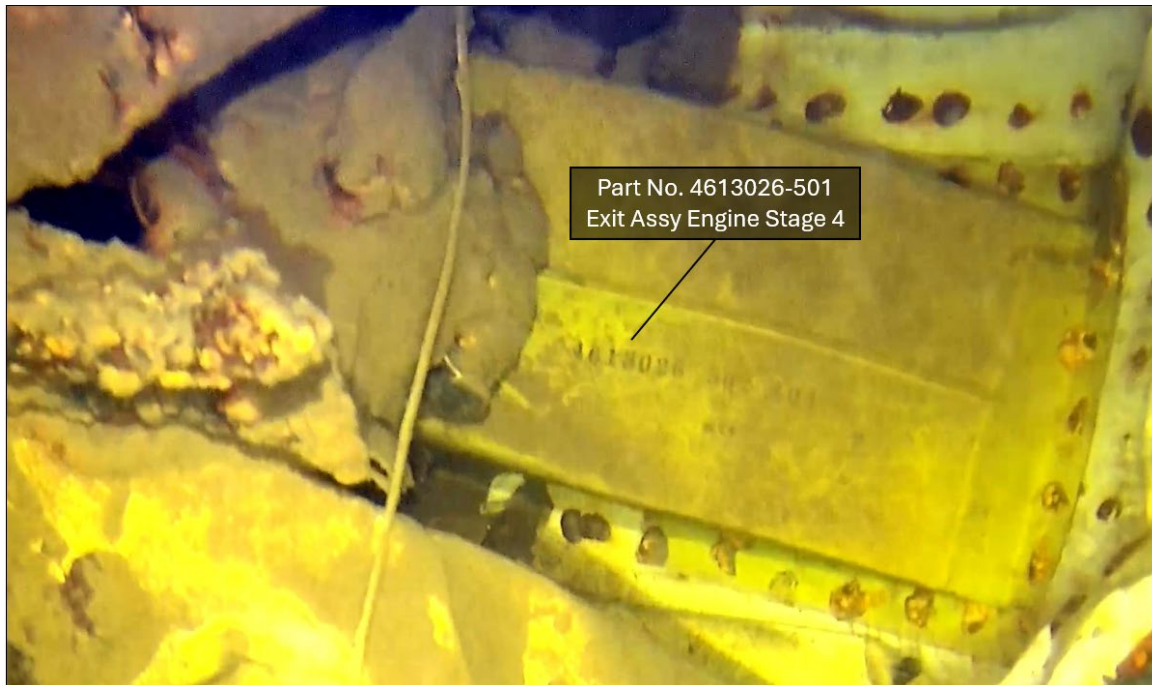
The part No. 4613026-50 'Exit Assy Engine Stage 4' was identified.

Figure 3: Part No. 4613026-501 'Exit Assy Engine Stage 4'.

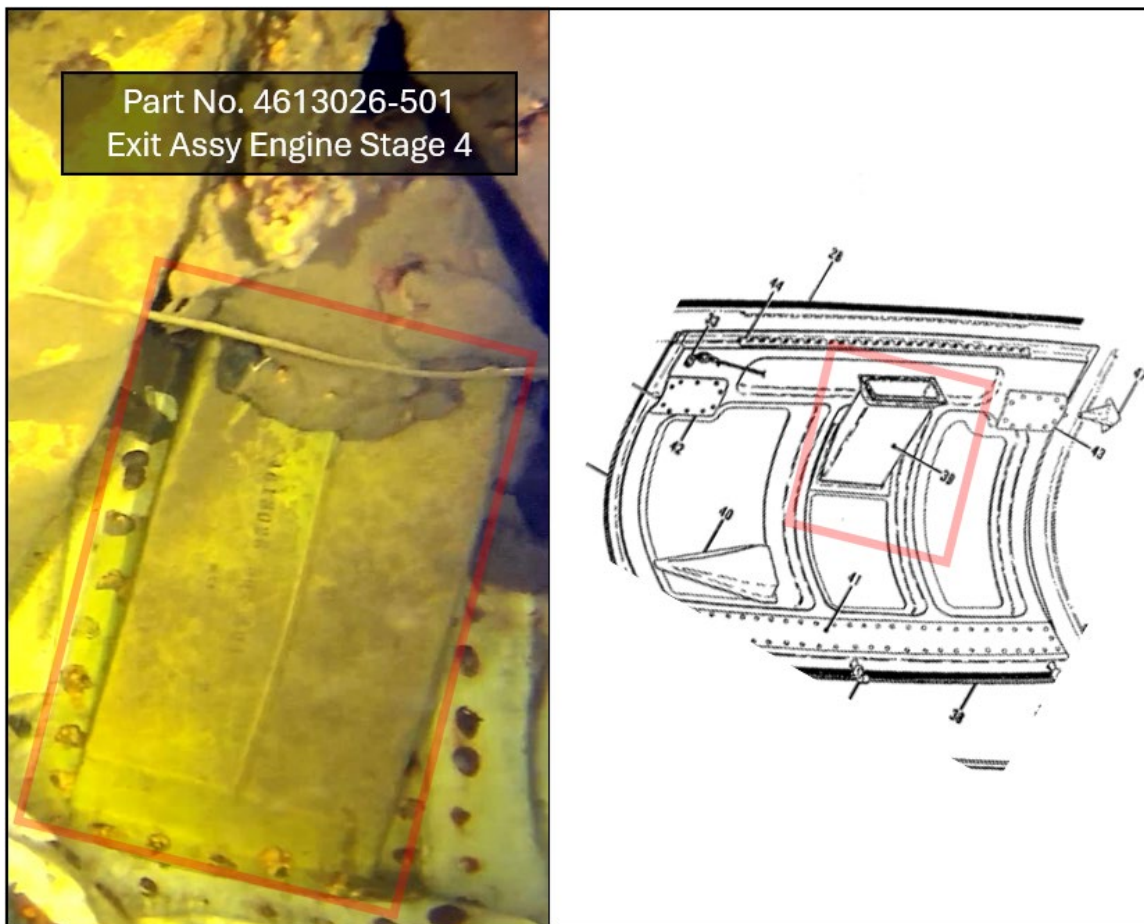
Figure 4: Additional View Part No. 4613026-50 'Exit Assy Engine Stage 4.'

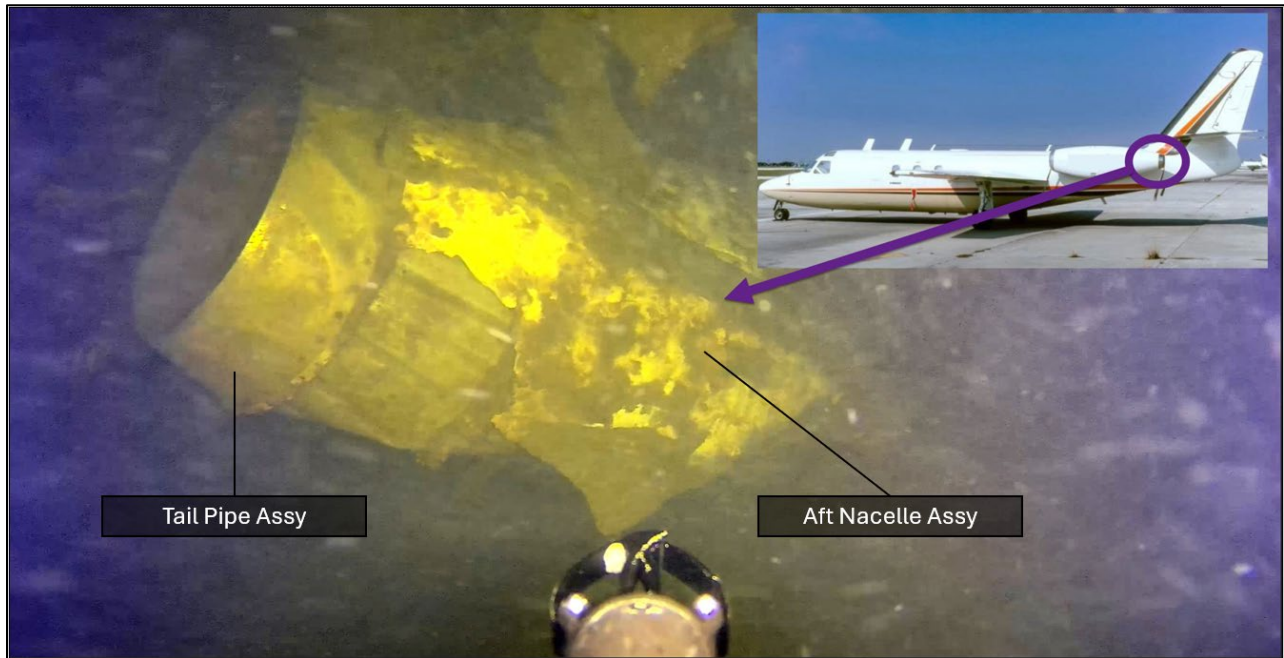
Areas of the engine tail pipe assembly were identified.

Figure 5: Engine Tail Pipe Assembly. Note the airplane is an exemplar Aero Commander.

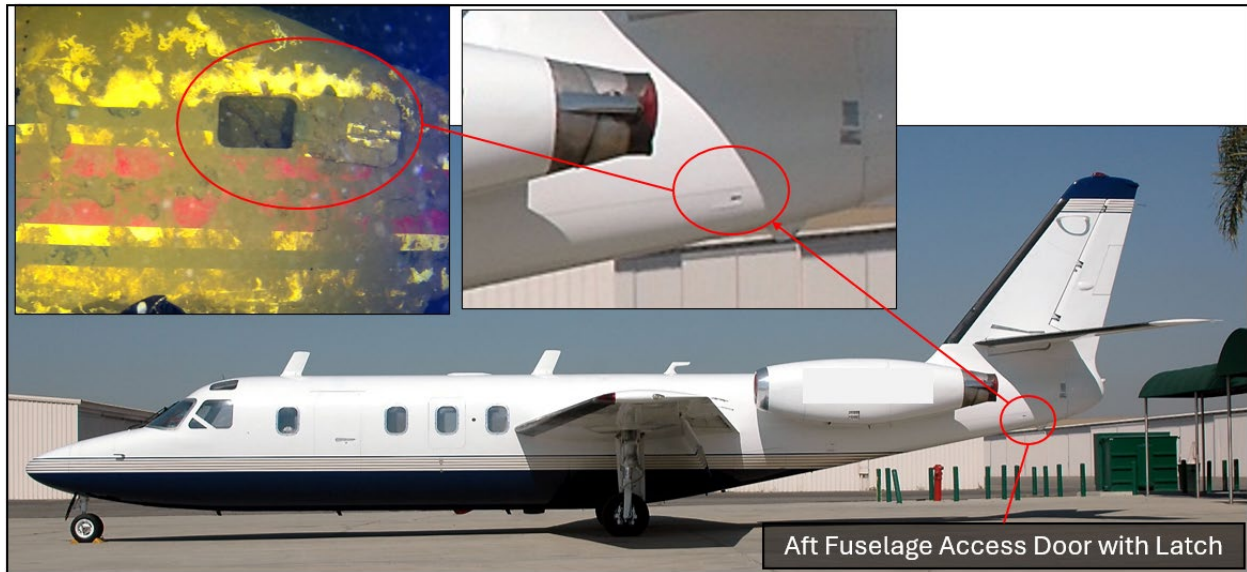
An exemplar airplane's aft fuselage access door with the latch was identified.

Figure 7: Exemplar airplane showing location of Aft Fuselage Access Door with latch.

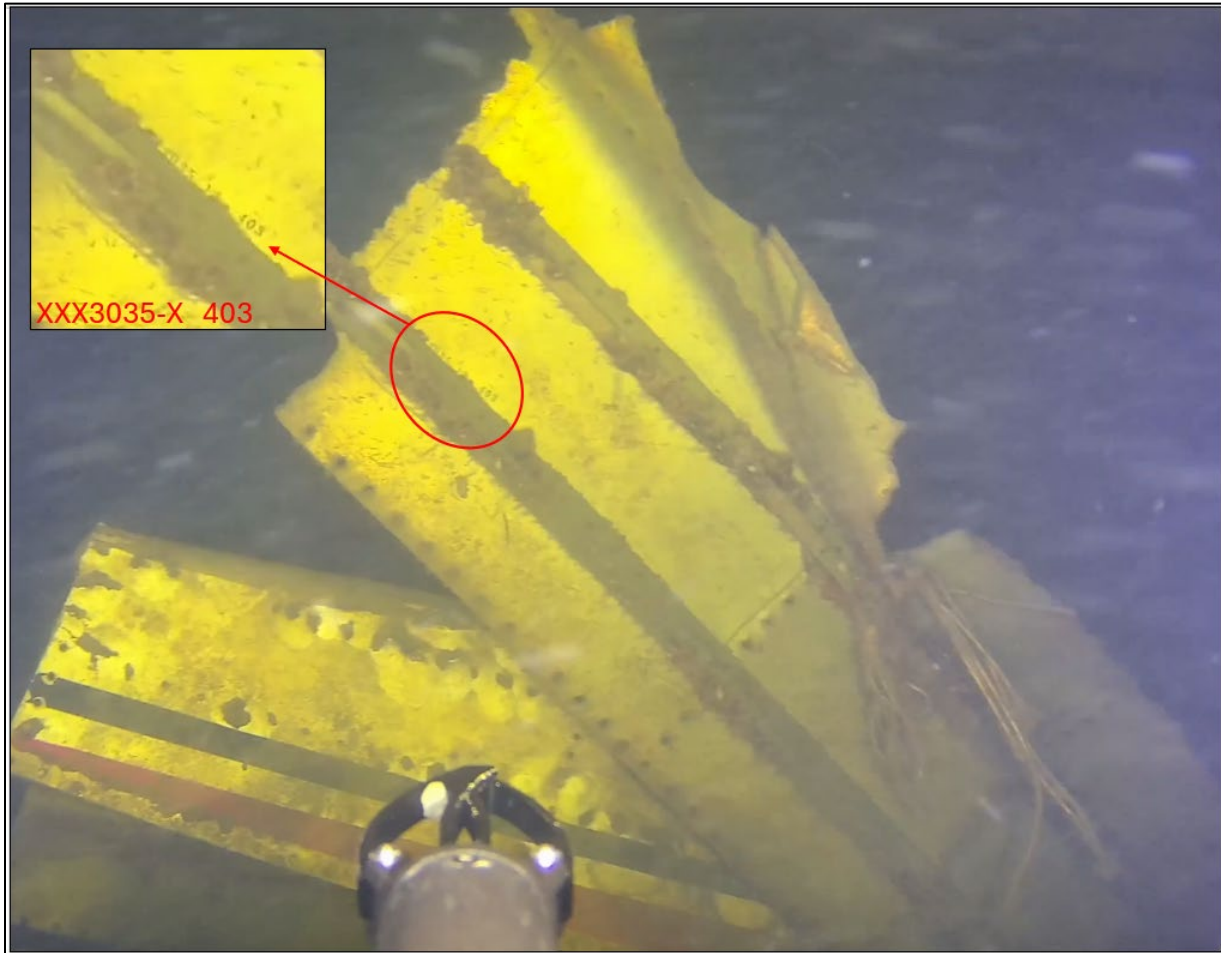
Additional areas of aft fuselage plating were identified near station '403.'

Figure 8: View of fuselage plating denoting the station location near '403' and an excerpt of Part No. '3035'.

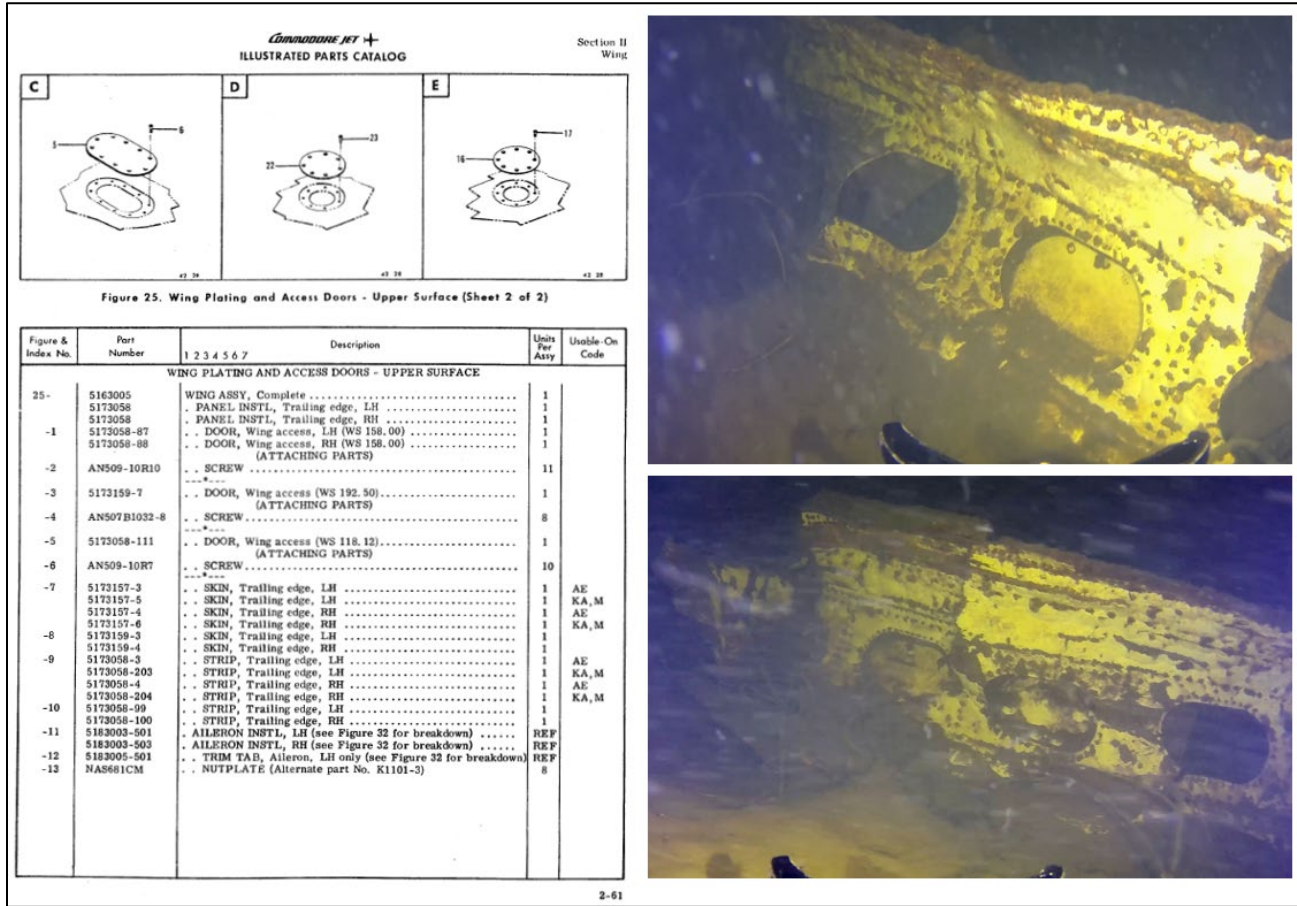
Multiple wing plating and access panels were identified.

Figure 11: Views of wing plating and access doors.

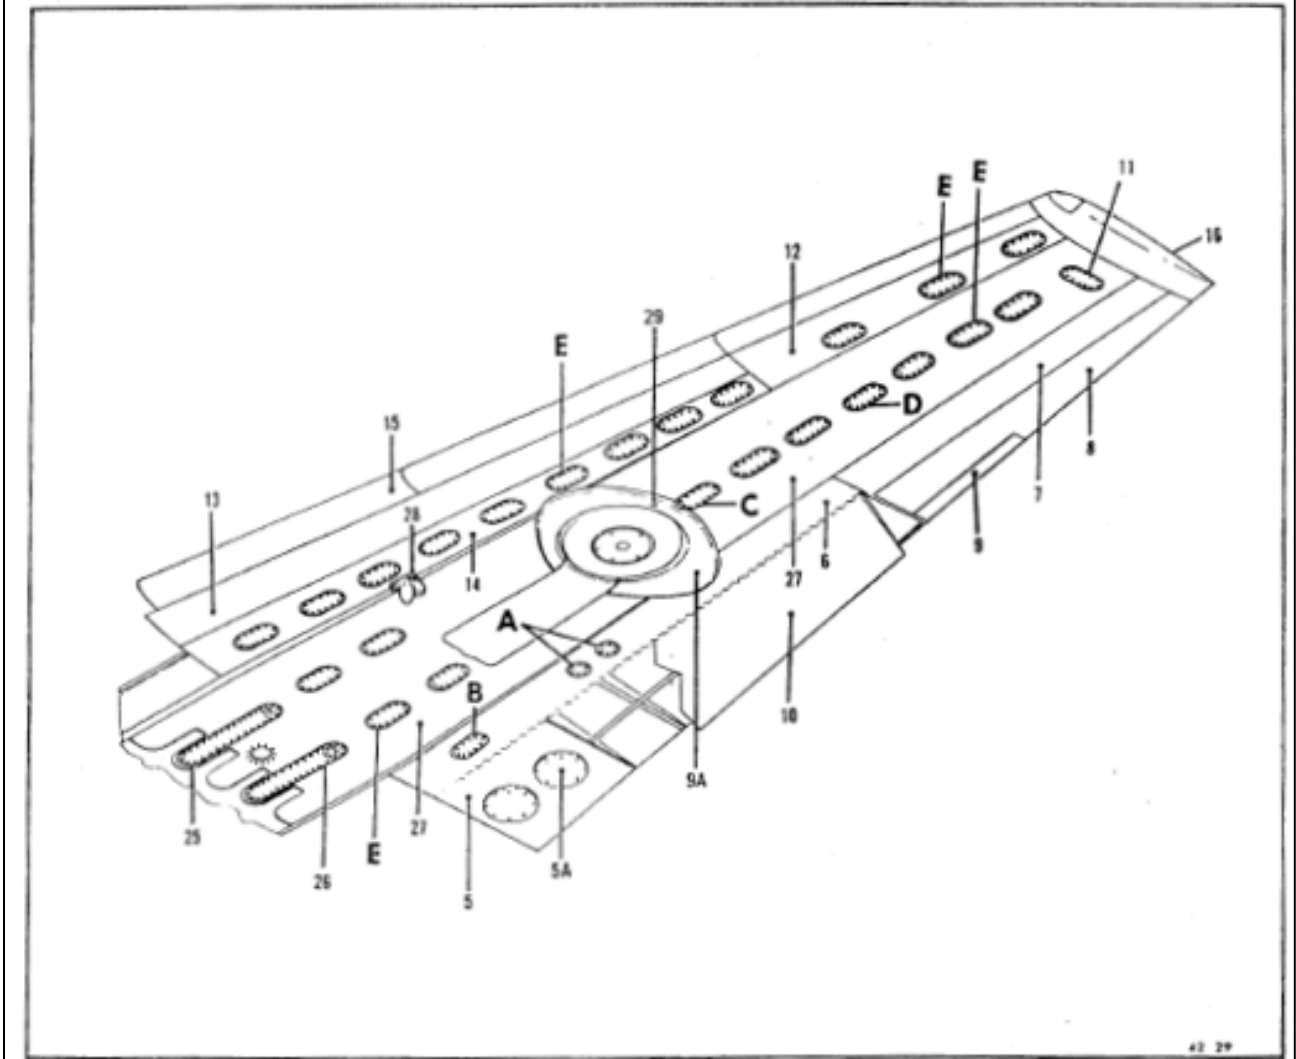
Figure 12: Additional views of wing plating and access doors.

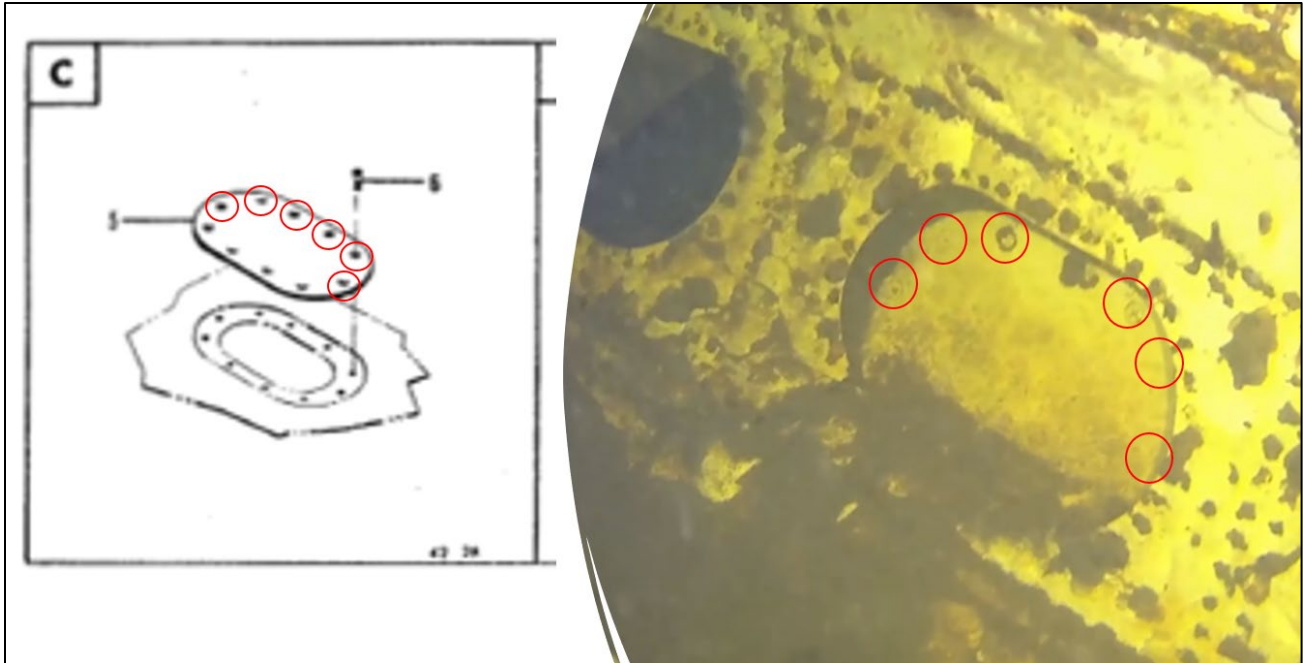
Figure 13: Additional view of wing plating and access doors.

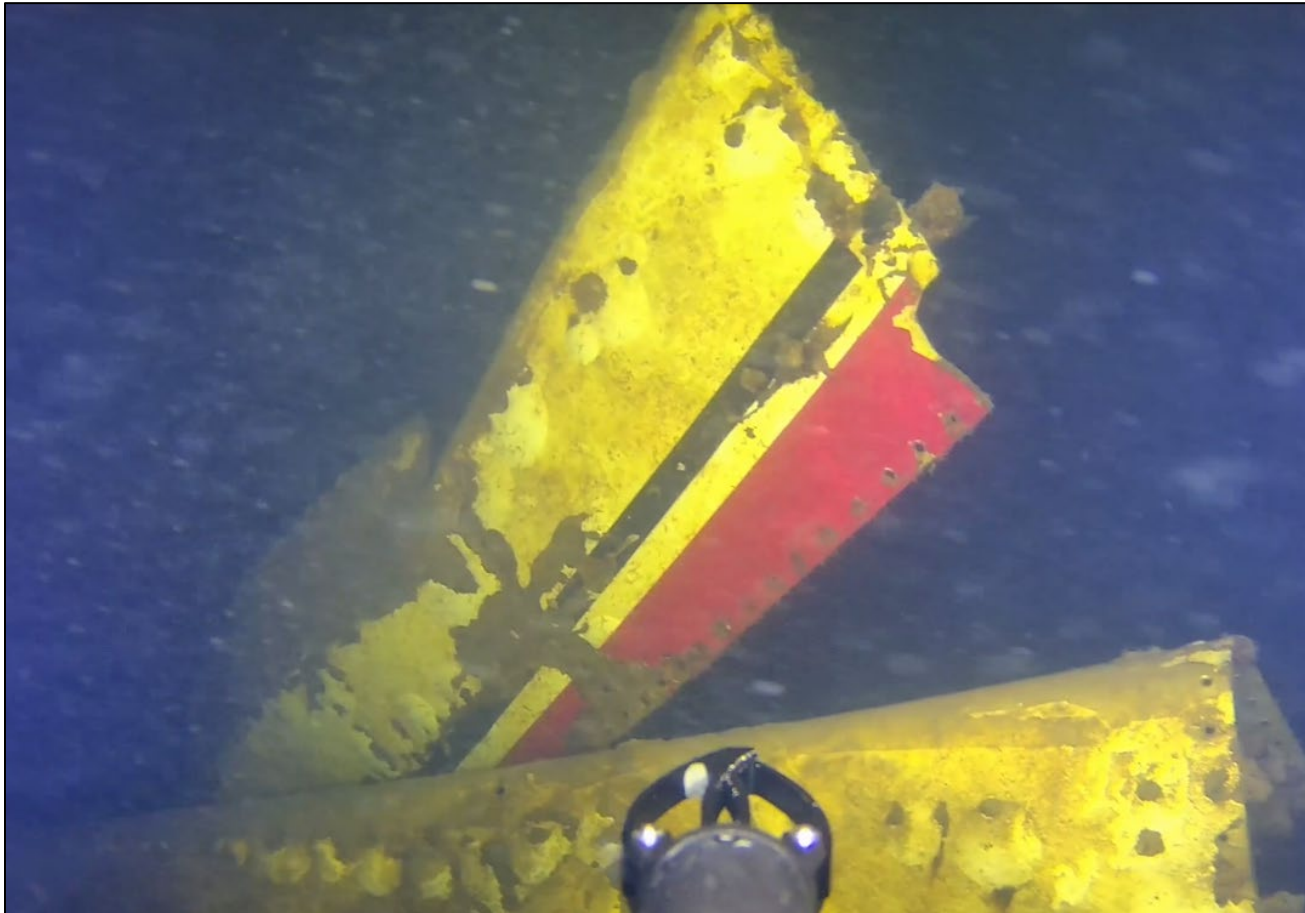
Figure 14: Additional view of paint scheme and fuselage skin matching reported picture of accident airplane.
