Response to Petition for Reconsideration

April 21, 2021

DuPont, Washington, Accident

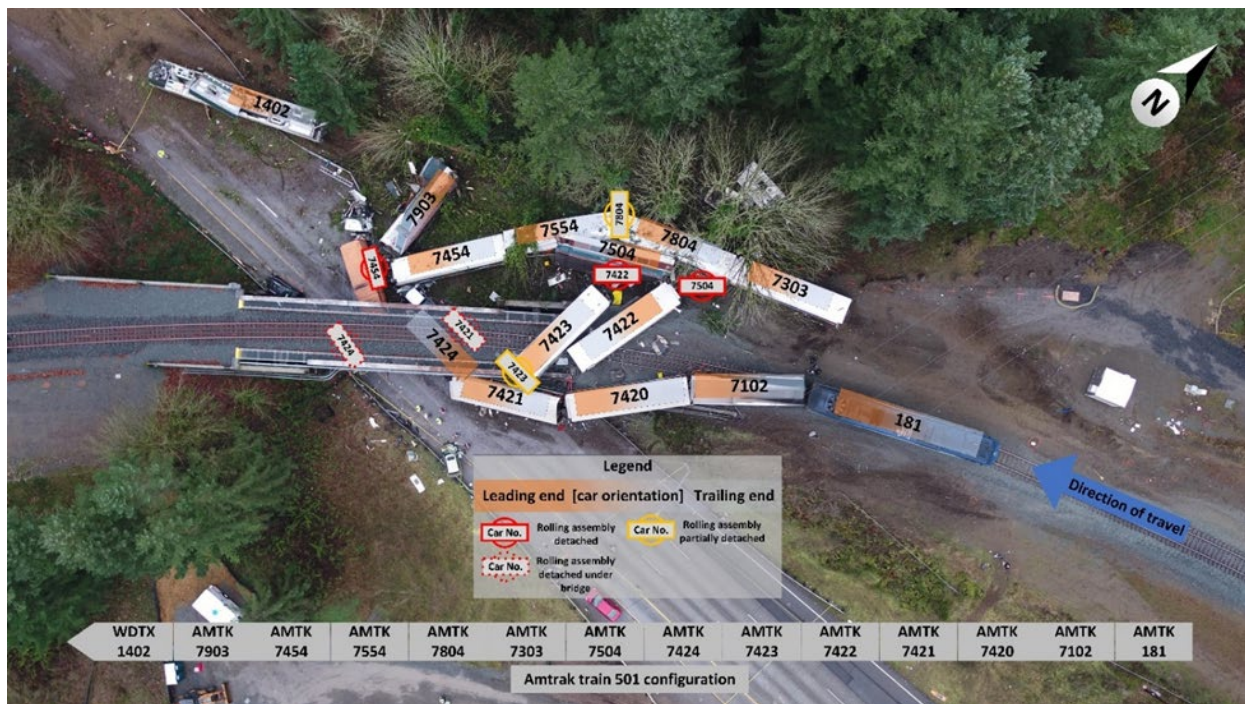
Figure 1. Overhead view of the DuPont accident site showing railcar numbers, their position in the consist, and their direction of travel. Railcar 7424 was under the overpass.

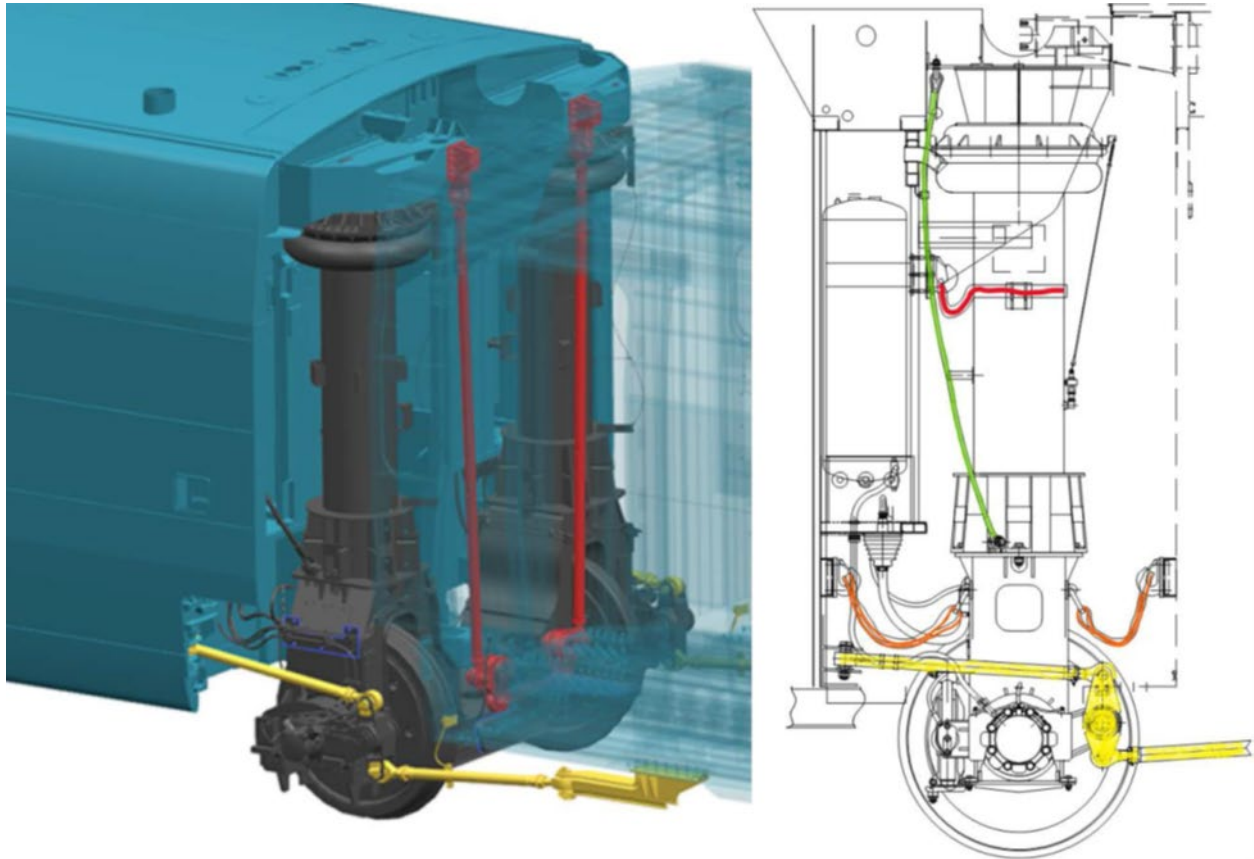
In the image on the left in figure 2, the weight of the suspended end of the transparent railcar is carried by the two weight bearer bars shown in red. Fore and aft forces between railcars are carried by the articulated connection at the base of the railcars (not shown), which has flexible elements to allow the railcars to track around curves.

Figure 2. Rolling assembly cutaway and its side view.

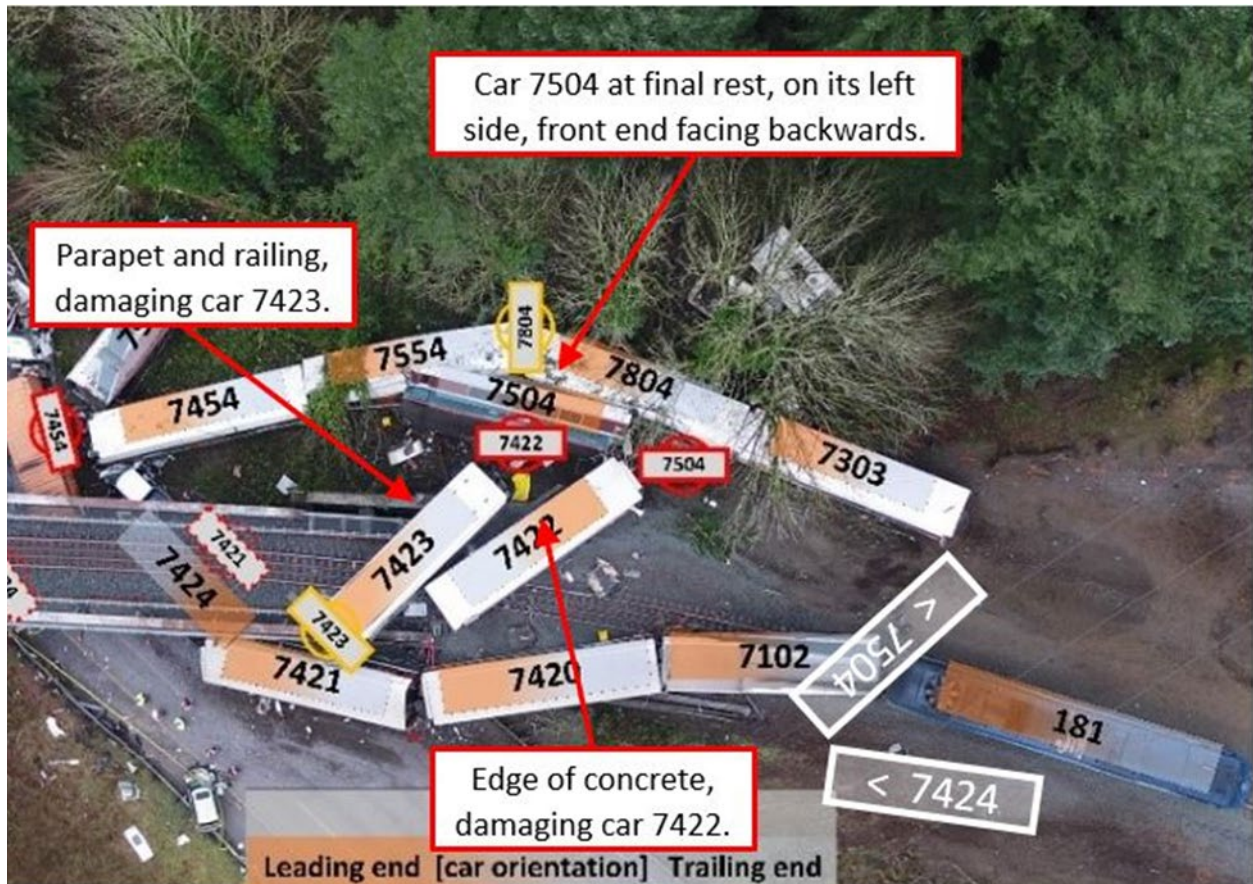
As railcar 7303 and the other railcars in front of railcar 7504 were stopping (after following the locomotive along the right side of the tracks), railcar 7504 was being pushed by railcar 7424 and the rest of the consist behind it. Figure 4 indicates the approximate positions of railcars 7504 and 7424 partway through the derailment sequence. Railcar 7424 traveled down the left side of the tracks and came to rest under the overpass. Figure 4 indicates the final resting position of railcar 7504, on its left side on top of railcars 7554 and 7804, with the front end of the railcar pointing back in the direction from which it came. The end of the concrete bridge is indicated where it caused an indentation on the left side of railcar 7422. Railcar 7423, in front of railcar 7422, slid farther onto the bridge and was damaged by impact with a parapet and railing.

Figure 4. Approximate positions of railcar 7504 and railcar 7424 during the derailment sequence, as indicated by white rectangles on the right side of the image. The < symbols indicate the direction of travel before the derailment. The small red boxes with circles indicate the positions of rolling assemblies; see figure 1 for the complete legend.

As railcar 7504 was separating from the stopped railcar 7303, it was being pushed from behind by railcar 7424. As a result, railcar 7504 acquired angular momentum that would tend to keep it rotating, as well as linear momentum carrying it toward the front of the train. Talgo's explanation for the damage to railcar 7504 would have required it to stop rotating and then slide sideways about 65 feet to a point where it contacted the bridge, after which it would have had to rotate an additional 90° and turn onto its left side.

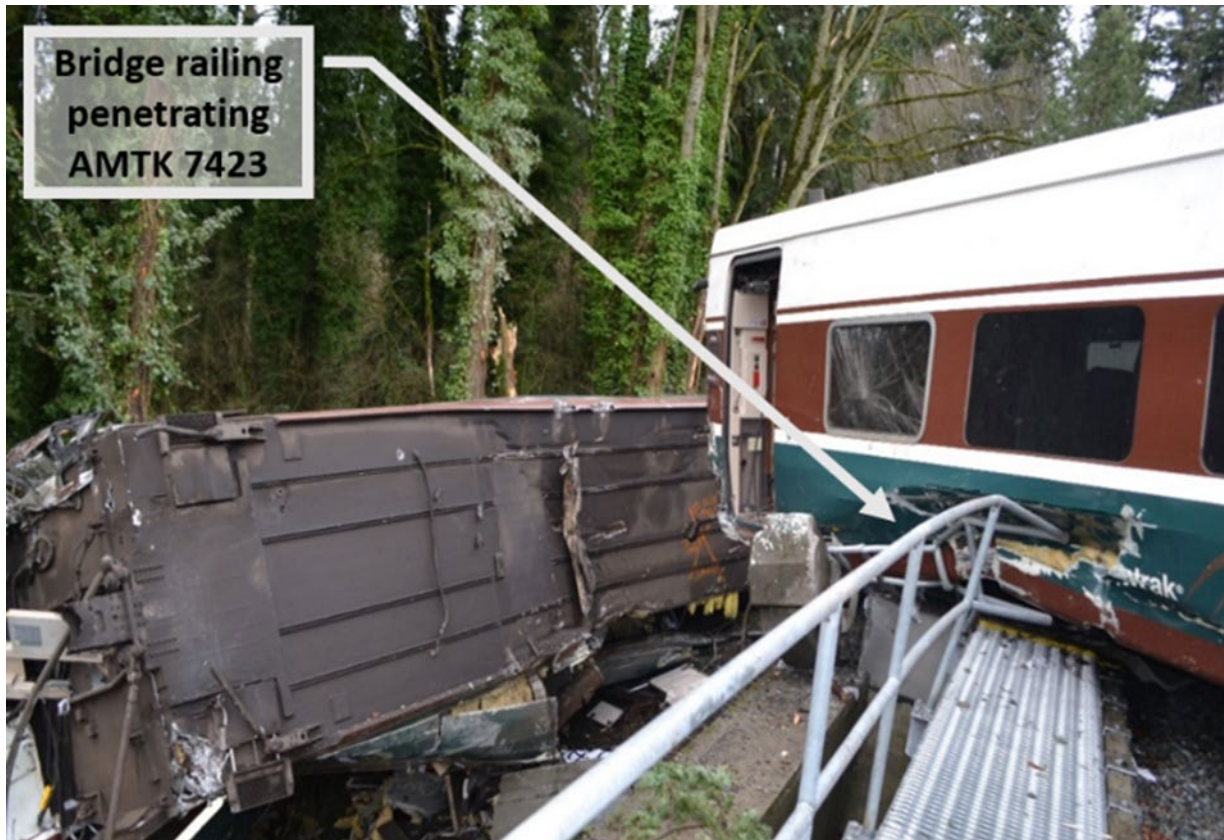
Photographs illustrate that the petitioner's proposed scenario is incorrect. Figure 5 reproduces figure 31A from the NTSB DuPont accident report. The subject of the photograph was the penetration of railcar 7423 by the bridge railing; the displaced concrete parapet can be seen just in front of the railcar door. However, the bottom of railcar 7504 is clearly seen on the left of the photograph. There are no scrape marks on the bottom of the railcar. There is no evidence that the railcar slid sideways for 65 feet. An impact at floor level on the left side of the railcar (at the bottom in the photograph) would have pushed the floor structure toward the right (upward in the photograph).

Figure 5. The bottom of railcar 7504 on the left shows no evidence of the railcar sliding sideways.

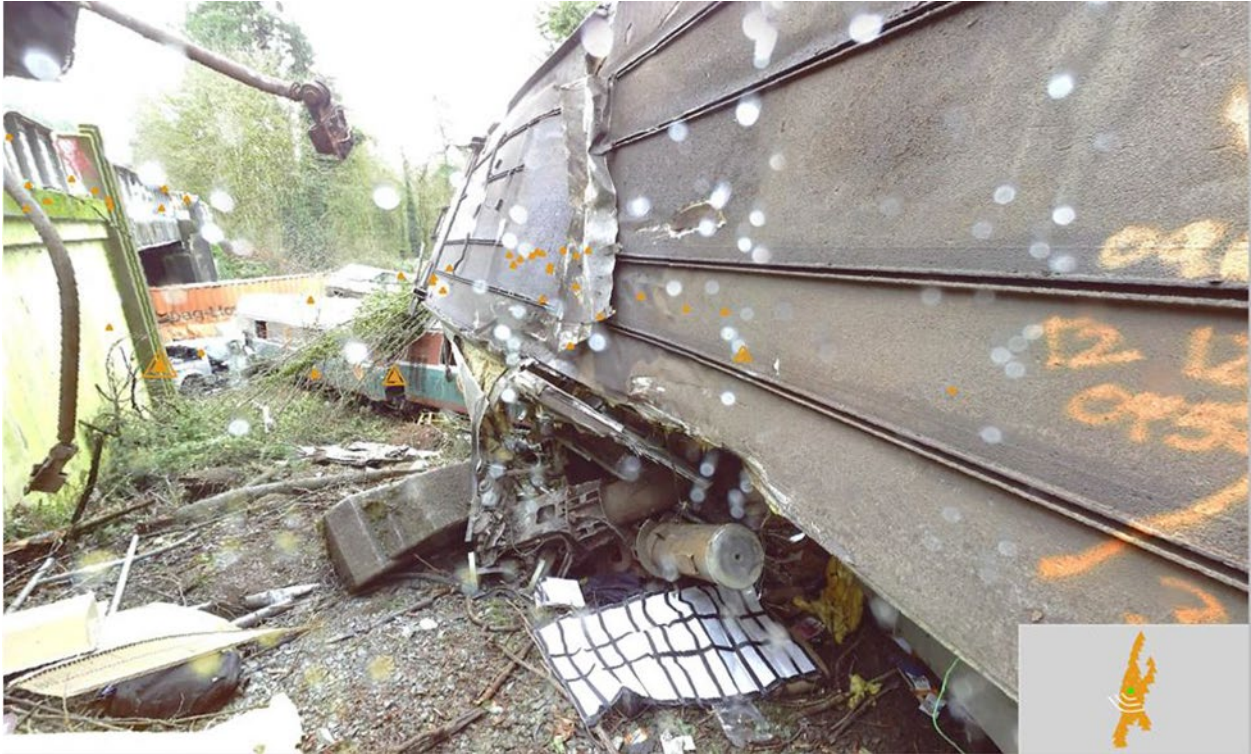
Figure 6 also shows the bottom of railcar 7504 but looking from the opposite direction. Again, there are no scrape marks to indicate the railcar slid sideways, and the bottom of the railcar remains generally intact except for the tear in the railcar floor. Figure 6 reproduces figure 56 from Talgo's party submission.

Figure 6. The bottom of railcar 7504 is on the right, looking in the opposite direction from figure 5. There are no marks to indicate the railcar slid sideways, and the bottom structure is not deformed. The detached rolling assembly from railcar 7422 is underneath railcar 7504.

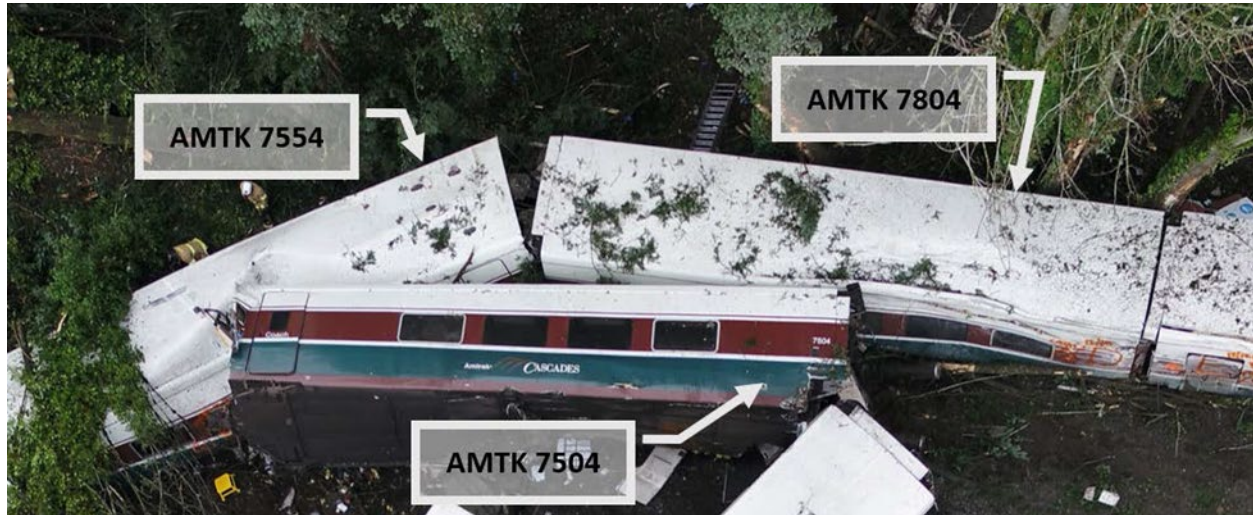
Figure 7 shows the right side of railcar 7504 after coming to rest on top of railcar 7554 and alongside railcar 7804.¹⁴ The right side of railcar 7504 is generally clean and shows little damage. The indentation along the left side of the roof of railcar 7804 that was caused by railcar 7504 begins just above the last window, and there are scrape marks along railcar 7804 and the trailing railcar 7303 (to the right in the photograph), again indicating that railcar 7504 slid backward alongside these railcars to its final resting position.

Figure 7. The right side of railcar 7504, at rest on top of railcar 7554 and alongside railcar 7804. The indentation of the roof of railcar 7804 begins just above the last window, and there are scrape marks along railcar 7804 and the trailing railcar 7303, again indicating that railcar 7504 slid backward alongside these railcars to its final resting position.
