Submission to the  
National Transportation Safety Board  
for the

**United Airlines 777-200 N772UA  
Engine Failure and Inlet-Fan Cowl  
Departure  
Denver, CO  
20 February 2021**

**The Boeing Company  
12 June 2023**

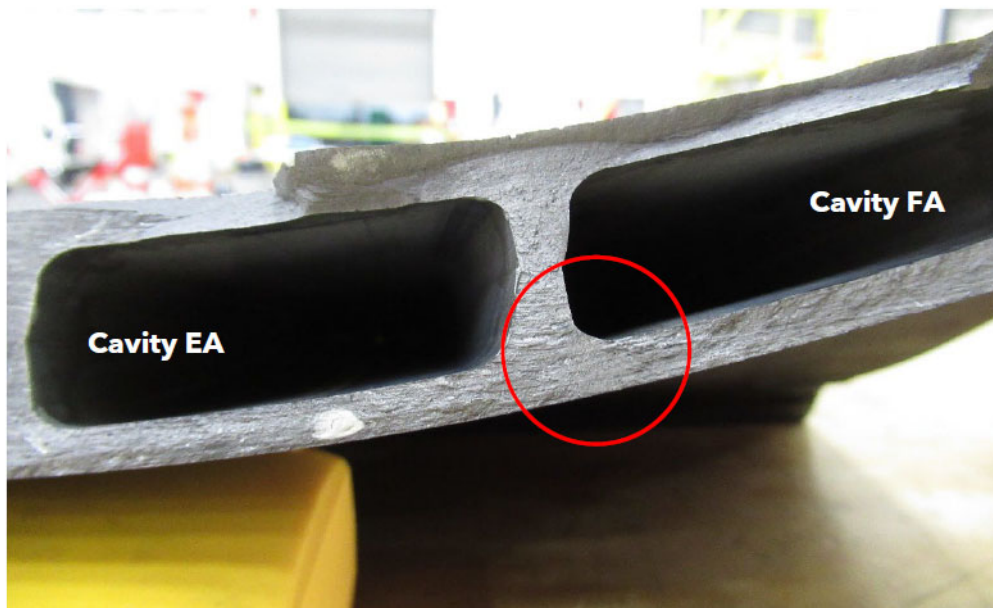
*Figure 1 - Fan Blade No. 19 Fracture Surface and Fatigue Evidence*

The metallurgical examination of the fractured blade no. 19 was performed at the P&W Materials Laboratory under direction of the NTSB. The examination confirmed that the fan blade fractured due to a fatigue crack, which initiated internally about 6.6 inches above the root bottom at the surface of an internal radius in the FA cavity<sup>7</sup> of the hollow core fan blade shown in Figure 1.

The team concluded that the two most significant contributing factors that decreased the life of the blade material were (1) a local geometric discontinuity and (2) carbon contamination of the internal cavity surface that had likely formed from contact with contaminated argon gas that was used during the blade manufacturing process.<sup>8</sup>

The analysis of the internal blade geometry discovered a local tight radius in the flowpath cavity caused by machining and exacerbated by forming operations. A P&W technical review of the geometric discontinuity estimated a local steady stress increase at the location that

reduced the fatigue life resistance. P&W performed an analysis of the diffusion bonding and forming process that showed that the bonding / forming process exacerbates the discontinuity at any tight radius that was caused by machining.

Advanced metallurgical and chemical characterization performed by the P&W laboratory revealed the internal surface of the blade cavities had carbon contamination. Carbon contamination of titanium can cause decreased fatigue resistance capability. A review of the blade manufacturing process revealed that the most likely source of carbon contamination was the shop argon system. After the diffusion bonding process was completed during initial manufacture, the blades were subjected to the hot final form process at which time high-pressure argon was introduced into the part to prevent buckling of the unsupported outer skin. The event fan blade was manufactured during a time when the high-pressure argon was supplied through the regular shop lines that were not cleaned and could have contained various contaminants.

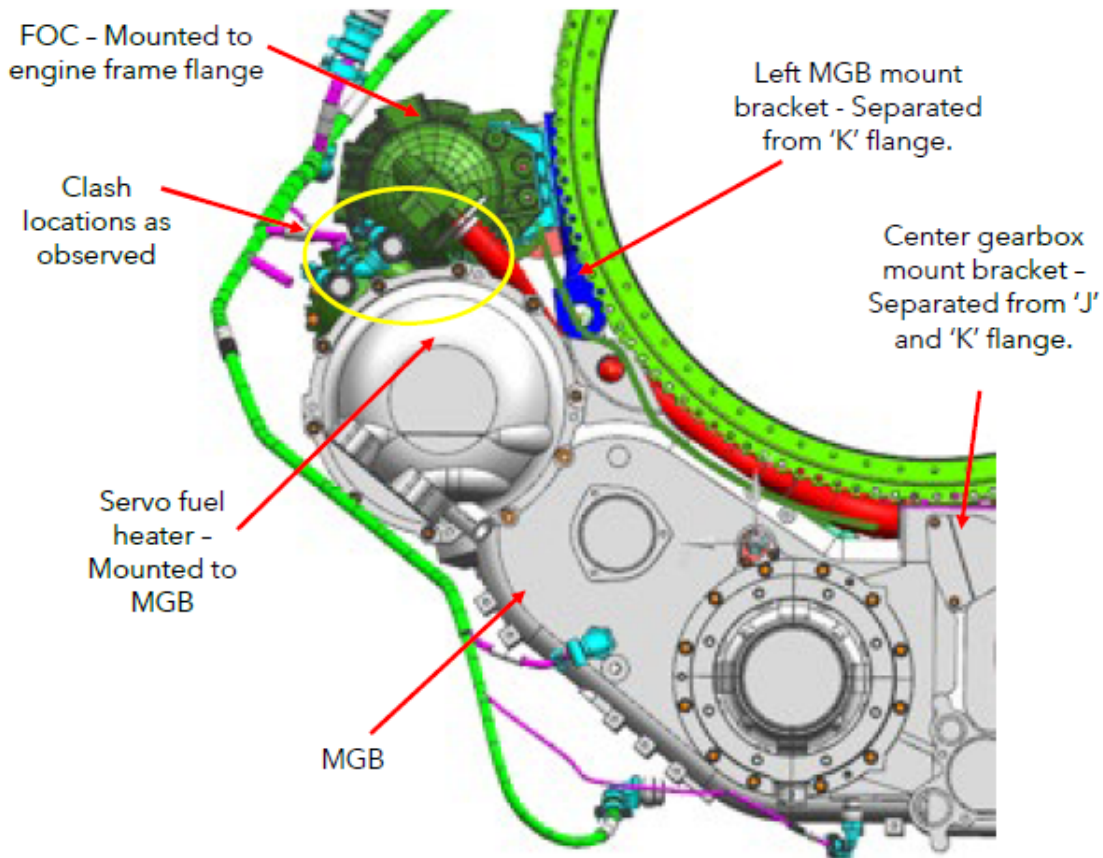
Figure 2 – Relative Locations of servo fuel heater and FOC (Aft Looking Forward)

The FOC, which is mounted to the engine core structure, was found to be fractured and thermally distressed at the upper aft outboard section, exposing the internal heat exchanger core. There was impact damage on one mount flange of the FOC consistent with contact against the servo fuel heater.

The servo fuel heater, which is mounted to the MGB, was heavily sooted but intact; however, a forward inboard corner was fractured at the axial cross-drilled pressure fuel channel. This damage is consistent with contact against the FOC housing. The lack of thermal distress on the impact marks suggests this could have been the initiating fracture of the fire event.<sup>9</sup>

Figure 2 below depicts a cross section of the engine and MGB and the relative locations of the FOC and the servo fuel heater.<sup>10</sup> The FOC is mounted with brackets to the engine frame while the servo fuel heater is mounted to the MGB. If the MGB mount brackets became separated from the 'K' flange the MGB was free to move relative to the engine core allowing possible contact between the FOC and the servo fuel heater. The contact and contact locations observed between the FOC and servo fuel heater were confirmed<sup>11</sup> by the NTSB powerplants group during the examinations described above.
