National Transportation Safety Board Tank Car Damage Assessment Form

Reporting Marks	WFRX 160411		Car Location City/State	RAYMOND, MN	
Date inspected	03-31-23	Railroad	BNSF	DOT Specification	117J100W
Last Contained	ETHANOL		Was product released?	YES	
(Indicate One)	Jacket	YES		Does car contain product	YES
Car builder	GBRX	Stub Sill Design		Built Date	
Capacity (GAL)	30,590		LD Limit (LB)

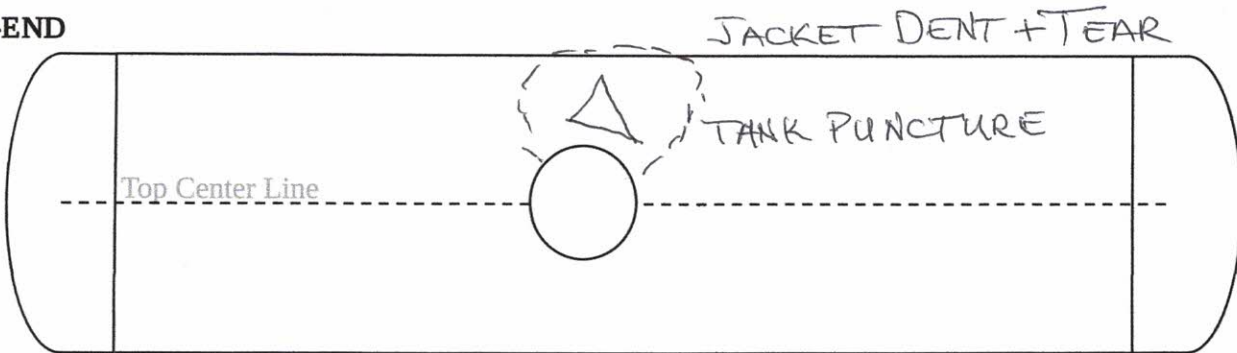
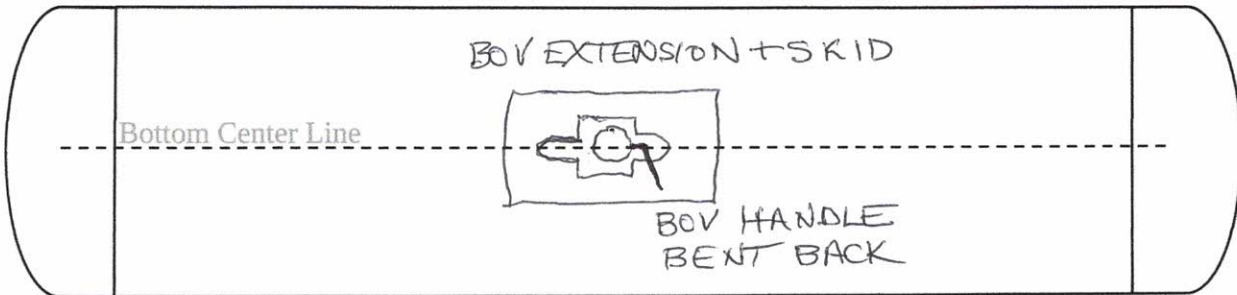
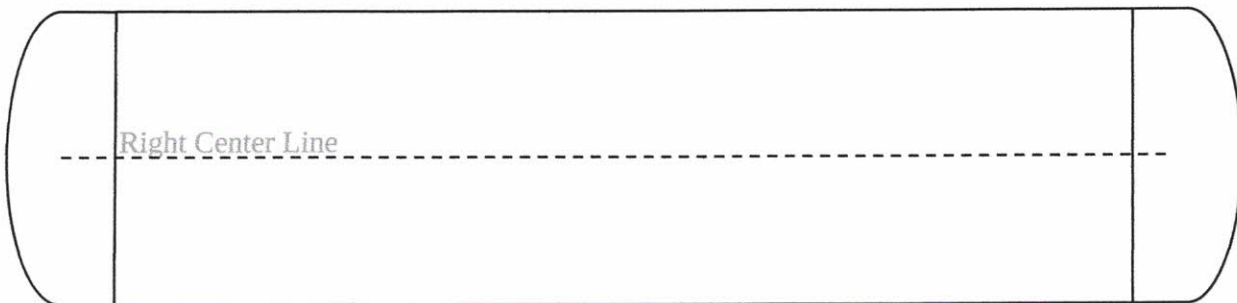
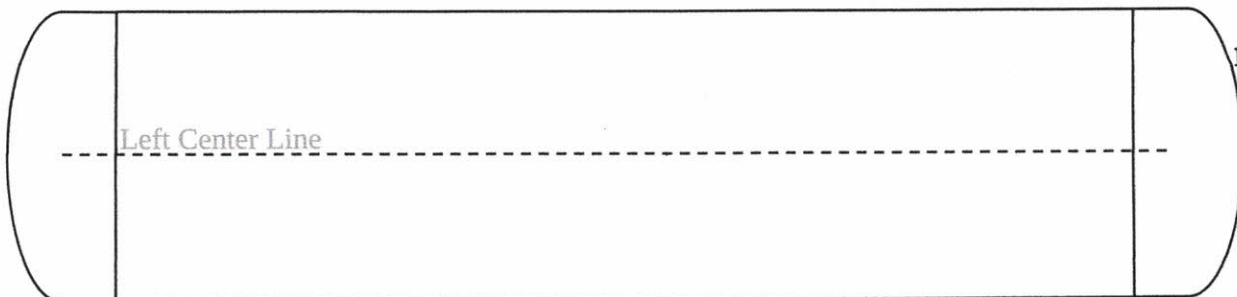
1.	Affected?	JACKET	Location?	MIDDLE	Dimensions:	Length	6'	Width	5'	Depth	18"
-	Defect type?	DENT	Shape?	OVAL							
2.	Affected?	JACKET	Location?	MIDDLE	Dimensions:	Length		Width		Depth	
-	Defect type?	TEAR	Shape?	SQUARE							
3.	Affected?	TANK	Location?	MIDDLE	Dimensions:	Length	18"	Width	18"	Depth	18"
-	Defect type?	PUNCTURE	Shape?	SQUARE							
4.	Affected?		Location?		Dimensions:	Length		Width		Depth	
-	Defect type?		Shape?								
5.	Affected?		Location?		Dimensions:	Length		Width		Depth	
-	Defect type?		Shape?								
6.	Affected?		Location?		Dimensions:	Length		Width		Depth	
-	Defect type?		Shape?								
7.	Affected?		Location?		Dimensions:	Length		Width		Depth	
-	Defect type?		Shape?								
8.	Affected?		Location?		Dimensions:	Length		Width		Depth	
-	Defect type?		Shape?

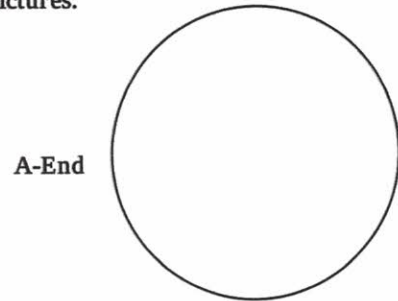
QTY. 1 - BOV EXTENSION NUTS LOOSE

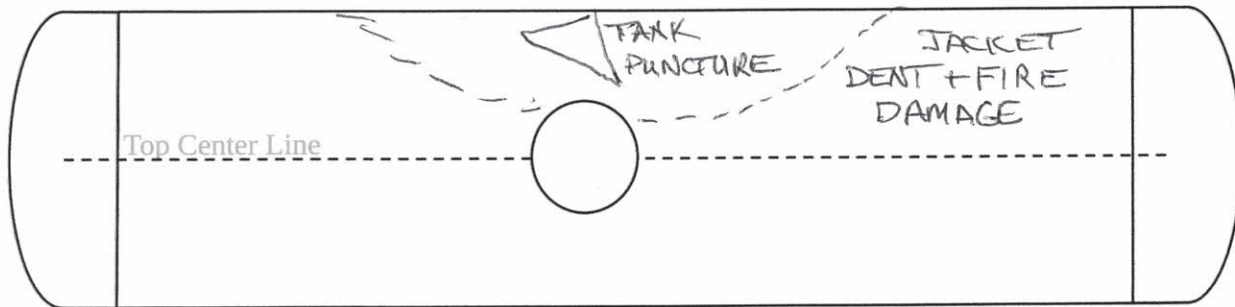
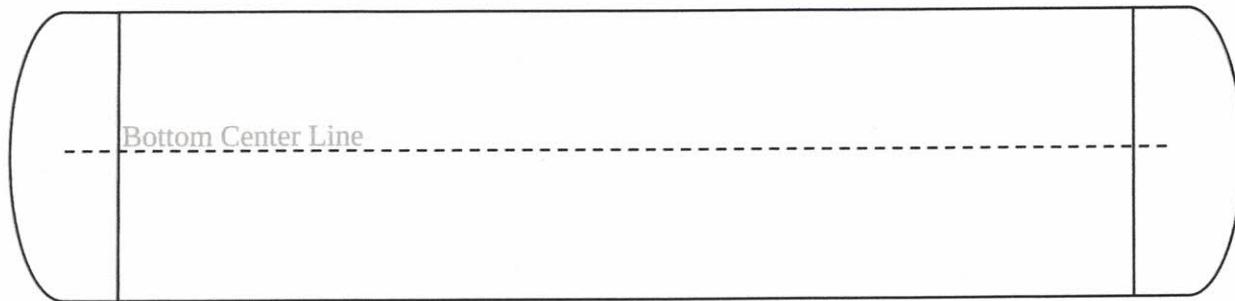
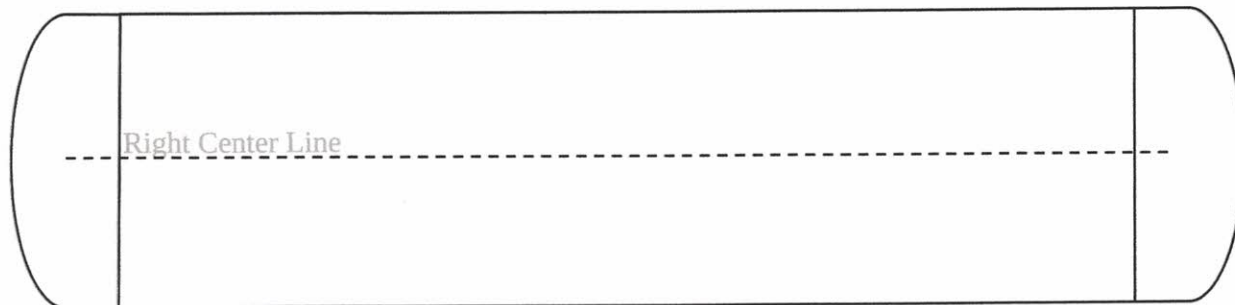
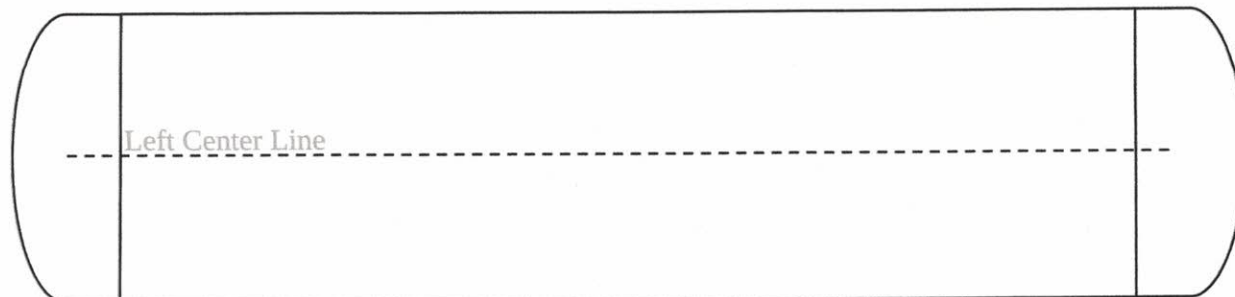
1.	Affected?	JACKET	Location?	BL MID	Dimensions:	Length	120"	Width	60"	Depth	36"
-	Defect type?	DENT	Shape?	OVAL							
2.	Affected?	JACKET	Location?	BL MID	Dimensions:	Length	30"	Width	48"	Depth	36"
-	Defect type?	TEAR	Shape?	OVAL							
3.	Affected?	TANK	Location?	BL MID	Dimensions:	Length	30"	Width	48"	Depth	36"
-	Defect type?	PUNCTURE	Shape?	PIE							
4.	Affected?	JACKET	Location?	AL END	Dimensions:	Length	24"	Width	60"	Depth	3"
-	Defect type?	DENT	Shape?								
5.	Affected?		Location?		Dimensions:	Length		Width		Depth	
-	Defect type?		Shape?								
6.	Affected?		Location?		Dimensions:	Length		Width		Depth	
-	Defect type?		Shape?								
7.	Affected?		Location?		Dimensions:	Length		Width		Depth	
-	Defect type?		Shape?								
8.	Affected?		Location?		Dimensions:	Length		Width		Depth	
-	Defect type?		Shape?

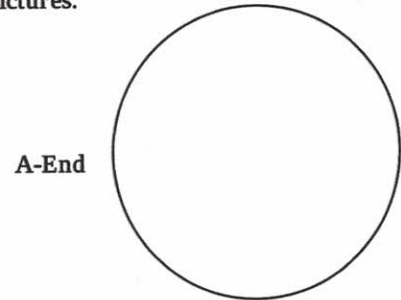
QTY. 1 - M/W EYEBOLT LOOSE
QTY. 2 - BOV EXTENSION BOLTS LOOSE

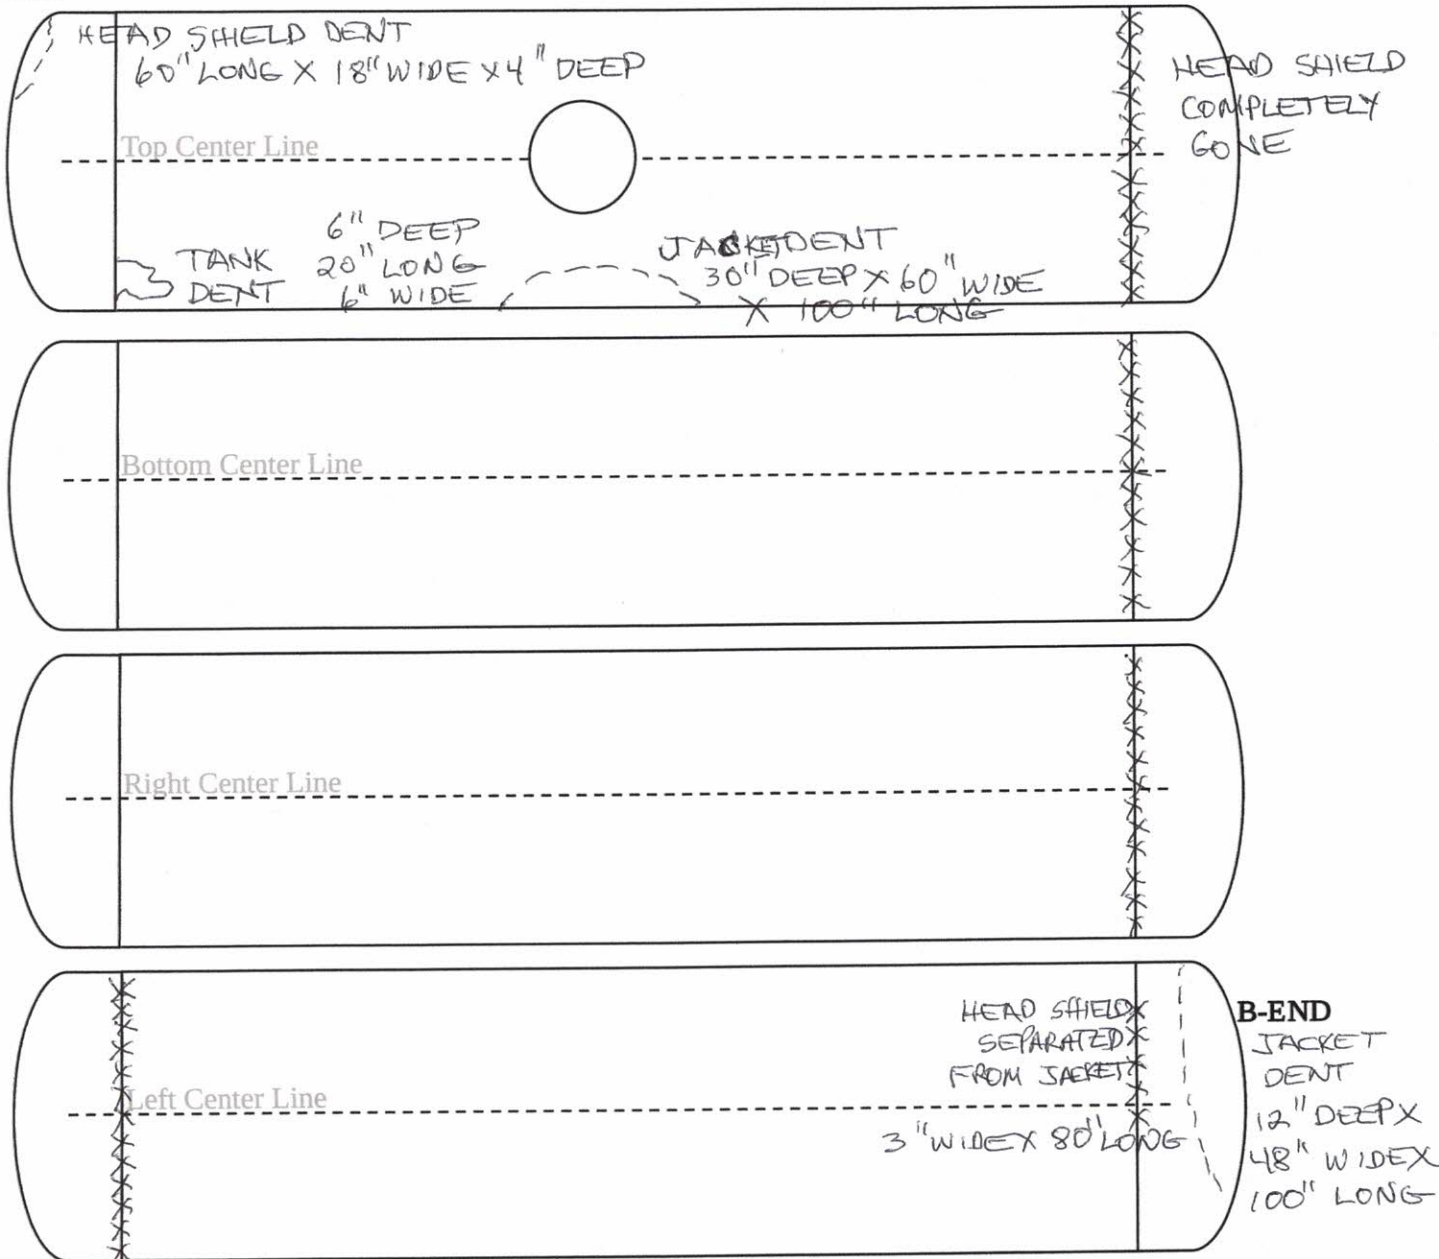
1.	Affected?	H.D. SHIELD	Location?	BL	Dimensions:	Length	60"	Width	18"	Depth	4"
-	Defect type?	DENT	Shape?	FLAT							
2.	Affected?	H.D. SHIELD	Location?	BL	Dimensions:	Length	80"	Width	3"	Depth

-	Defect type?	CRACK	Shape?	LINEAR	HEAD SHIELD SEPARATED FROM JACKET						
3.	Affected?	JACKET	Location?	RL	Dimensions:	Length	100"	Width	48"	Depth	12"
-	Defect type?	DENT	Shape?	OVAL

4.	Affected?	JACKET	Location?	BR	Dimensions:	Length	100"	Width	60"	Depth	30"
-	Defect type?	DENT	Shape?	OVAL							
5.	Affected?	JACKET	Location?	BR	Dimensions:	Length		Width		Depth

-	Defect type?	TEARS	Shape?	CUTS	VARIOUS						
6.	Affected?	JACKET	Location?	A	Dimensions:	Length		Width		Depth	
-	Defect type?	PEELED	Shape?	SCALD	ENTIRE JACKET END PEELED BACK

7.	Affected?	H.D. SHIELD	Location?	A	Dimensions:	Length		Width		Depth	
-	Defect type?	MISSING	Shape?	N/A	A-END HEAD SHIELD MISSING						
8.	Affected?	TANK	Location?	BR	Dimensions:	Length	20"	Width	6"	Depth	6"

-	Defect type?	DENT	Shape?	OVAL

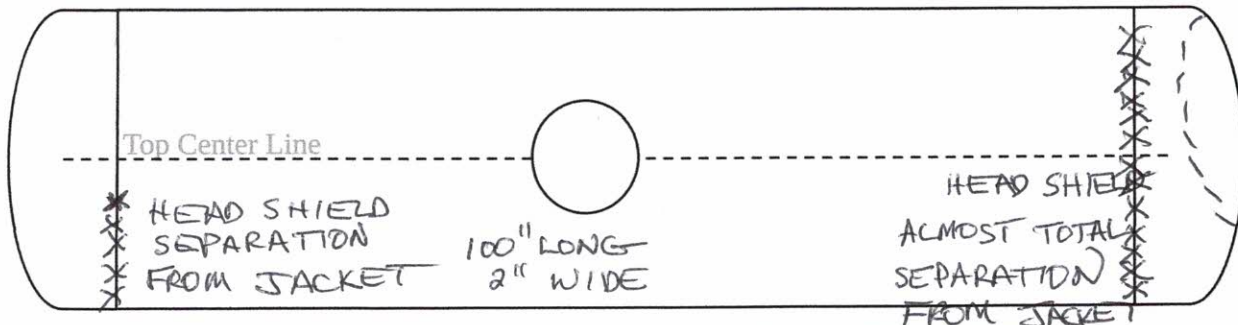
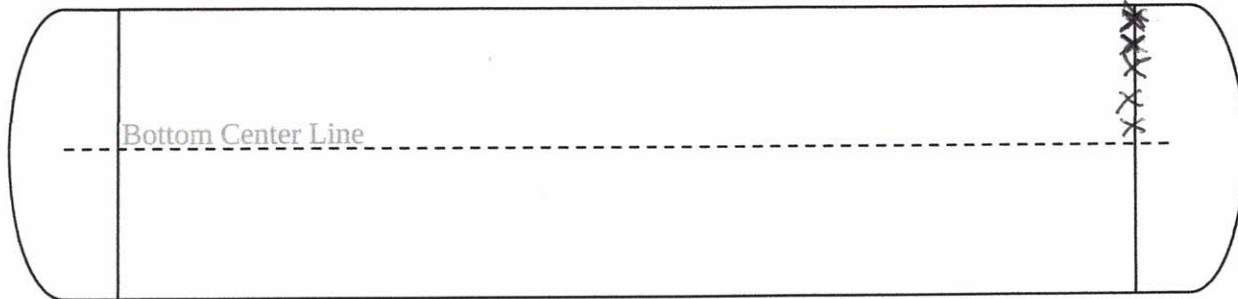
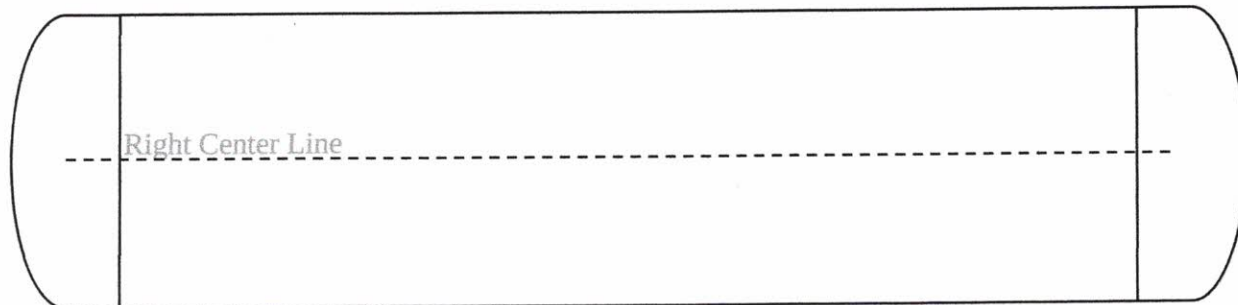
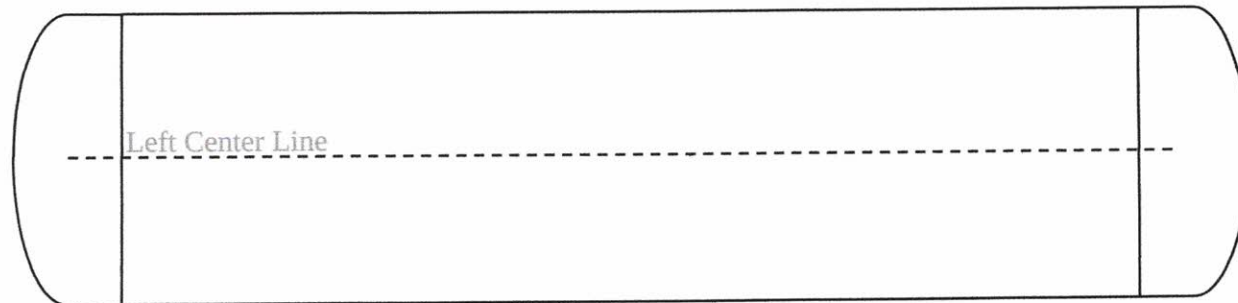
HEAD SHIELD
DENT
82" LONG
54" WIDE
24" DEEP

1.	Affected?	HD. SHIELD	Location?	BR	Dimensions:	Length	100"	Width	2"	Depth	
-	Defect type?	SEPARATION	Shape?	LINEAR							
2.	Affected?	HD. SHIELD	Location?	AR	Dimensions:	Length	250"	Width	48"	Depth	
-	Defect type?	SEPARATE	Shape?	SPLIT							
3.	Affected?	HD. SHIELD	Location?	AL	Dimensions:	Length	82"	Width	54"	Depth	24"
-	Defect type?	DENT	Shape?	OVAL							
4.	Affected?		Location?		Dimensions:	Length		Width		Depth	
-	Defect type?		Shape?								
5.	Affected?		Location?		Dimensions:	Length		Width		Depth	
-	Defect type?		Shape?								
6.	Affected?		Location?		Dimensions:	Length		Width		Depth	
-	Defect type?		Shape?								
7.	Affected?		Location?		Dimensions:	Length		Width		Depth	
-	Defect type?		Shape?								
8.	Affected?		Location?		Dimensions:	Length		Width		Depth	
-	Defect type?		Shape?
