NATIONAL TRANSPORTATION SAFETY BOARD

AIRFRAME AND ENGINE EXAMINATION

WPR20FA063

Aircraft: Cessna TR182 Skylane

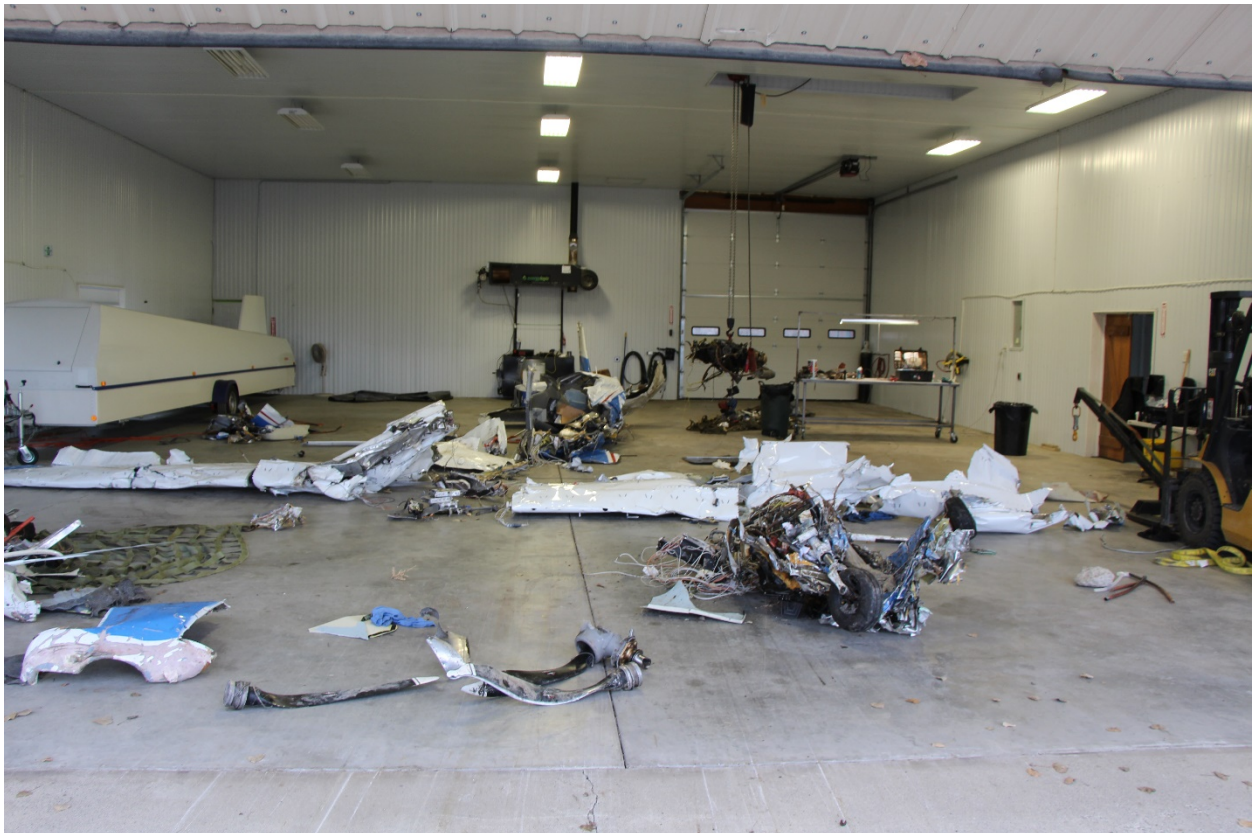
The airplane was located in mountainous terrain area at an elevation of about 4,252 ft mean sea level. All major sections of the airplane were accounted for at the accident site. The initial impact point (IIP) was marked by several bent cross members and a broken guy wire about 65 feet high on an approximately 185 foot tall radio tower. Several sections of the outboard left wing were located about 100 ft north of the tower and two pieces displayed longitudinal signatures consistent with impacting a wire. The remaining section of left wing was found in the debris path about 300 ft from the main wreckage. Several airframe and engine fragments were distributed along the energy path, which was oriented on a heading of about 295° magnetic. A 5 foot-long intermediate ground scar was located about 120 ft from the main wreckage. The main wreckage was located about 600 ft northwest of the IIP in a coulee and comprised of the right wing, fuselage, empennage, and engine and oriented on a heading of 122° magnetic.

Photograph 1: Layout of Wreckage

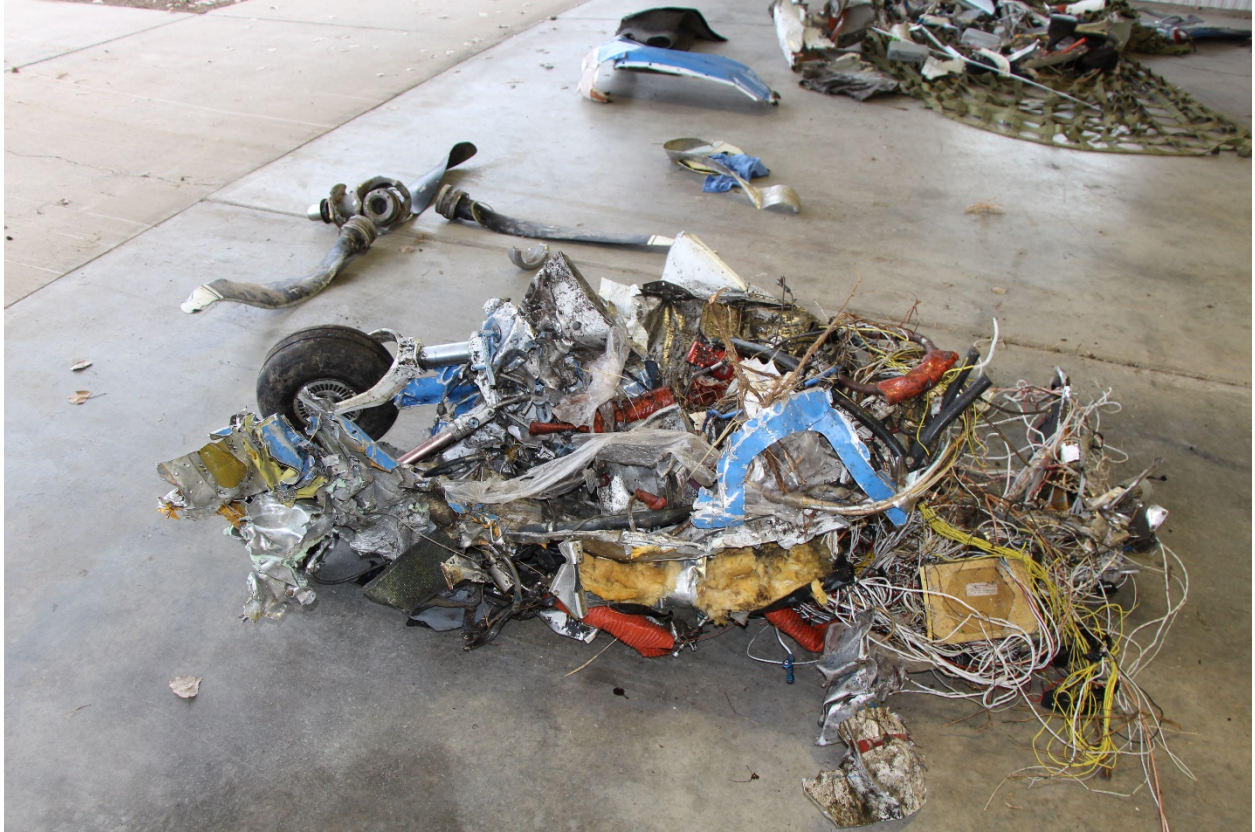
The cockpit was comprised of the instrument panel and cockpit controls, which were fragmented and deformed from the accident sequence. Both the circuit breaker switch panel and throttle quadrant remained intact. The propeller lever was in the full forward position, the throttle was in the FULL OPEN position, and the mixture control was in the FULL RICH position. Cockpit control continuity was verified for the elevator, aileron, and rudder flight controls through various separations in their respective control systems. The rudder pedal torque tube was intact and the right pedal for the right seat passenger remained attached to the tube along with the rudder cables, which remained intact. The cables were continuous from the pedals to the aft section of the cockpit where they separated with evidence consistent with overload separation. The cockpit elevator bellcrank push/pull tubes separated from the control column and the elevator trim cable was continuous from the trim chain to a separation in the aft section of the cockpit. Both elevator cables remained attached to the elevator torque tube. The right aileron control wheel cables displayed fracture signatures consistent with overload. Both cables were continuous to the aft section of the cockpit; one cable fractured in overload and the other was cut by recovery personnel. The airframe boost pump was intact.

Photograph 2: Postaccident Condition of Cockpit Area and Instrument Panel

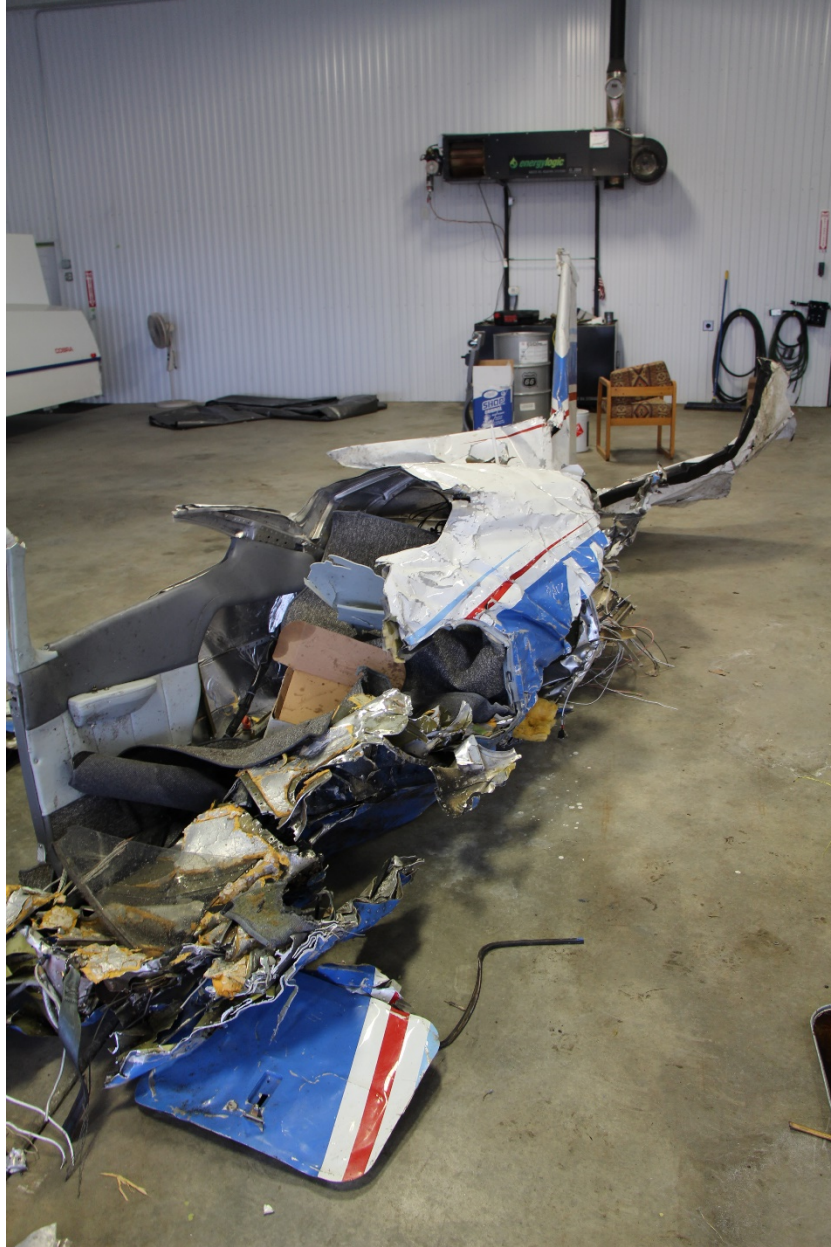
The main fuselage was crushed during the accident sequence and exhibited deformation throughout. Each of the four seats had been ejected from the main fuselage. Most of the seat belt buckles were connected except for the pilot's restraints. His shoulder harness was attached to the ceiling structure, but not latched to the buckle, lap belt segments were still attached to floor, and the lap belt buckle not found. The co-pilot seat 4 point harness was latched into the belt buckle and the overhead was still connected to the inertial reels and the lap restraint was cut by recovery personnel. Both rear seat occupant lap belt buckles were attached and the belt attachments have been separated from the floor structure. The elevator and rudder cables were continuous throughout the main fuselage and the cables displayed signatures consistent with overload failure.

Photograph 3: Postaccident Condition of Fuselage

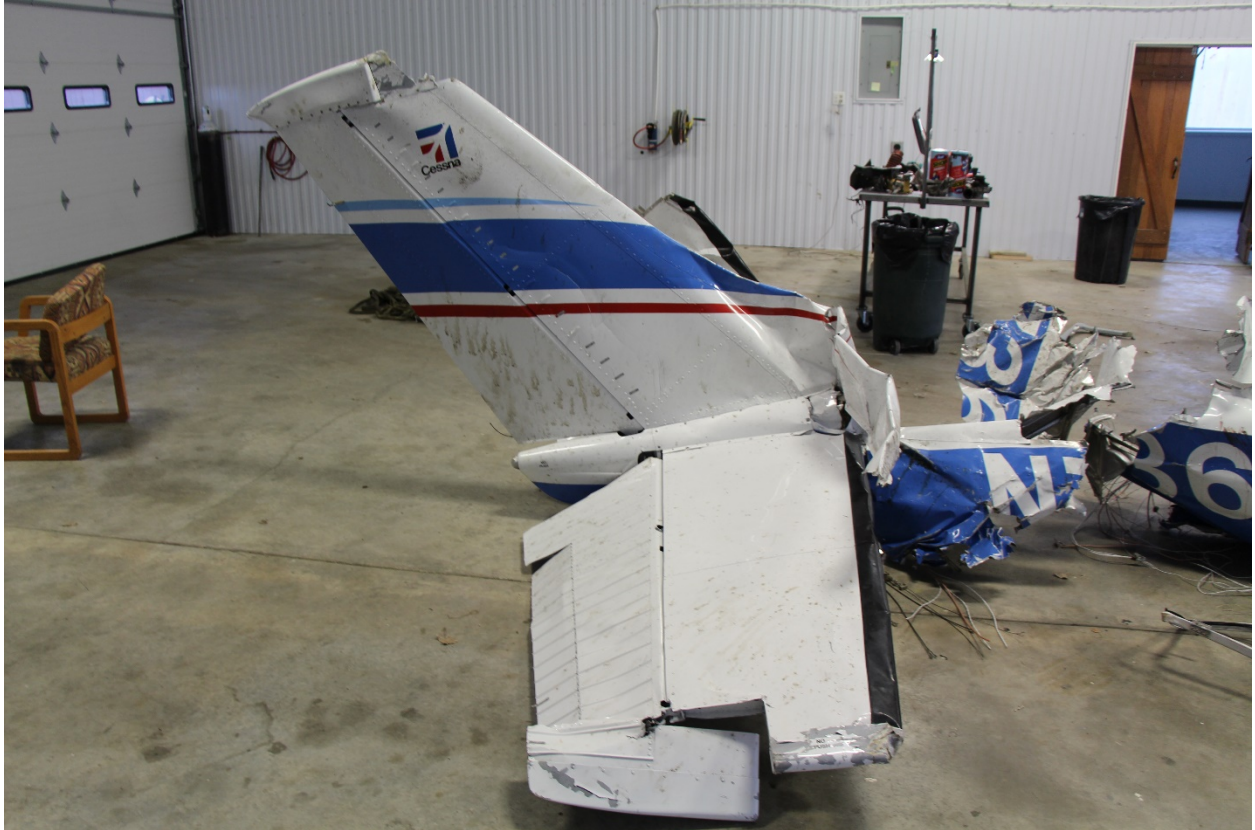
The tail section separated from the fuselage, but was mostly intact with deformation to the vertical stabilizer, rudder, and both horizontal stabilizers. The rudder cables, elevator cables, the autopilot servo cable, and electric pitch trim cable had separated at the aft fuselage with signatures consistent with overload separation. Control continuity was confirmed for the rudder and elevator control cables to their respective control surfaces. The elevator trim actuator measured 0.8 inches, consistent with a 15° nose up trim position (full nose up trim).

Photograph 4: Postaccident Condition of Tail Section

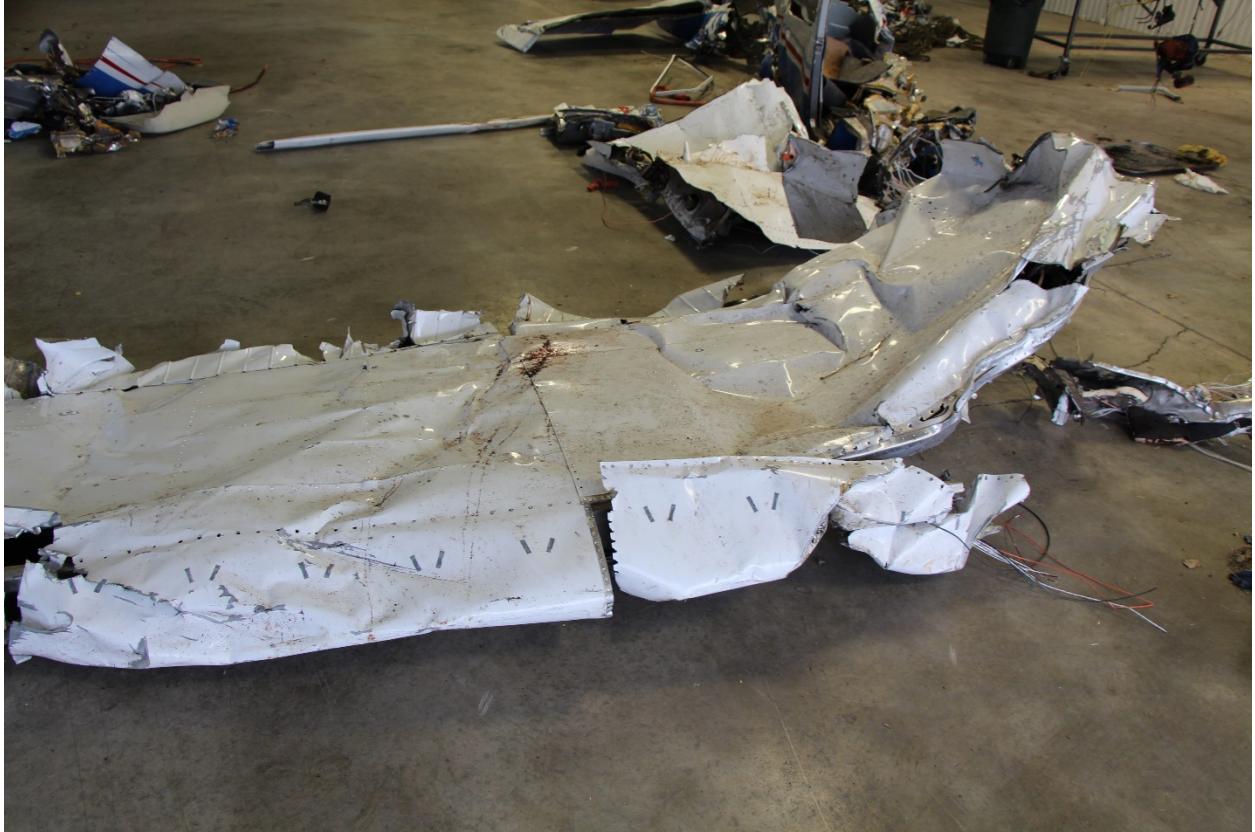
The right wing and flap remained intact along with most of the right aileron, which had separated about midspan. The inboard portion of the right wing including the wing tank were intact and most of the outboard left wing had separated into sections, most of which were found near the tower. Aileron flight control continuity of the right wing was confirmed from the wing root to the right aileron. The aileron carry through cable was continuous from the right wing to the left

Photograph 5: Right Wing

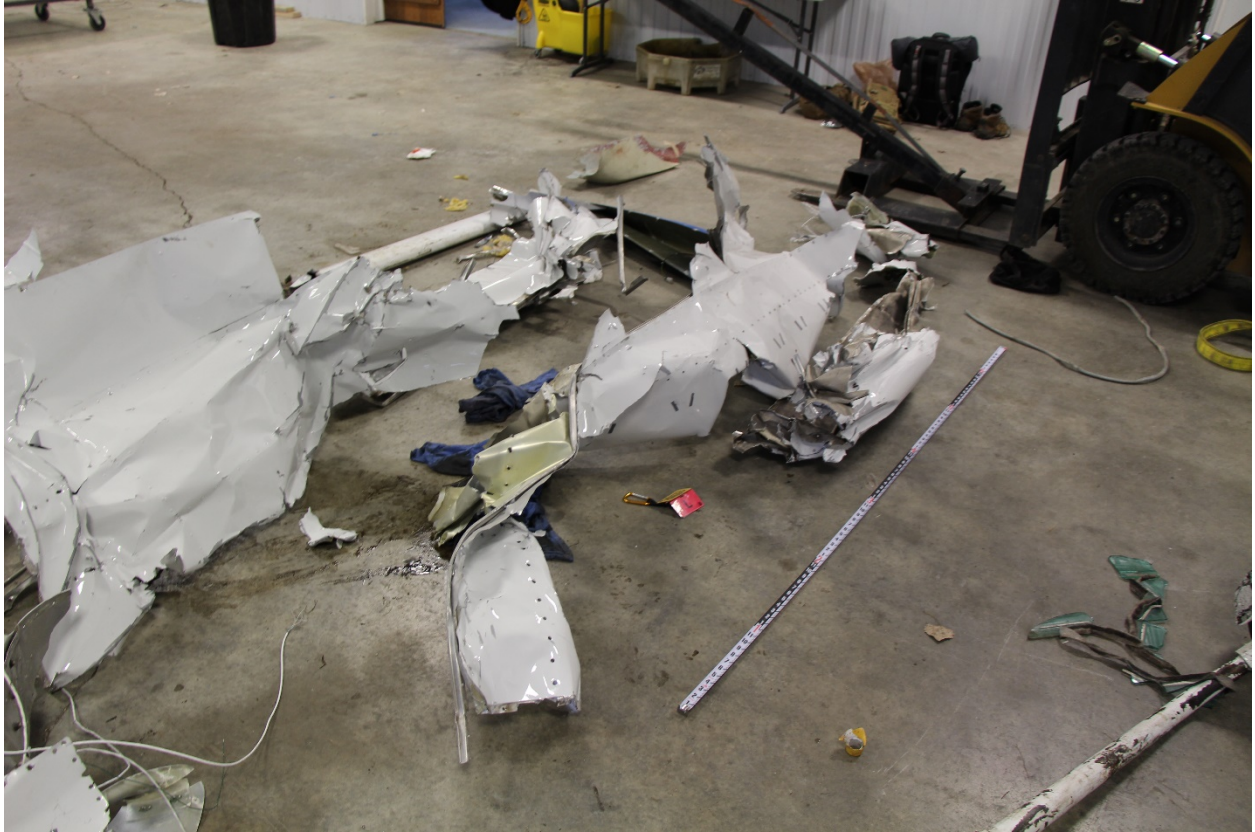
Photograph 6: Outboard Left Wing

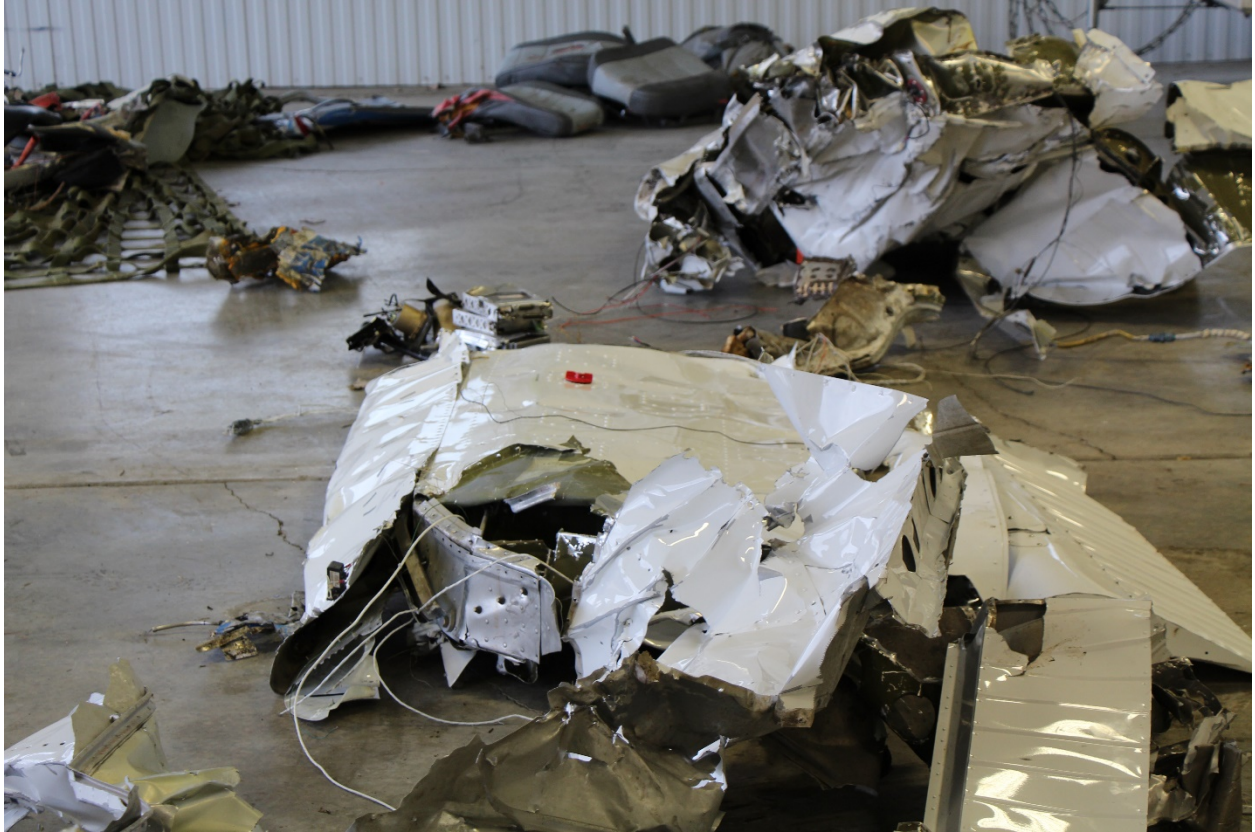
wing through a separation that was consistent with overload failure. The left aileron bell crank was not recovered. The flap down cable was continuous from the right wing flap motor to the left wing, but separated at the flap bellcrank. The flap up cable was continuous from the center flap bellcrank to a separation at the left wing root. The flap motor actuator measured 0.1 inches, consistent with a flap retracted position.

Photograph 7: Inboard Left Wing

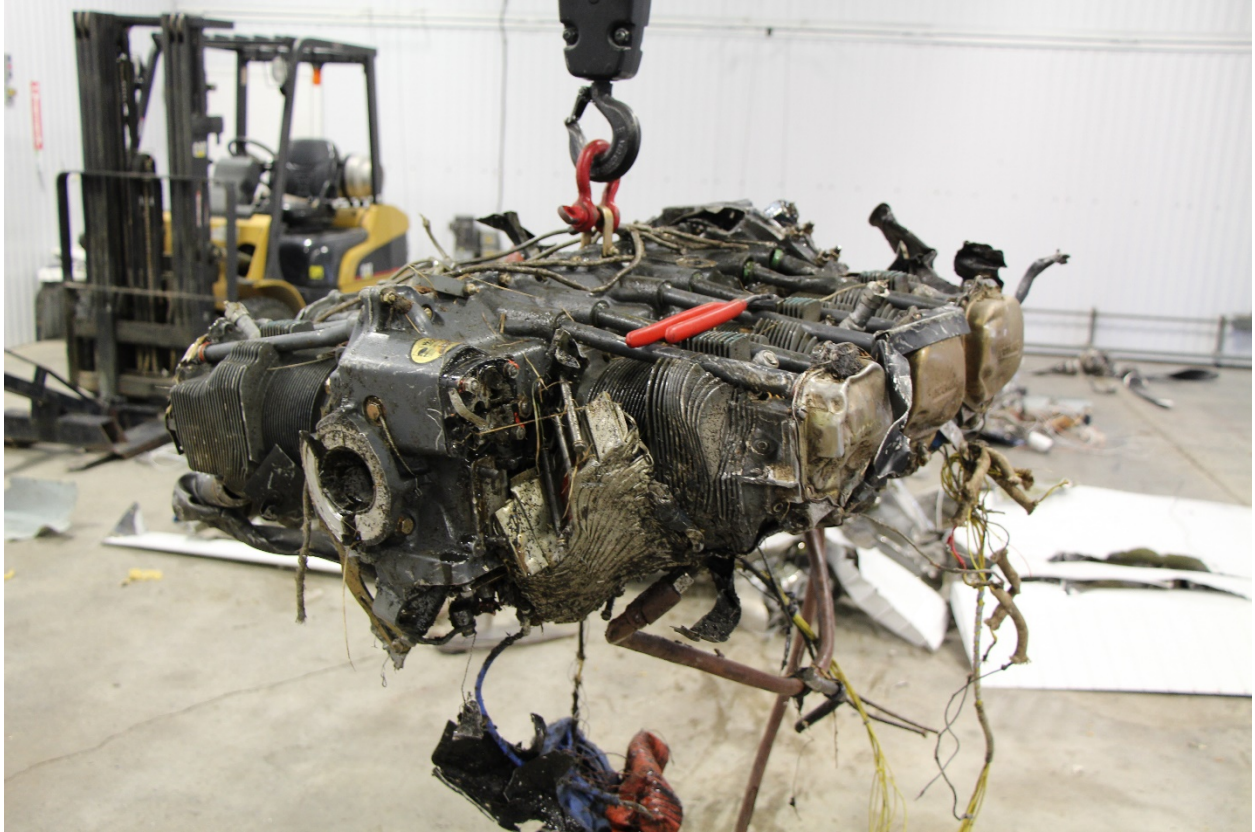
The engine case was mostly intact, with exception of the oil sump and lower half of the accessory case, which was destroyed along with several accessories that had separated. The magnetos were destroyed. Mechanical continuity of the crank shaft and valvetrain were visually confirmed by removing cylinder nos. 1 and 5. The crankshaft could only be rotated partially due to impact damage. The oil cooler remained attached, but was crushed. Each of the ignition leads had separated from the spark plugs, which were mostly attached to their cylinders. The bottom spark plug to cylinder no. 2 had separated. Most of the spark plugs displayed signatures consistent with normal wear except for the cylinder no. 2 top spark plug, which was oil fouled. Cylinder nos. 1 and 5 were removed from the case and both exhibited normal wear on the cylinder walls, the piston and valve faces. Cylinder nos. 2, 3, 4, and 6 were examined with a borescope and displayed normal wear on the cylinder walls and valve faces. Visual inspection of the internal case through the cylinder no. 1 and 5 positions revealed minimal wear on the cam lobes and lifters. Both connecting rods were unremarkable. Internal inspection of the case did not reveal any indications of oil starvation. The oil sump suction screen was partially exposed due to sump damage and the screen showed minimal debris due to the accident. The right side exhaust outer shroud was removed and no cracks or black soot or burn signatures were observed on the external case of the inner shroud. A visual examination of the inner shroud did not reveal any anomalies. The left side exhaust was not recovered. The engine driven fuel pump had separated from the engine and was damaged, but was connected to the electric boost pump through a fuel line.

Photograph 8: Engine

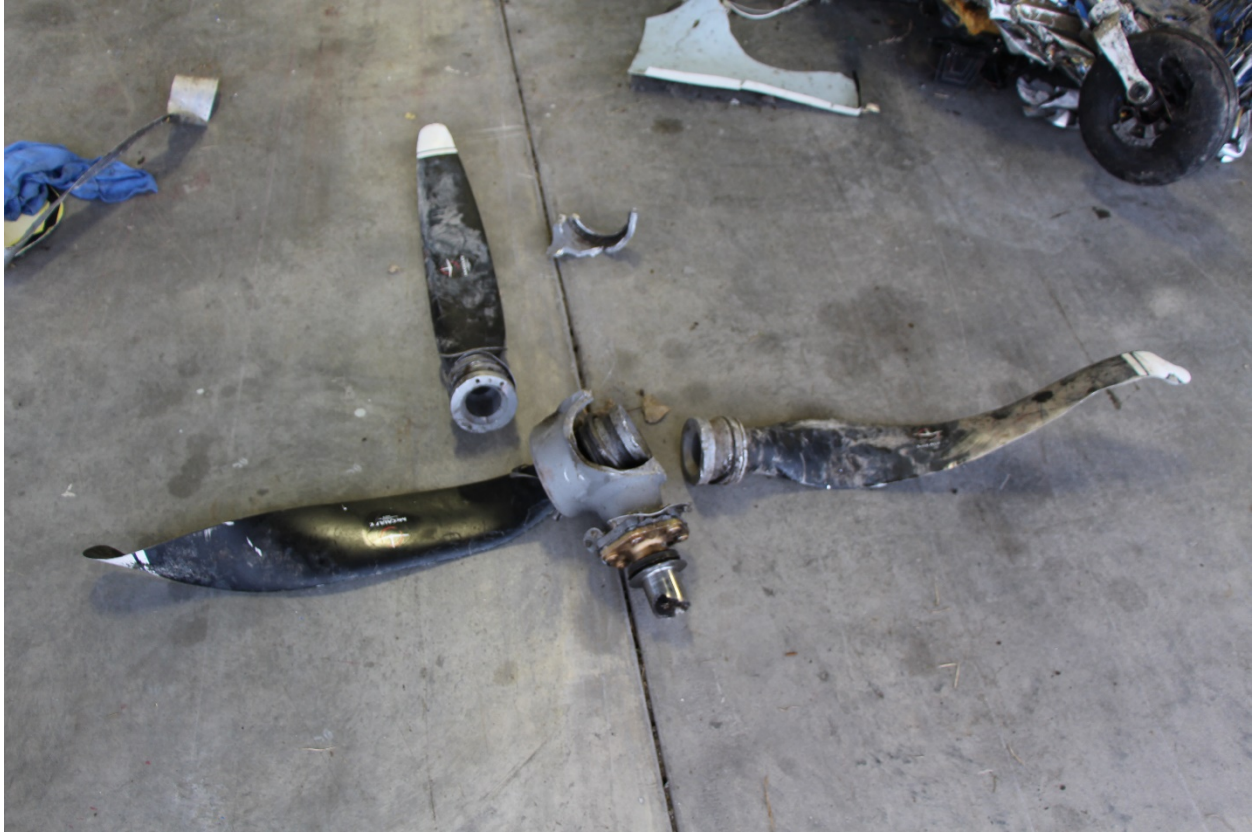
All three propeller blades were recovered from the accident site. Two of the propeller blades separated from the blade hub, which had fractured during the accident. One propeller blade displayed a forward bend, S bending, and leading edge nicks. Another propeller blade also displayed a forward bend and leading edge nicks and gouges along with a bend at the blade tip. The remaining propeller blade had a minimal forward bend.

Photograph 9: Propeller Blades and Propeller Hub

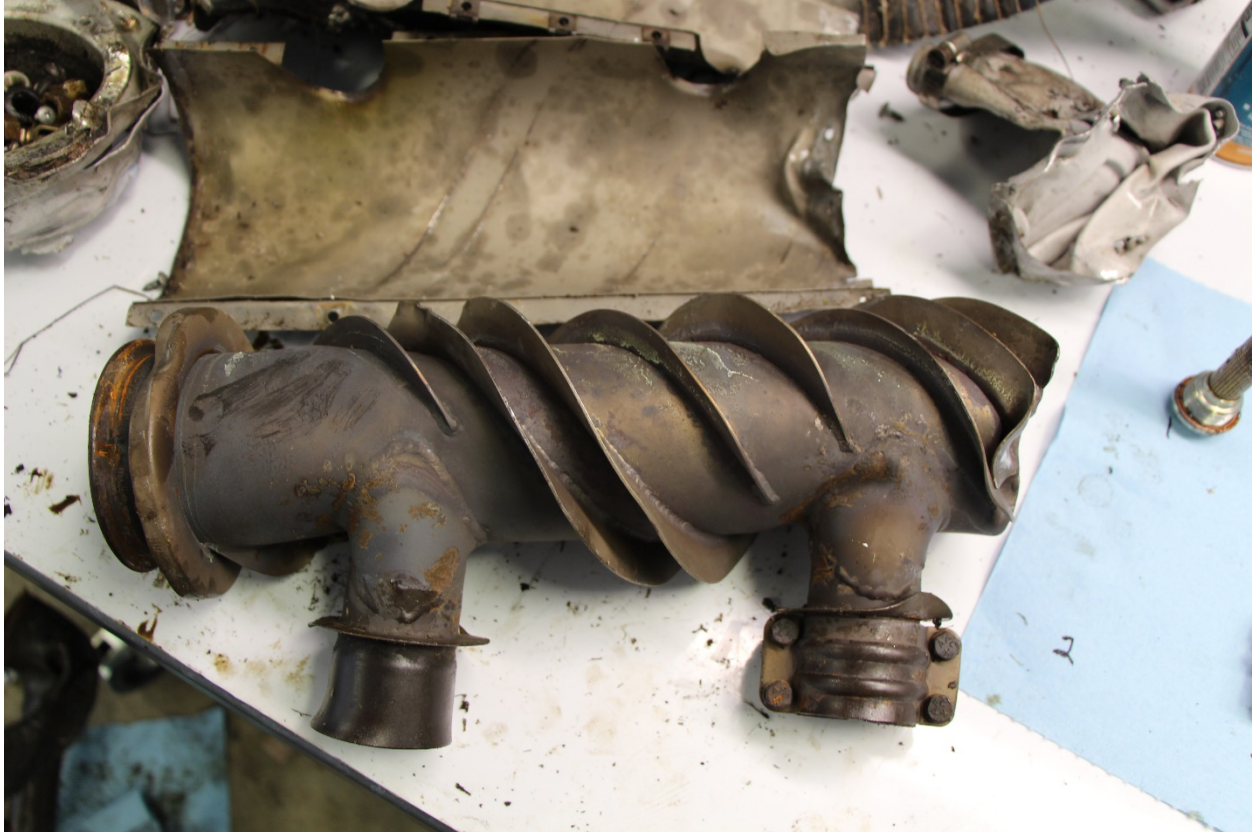
Photograph 10: Exhaust Inner Shroud
