# National Transportation Safety Board

WPR24FA018

## **NTSB ONSCENE AND WRECKAGE EXAMINATION REPORT**

Location: Covelo, California  
Date: October 20, 2023  
Time: 1801 pacific daylight time  
0101 UTC  
Airplane: Beechcraft A36 Bonanza

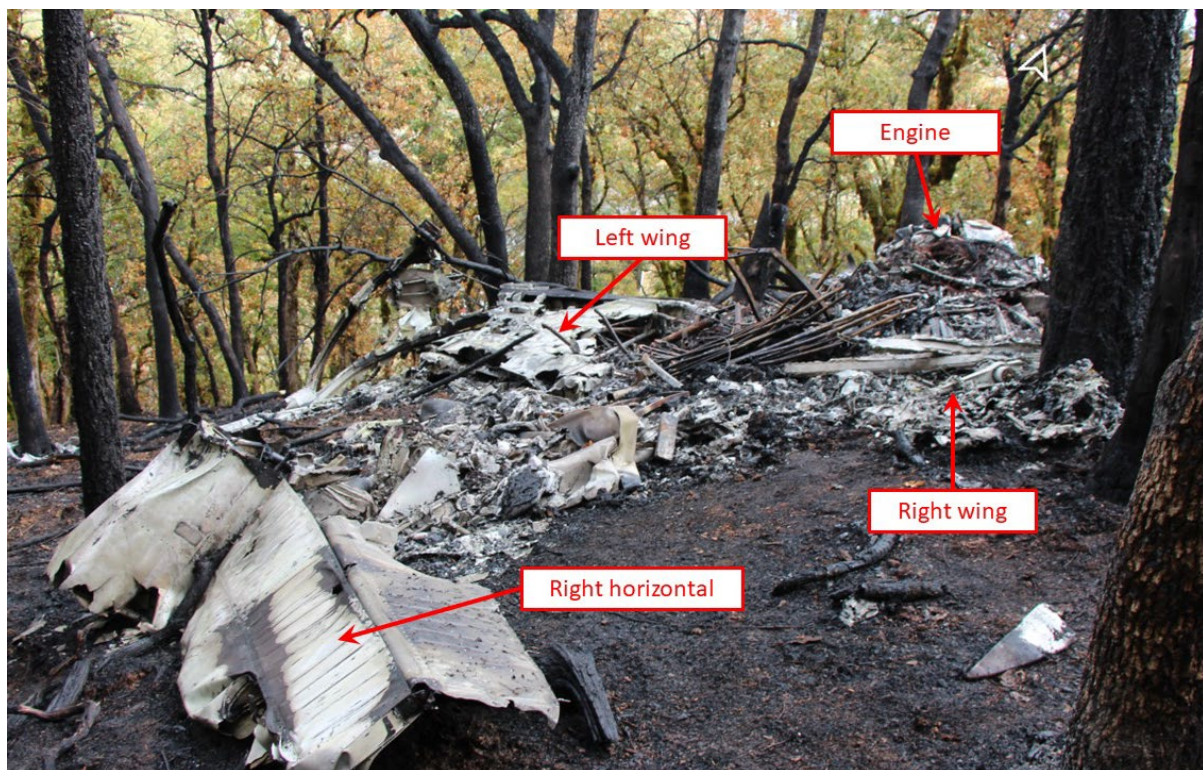
The airplane came to rest on a hillside about 0.40 nm west of the departure end of runway 28 at a field elevation of about 1,500 ft mean sea level and oriented on a northeasterly heading. The airplane's major structures were all accounted for at the accident site. The first point of impact (FPI) was marked by several trees about 20 feet tall with broken tree tops and broken branches at the base of each tree. A debris path was traced from the FPI to the main wreckage and was oriented on a heading of 120° magnetic. The main wreckage was located about 40 ft southeast of the FPI and was mostly consumed by postcrash fire.

**Figure 1: Accident site**

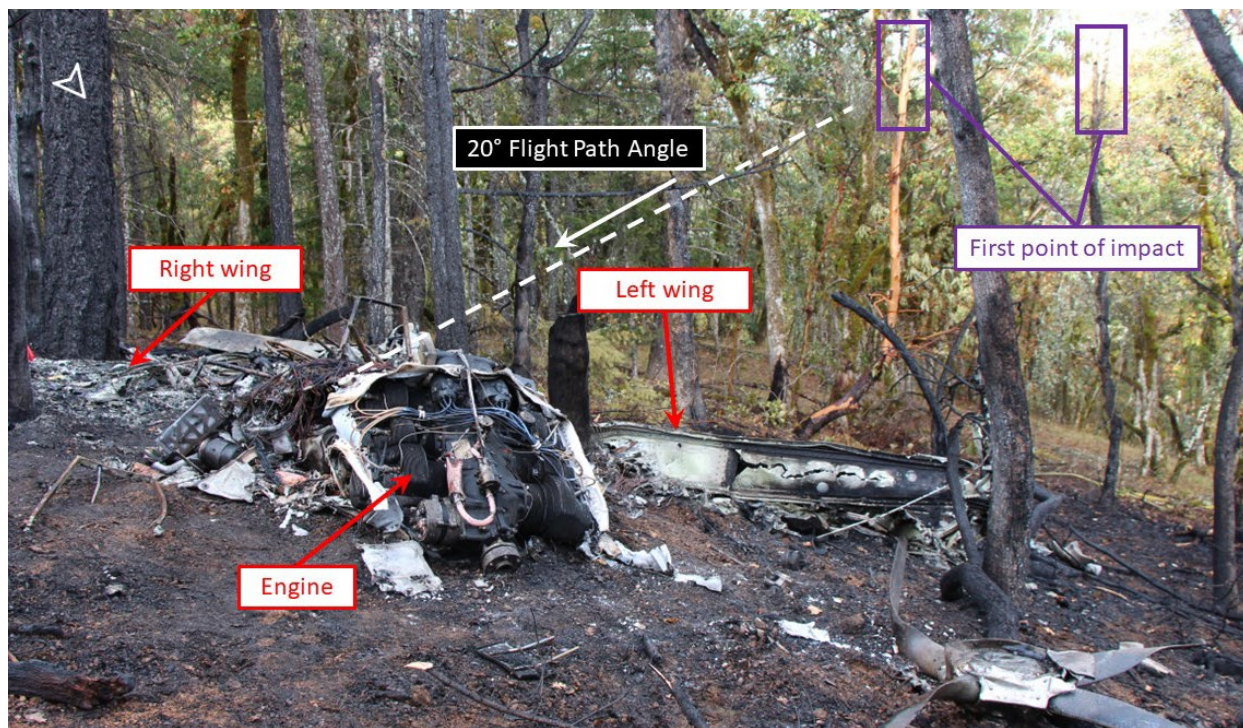
**Figure 2: Accident site with flight path angle**

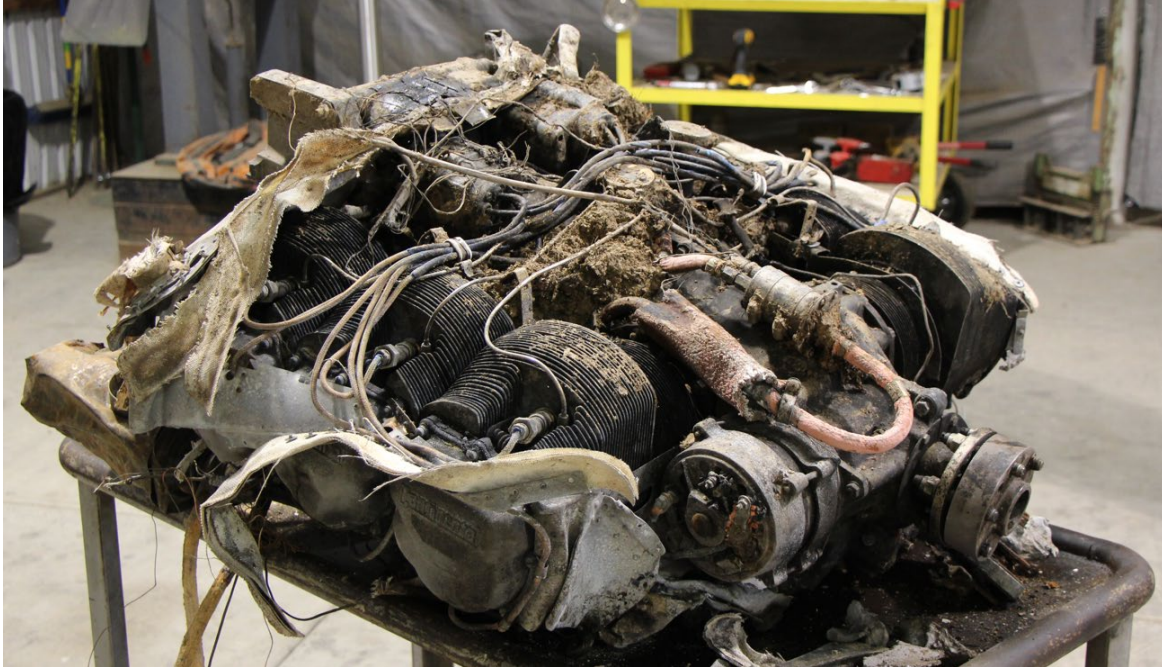
The airplane was equipped with a Continental IO-550-B, an air cooled, horizontally opposed, normally aspirated reciprocating engine and was examined at a secure facility on December 7, 2023 by the NTSB IIC and a representative from the airframe manufacturer. Prior to the examination, the engine was stored outside in its inverted position in an uncovered container. The oil sump was destroyed, which exposed the internal components of the engine. The engine sustained thermal damage from the postcrash fire, but remained mostly intact with exception of some cooling fin damage. The propeller governor and left side exhaust separated from the engine and the cylinder no. 6 exhaust tube was damaged.

**Photograph 1: Engine prior to examination**
