# National Transportation Safety Board

## Safety Recommendation Report

### Installation of PermaLock Mechanical Tapping Tee Assemblies

<b>Accident/Incident Number:</b>	DCA17FP006
<b>Operator:</b>	UGI Utilities, Inc.
<b>Accident:</b>	Residential Natural Gas Explosion
<b>Location:</b>	Millersville, Pennsylvania
<b>Date:</b>	July 2, 2017
<b>Recommendation Number:</b>	P-18-1 through -4
<b>Adopted:</b>	June 18, 2018

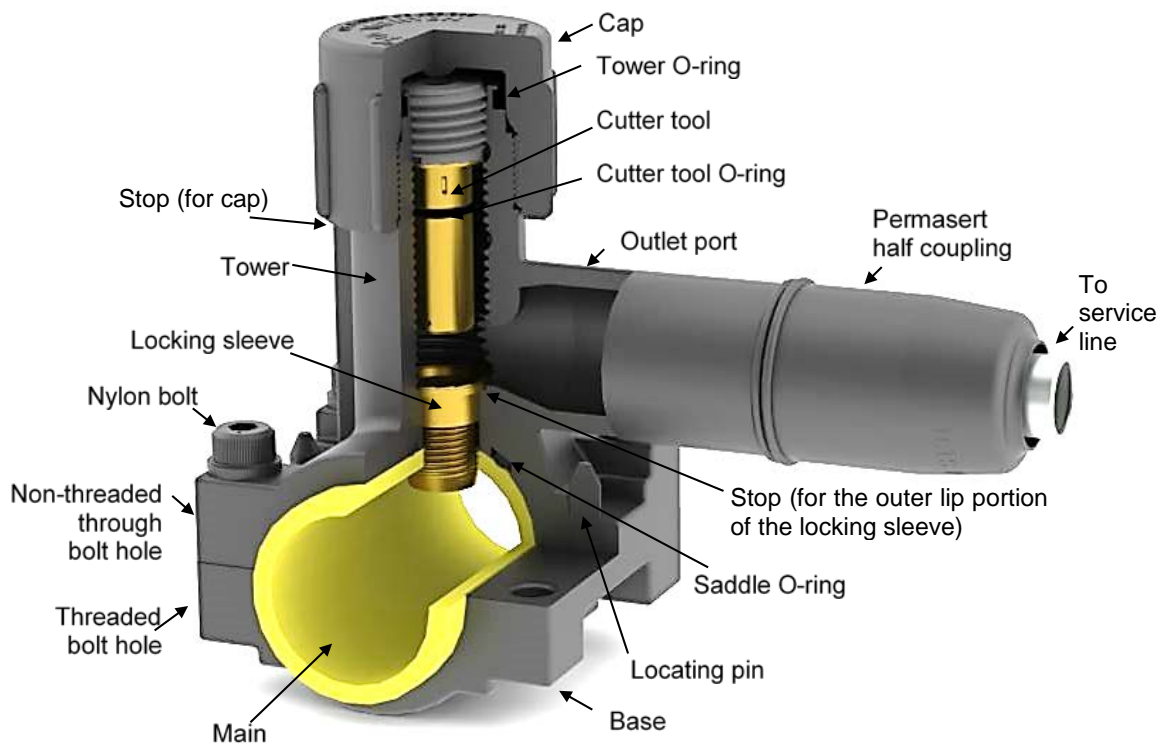
**Figure.** Cross-section diagram of an exemplar PermaLock mechanical tapping tee assembly, provided by Honeywell.

NTSB examination of the PermaLock tee assembly involved in the accident has revealed that the tee assembly was incorrectly installed. Although the cutter tool pierced a hole in the main, the locking sleeve did not progress down far enough into the tower to form threads in that hole. As a result, the locking sleeve was not attached to the main.<sup>6</sup> The NTSB also found that two of the four Nylon bolts on the tee assembly were fractured in a manner consistent with *slow crack growth*.<sup>7</sup> These findings indicate the likelihood of varying tee assembly installation techniques.

According to a Honeywell representative, the locking sleeve is the primary means of securing a PermaLock tee assembly tower to a main. A saddle O-ring, made from an elastomer, is located under the tower of the tee assembly (see figure). When the tower is attached to the main, the saddle O-ring forms a seal between the tower and the main that prevents gas from escaping out of the tee assembly. If the locking sleeve within the tower is not attached to the main, additional tensile stress is placed on the four Nylon bolts, which are used to join the tower and the base together around the outer surface of the main. The four Nylon bolts then become the fail-safe feature holding the tee assembly in place. When the locking sleeve is not attached to the main, fracture of one or more of the Nylon bolts can be sufficient to allow a gap to open in the saddle O-ring area between the tower and the main where gas can escape out of the tee assembly.

crack growth when overtightened. Therefore, the NTSB recommends that Honeywell specify in its PermaLock mechanical tapping tee assembly installation instructions a not-to-exceed torque limit for Nylon bolts and have that value checked and adjusted with a torque wrench immediately after installation.
