**NATIONAL TRANSPORTATION SAFETY BOARD**  
Office of Aviation Safety

**Onscene and Wreckage Examination Group Field Notes**

**A. ACCIDENT      WPR22FA235**

Location:            Vancouver, Washington  
Date:                 June 28, 2022  
Time:                 0740 PT  
Operator:            Private  
Aircraft:             Beechcraft V35B  
Registration:        N444PM

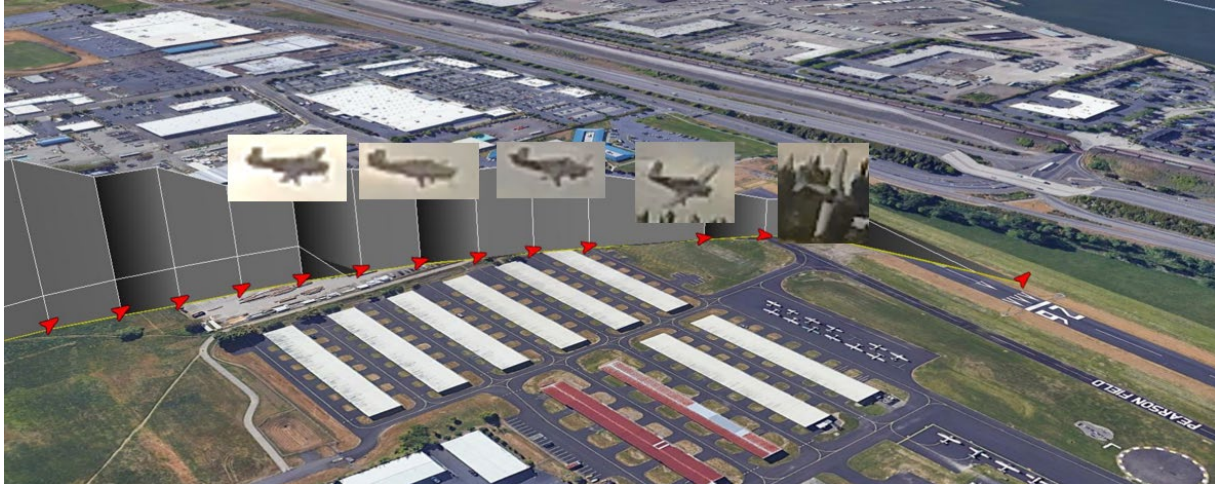
Surveillance video captured the airplane’s final three seconds of flight before its initial impact with the ground. The airplane came into view in a slight right wing low attitude. In the two seconds that followed the airplane’s right bank angle increased as it descended rapidly towards the ground. The airplane’s right wing impacted the ground first in a near 90° attitude immediately followed by the nose as it burst into flames. The airplane slid inverted for several seconds along the displaced threshold to runway 26 and came to rest about 120 ft from the runway numbers.

*Figure 1: Base turn to final with graphics excerpted from surveillance video*

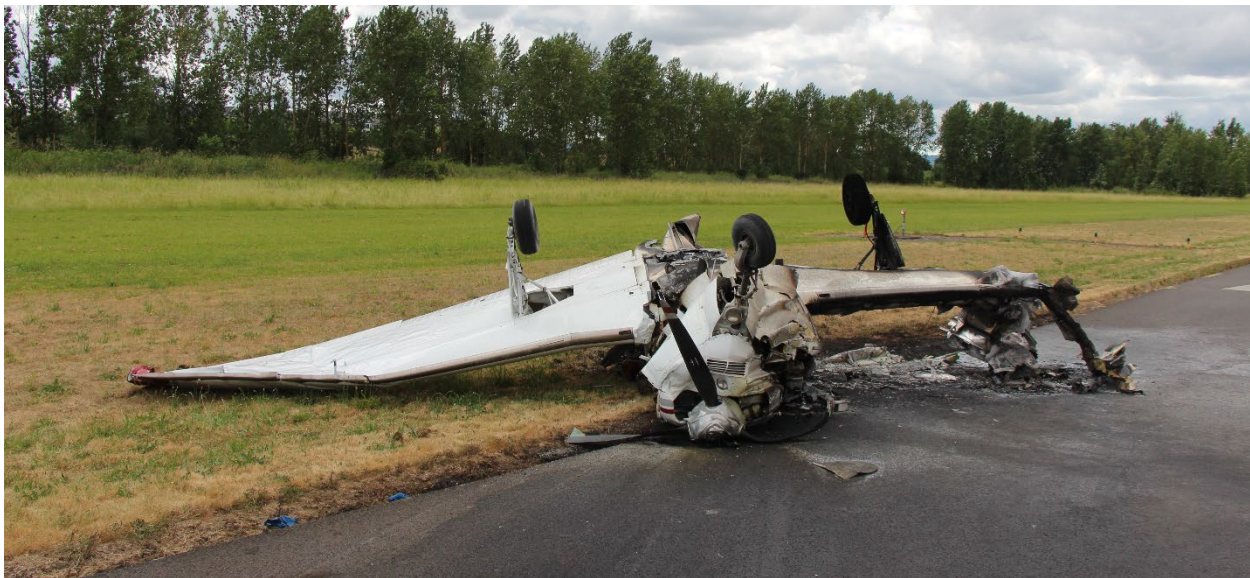
The airplane came to rest inverted on a heading of about 038° magnetic. All four corners of the airplane were accounted for at the accident site.

*Photograph 1: Accident site from the northeast*

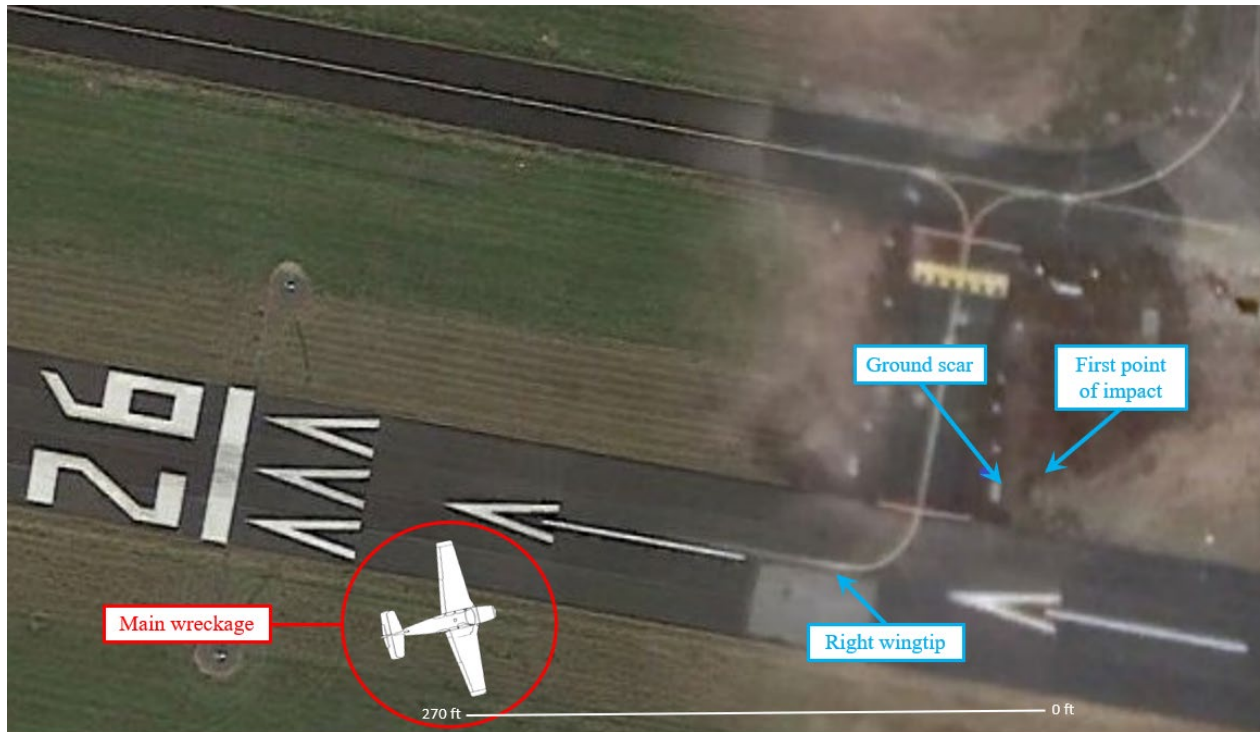
The first point of impact (FPI) was marked by a 20 inch long depression about 270 ft northeast of the main wreckage and adjacent to the displaced threshold for runway 26. A second ground scar was observed adjacent to taxiway A2 about 10 ft forward of the FPI and measured 30 inches long. The second ground scar was collocated with a broken airport taxi light. Burned grass was observed to the right of the displaced threshold. A debris field was oriented on a heading of 255° magnetic and was comprised of plexiglass and fragments of airframe skin. The right wingtip was located in the debris field about 90 ft from the main wreckage.

Figure 2: Debris path and main wreckage

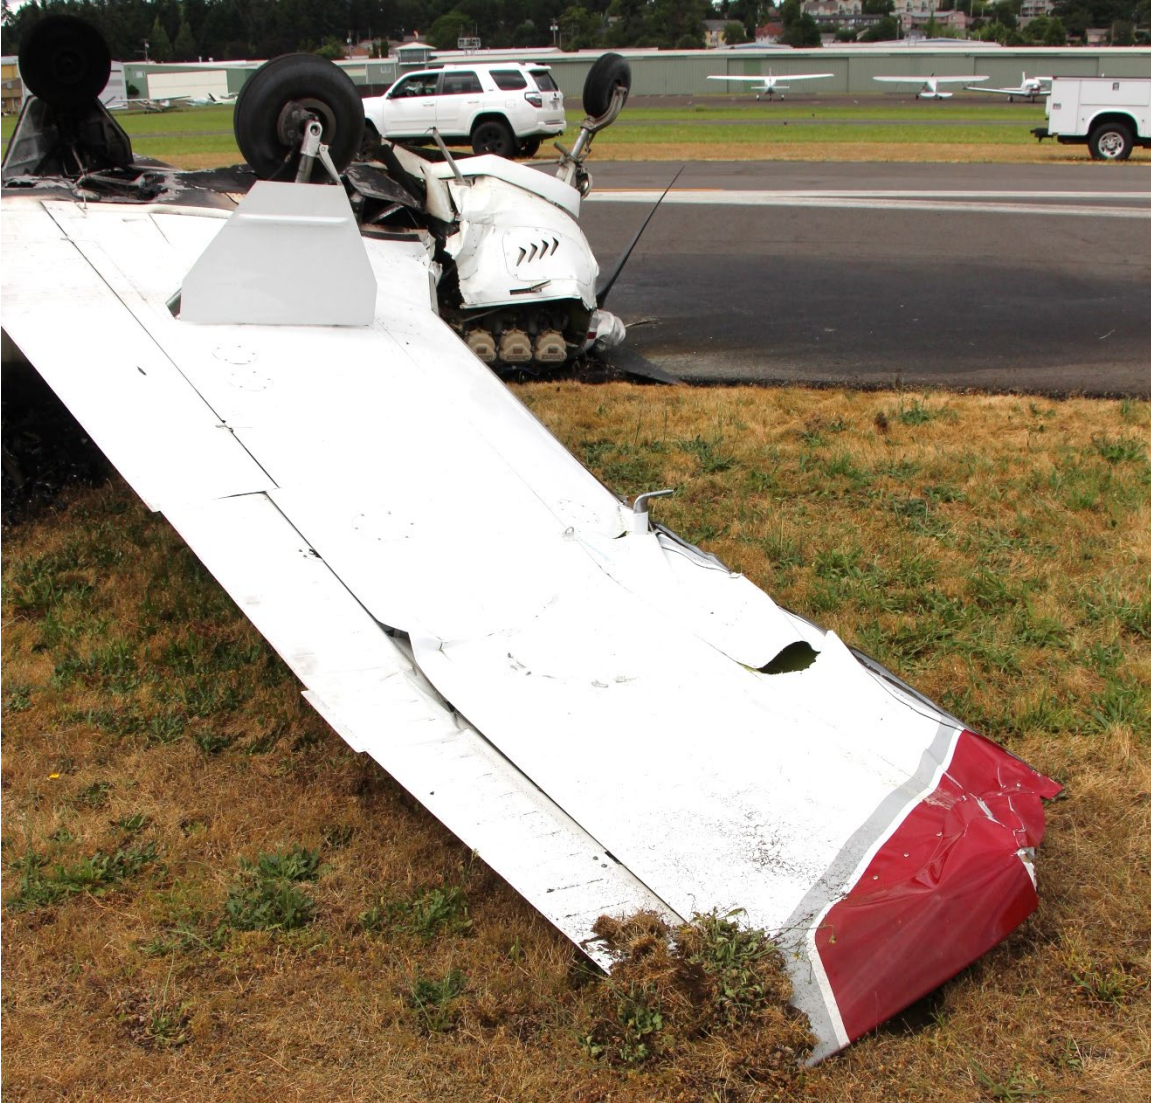
The outboard section of the left wing was bent downwards and the left wing leading edge was crushed. Both the wing flap and aileron remained attached to the wing at their mounts and the aileron push pull tube remained attached at the bellcrank. The left main landing gear was in the extended position.

*Photograph 2: View of left wing at accident site*

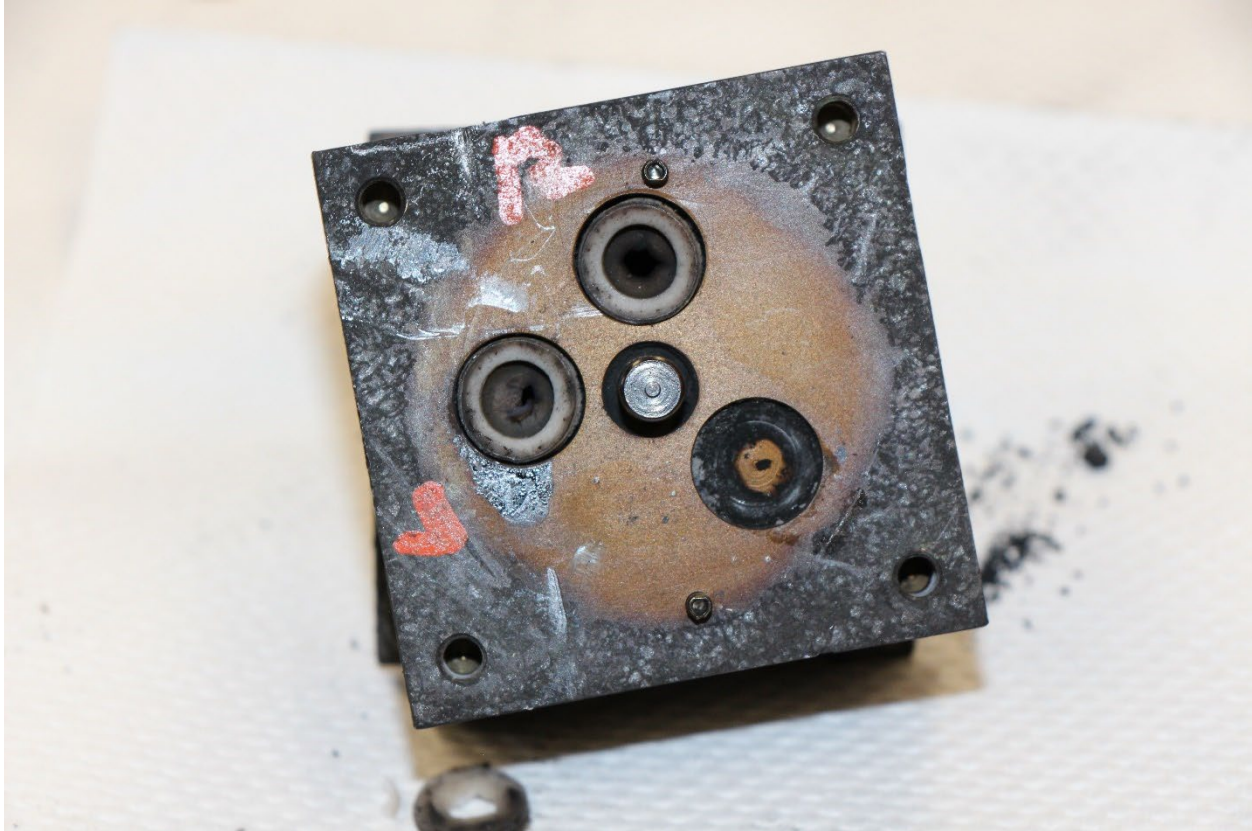
The fuel selector was in the OFF position and rotated normal from the OFF, LEFT, and RIGHT detents. Plastic white inserts were observed within the OFF, LEFT, and RIGHT ports of the selector case and all three inserts had partially melted.

*Photograph 3: Fuel selector case and plastic inserts*

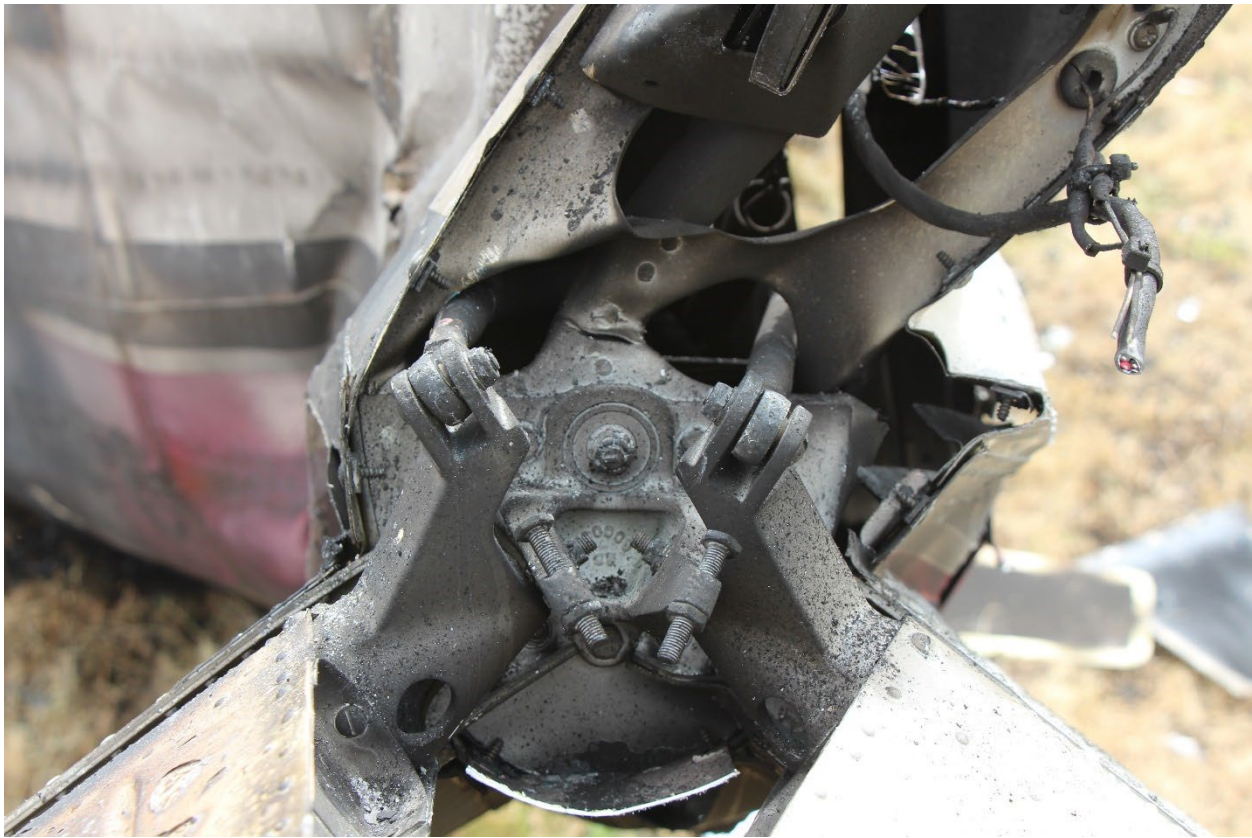
Flight control continuity of the right and left aileron and rudder/elevator control surfaces were traced from their control surfaces to the cockpit controls. The rudder/elevator differential bellcrank was intact; however, the left differential tail control rod separated at the differential mechanism and the right tail control rod partially separated about midspan. Both rudder/elevator control surface top and bottom stops were intact. The rudder/elevator control cables were continuous from the differential mechanism to the cockpit controls.

*Photograph 4: Differential tail control rod attachments to rudder/elevators torque fittings*

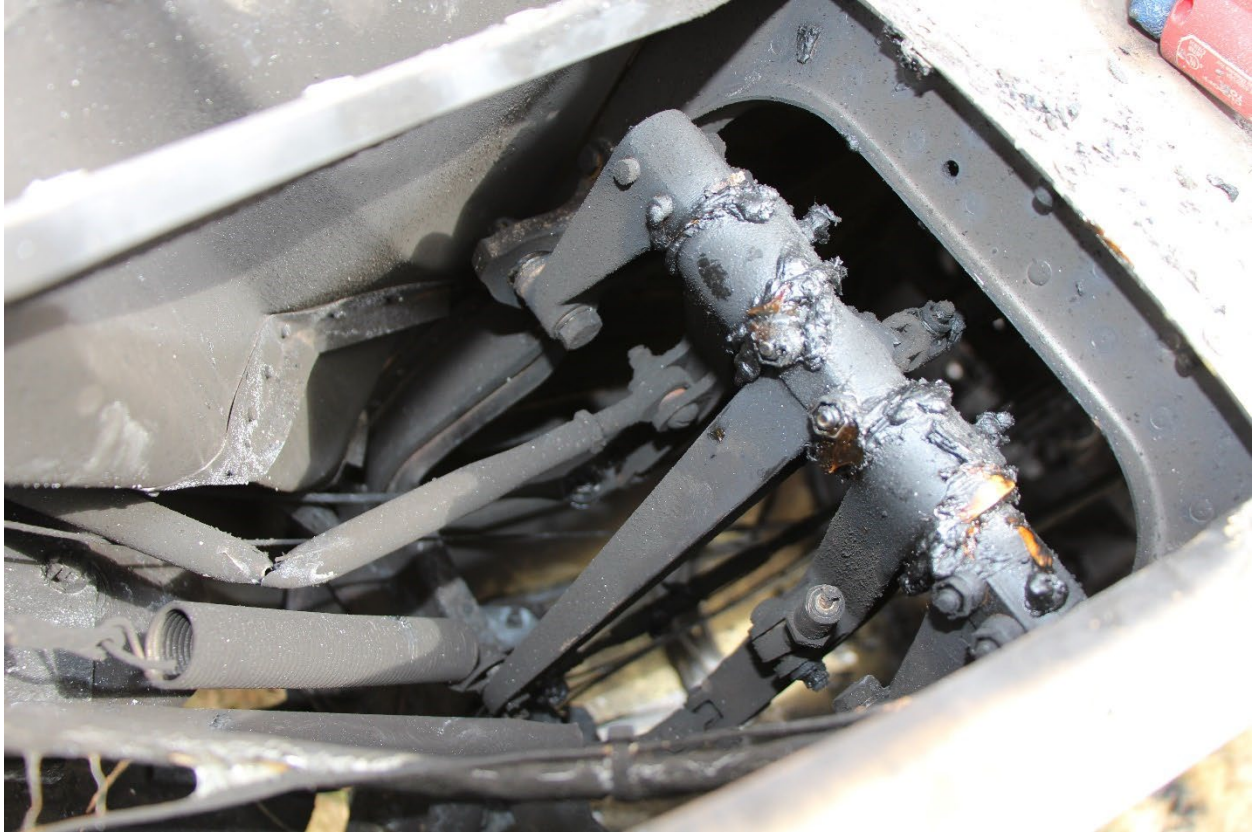
*Photograph 5: Differential mechanism and differential tail control rods*

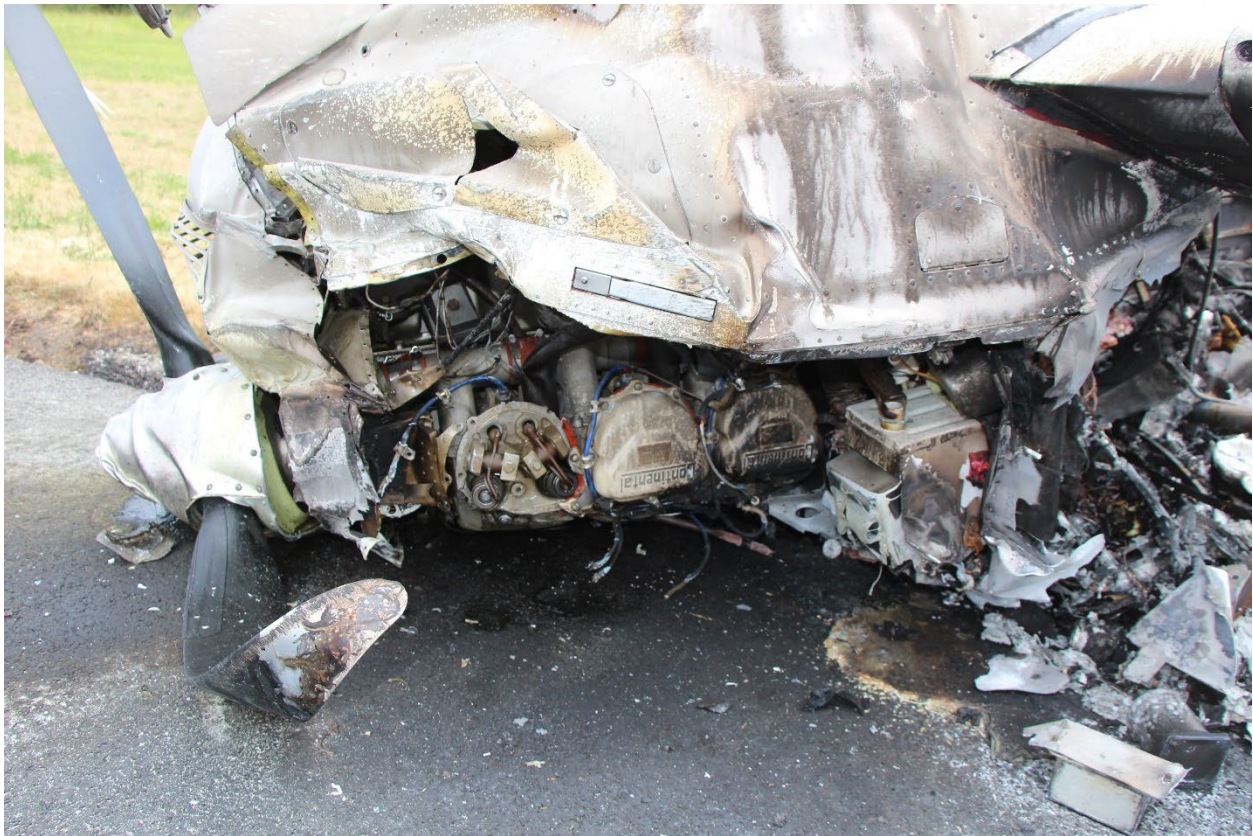
The airplane was equipped with a Continental Motors IO-520-BA (s/n 562396), a 285 hp, horizontally opposed, air cooled, reciprocating engine. The engine sustained thermal damage around cylinders 1 and 3. The engine firewall and lower cowling were both physically and thermally damaged. The propeller hub exhibited aft crush damage at the tip and was fractured. Most of the rocker covers were still attached with exception of box cover no. 5, which was recovered in the debris field at the accident site. Several of the top cooling fins for cylinder 5 were

bent and displayed evidence of scraping. The fin directly above the cylinder 5 top spark plug port was cracked. The cylinder 5 rocker arm was displaced from the valve stem and a portion of the cylinder case was bent over a portion of the spring, which partially inhibited movement of the intake valve for that cylinder. The exhaust and intake tubes for cylinders 2, 4, and 6 all remained attached; however, the exhaust tubes were all crushed about midspan as was the exhaust shroud. The intake tubes to cylinders 1, 3, and 5 were cracked at the engine case and their respective exhaust tubes were crushed.

Each of the 6 top and 6 bottom spark plugs were attached at their spark plug ports and secured in place. The top spark plug leads for cylinders 3 and 5 and bottom lead for cylinder 5 were completely separated. The bottom leads for cylinders 1 and 3 were attached and the top lead for cylinder 4 was partially attached. The top and bottom leads for cylinders 2, 4, and 6 were all attached and secured in place. Both the top spark plugs to cylinder 4 and 6 were canted and the top plug to cylinder 2 and the bottom plugs to cylinder 2, 4, and 6 were all straight. Each of the spark plugs was secured in its respective plug port.

*Photograph 6: Engine compartment at accident site*

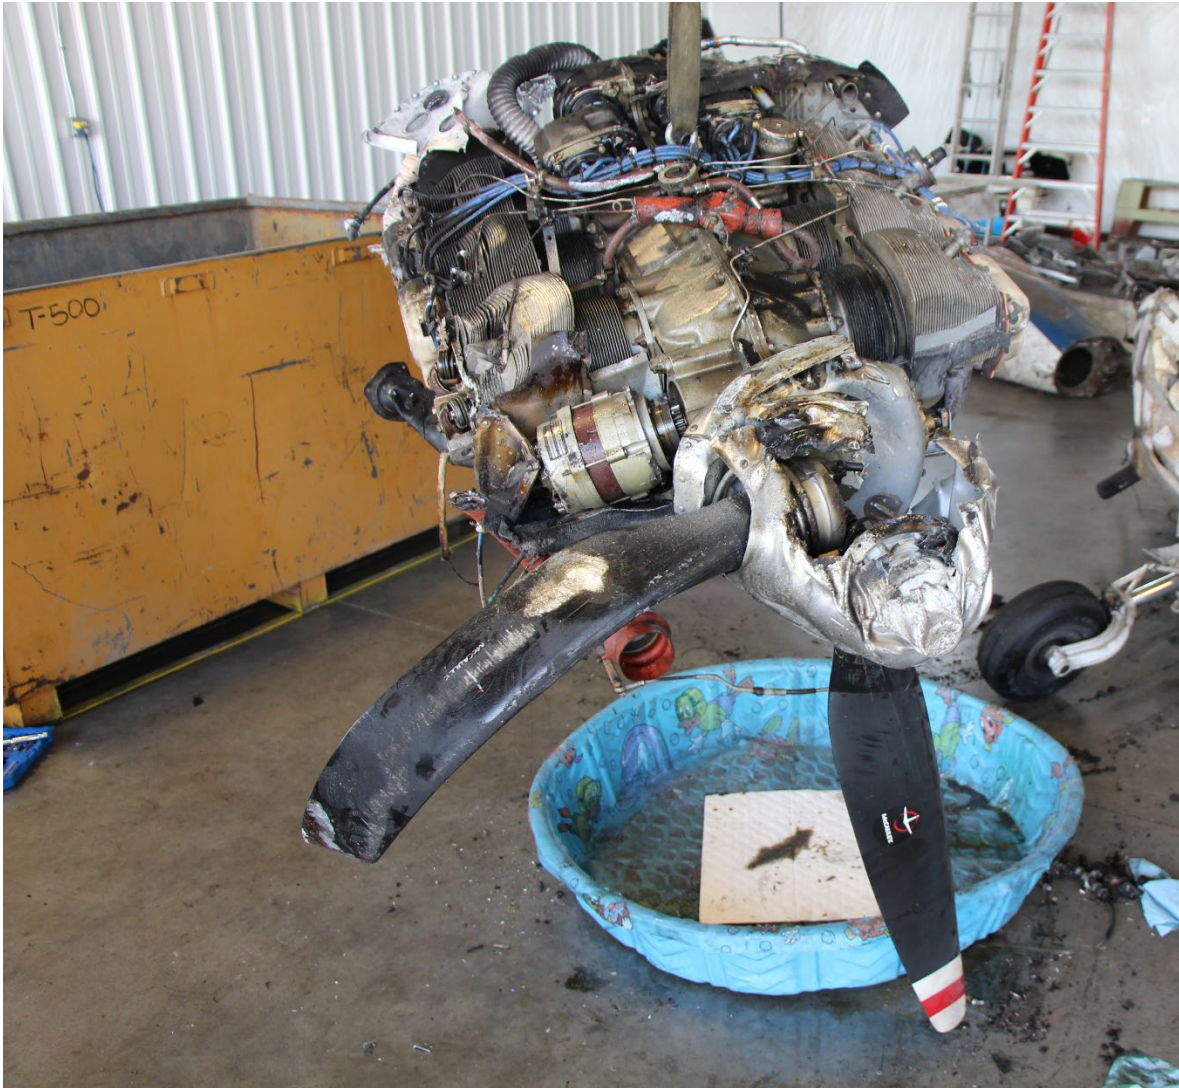
*Photograph 7: Hoisted engine prior to examination*

The crankshaft did not rotate smoothly and bound after a few rotations; however mechanical continuity was established throughout the rotating group, valve train and accessory section for cylinders 2, 4, 6, the exhaust to cylinder 1 and intake to cylinder 3 as the crankshaft was manually by hand at the accessory case using a drive tool. Continuity from the piston to the crankshaft for cylinders 1 and 3 were verified using a lighted borescope. Thumb compression was not achieved due to postcrash damage to the engine, but normal valve lift was observed at the intake and exhaust for cylinder 2, 4, and 6 and the cylinder 1 exhaust and cylinder 3 intake. Examination of the cylinders combustion chamber interior components using a lighted borescope revealed normal piston face and valve signatures, and no indications of catastrophic engine failure. Cylinder 6 was physically removed from the engine case and the piston, cylinder walls, and valve faces all exhibited normal wear.

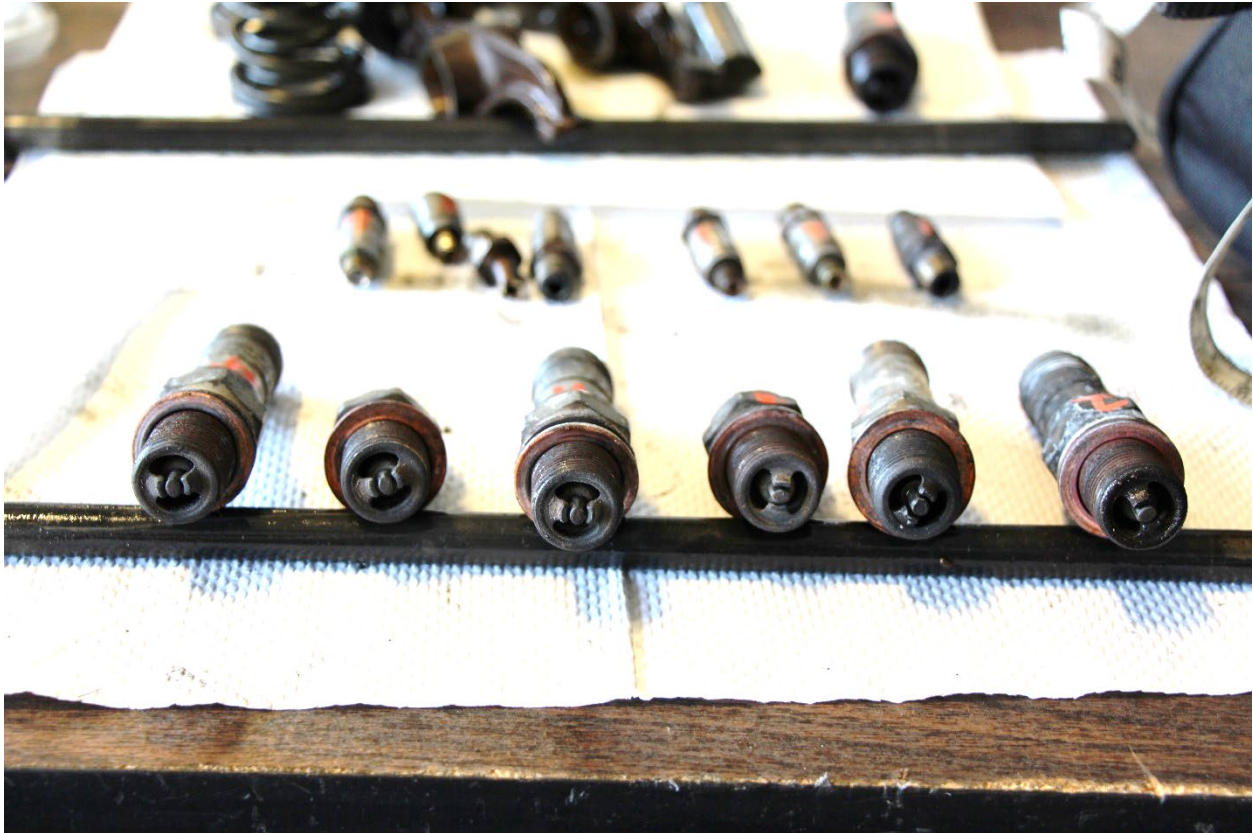
bound crankshaft. Both magnetos were removed and the ignition leads were cut; spark was observed at the cut ends of all 6 ignition harness leads as each magneto was rotated using a power tool. The top spark plugs were manufactured by Champion, and were model REM 32E two prong massive electrode plugs. Both the top plug to cylinder 1 and bottom plug to cylinder 5 were mildly oil fouled and the top plug to cylinder 2 was displayed mild carbon fouling. The top plugs to cylinder 3-6 were all gray in appearance, consistent with normal wear.

*Photograph 8: 6 Top Spark Plugs*

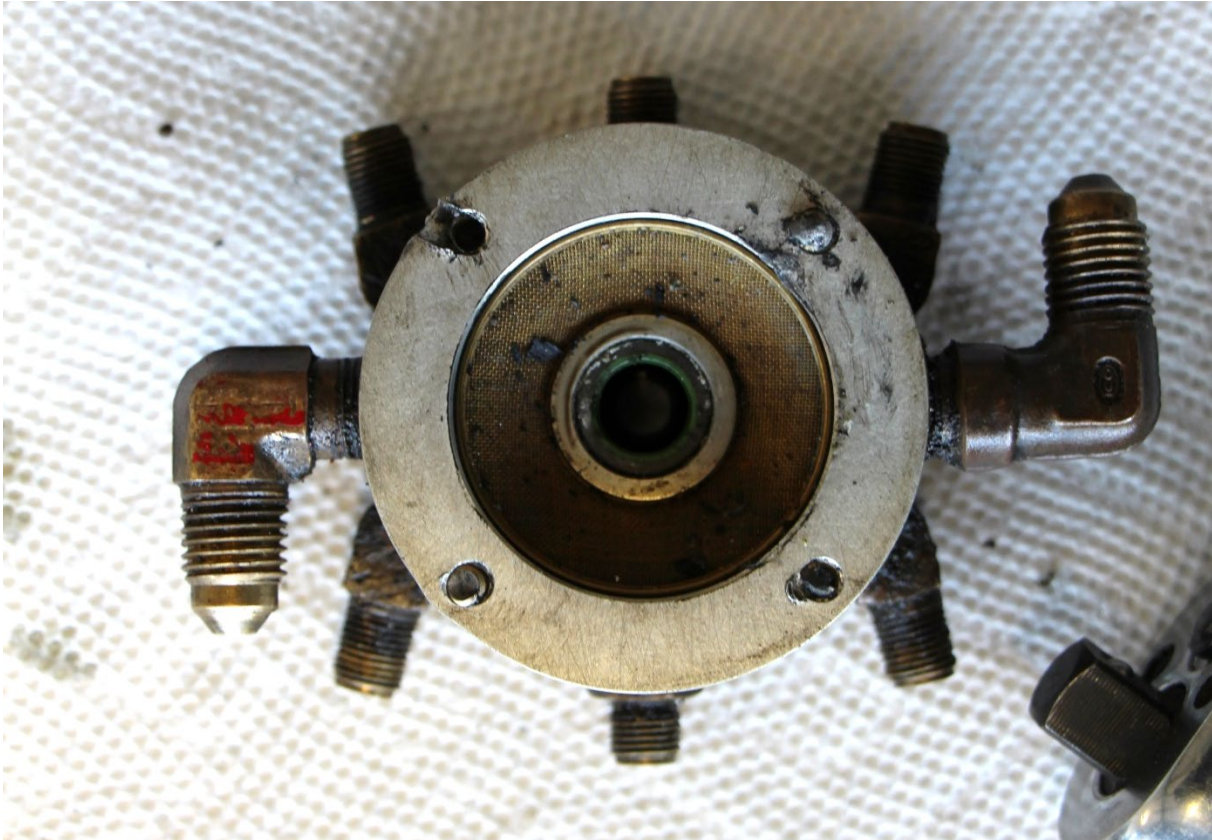
The flow divider remained partially attached to its mount the top of the engine case; the divider filter was free of debris and secured in place. The fuel pump was free of internal mechanical malfunction and obstruction to flow.

*Photograph 9: Fuel flow divider*

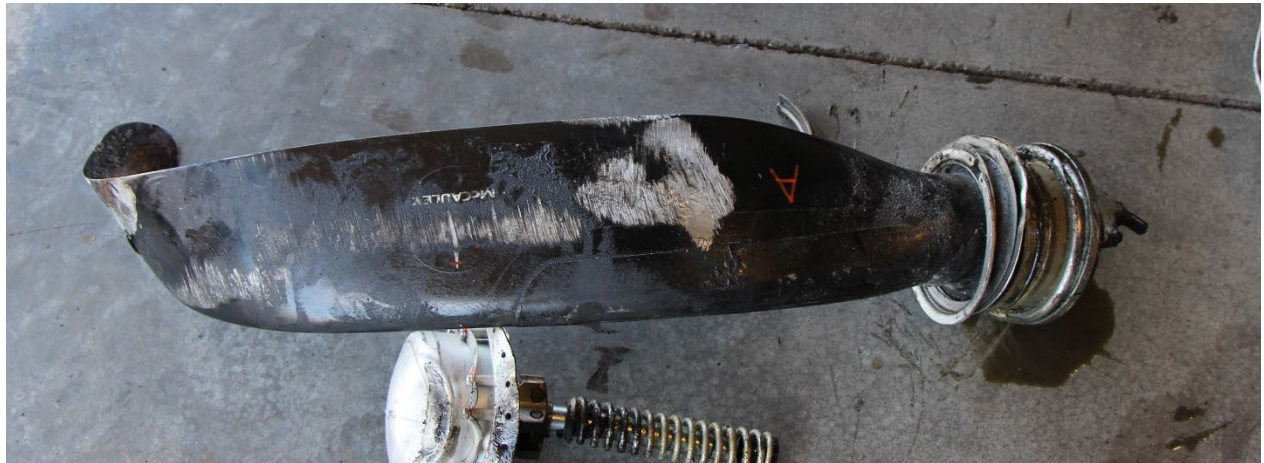
The 3 bladed constant speed propeller remained attached to the engine at the crankshaft. Propeller blade A was bent towards the blade face and exhibited tip curling also towards the face. Chordwise striations were observed along the camber side of the blade along with scraping. The other two blades were not bent. Blade B exhibited nicks and gouges along most of the leading edge of the blade.

*Photograph 10: Blade A with striations and tip curling*

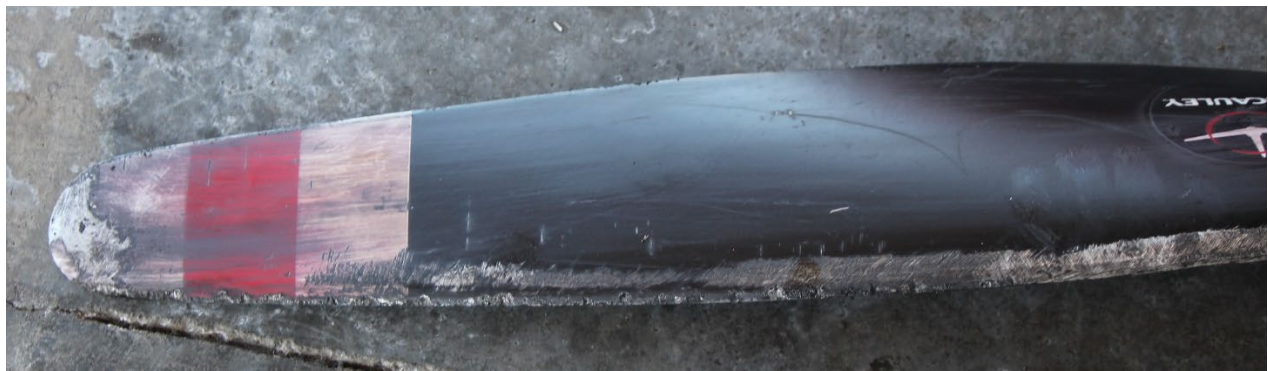
*Photograph 11: Blade B nicks and gouges and leading edge*
