NATIONAL TRANSPORTATION SAFETY BOARD
Office of Aviation Safety

Wreckage Examination Report

A. ACCIDENT WPR22LA196

Location: Oroville, California
Date: June 22, 2022
Time: 1218 PDT
Operator: Private
Aircraft: Beechcraft 19A Musketeer
Registration: N7641R

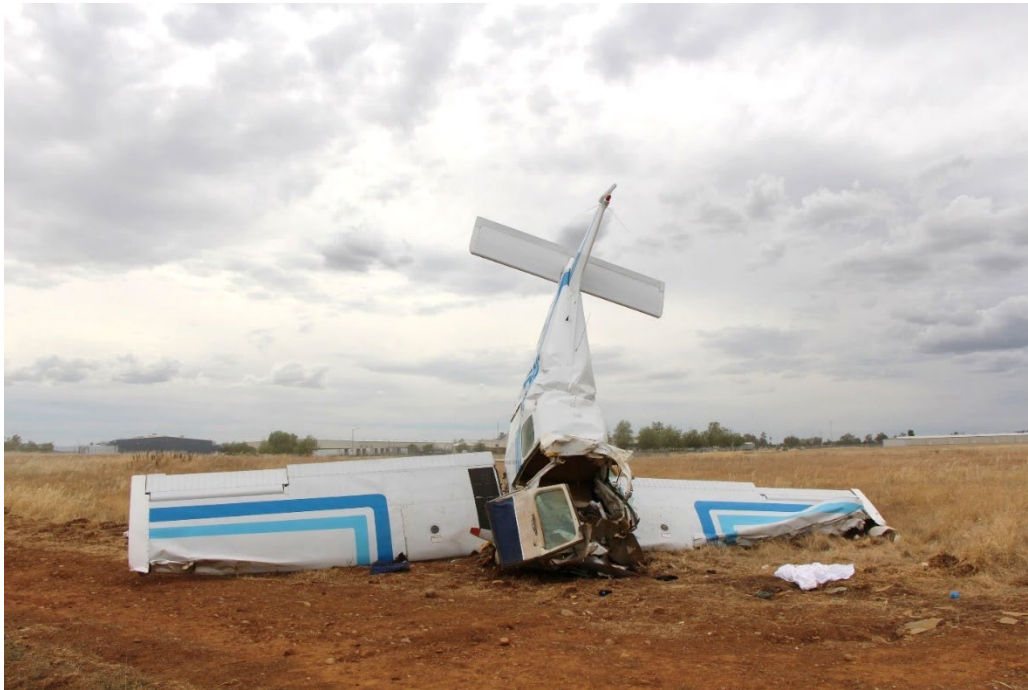
The airplane came to rest in an approximately 40° nose down attitude on a heading of about 097° magnetic, about 500 ft south of the departure end of runway 13. All major structures were accounted for at the accident site. The left wing remained attached to the fuselage, and the right wing was partially separated at the wing root. The fuselage frame was deformed about midspan and the tail was canted slightly left of the fuselage. Both the stabilator and rudder remained connected to the empennage at their attachments. The engine remained attached to the engine firewall, which was wrapped around the engine accessory case. Both propeller blades remained attached to the propeller hub, which was still connected to the engine crankshaft.

Photograph 1: Accident site from the southeast

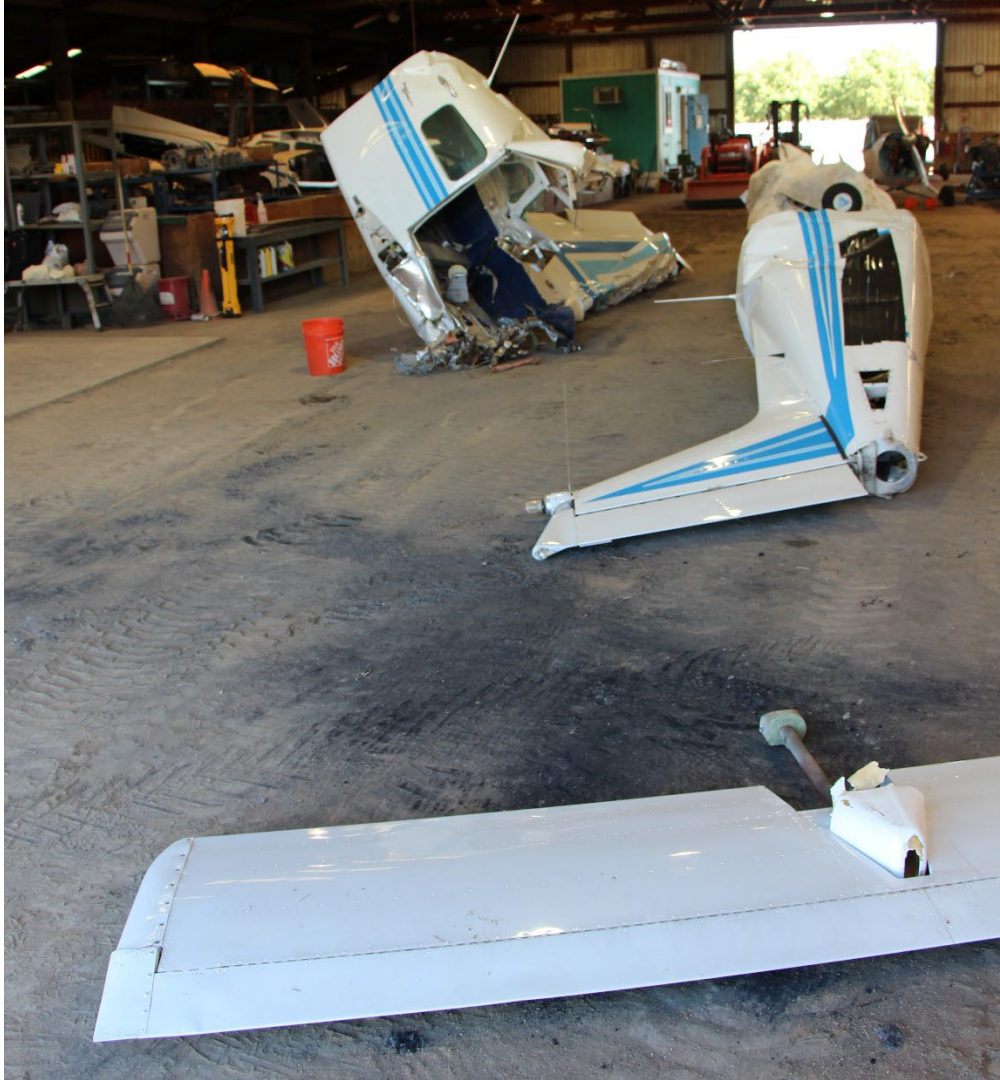
Photograph 2: Accident airplane prior to examination

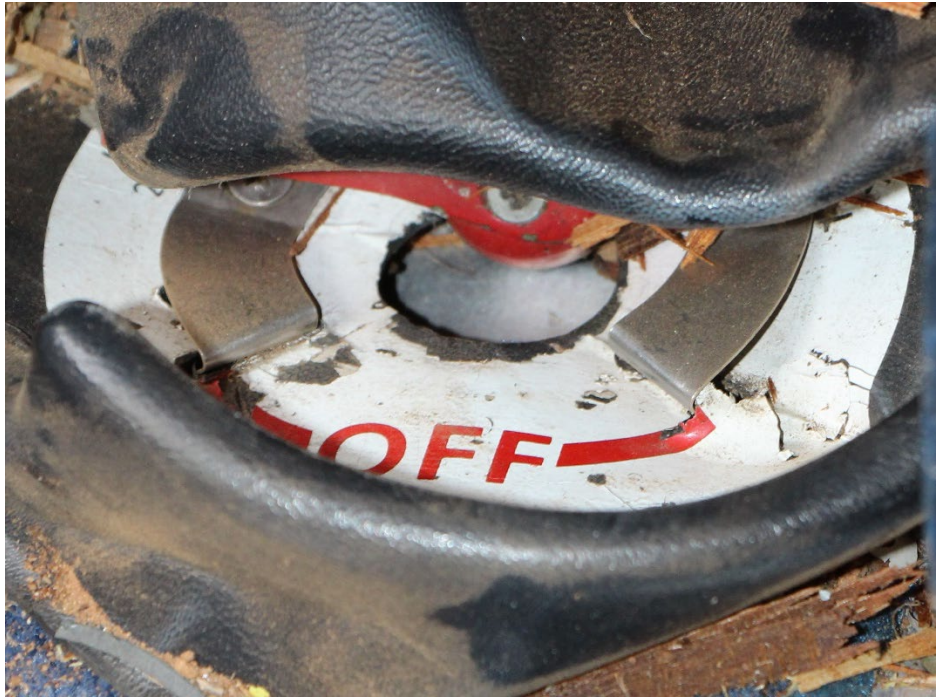
Continuity of the fuel system was traced from a fractured line at the right wing root to the fuel selector and from the left wing root to the fuel selector. The fuel selector was found in an intermediate position between the OFF and RIGHT fuel tank positions. The cockpit floor at the fuel selector displayed upward bending in a photograph taken at the accident site (see photograph 3). The fuel selector was removed from the cockpit and disassembled during the postaccident wreckage examination. The selector moved throughout each of the 4 detents (RIGHT, LEFT, OFF, and OFF) with resistance. Disassembly of the unit revealed metallic particles along the circumference of the LEFT, RIGHT, and ENGINE ports, but none of the ports were obstructed. The selector was an OEM product.

Photograph 3: Fuel selector at accident site

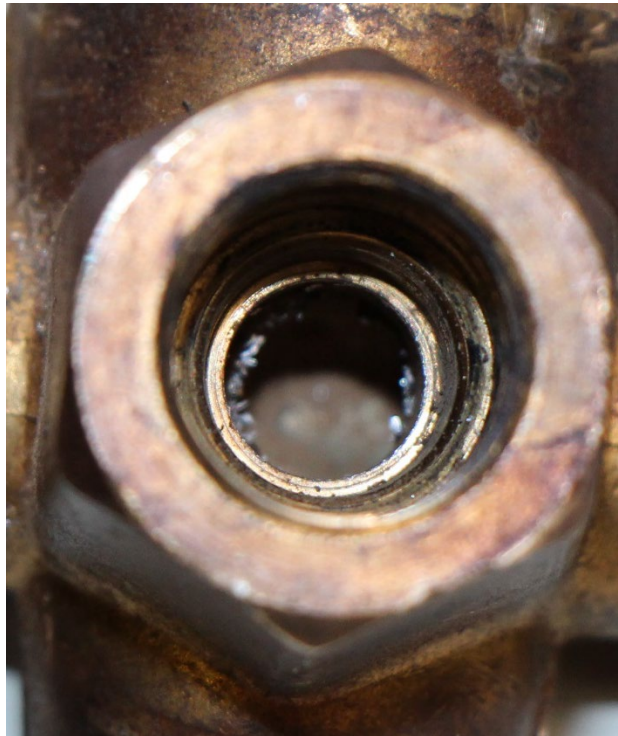
Photograph 4: Engine port with particles

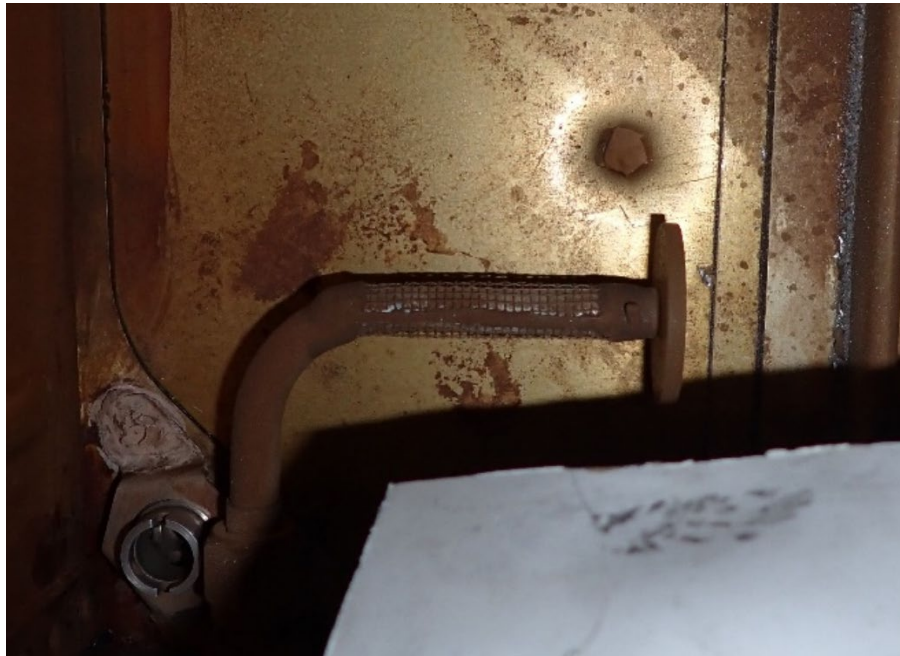
An internal examination of the left wing revealed dirt along the outer shroud of the fuel screen, but was free from internal obstructions.

Photograph 5: Left fuel tank fuel screen

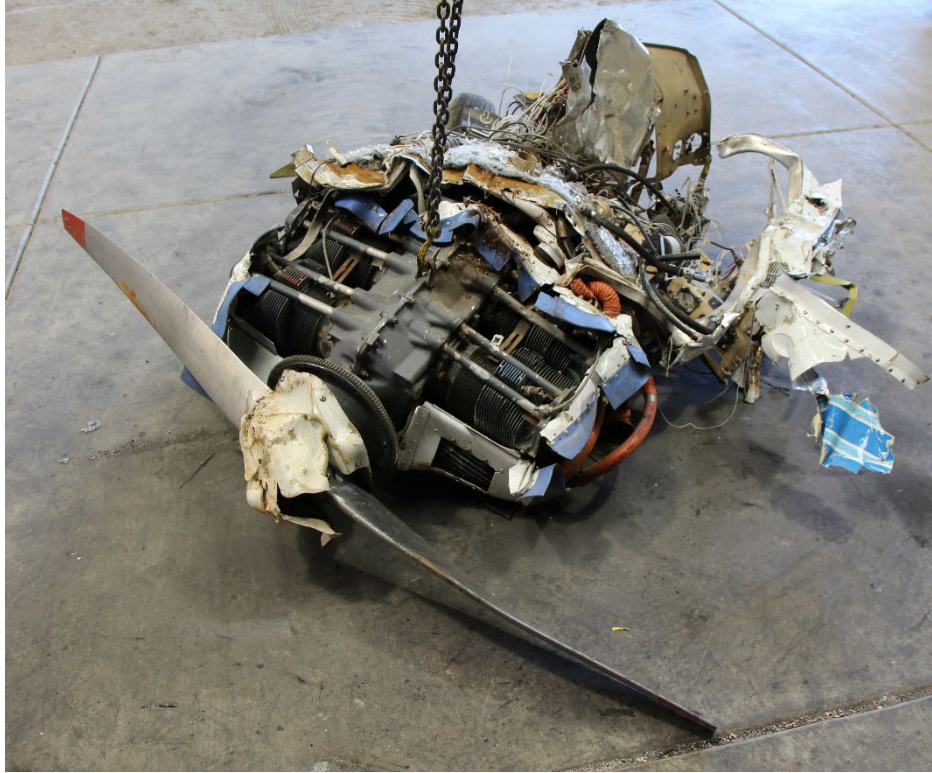
The engine was a Lycoming Engines O-320-E2D, s/n L-24111-27A, an air-cooled, 160 hp reciprocating engine. The engine was converted from 150 hp through supplemental type certificate, SE3692SW-D. The engine baffling was damaged. The left side muffler was crushed and the right side muffler sustained impact damage. The engine flywheel was fractured. The accessories remained attached to the engine case. The no. 1, 2, and 3 exhaust tubes were damaged.

Photograph 6: Engine prior to examination

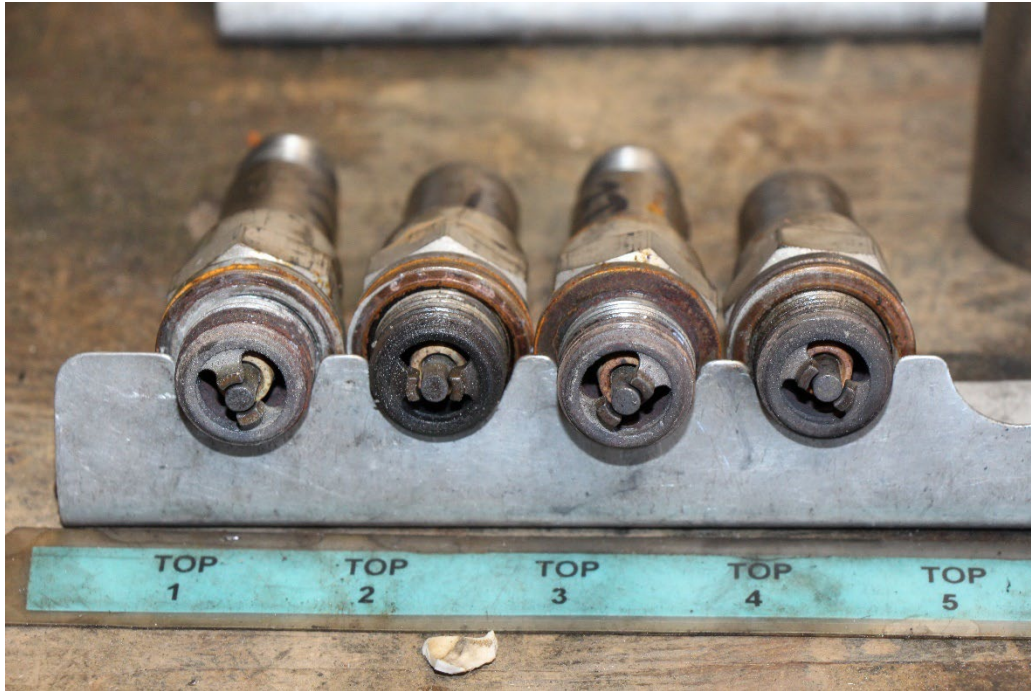
Both magnetos were securely clamped at their respective mounting pads. The left magneto was a Slick Aircraft Products model no. 4371. The right magneto was a Slick Aircraft Products model no. 4370. The magneto to engine timing was approximately 25° BTDC. The magnetos were timed within 1° of each other. Each of the ignition harness B nuts were secured at their respective spark plugs. The top ignition harness coils to cylinder nos. 2 and 4 were separated at their spark plugs. Both magnetos were subsequently removed and the ignition leads were cut. The left magneto impulse coupling was heard as the gear was rotated by hand. Spark was observed at the cut ends of all 8 ignition harness leads as each magneto was rotated by hand. The top spark plugs were manufactured by Tempest, model UREM 40E massive electrode plugs. Each of the 4 spark plugs exhibited normal wear and were free of mechanical damage.

Photograph 7: Top spark plugs

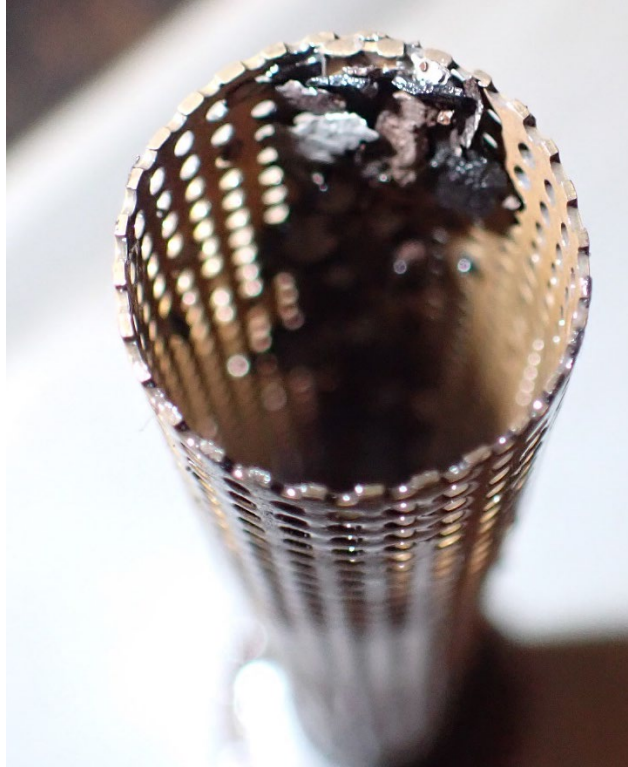
The oil suction screen contained some non-metallic fragments with few magnetic fragments.

Photograph 8: Oil suction screen and particles

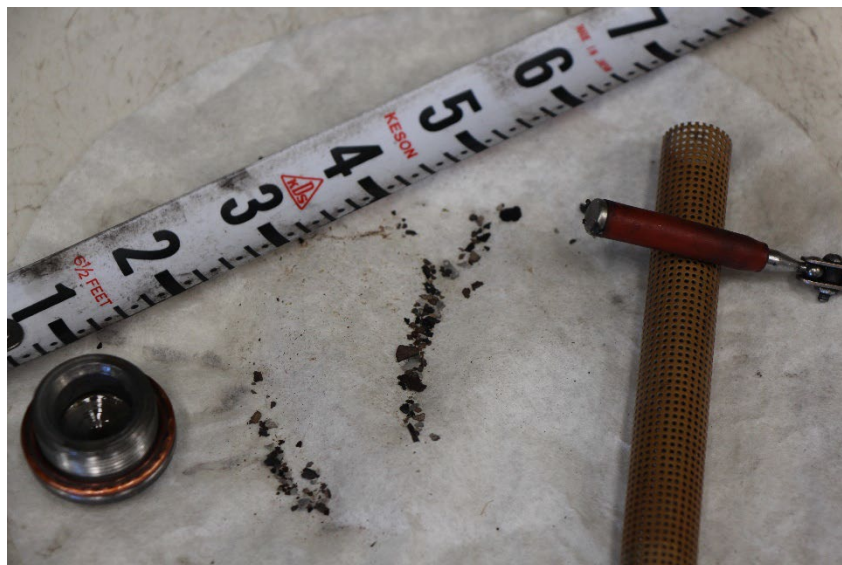
Photograph 9: Oil suction screen particles removed from screen

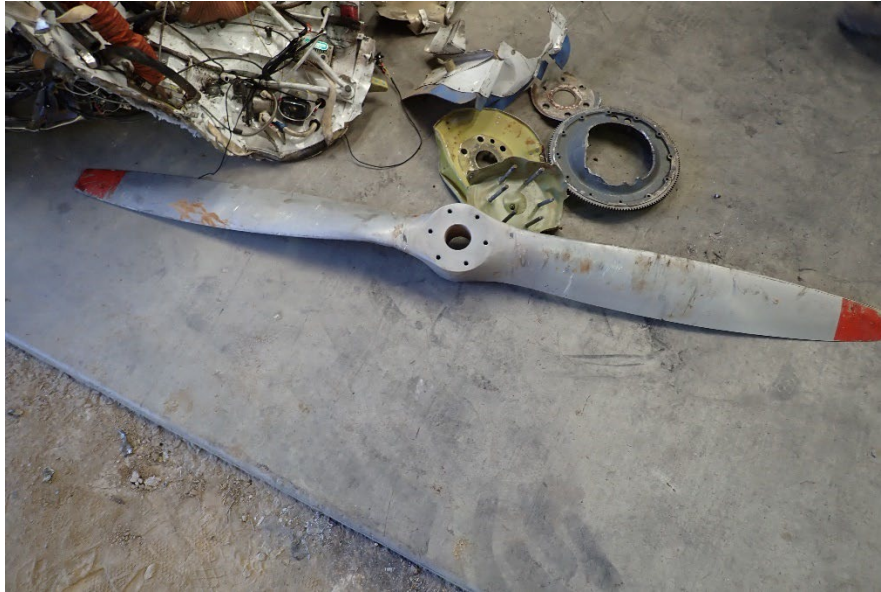
The two bladed fixed pitch propeller remained attached at the crankshaft flange. Both blades remained attached to the hub and the metal propeller spinner was crushed. The blades remained continuous from tip to tip. The propeller remained undamaged.

Photograph 10: Two bladed propeller
